**New Multi Product Pipeline
(NMPP) Project**

The Mitigation Of All Heritage
Sites Affected By The NMPP

2684358-UM-PL1- ENV-RP-002

<Heritage Impact
Assessment >

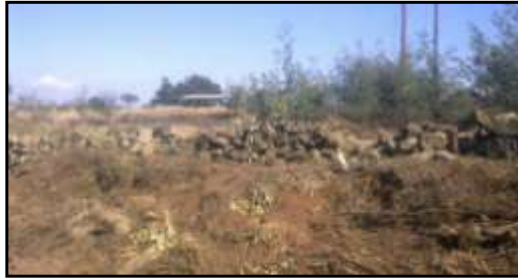
Fig. 72: Vegetation Clearance Exposing Southern Wall at GLK097

Unfortunately the wall was bulldozed by a further 12m – 15m by one of the construction teams. Transnet then had to pay for the rebuilding of both walls, and a building company who had some experience in dry stone walling was hired to complete the walls under our supervision. Figures 76 – 78 show the rebuilding of both walls.

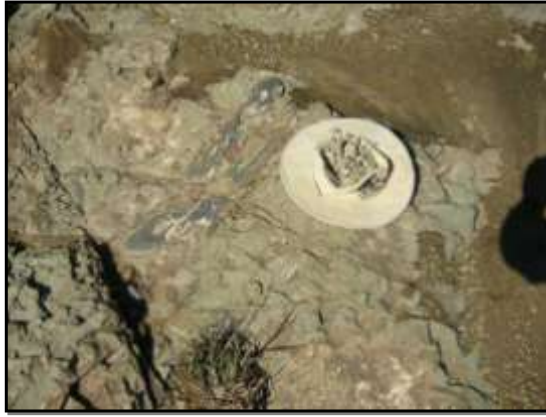
- 191 to 195
 - Weathered Beaufort Group mudstone with prominent layers of plant rich material (Fig. 154). Glossopteris flora recorded. Thin zones of "algal" mats and Stromatolite structures. One record of bone fossils - very small - possibly bony fish. Remains too damaged for identification (Fig. 1556).
 - Located at 29 03' 44.03"S 29 56' 24.58"E
- 196 to 200
 - Deep soil on Beaufort Group mudstone. Field inspection on RoW completed. No indication of fossil remains.
- 200 to 211
 - Beaufort Group mudstone and dolerite outcrop areas. Large concretions with potential for fossils of Dicynodon lacerticeps - no remains recorded during field inspection on Saturday 20 March 2010. Lystrosaurus fossils recorded (Fig. 157) from high ground to the west of the RoW as would be expected. Fossils collected for confirmation of species at BPI Wits.

Fig. 153: Glossopteris Flora (Fossilised Tree) between Points 191 -195

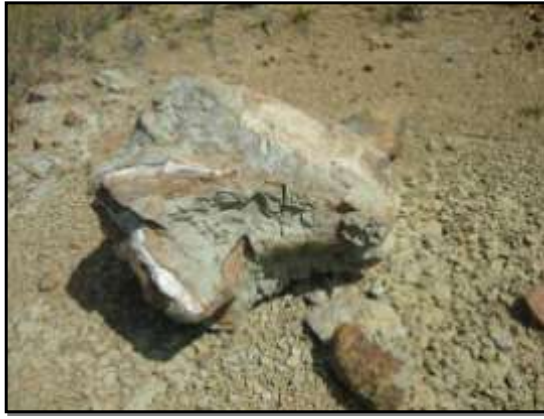
Fig. 155 Lystrosaurus Skull, Recorded outside of the RoW at KP209

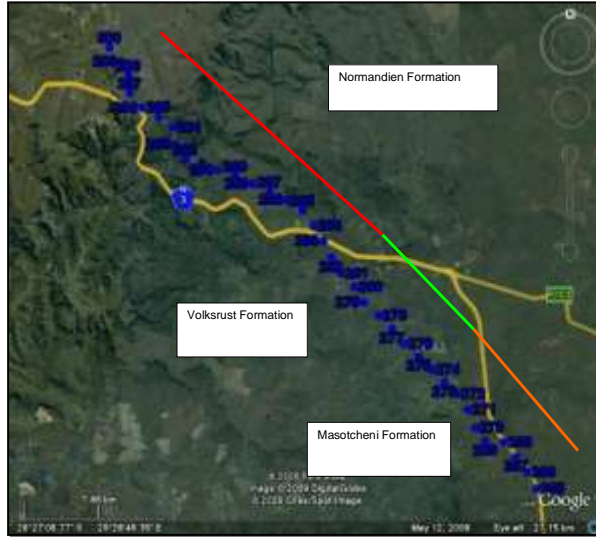
Fig. 158: Pipeline Route from Bergville Toll Plaza to Van Reenen

Inspection of the low lying areas RoW before clearing did not reveal any *in situ* fossils and most of the fossil plant material are related to pieces of petrified trees that occur higher up in the sequence of the Normandien Formation. Inspection of the entire escarpment revealed extremely weathered character of the entire Normandien Formation. It is characterised by deep weathering with very few rock outcrops. Broken pieces of fossil wood abundantly present in the field on the last section of the route.

The contractor was however made aware of the fact that this section of the pipeline will cross several extinction zones and that he should record the presence of tree fossils which are abundantly present in this geological sequence. Fossilised remains of *Dicynodon lacerticeps* and *Lystrosaurus* Assemblage Zones are present in the outcrops area away from the RoW and it is noteworthy that the excavators did not encounter some concretions with fossils of both assemblage zones.

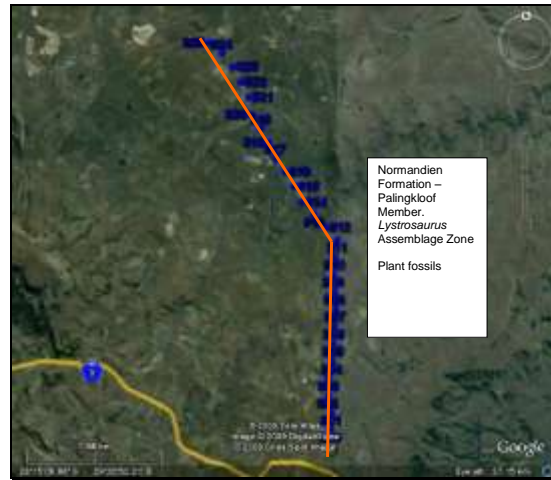
Fig.159: Pipeline Route from Van Reenen to Kiesbeen

Section inspected and no fossils recorded before clearing of RoW. Outcrops of *Dicynodon lacerticeps* Assemblage Zone observed very close to route at GPS 28° 09' 13, 4' S; 29° 18' 33, 6' E. Subsequent inspection during excavations revealed that although the excavation is highly destructive, some of the concretions are resistant and are left in the spoil as boulders. Further inspection of these concretions might lead to the discovery of *Lystrosaurus* sp.

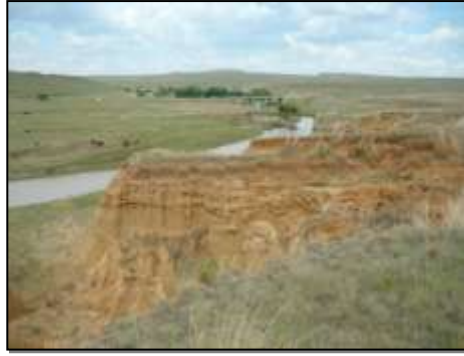
KP Numbers	Type of fossil observed in field	GPS
331 to 340	Field inspection completed. Outcrops of <i>Dicynodon lacerticeps</i> Assemblage Zone very close to the route at KP335. Well preserved fossils of wood and remains of <i>Dicynodon lacerticeps</i> bones at KP340. (Fig. 161)	Fossil Wood 28 01 45,7S 29 14 58,3E Skull Material 28 01 43,9S 29 14 58,8E Skull Material 28 01 37,2S 29 15 01,7E Fossil Bones 28 01 36,5S 29 14 53,7E Body Fossil 28 01 36,8S 29 14 53,7E
341 to 350	Field inspection completed. Outcrops of <i>Lystrosaurus</i> Assemblage Zone with very well preserved fossil material. Fossils occur in well-defined concretions that will be recognised as hard blocks by contractors at KP 343 (Fig. 162). The concretions are silicified and might damage the teeth of the digging machine and need to be assessed by the responsible engineer before excavations.	5 x Skull Material 28 00 11,0S 29 15 3,45E 2 x Skull Material 27 59 14,12S 29 11 17,20E

Figure 161: Outcrop at Meul River where 5 Fossils were recorded – Point 340

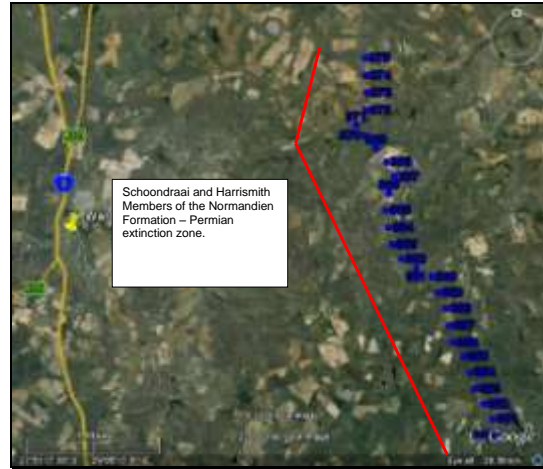
Fig. 163: Pipeline Route from Meul River to Warden

Inspections indicated deep soil with very few outcrops and dolerite outcrops that will not have any fossils at most of the alignment. The Normandien Formation mudstones found were deeply weathered. Fossils were recorded from zones associated with KP371. These included skull material recorded at 27° 45' 47,3" S and 29° 16' 23,9" E. Silicified concretions found and moved were extremely big (6 000 mm long and 500 mm thick) because it might damage the teeth of the digging machine.

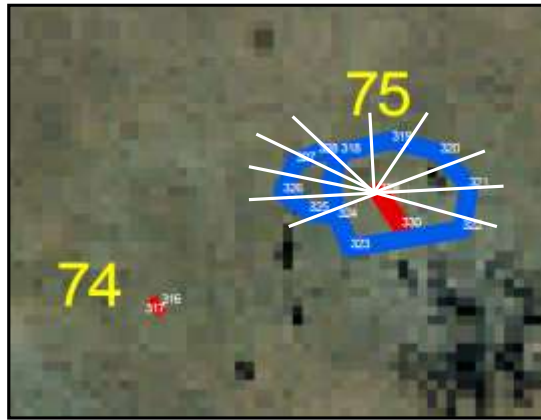
Fig. 176: Excavation Lines at GLK066_75

Umland placed several excavation lines in a wheel spoke alignment from the middle of the byre, for the assessment (fig. 176 - 177). The excavations used the site map (fig. 174) to determine where the walling would occur. The excavations went down to the original surface – visible by the layer of grass. If the stone wall existed, then the excavation lines would locate an *in situ* wall. If no walling was observed, then it implies that it has been removed by the RoW clearance.

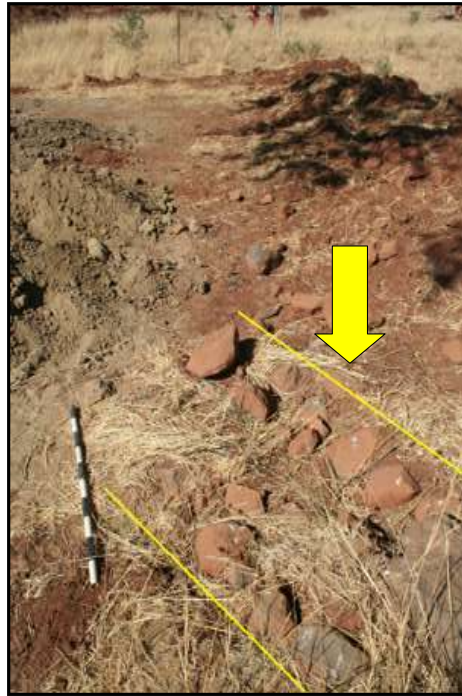
Fig. 177b: Excavations and Remaining Part of Stone Wall at GLK066_75

The excavations located parts of the primary wall. These remains were the basal stone layer. Most of the secondary wall has been cleared and I only located isolated stones. It appears that at least 75% of the byre has been damaged in some manner. Fig. 177b shows parts of the undamaged wall. It is not possible to repair the byre wall.

²² Yellow line = location of stone wall; yellow arrow = undamaged stone wall

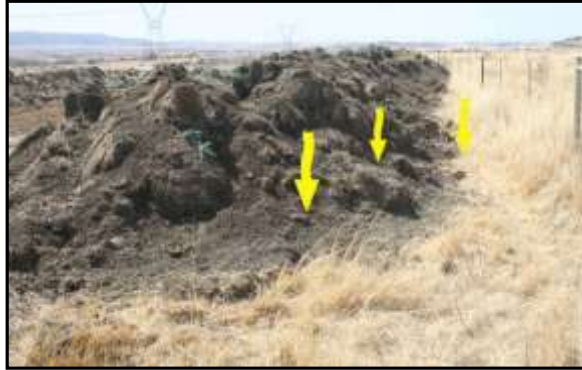
Fig. 181: Location of GLK118_96

The initial site inspection could not locate the graves, or their markers, however, the grave was later located with the surveyors using our previous survey data. The grave was covered with the topsoil (fig. 181). The graves were located and the topsoil was removed to expose the graves.

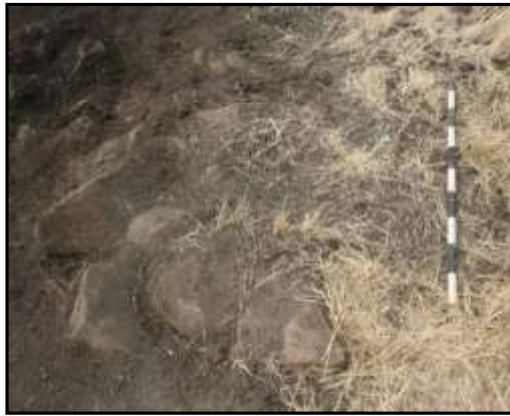
Fig. 182: GLK118_96 Grave after Cleaning

Assessment of Damage: The graves were technically not damaged and have been cleaned. The associated walling was also cleaned. There was however, an infringement on the site and this forms part of the pattern of demarcated heritage sites being ignored by the contractor.

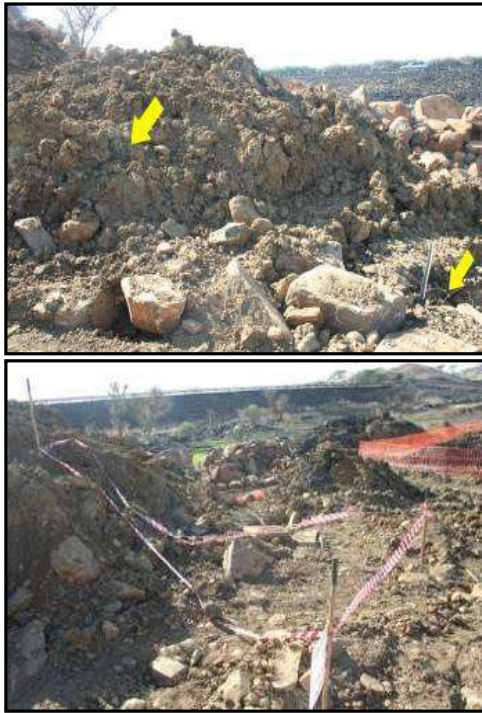
The possible grave has been damaged in several ways. The fenced off area has been ignored and damaged. The stone cairns are visibly missing due to trenching spoil material being placed on top of it (fig. 190). Site instructions were given for the grave to be covered with protective material during blasting activity; however, I am not sure if this was undertaken. All work activity in the area of the grave had to cease until further notice as from June and a site directive for this was given from Transnet. This meant that the pipe could not be placed into the trench, nor could any backfilling occur. The site was visited in early July with the surveyors to demarcate its extent. At this stage, the pipe had not been placed into the trench. When Umlando visited the site in mid-September, the pipe had been placed into the trench, and the trench had been backfilled (fig. 191). This was undertaken without Umlando's permission, as they had not yet mitigated the site. There was thus a disregard for Transnet's and my directives. One reason for closing the area off was that human remains may be scattered and construction work would further affect these remains.

Fig. 190: Stockpile over Demarcated Fencing²⁵

²⁵ Yellow arrow indicate original fence poles
Document Location On J: Drive
224

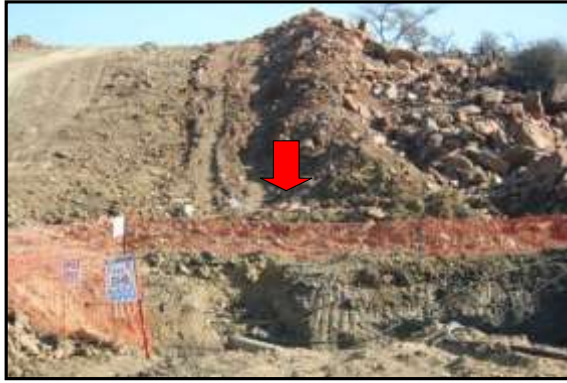
Fig. 191: Backfilling after the Area Had Been Closed²⁶

²⁶ Red arrow indicates the location of the possible grave.

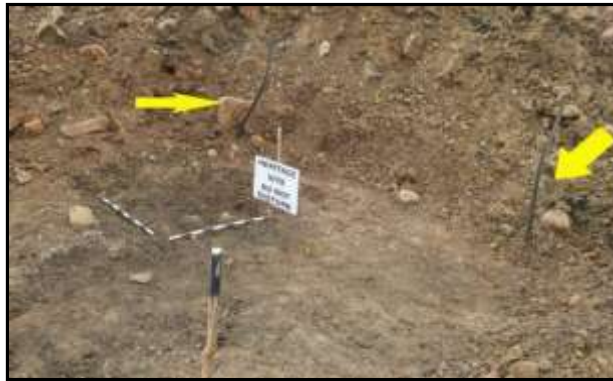
The trenching team has removed the poles demarcating the outer edges of the grave. The demarcated area was cleaned of the stockpile and the some of the original cairns were exposed (fig. 192). Some of the rocks are missing. I placed some stones to indicate the position of the possible grave (fig. 193). The area was also blasted without permission from me, as I was concerned the blasting debris would affect the grave. This email was dated 27/03/2010. NMPP then informed the various people (28/03/2010) to liaise with me regarding my concerns. This never occurred, and the blast went ahead without the possible grave being protected.

Fig. 192: Possible Grave Is Exposed²⁷

²⁷ Yellow arrows indicate the original fencing poles
Document Location On J: Drive
225

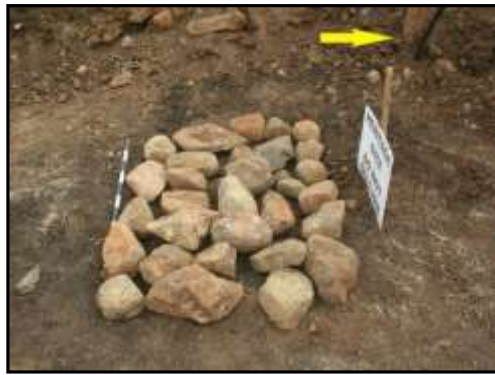
Fig. 193: Possible Grave with Stones Demarcating the Area

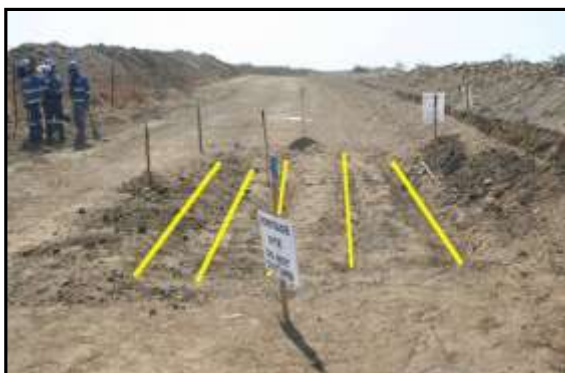
The stonewalling has had topsoil placed over the walls since RoW clearance. The cairn (fig. 197) does not exist anymore and Umlando had to relocate the ends of the grave with our survey data. I placed several trenches in the area of the poles to determine if any form of stone cairn or burial could be seen (fig. 198). It appears that the entire cairn has been removed and Umlando could not locate a burial pit. There was no change in

Assessment of Damage: The entire cairn has been removed and presumably the grave itself.

Fig. 198: Poles Indicating the Extent of the Grave and the Excavation Trenches

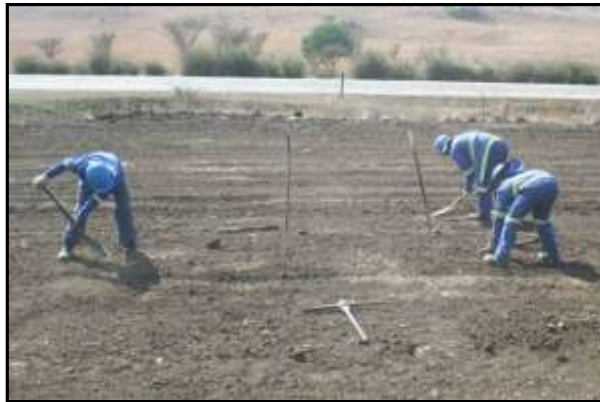
The stone cairns are missing due to additional construction activity. The excavations could not locate any concentration of stones, although two possible areas were noted (fig. 202). I believe that these two possible areas are the result of natural rock formations and not the graves. The area was fenced off after the excavations. The grave ~50m uphill was not damaged.

Fig. 201: Cleared Area Where the Grave Occurred

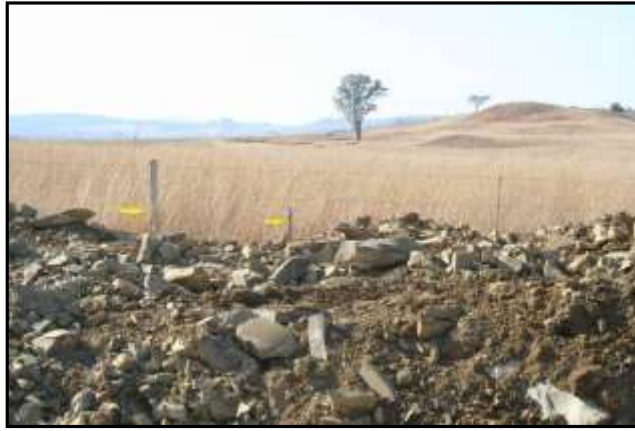
The grave was demarcated with metal and wooden poles and was fenced off before the RoW clearance (fig. 206 shows the grave in 2009). Two HIA were on site during RoW clearance. Subsequent to RoW clearance, the grave was covered by trenching spoil (fig. 207). This is the first grave of the damaged sites that has definite living descendents. Transnet may need to compensate the descendents.

Fig. 207: Trenching Spoil over Graves at GLK063a Grave 16a

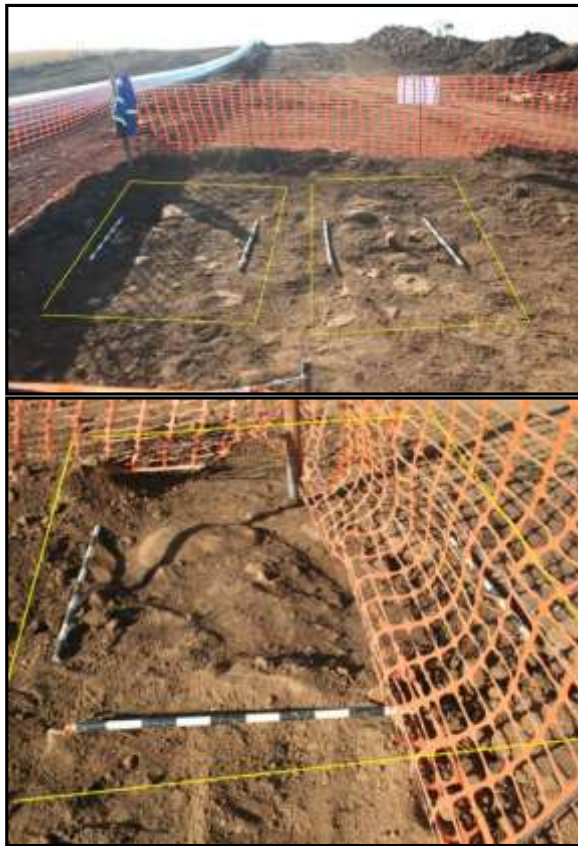
The excavations yielded three possible localities for the grave (fig. 212). These do not; however, appear to be the graves themselves.
Transnet may be required to undertake a social impact assessment to determine if any living relatives claim this grave.

Assessment of Damage: The grave does not exist anymore

Fig. 212: Possible Locations of the Grave KP189.300

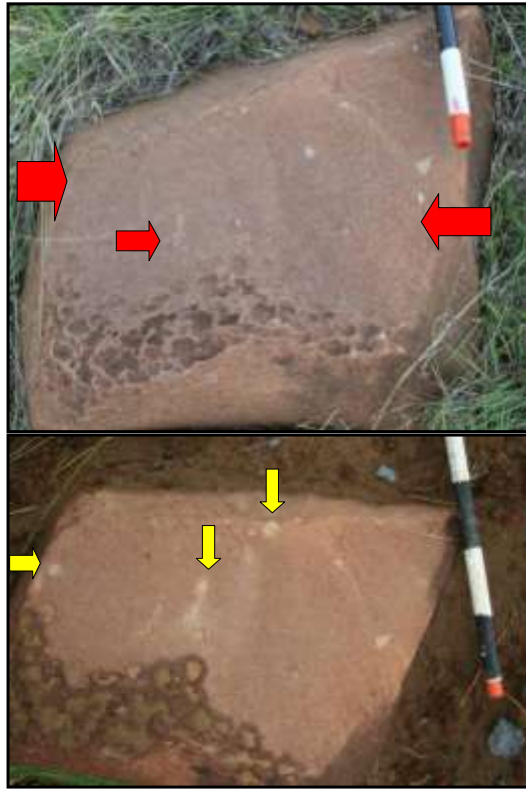
Fig. 217: Before/After Images of GLK078_290_WP20³⁴

³⁴ Yellow arrow = impact points, red arrow = area of engraving
Document Location On J. Drive

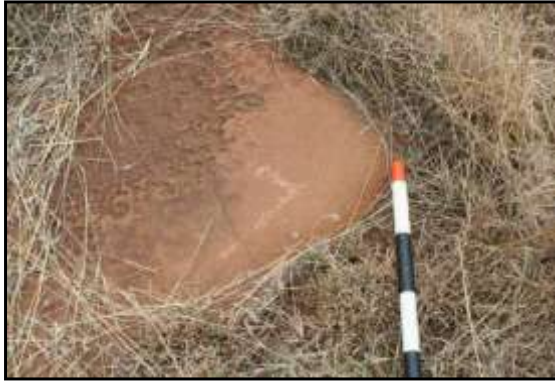
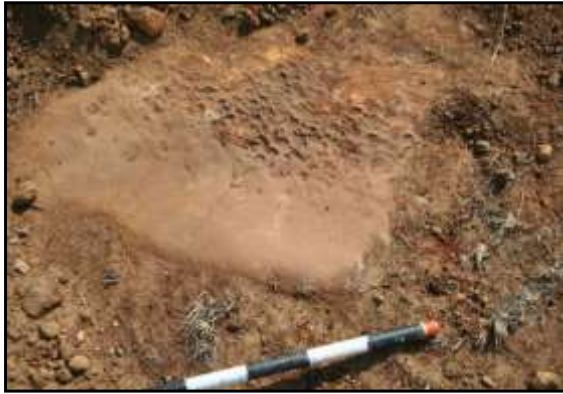
Fig. 218: Before/After Images of GLK078_291_2119

Engraving 2119 (fig. 217) consists of a semi-rectangular pecking. It has not been damaged even though it was at the bottom of the spoil heap.

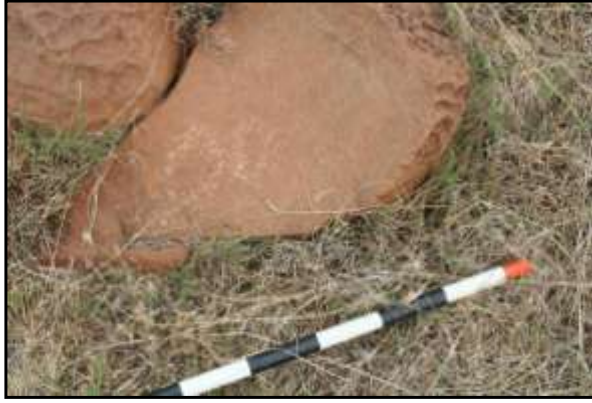
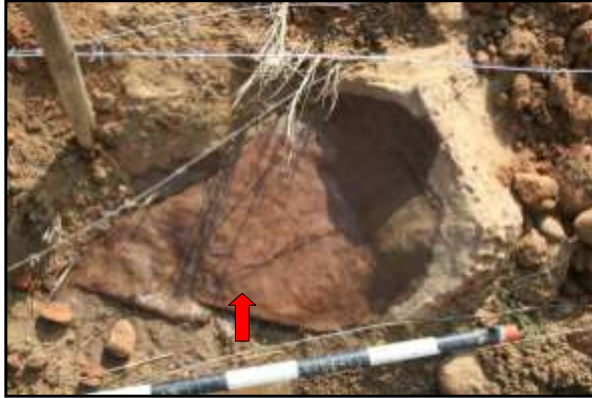
Fig. 219: Before/After Images of GLK078_291_2120

Engraving 2120 (fig. 218) consists of two oval circles that have been pecked. The engravings have not been damaged despite being underneath the spoil heap. The 'after' photograph in fig. 48 does not show the engravings clearly. This is because it had rained and the soil was muddy and had slightly stained the engraving. I tried to wash off the mud but it did not work. The engravings are however visible on site.
