**New Multi Product Pipeline
(NMPP) Project**

Mitigated Heritage Sites
Damaged by the NMPP

2684358-UM-PL1- ENV-RP-001

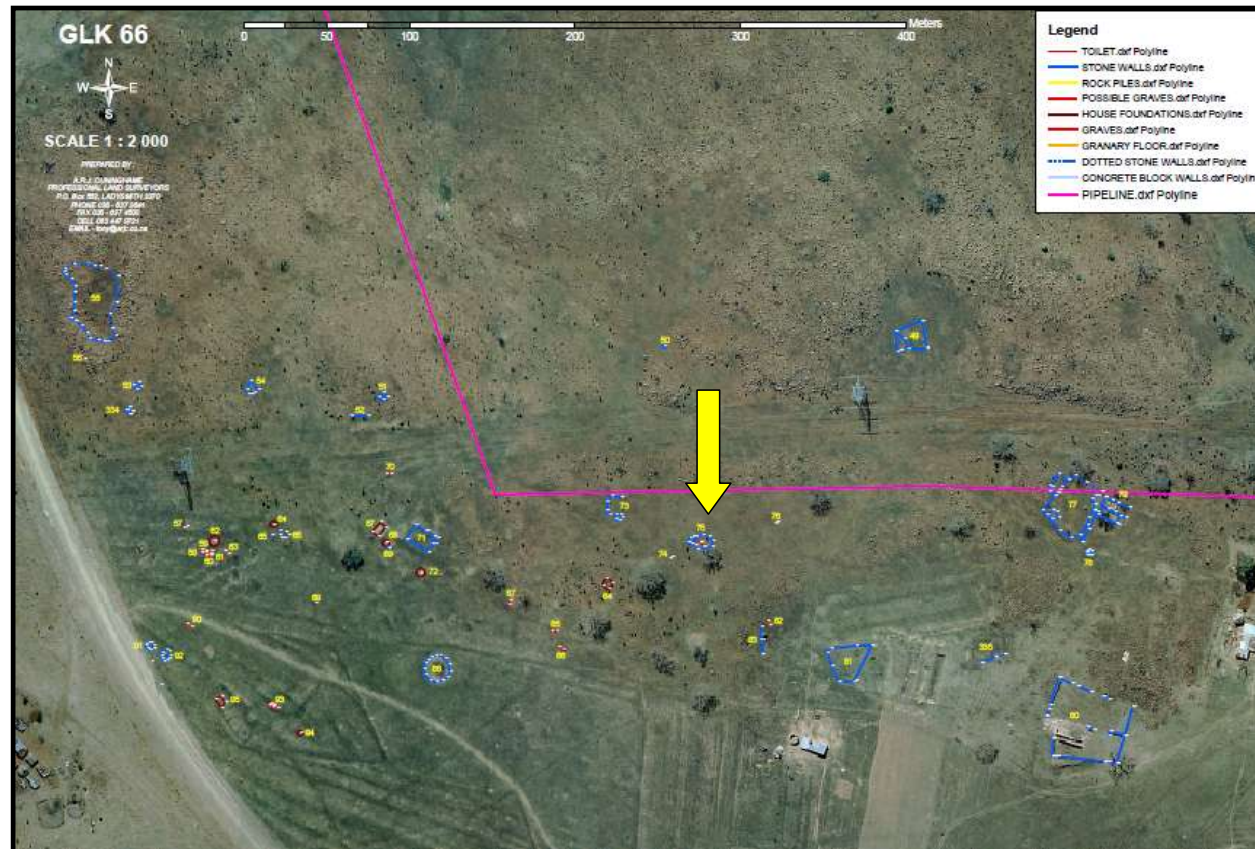
FIG. 5: FEATURES GLK066³

³ Blue = stone wall; red = grave; pink = pipeline; yellow arrow = feature 75

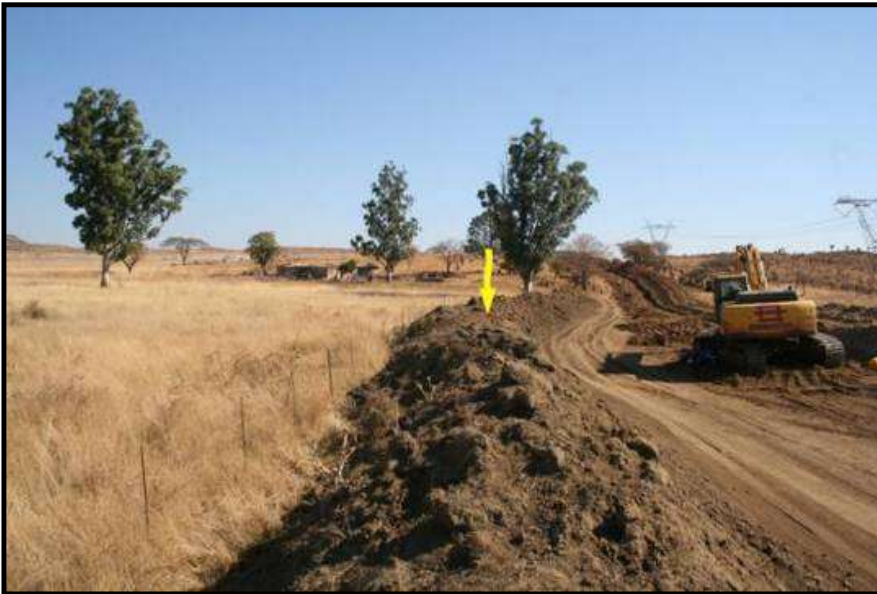
FIG. 11: LOCATION OF GLK118_96

The initial site inspection could not locate the graves, or their markers, however, the grave was later located with the surveyors using our previous survey data. The grave was covered with the topsoil (fig. 11). The graves were located and the topsoil was removed to expose the graves.

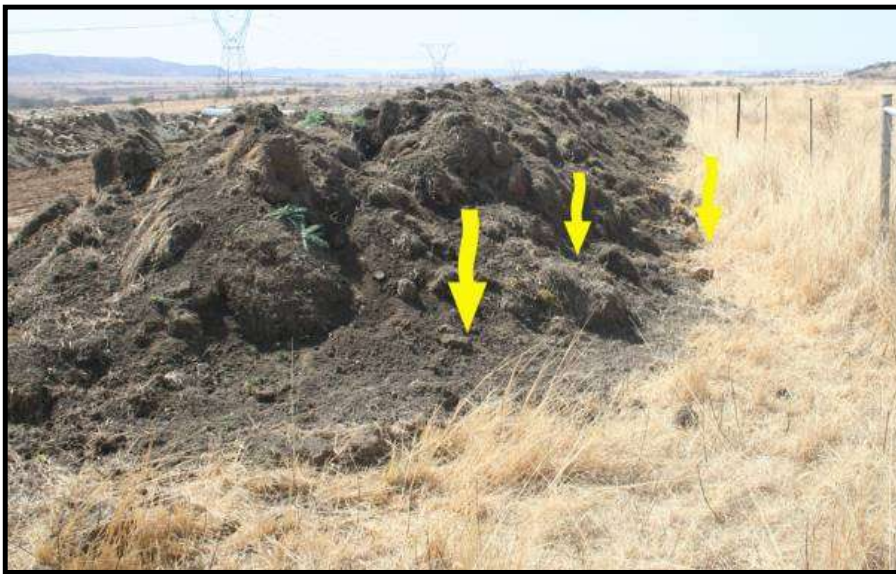
FIG. 12: LOCATION OF GLK118_96

Assessment of Damage: The graves were technically not damaged and have been cleaned. The associated walling was also cleaned. There was however, an infringement on the site and this forms part of the pattern of demarcated heritage sites being ignored by the contractor.

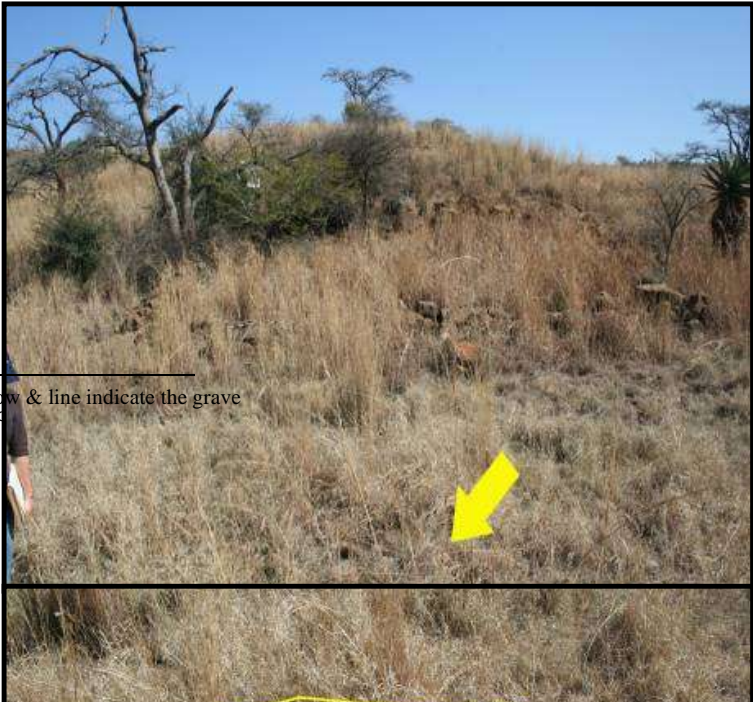
The stonewalling has had topsoil placed over the walls since RoW clearance. The cairn (fig. 27) does not exist anymore and we had to relocate the ends of the grave with our survey data. I placed several trenches in the area of the poles to determine if any form of stone cairn or burial could be seen (fig. 28). It appears that the entire cairn has been removed and we could not locate a burial pit. There was no change in soil colours to indicate a burial however; this is expected as the bedrock is near the surface. We could

FIGURE 27: POSITION OF GRAVE IN JULY 2009¹²

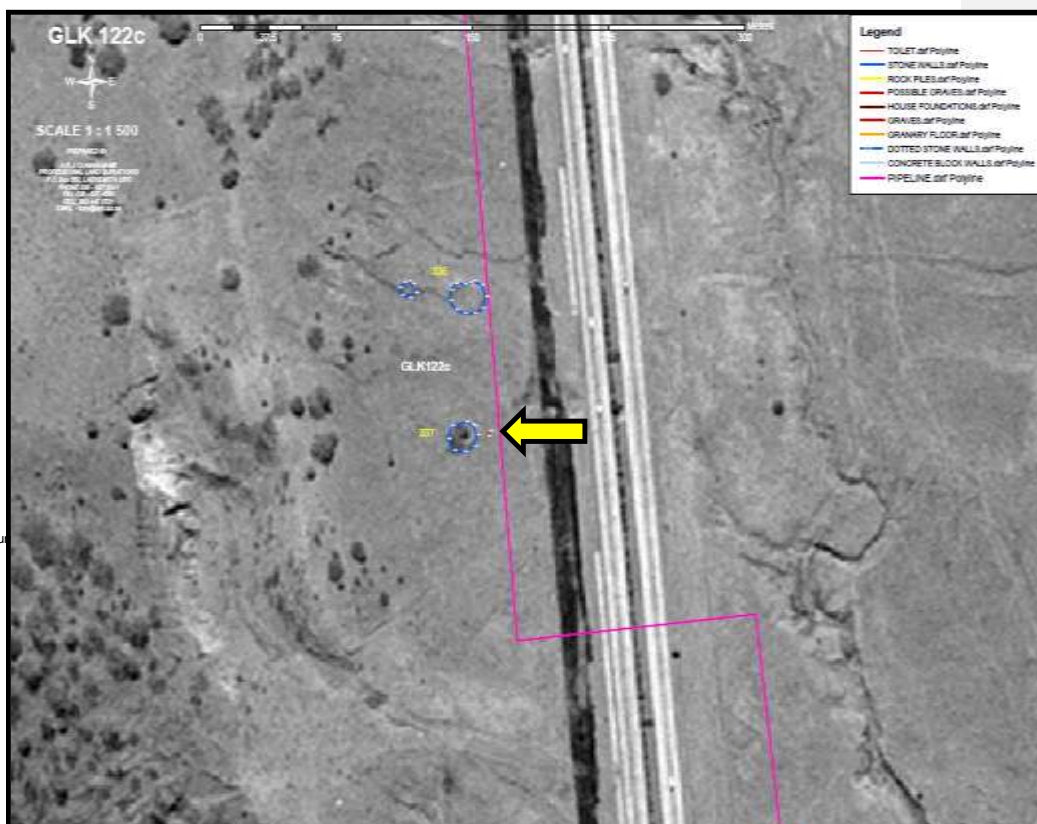
This site is located at KP261 and consisted of one grave (fig. 29 - 30). The site dates to the HP, if not the LIA. The grave was demarcated with metal and wooden poles, and fenced off at a later stage. Several JV members also saw the fenced grave during a site inspection. Two HIA were present on site during the RoW clearance. I originally thought the grave was under the trenching spoil, but I then rechecked the location and realised it was further north. I relocated the site with a GPS. I then placed a 4m x 4m excavation square around the centre point of the GPS (fig. 31). The soil was taken down to the next layer of yellowish gravel.

FIGURE 29: LOCATION OF GRAVE AT GLK122C

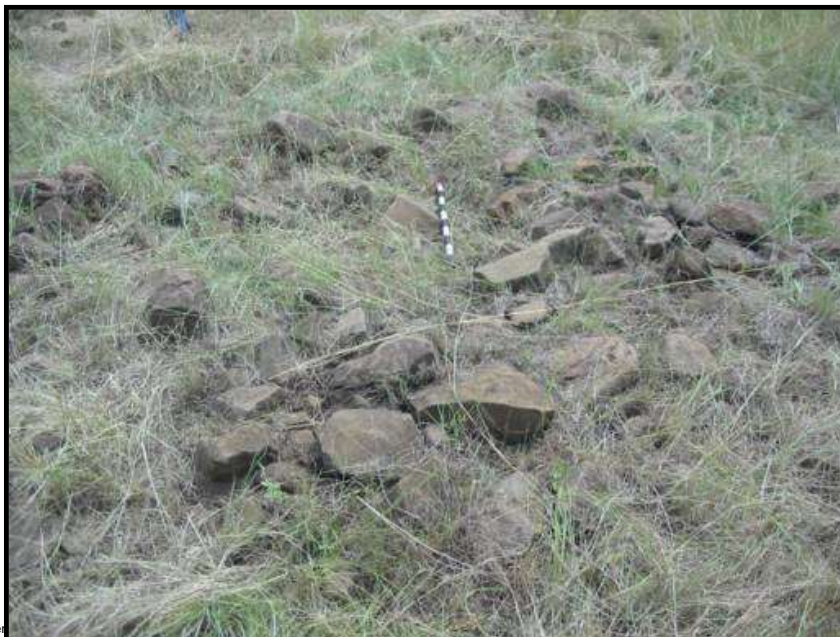
Assessment of Damage: The entire cairn has been removed and presumably the grave itself.

FIGURE 30: GRAVE AT GLK122C

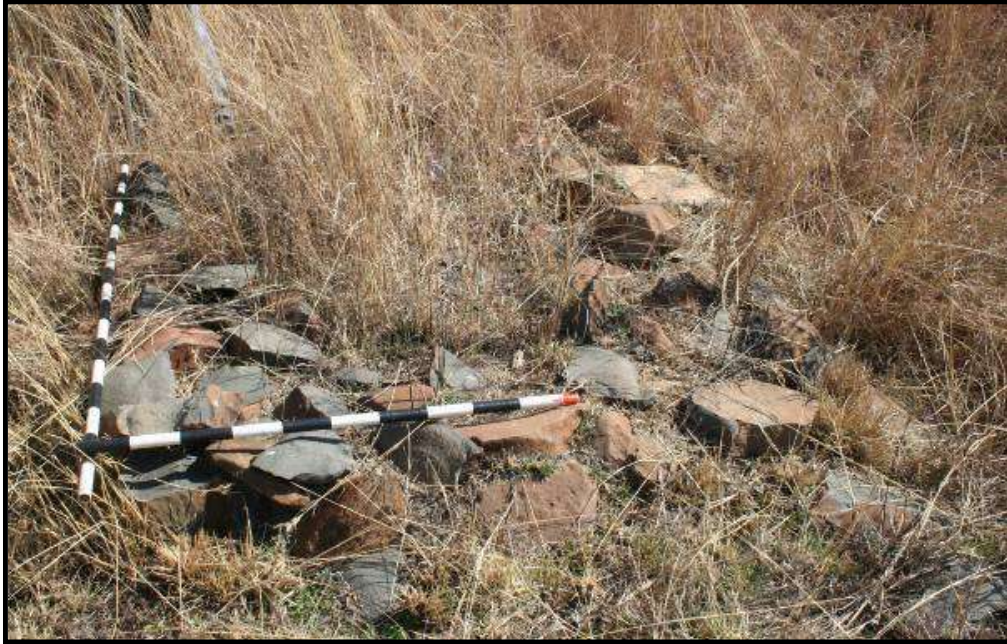
The grave was demarcated with metal and wooden poles and was fenced off before the RoW clearance (fig. 36 shows the grave in 2009). Two HIA were on site during RoW clearance. Subsequent to RoW clearance, the grave was covered by trenching spoil (fig. 37). This is the first grave of the damaged sites that has definite living descendants. Transnet may need to compensate the descendants.

FIGURE 36: 2009 PHOTOGRAPH OF THE GRAVE

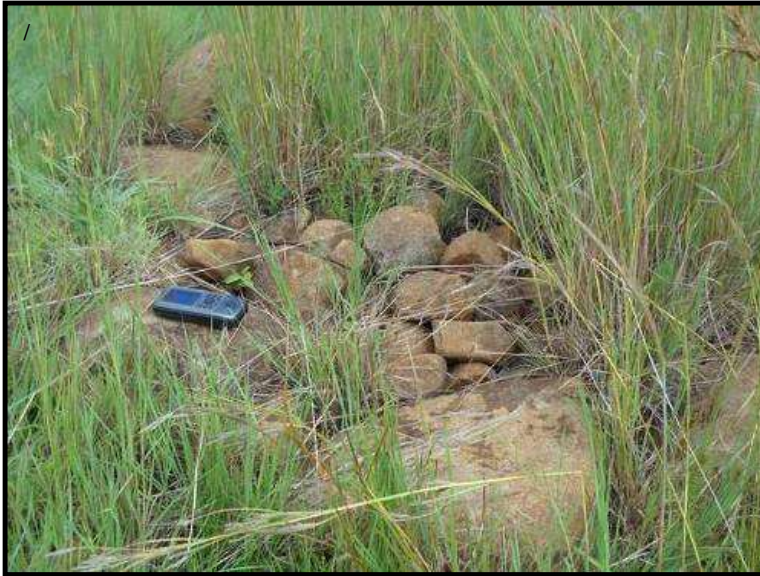
Assessment of Damage: The grave does not exist anymore

FIGURE 39: GRAVE AT KP189.300

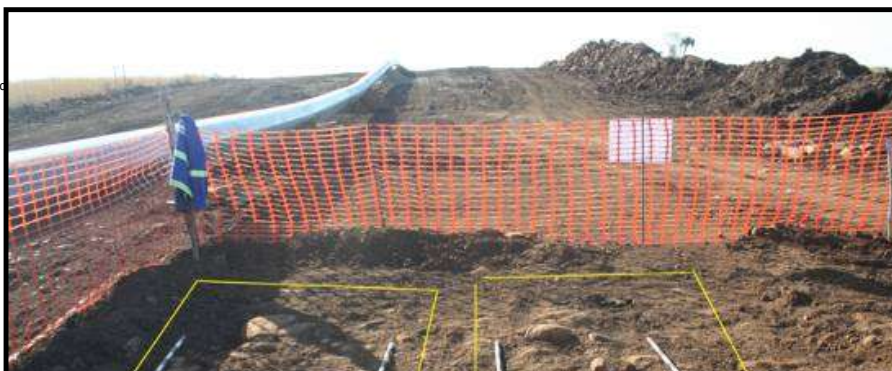
The excavations yielded three possible localities for the grave (fig. 42). These do not; however, appear to be the graves themselves.

FIGURE 42: POSSIBLE LOCATIONS OF THE GRAVE KP189.300
