SPIER FARM

DOCUMENTATION OF BUILDINGS I (1778) AND II (1817)

MAY 1994

H. N. VOS

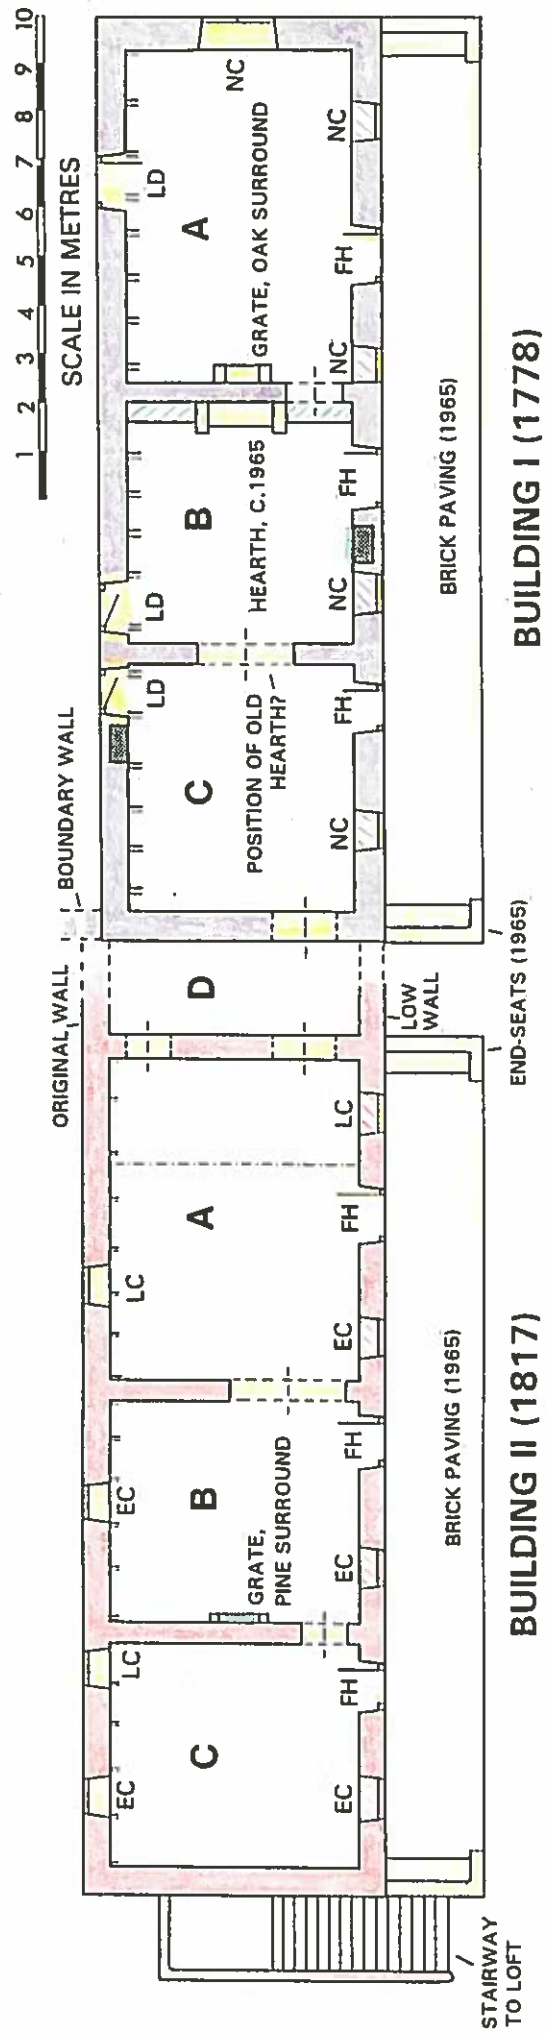
FIG.9 Groundplan of the two historic cottages, as found during the renovation of 1994. The plan is based on an architectural drawing.

Much of this building (FIG.9) was modernised in about 1975 by the former owner, mr Neil Joubert, leaving virtually only the 18th century walls as authentic. Modern alterations include:

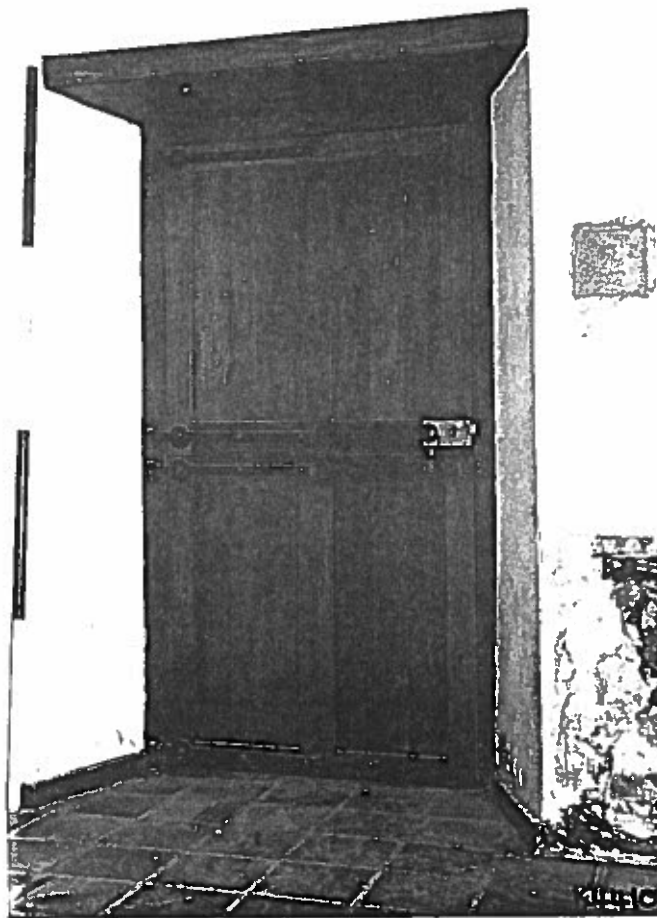
7. The unpainted doors (A2), frames and lintels are all identical and originate from Fairfield House in Bellville. They date from around 1900 with reproduction strap-hinges of c.1970.

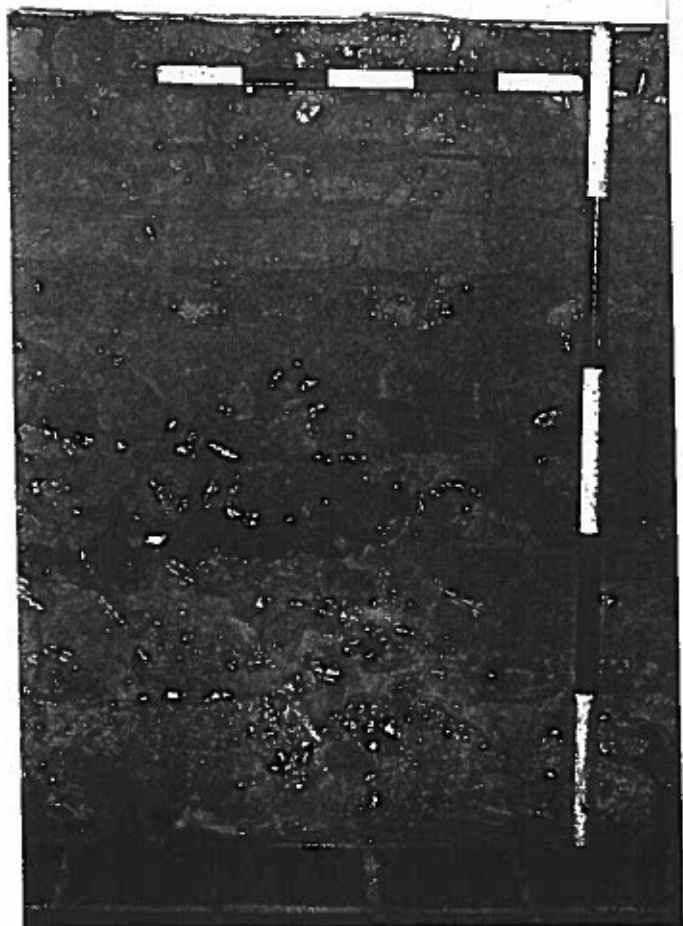
9

8,9. The grate is a 20th century innovation but the oak surround is earlier. They stand against the interior wall A3, which is built up primarily with river stones and flat raw brick (scales: 100 and 50 cm).

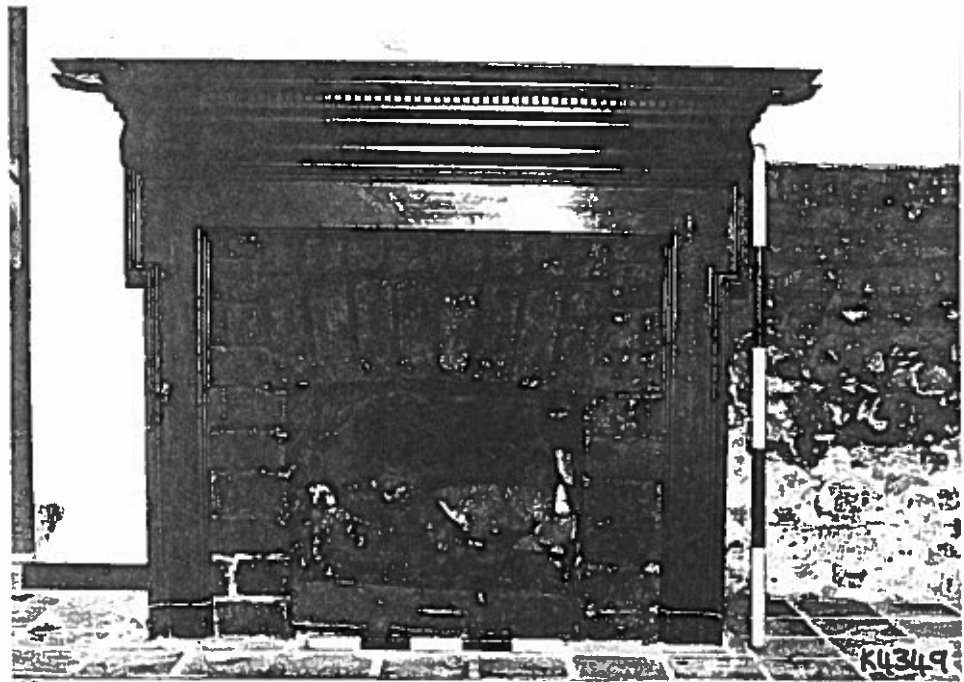
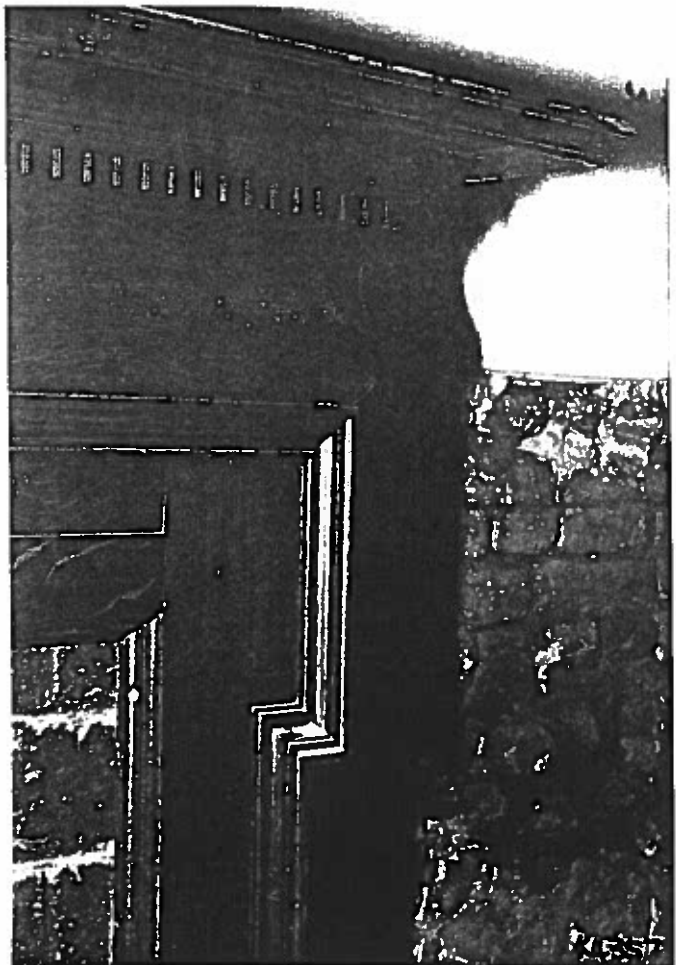
10

10,11. The oak surround is beautifully detailed and possibly dates from the 19th century.

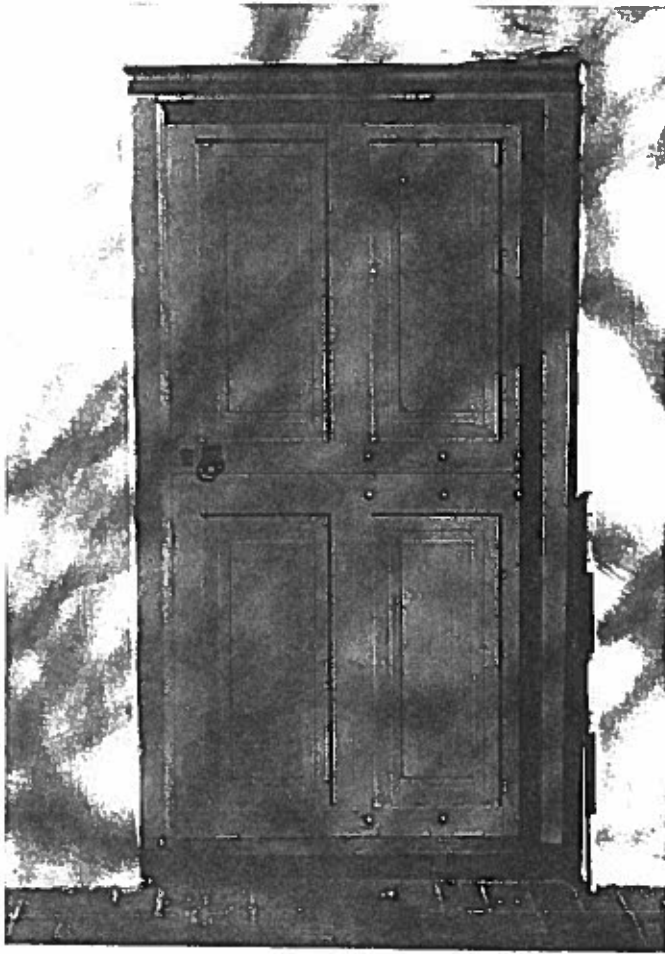
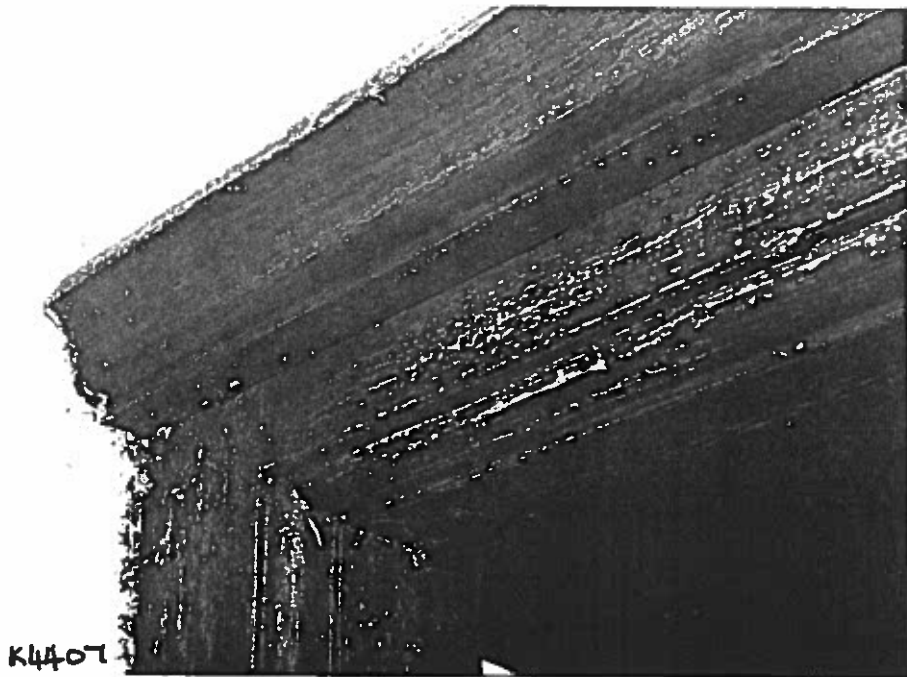
21

21,22. The outside of door C2 (now painted) was provided with an ornamental transom, previously unpainted (origin: Fairfield House).

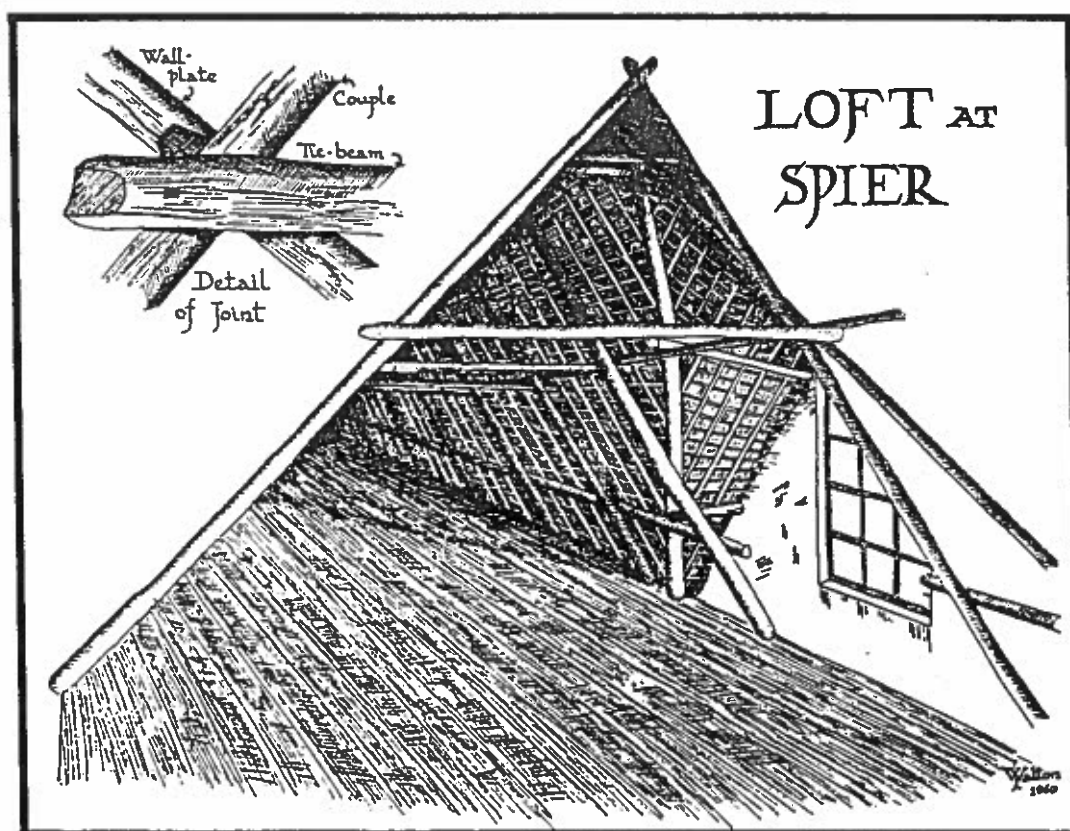
FIG.10.2 The earlier woodwork and joinery in a loft of one of the two cottages at Spier, before any renovations (Walton 1965:5).

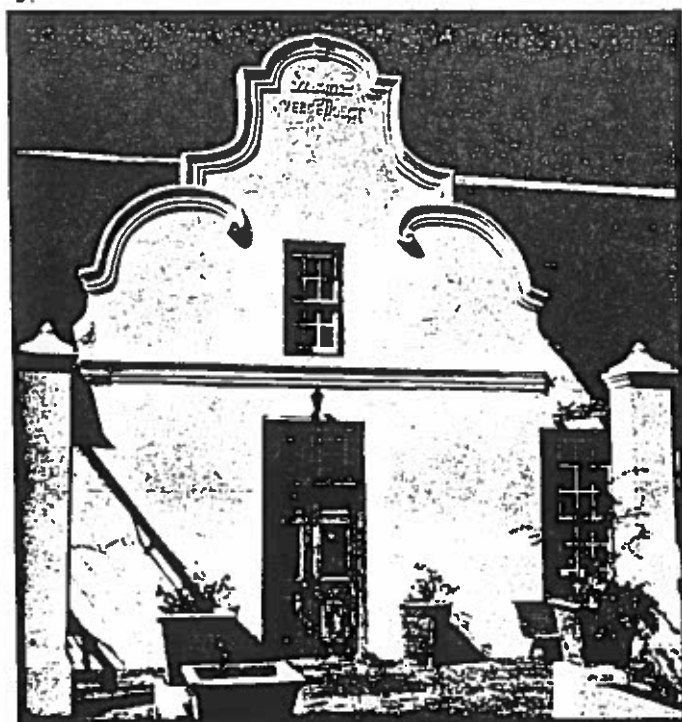
31

31. The gable of Vergenoegd (1773) near Faure resembles that of Spier (De Bosdari 1953: plate 49).

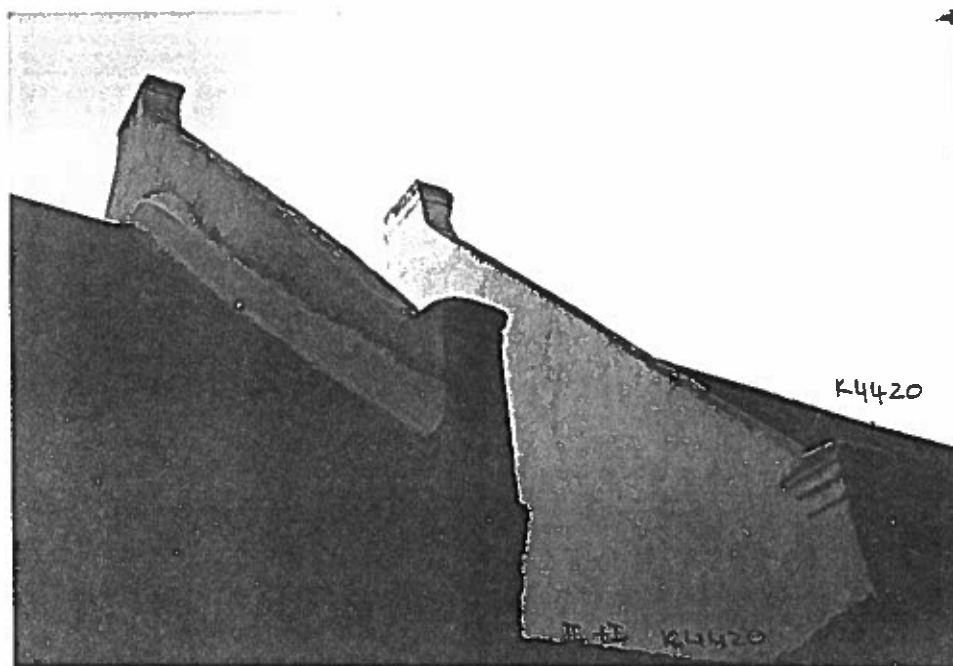
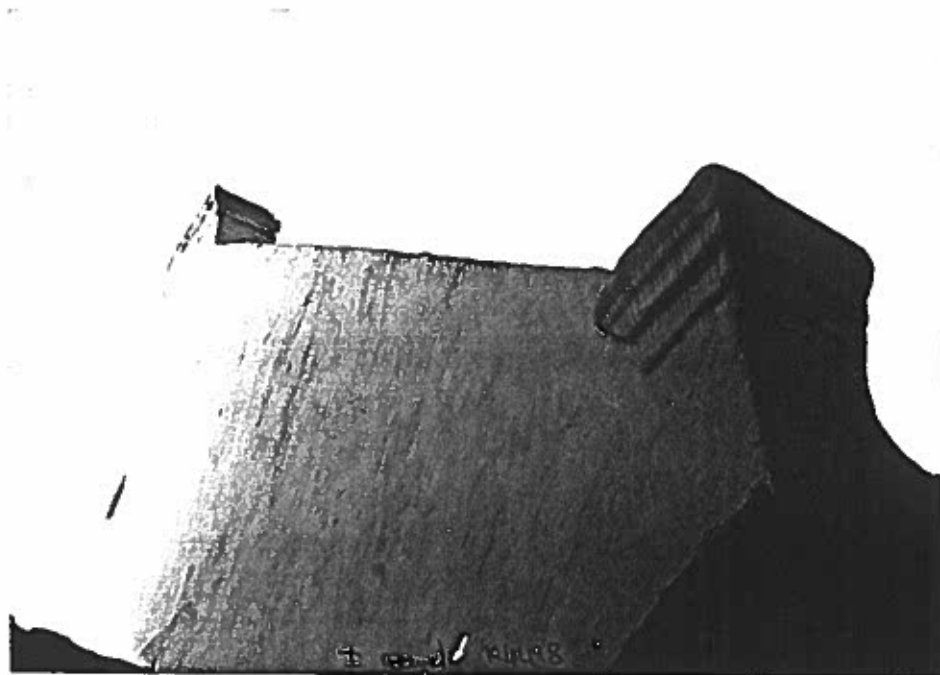
33,34. A straight "chimney" gable is typical of the late 18th century. The pilaster on the corner is more elaborate than its counterpart on the 1817 building.

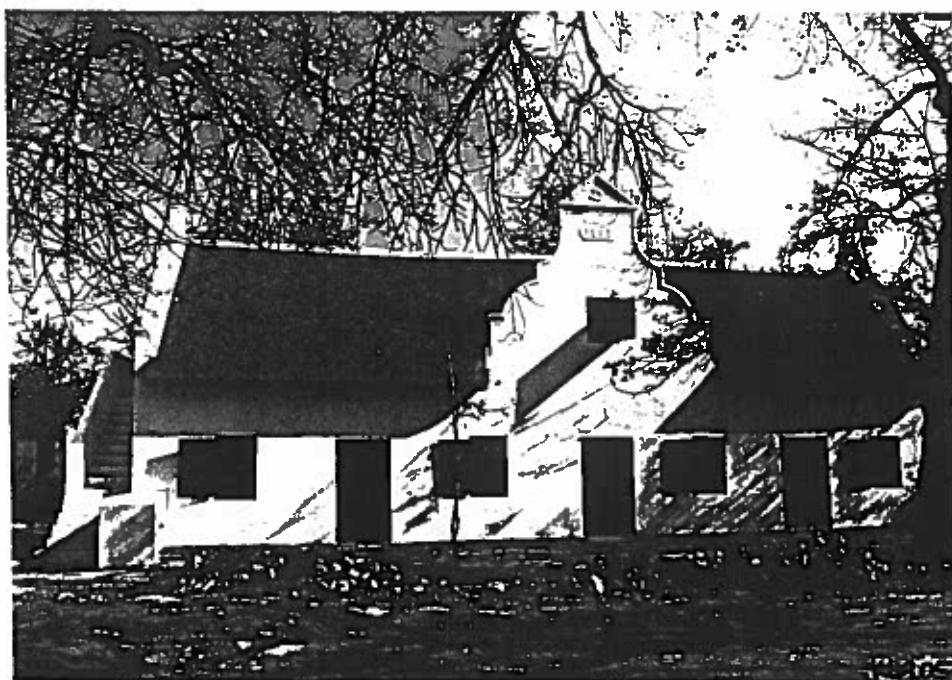
35.1 Though the 1817 building has been termed the *Jonkershuis* (i.e. house of the farm manager) there is at present little evidence of such a function. Note that the opening for the window on the far right previously accommodated a door (see next photo).

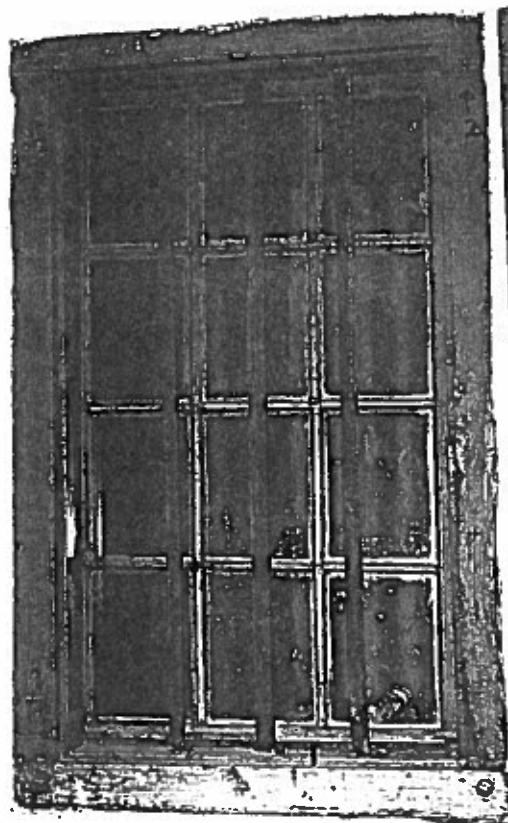
40

40. The southern casement in room A2 is original, as are the three iron bars. They have been clinched and rivetted at their base (1). Note the three notches (2), presumably made by the carpenter.

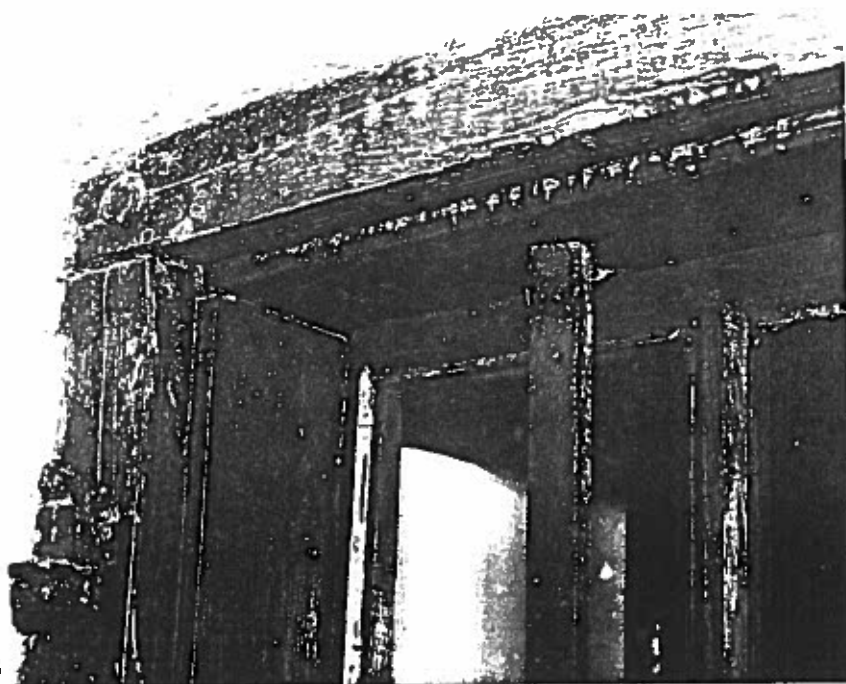
41. A detail shows how the hand-forged bars were let into the wood (upper transom). Note the joinery and pintle hinge.

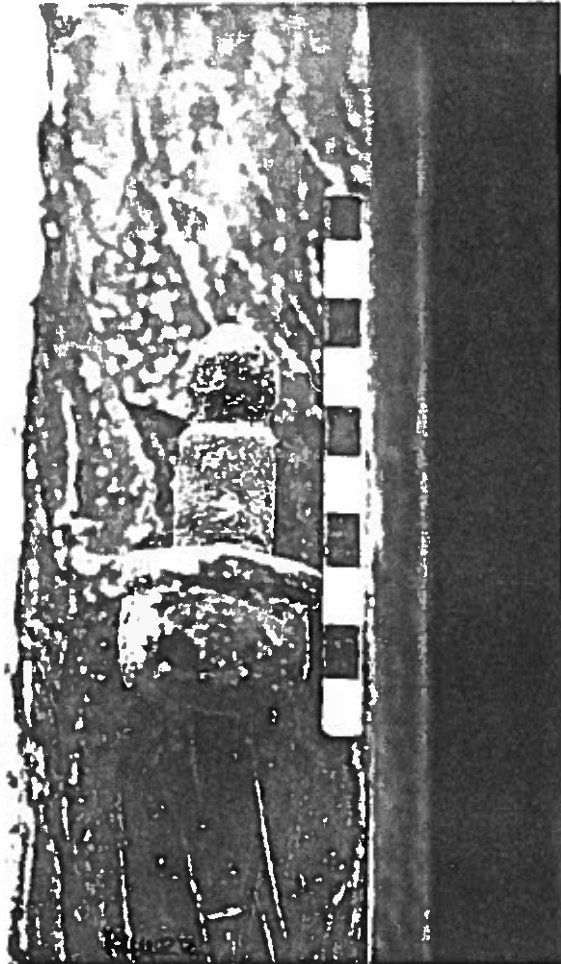
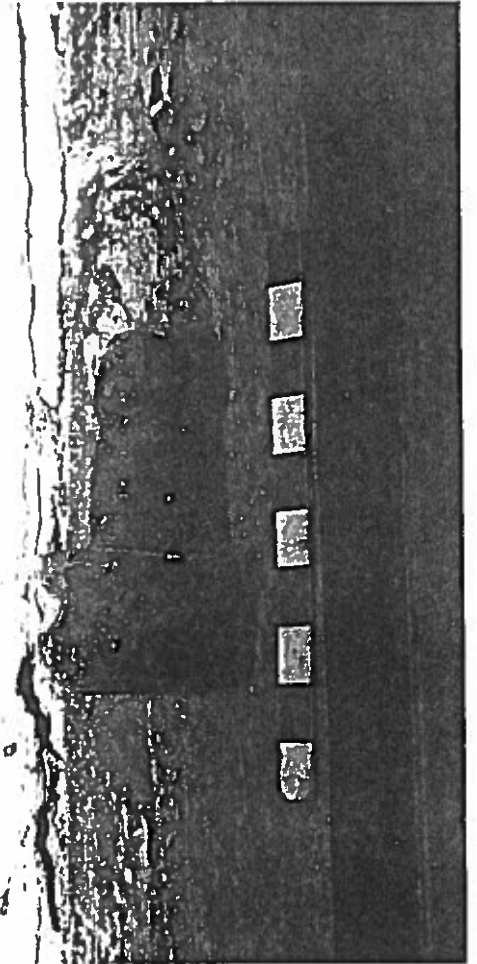
42,43. A comparison of upper pintles from the window cases south and north of the door of room A2. Their individuality is obvious (scale: 10 cm).

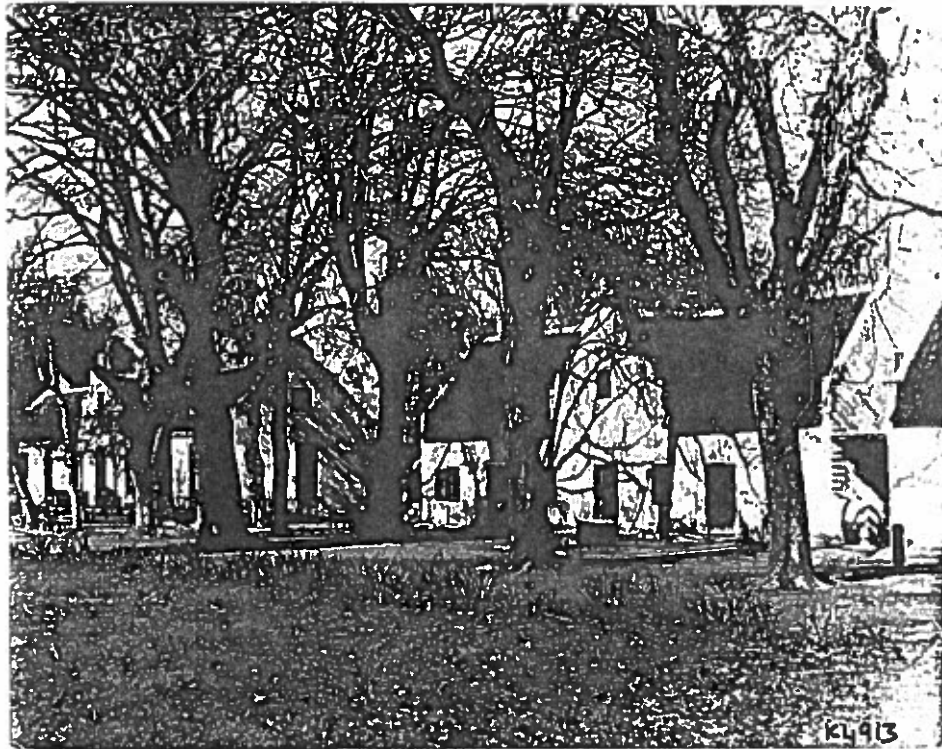
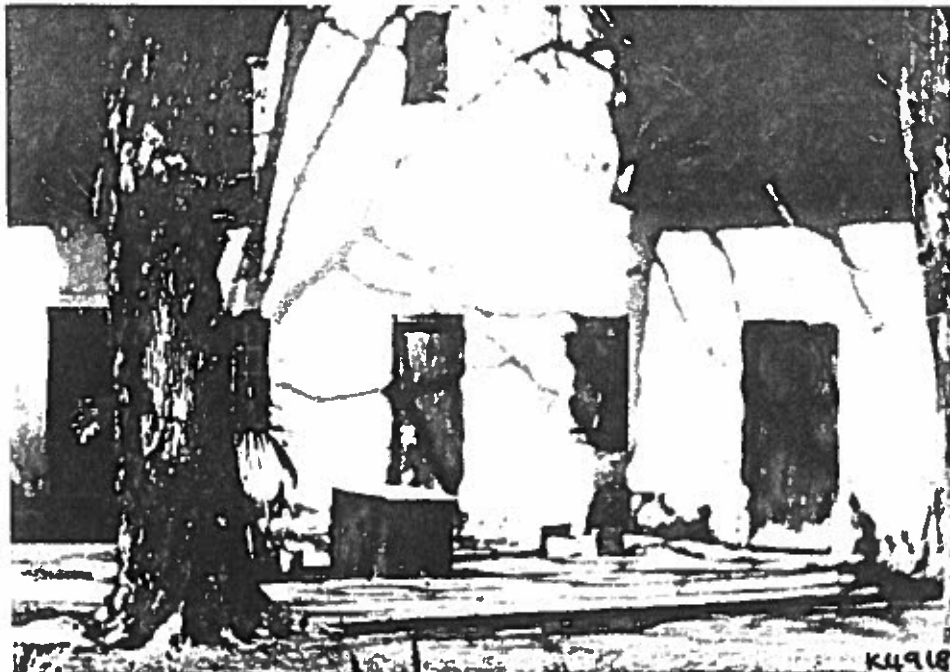
FIG.12,13 Another old photograph depicts the 1817 building with its earlier woodwork. In the close-up (13) a box, presumably for fowl, is visible (C.Joubert, photos to Spier Estate).

Little remains of the old inner wall to determine whether B1 contained earlier openings or chimneys. Wall B3 has a grate with an old mantelpiece surround of the early 1800s, but it is uncertain whether the former is original. The photographs of c.1920 (FIG.12,13) show no signs of a chimney and the present flue is definitely modern. The mantelpiece is probably a recent addition, possibly originating from the 1822 dwelling. Surrounded by a specially designed wooden frame (c.1975), are five polychrome Dutch Delft tiles of the mid-18th century, depicting horsemen (one is a reproduction). Though three are badly cracked, they are still valuable and proper restoration is recommended.

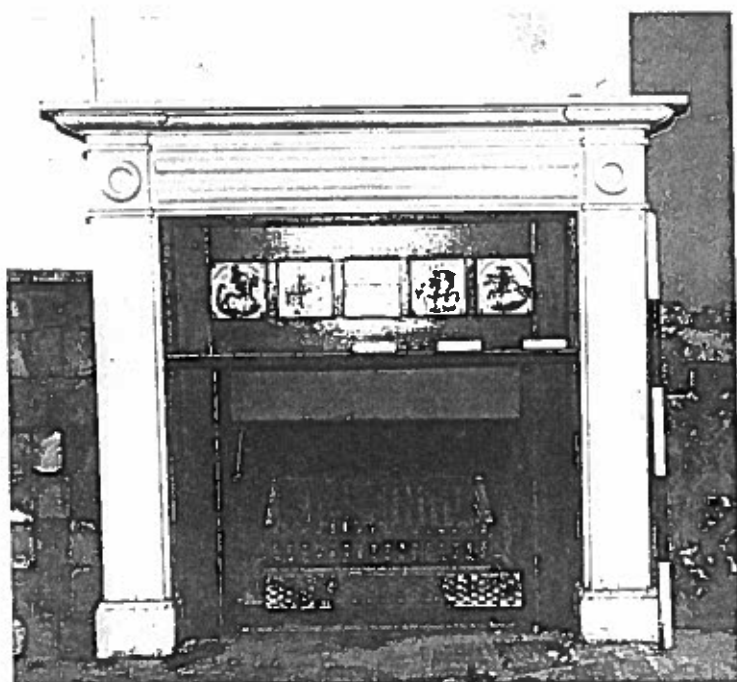
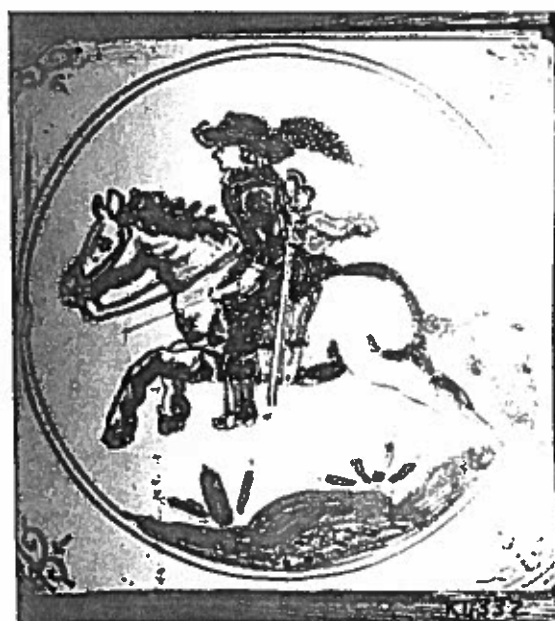
44. A simple but impressive fireplace surround of the 19th century adorns room B3. Set in the wood panelling are five Dutch tiles of the 18th century (The central one is a modern reproduction). The medallions contain a mounted rider in polychrome enamels, while the corners of the tiles are decorated with a design reminiscent of an ox-head (*ossekop*) (Korf 1972:45).

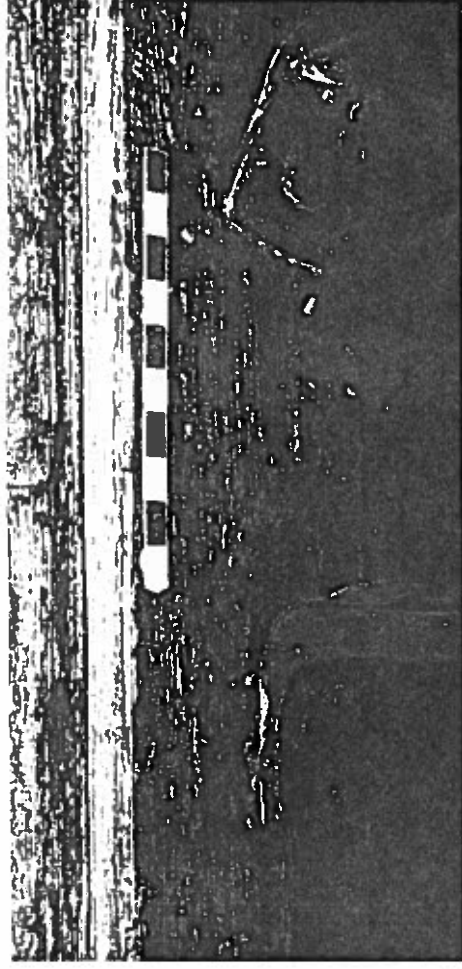
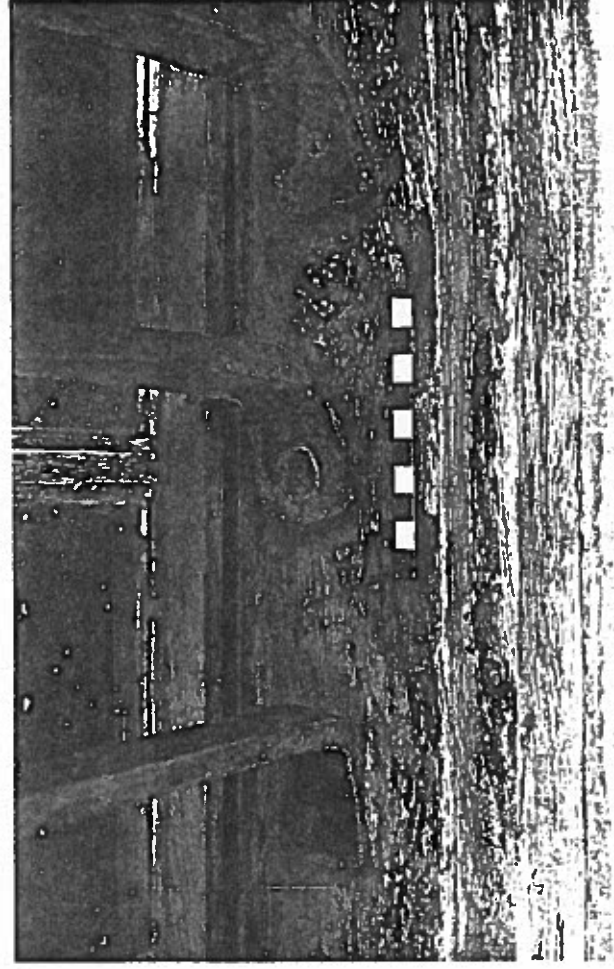
48,49,50. The facade casement in room C2 is of special interest, because of its four iron bars. They are individually hand-wrought and twisted near the centre for strength and decoration. At the top (49) and bottom (50) the bars are clinched and rivetted. It is such features as these which authenticate the building furniture.

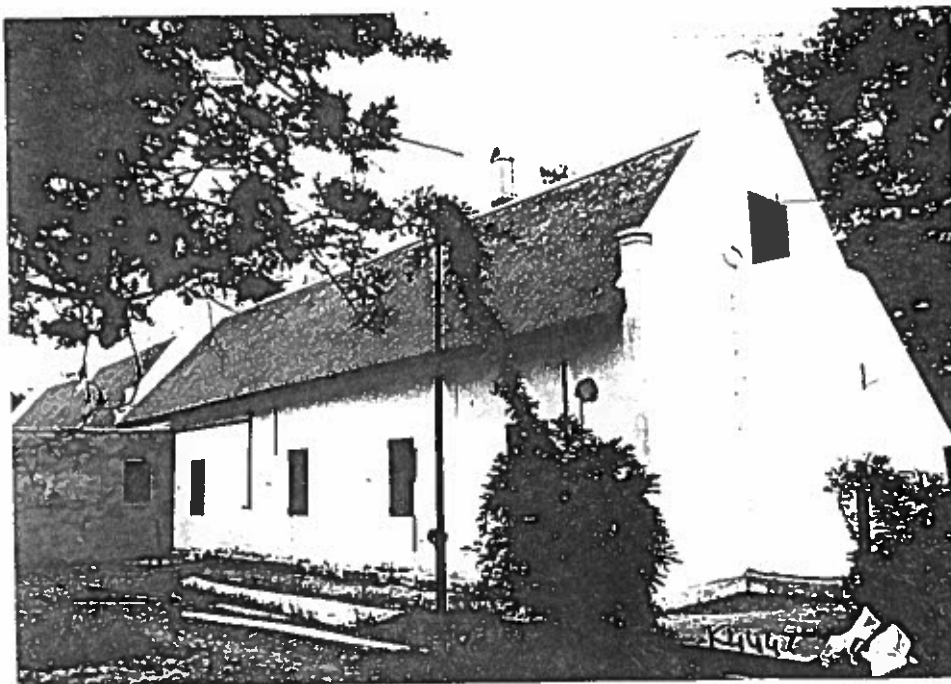
53

53. A view of the back shows the positions of the casements added in 1970.

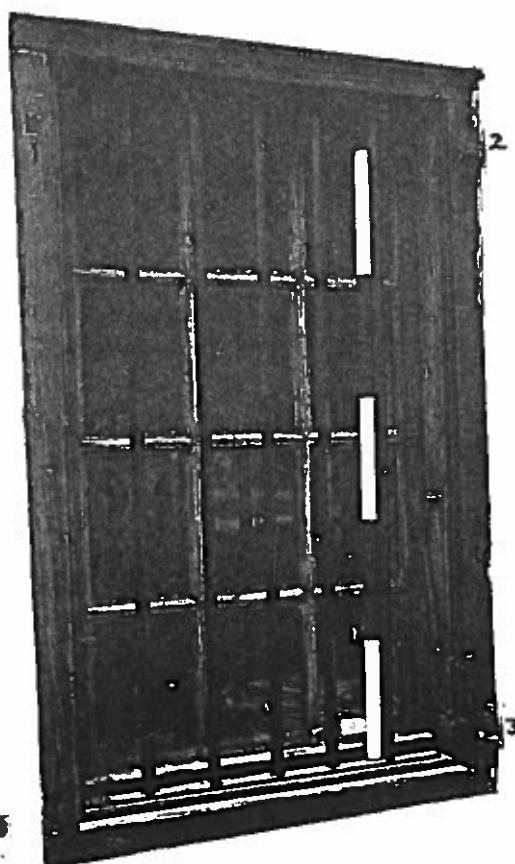
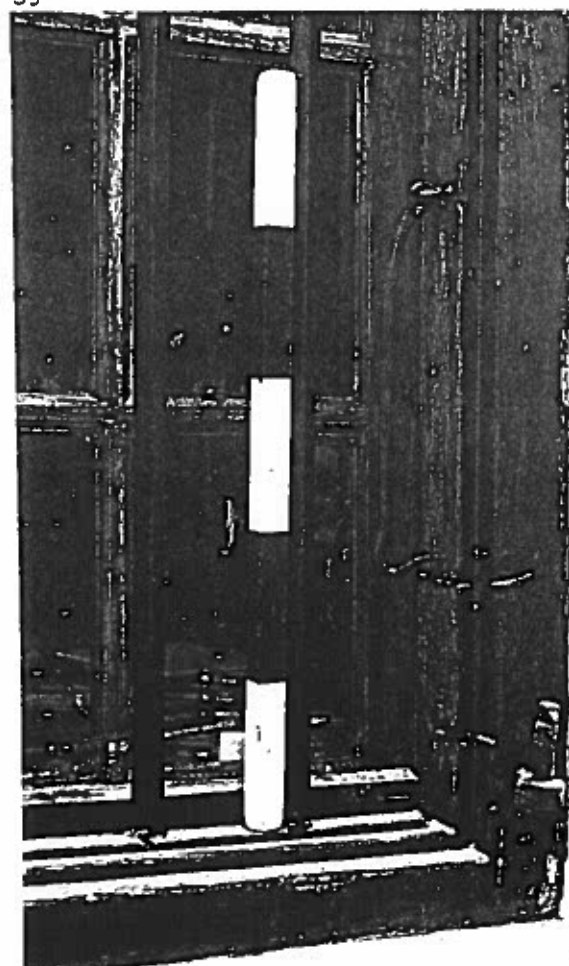
54 55

54,55. An old casement (room C4) was installed at the back c.1970. It has been re-used, with older pintle holes (1) on the left. The pintle hinges on the right (2 and 3) also differ, with the oldest one (2) at the top. The hook (4) is particularly old and could have been used as a catch for both a window or the earlier shutter. Note the old hole (5) for the sliding bolt of the shutter. The iron bars are recent (c.1970).

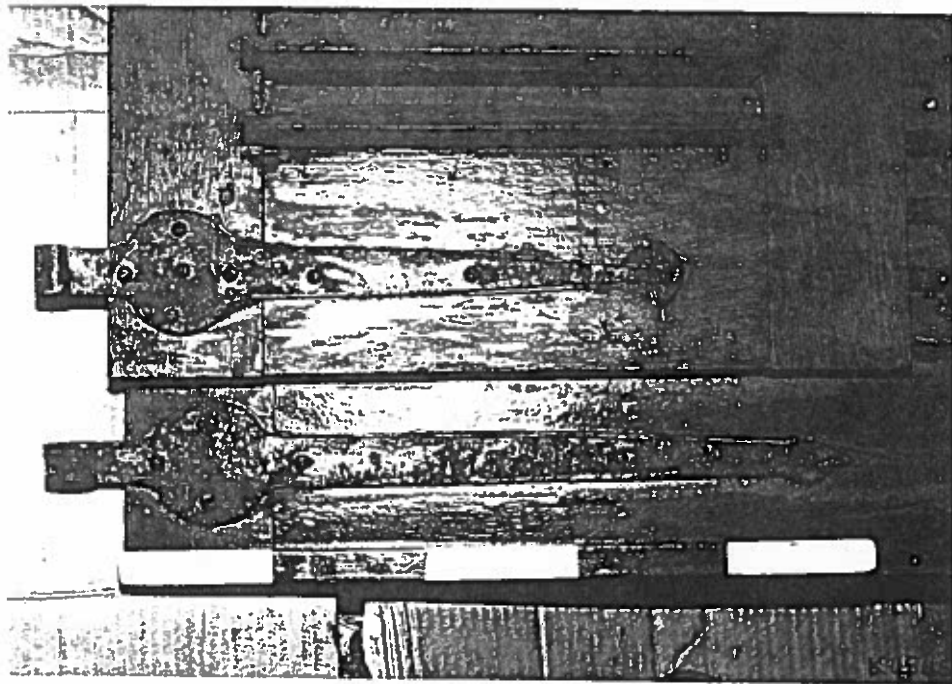
56

56,57. The louvred shutters (20th century) were fastened with a variety of 18th century strap-hinges. Their individuality is quite conspicuous.

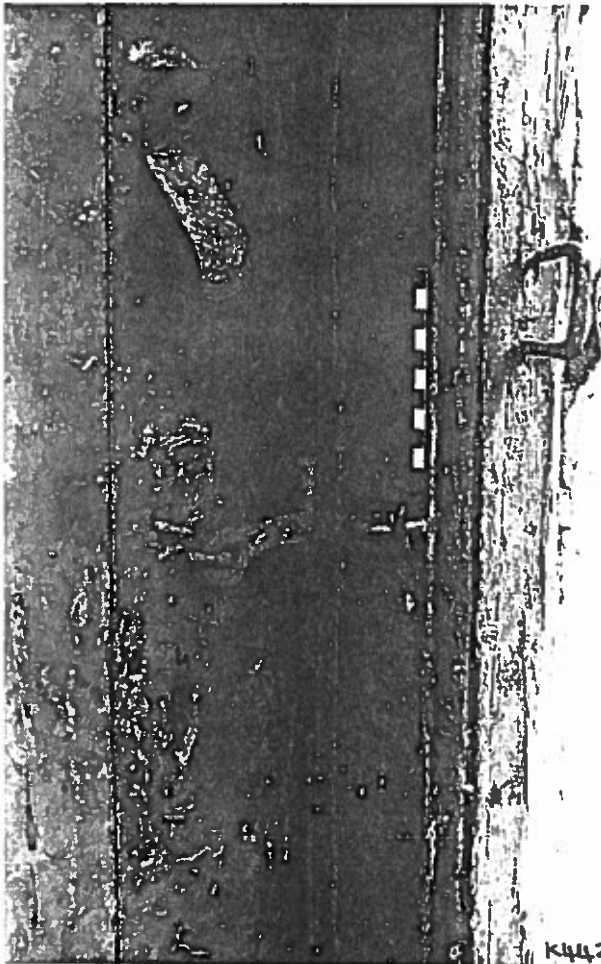
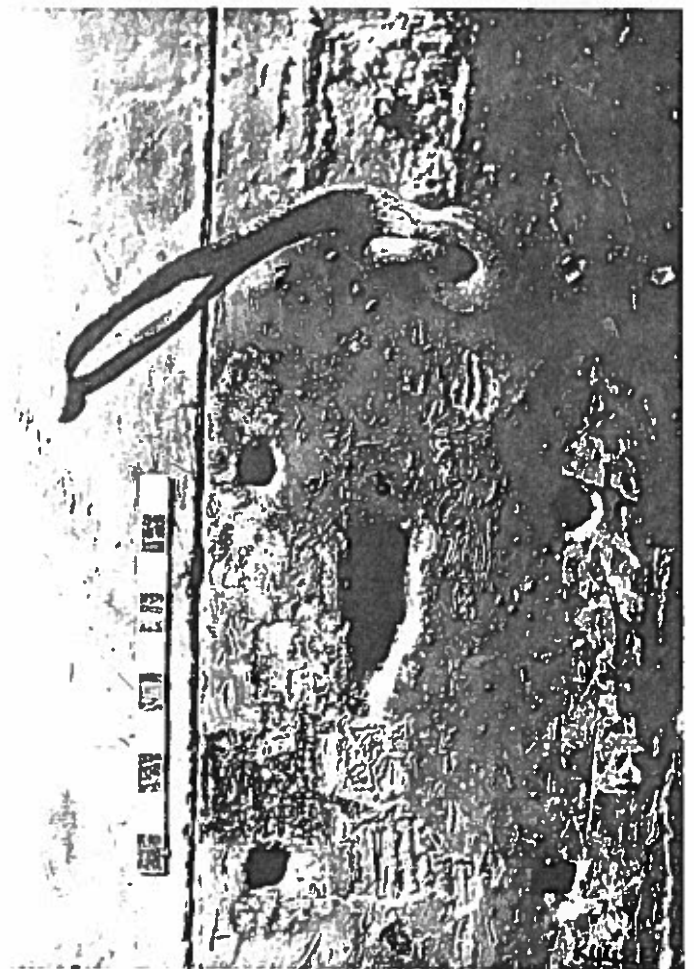
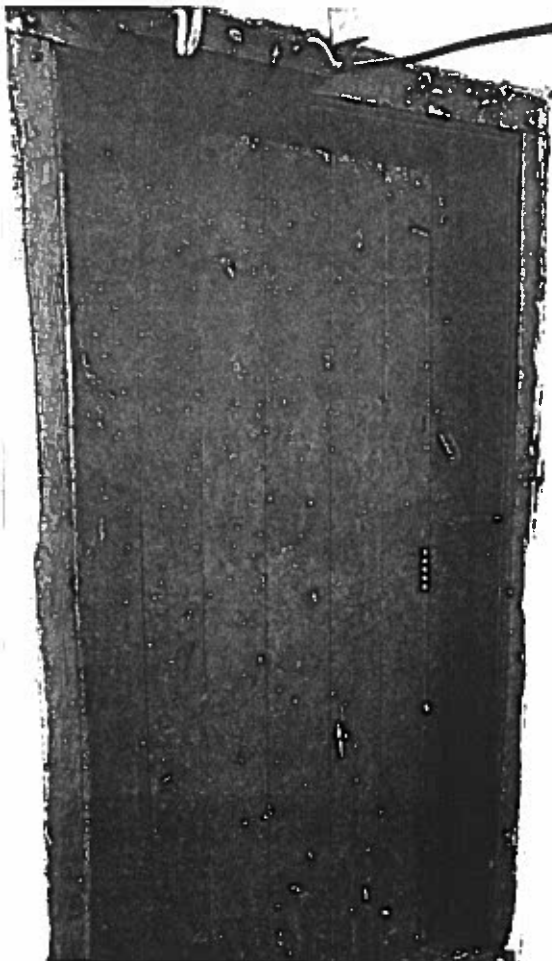
59 60

58,59,60. A particularly old ledge-and-batten door gave access to the loft via the staircase.

- 1) broken plate handle
- 2) looped catch device and
- 3) metal prong
- 4) earlier square-shaped prong
- 5) keyhole with four squarish holes of removed bolts which secured the lock.

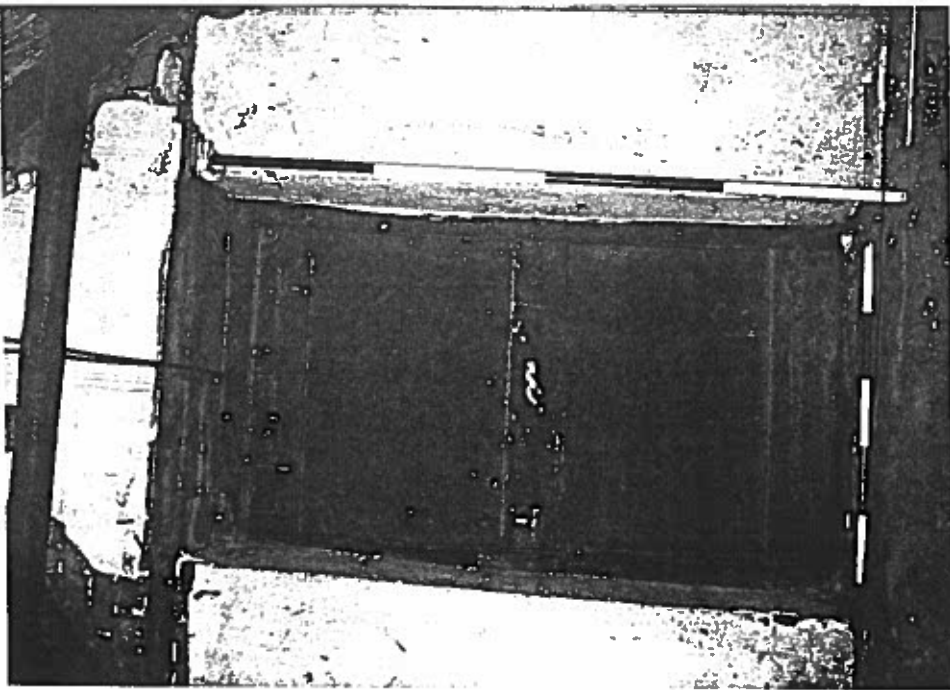
62

62, 63, 64. The long lintel (1) indicates that the door is in its original position. The pintles and strap-hinges are simple but elegant (2 & 3) as this close-up shows (photo 63). The strap-hinges (e.g. this lower one) are still attached with original square-headed nails (photo 64).

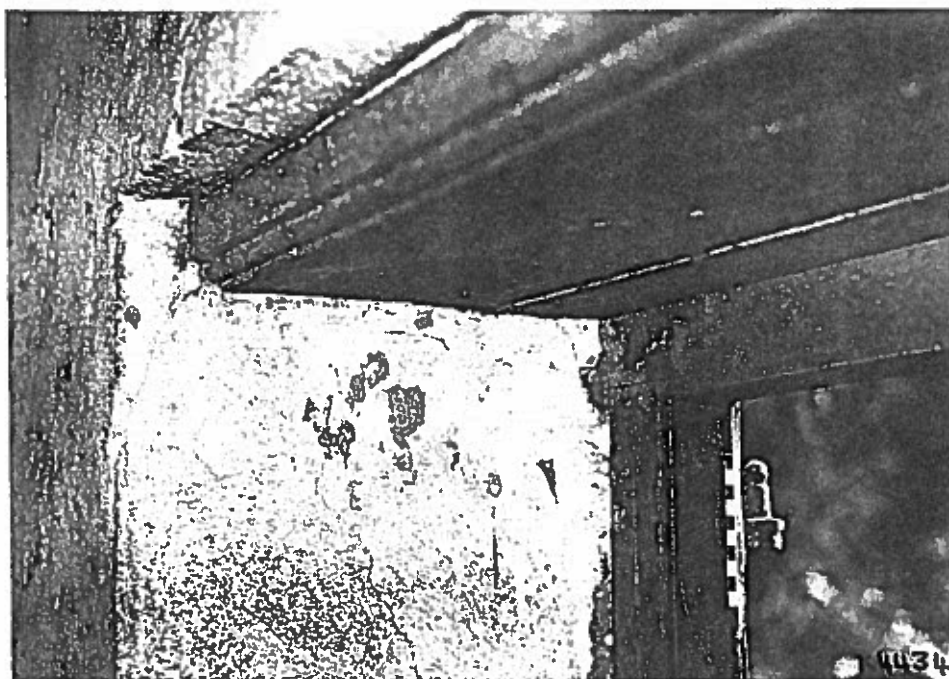
65

65,66. The brown painted lintel of the window in the centre gable, has an early 19th century moulding. The case is painted green on the exterior. There are signs of fire on the paintwork (1) and plaster (2).

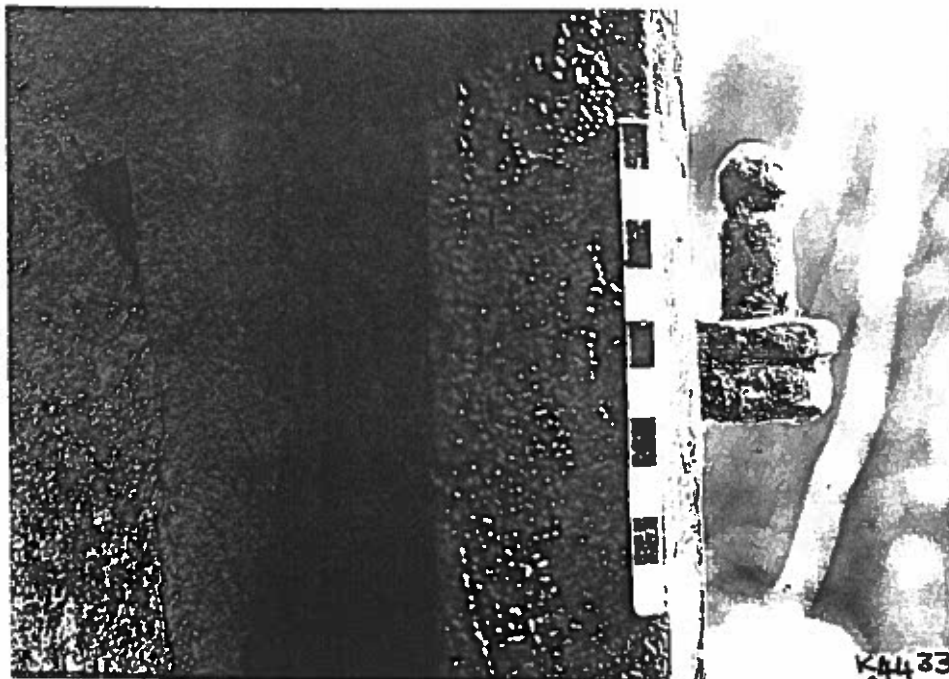
66

The central casement (c.1800+) in the loft originally had a solid shutter, replaced with a blind c.1975. The old pintles and strap-hinges are re-used ones of the 18th century. Judging by the plasterwork of the exterior, the gable had an earlier window frame, now gone. The pine lintel is painted a reddish shade and may date from 1790-1800. In the gable an old iron anchor, fastened to the original roof truss, is still visible. The casement of the northern end-gable has a glazed 19th century window and is surrounded with a double moulded line. The reddish lintel dates from c.1800.

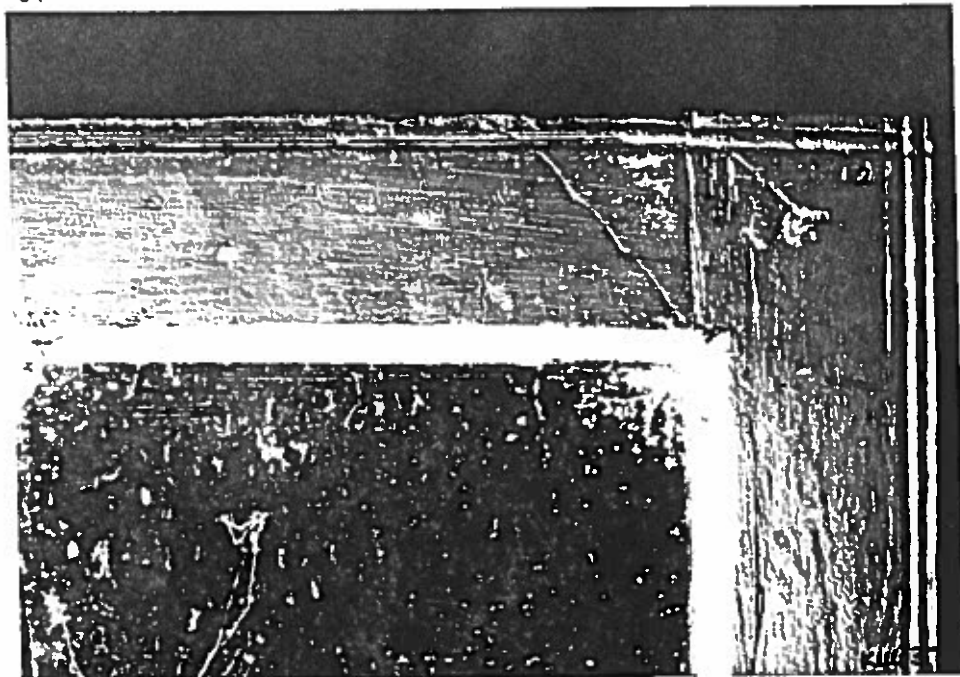
69

68,69. The northern end-gable contains an old lintel (1) and a 19th century casement window. The window frame with its double moulded line (2) is unusual. A close-up shows the upper righthand pane section (69).
