Heritage impact assessment of ancillary sites with potential heritage on the Cornubia development, Mount Edgecombe

Prepared for: Tongaat Hulett Developments (Pty) Ltd
P O Box 22319
Glenashley
4022

archaic consulting

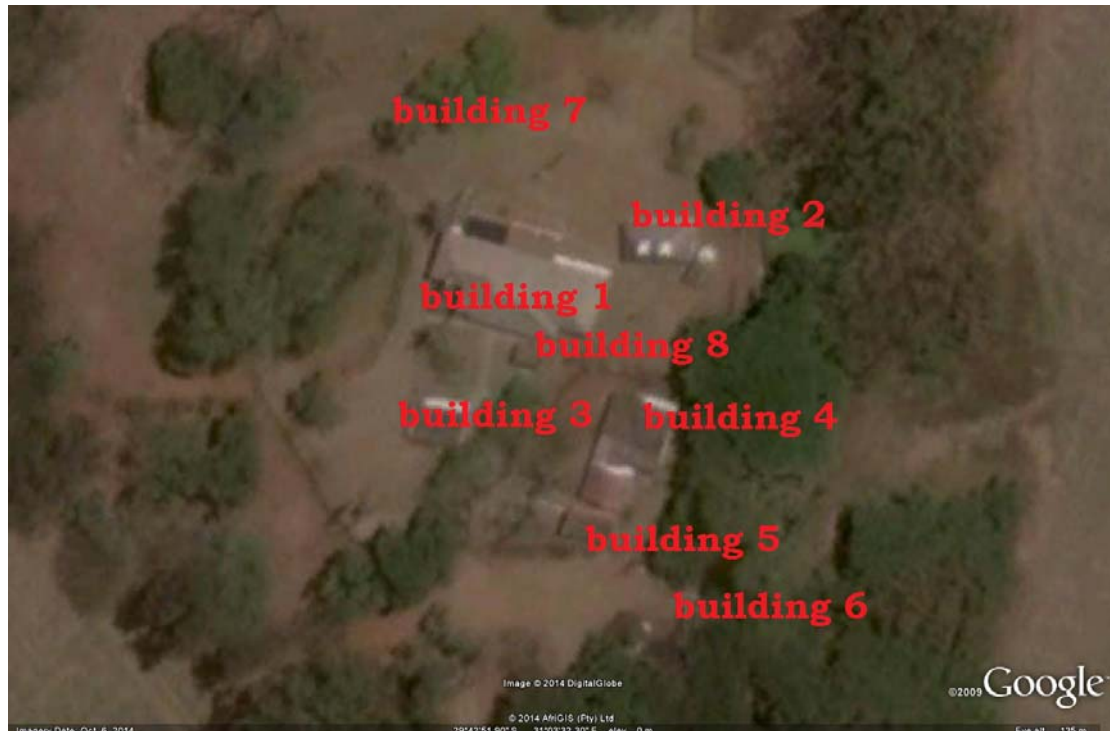
Fig 3: Aerial view of site 1, showing layout of buildings under discussion

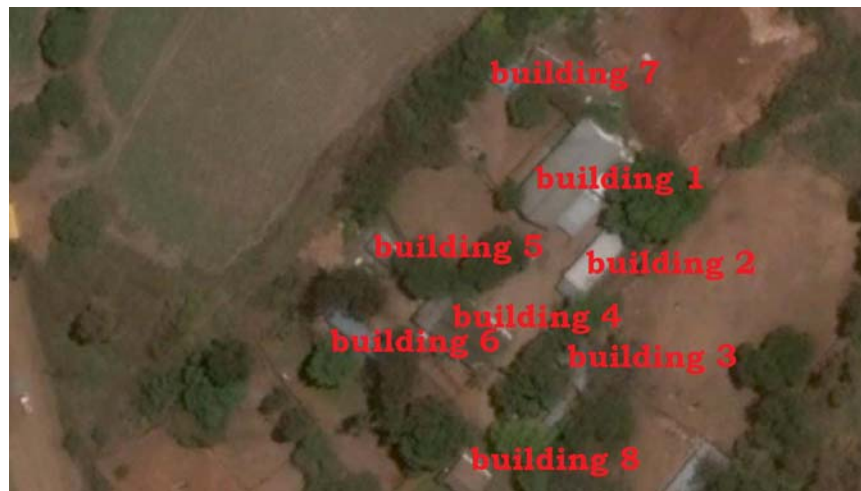
Site 2 is a complex site of ramshackle buildings that has been operating as a livery yard / stables for some time. These buildings have been constructed itinerantly over the years, and are mostly of mixed material and have very little architectural merit. However, the owner of the stables indicated that it was connected with the 'Tongaat' mules. Whilst there is scant mention of the mules in Saunders' comprehensive volumes on the Tongaat – Hulett history, mules were used in the operations of cane farms. It is important to note that there is strong evidence of this site on the 1953 aerial photographs, but any detail of the buildings is hazy: most likely, given the usually random manner in which stables and loose boxes are constructed, this could well have been an established 'yard' for the Tongaat mules² for many years in the past.

Fig 26: Buildings on site 2 under discussion

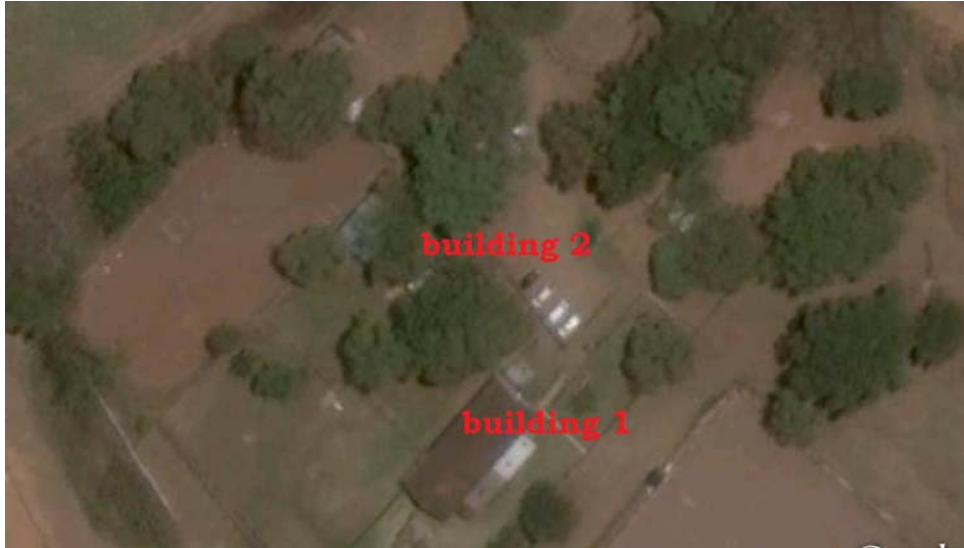
This site is also run as a riding school, and has a series of structures associated with it, as well as paddocks. However, all of the buildings are of recent construction, and lack any architectural value.

Fig 40: Buildings on site 3 under discussion
