**SUMMARY OF THE HERITAGE SITES DAMAGED ALONG  
THE TRANSNET NMPP**

**FOR KZN HERITAGE AND TRANSNET**

**DATE: 9 JULY 2010**

**Umlando: Archaeological Tourism and Resource  
Management**

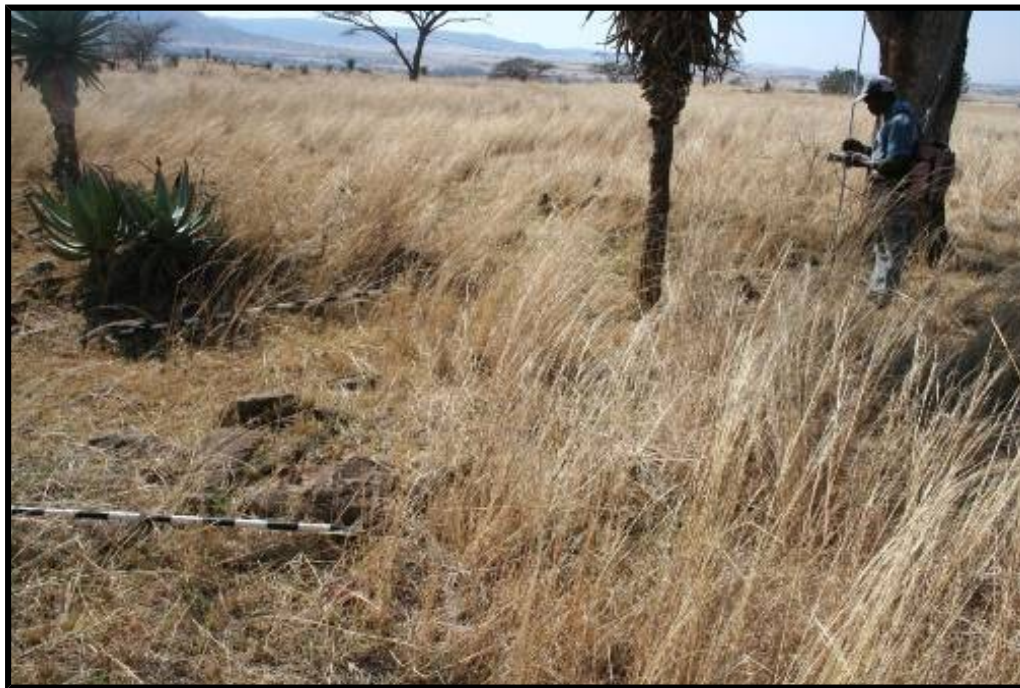
**FIG. 4: PHOTOGRAPH OF GLK066\_75 IN 2009**

**Previous mitigation:** The kraal was photographed (fig. 4) and mapped (fig. 5) in 2009 and thus some record of the site exists.

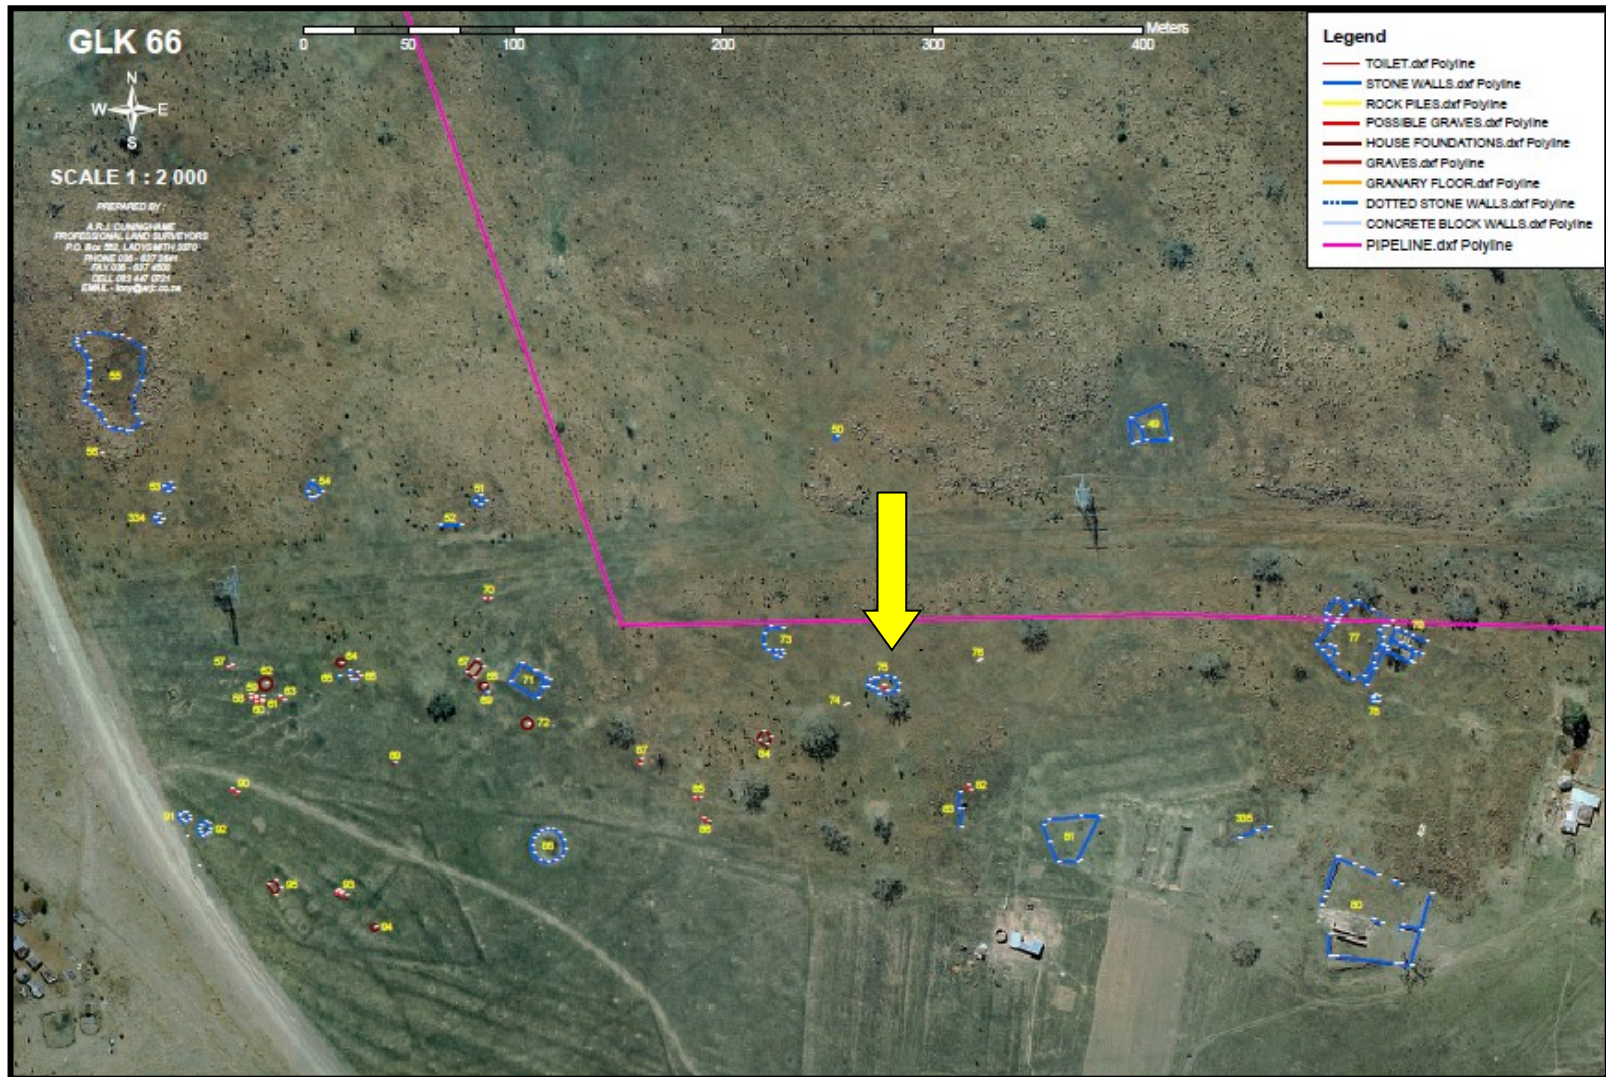
FIG. 5: FEATURES GLK066<sup>3</sup>

I placed several excavation lines in a wheel spoke alignment from the middle of the kraal, for the assessment (fig. 7 - 8). The excavations used the site map (fig. 5) to determine where the walling would occur. The excavations went down to the original surface – visible by the layer of grass. If the stone wall existed, then the excavation lines would locate an *in situ* wall. If no walling was observed, then it implies that it has been removed by the RoW clearance.

<sup>3</sup> Blue = stone wall; red = grave; pink = pipeline; yellow arrow = feature 75

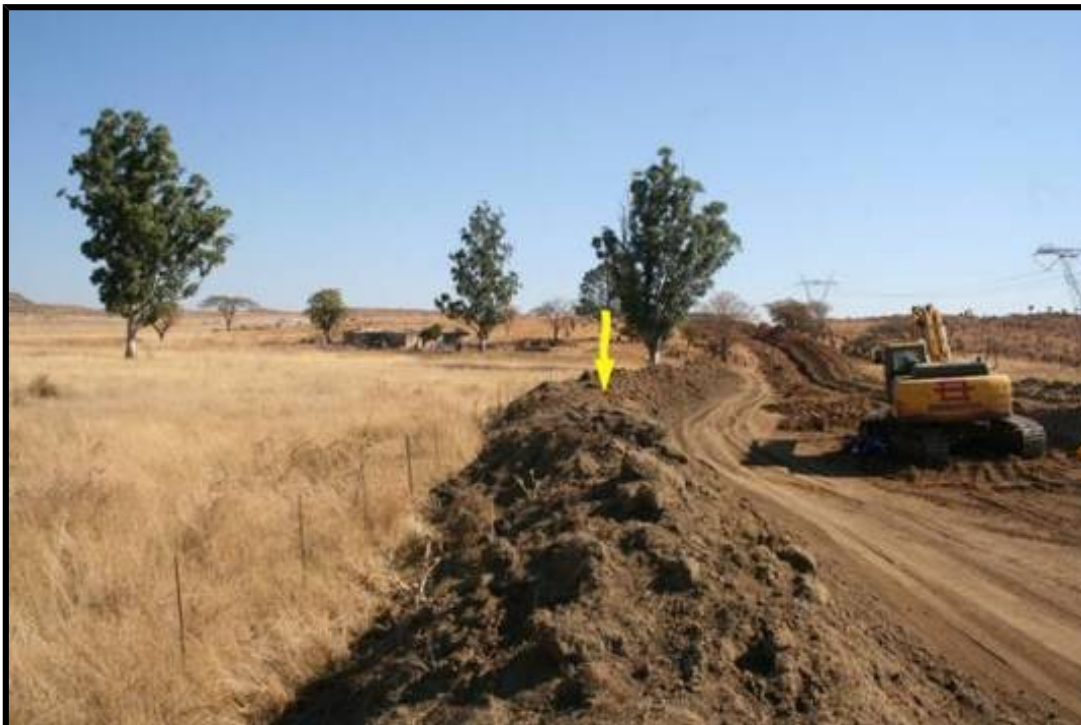
**FIG. 11: LOCATION OF GLK118\_96**

The initial site inspection could not locate the graves, or their markers, however, the grave was later located with the surveyors using our previous survey data. The grave was covered with the topsoil (fig. 11). The graves were located and the topsoil was removed to expose the graves.

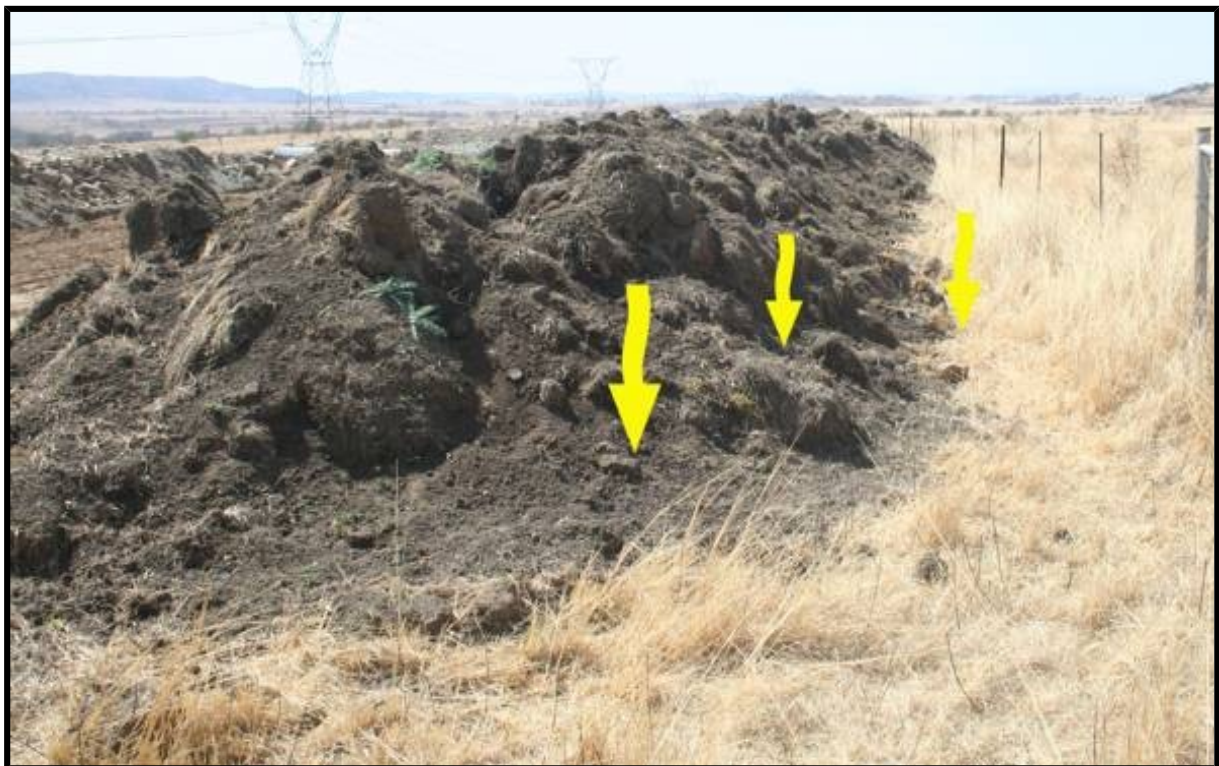
**FIG. 12: LOCATION OF GLK118\_96**

**Assessment of Damage:** The graves were technically not damaged and have been cleaned. The associated walling was also cleaned. There was however an infringement on the site and this forms part of the pattern of demarcated heritage sites being ignored by the contractor.

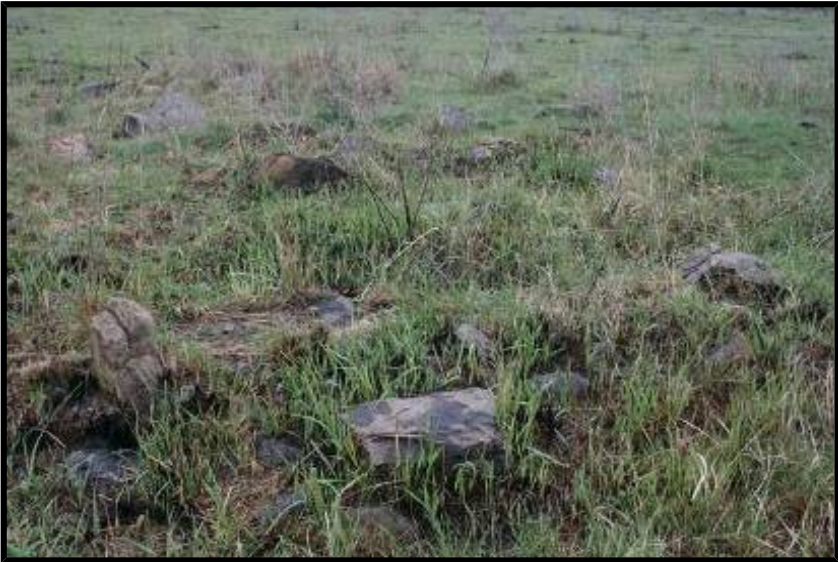
**FIG. 20: PHOTOGRAPH OF POSSIBLE GRAVE SUBMITTED BY THE ECO IN 2009**

This site is located at KP265+286 and consists of one possible grave. The possible grave probably dates to the HP or more recent past. Figures 17 – 19 indicate that there is no human occupation in this immediate area in 1937, 1954 nor 2000. The site was located by the ECO during pre-RoW clearance and demarcated with blue wooden poles (fig. 20). I visited the site and confirmed that it is a possible grave, and the area was fenced off and marked off by the RoW supervisor. The landowner recently stated that these features are related to the construction of the N3. This statement has no bearing on the site, as the area was demarcated as a heritage site, regardless of its content, and should have been treated as such.

**Assessment of Damage:** The area was cleaned and the outline of the possible grave was demarcated. A few of the rocks from the cairn are missing.

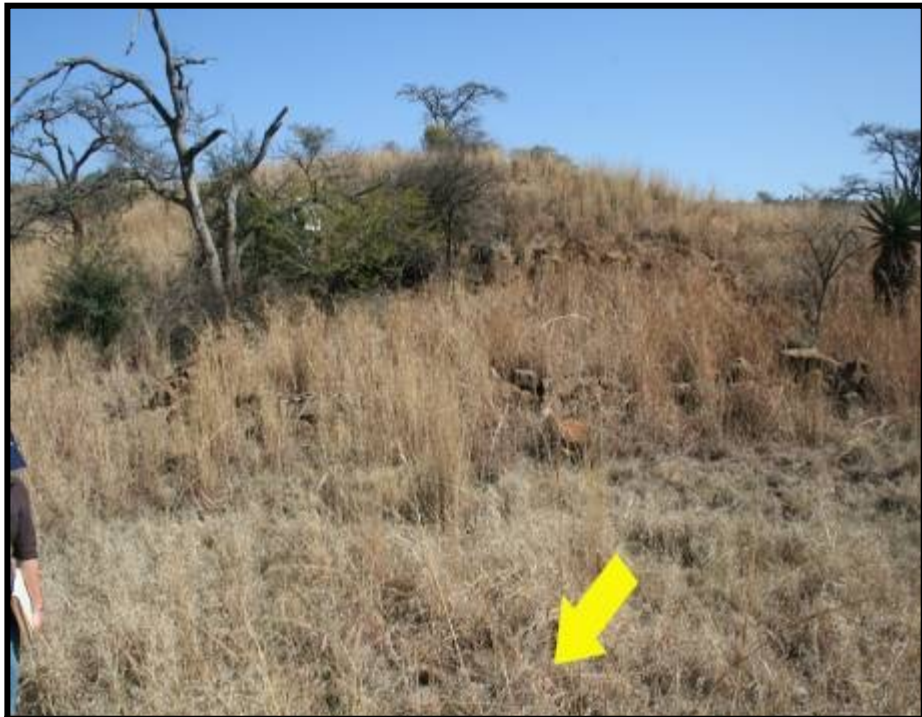
**FIGURE 27: POSITION OF GRAVE IN JULY 2009**

The stonewalling has had topsoil placed over the walls since RoW clearance. The cairn (fig. 27) does not exist anymore and we had to relocate the ends of the grave with our survey data. I placed several trenches in the area of the poles to determine if any form of stone cairn or burial could be seen (fig. 28). It appears that the entire cairn has been removed and we could not locate a burial. There was no change in soil colours to indicate a burial however this is expected as the bedrock is near the surface. We could not observe any soil colour changes for the archaeological graves that were excavated in this area in 2009. I did observe one bone fragment from the excavation, but could not determine if it was human or animal. The fragment was kept in case it needs to be analysed. The area was fenced off after the excavations.

**Assessment of Damage:** The entire cairn has been removed and presumably the grave itself.

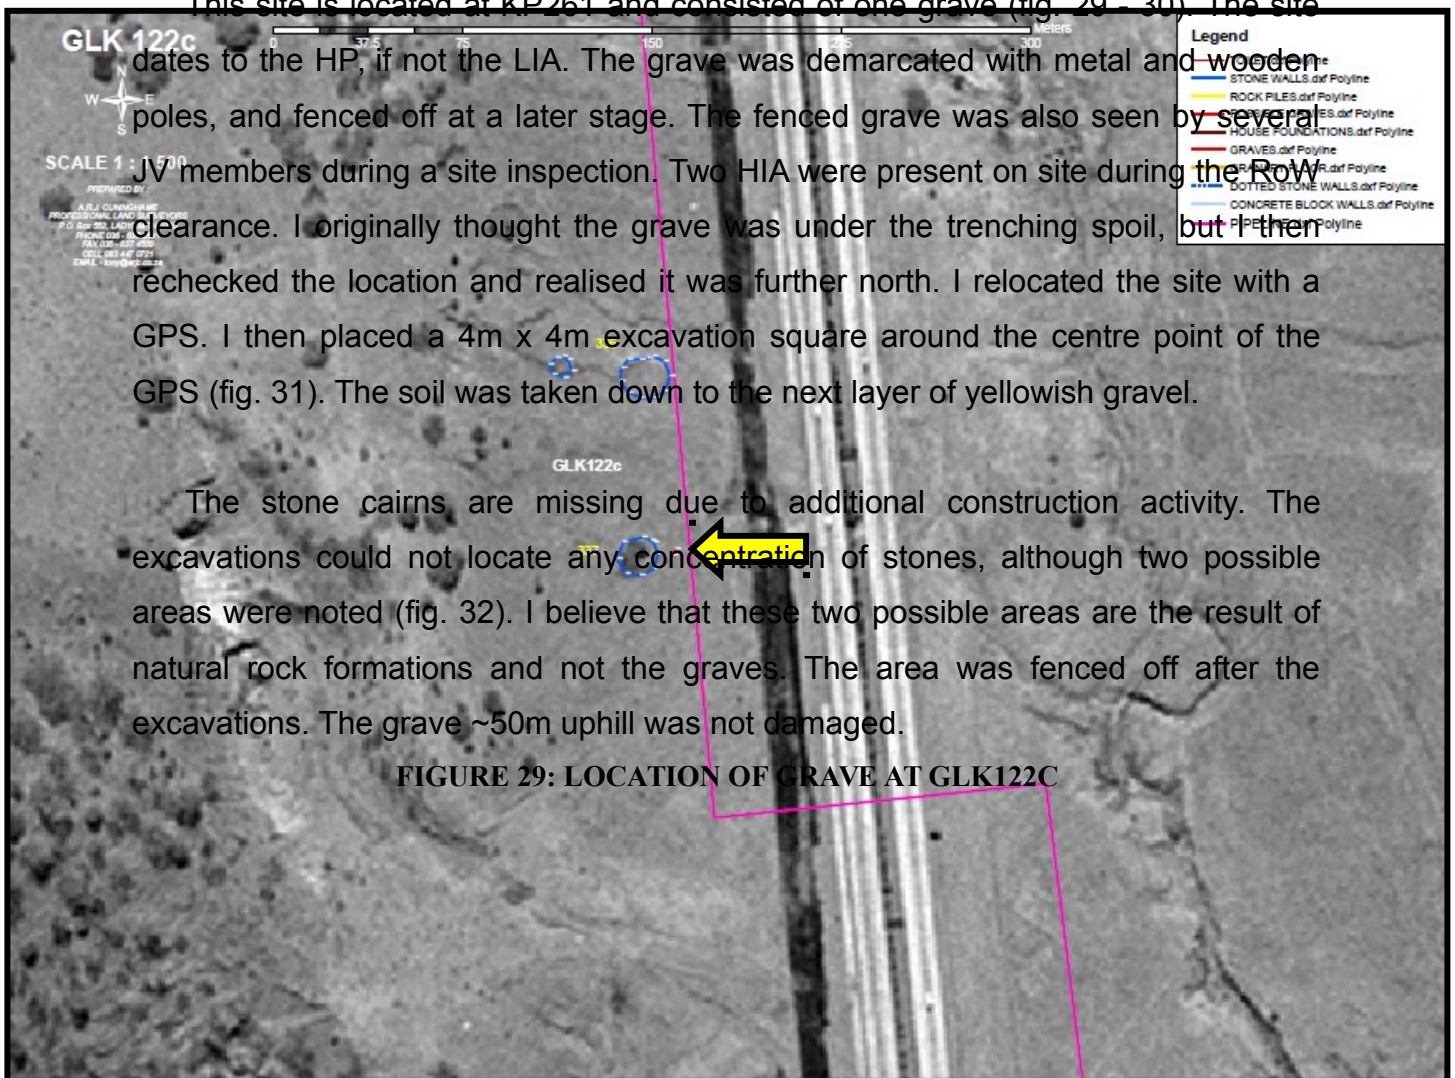
**FIGURE 29: LOCATION OF GRAVE AT GLK122C**

This site is located at KP261 and consisted of one grave (fig. 29 - 30). The site dates to the HP, if not the LIA. The grave was demarcated with metal and wooden poles, and fenced off at a later stage. The fenced grave was also seen by several JV members during a site inspection. Two HIA were present on site during the Row clearance. I originally thought the grave was under the trenching spoil, but I then rechecked the location and realised it was further north. I relocated the site with a GPS. I then placed a 4m x 4m excavation square around the centre point of the GPS (fig. 31). The soil was taken down to the next layer of yellowish gravel.

**Significance of site:** The site is of high significance  
**Significance of impact:** High negative  
**Previous mitigation:** Area was fenced off.  
**Occurrence of damage:** After RoW clearance.  
**Assessment of Damage:** The entire cairn has been removed and presumably the grave itself.

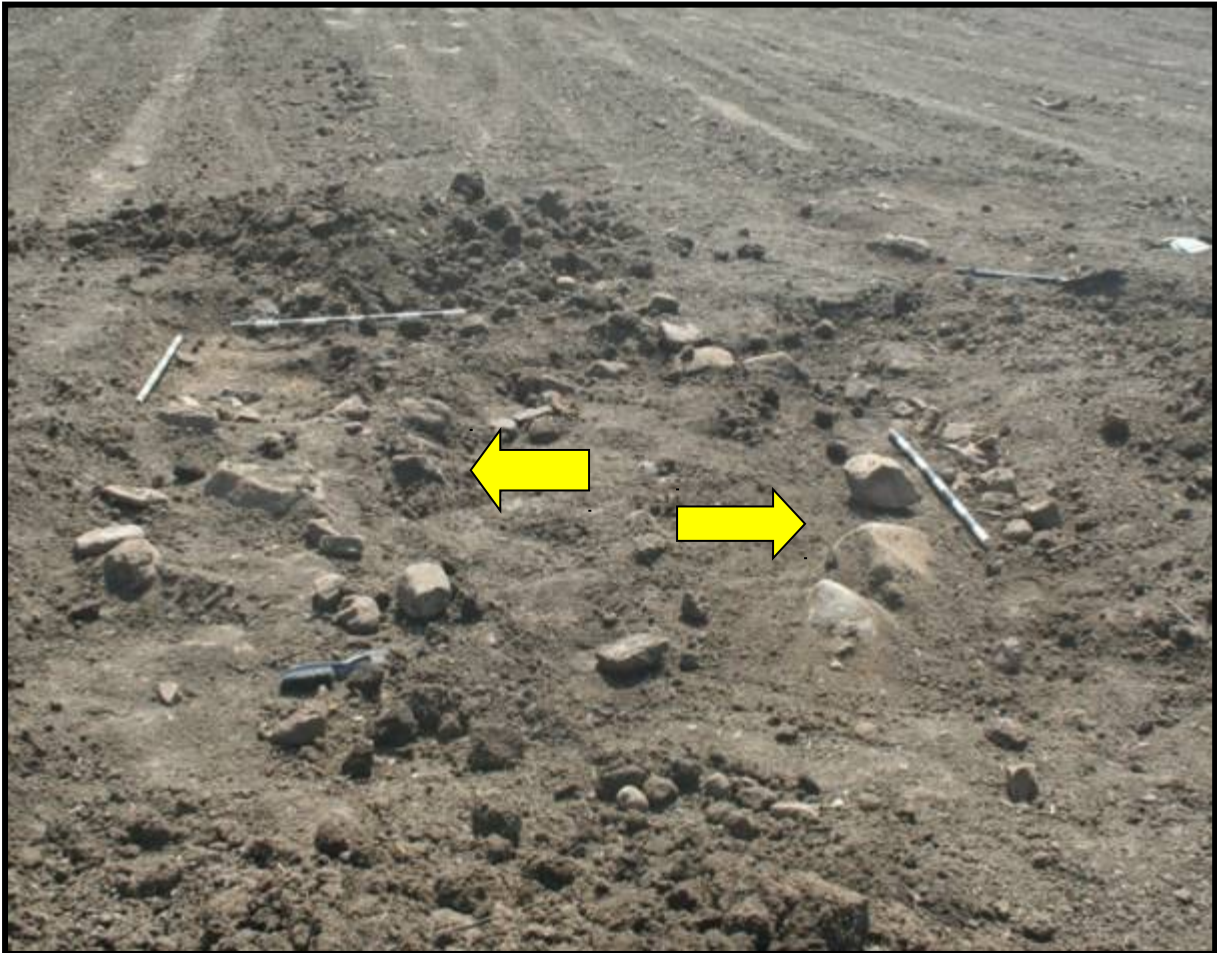
**FIGURE 32: GRAVE AT GLK122C**

The stone cairns are missing due to additional construction activity. The excavations could not locate any concentration of stones, although two possible areas were noted (fig. 32). I believe that these two possible areas are the result of natural rock formations and not the graves. The area was fenced off after the excavations. The grave ~50m uphill was not damaged.

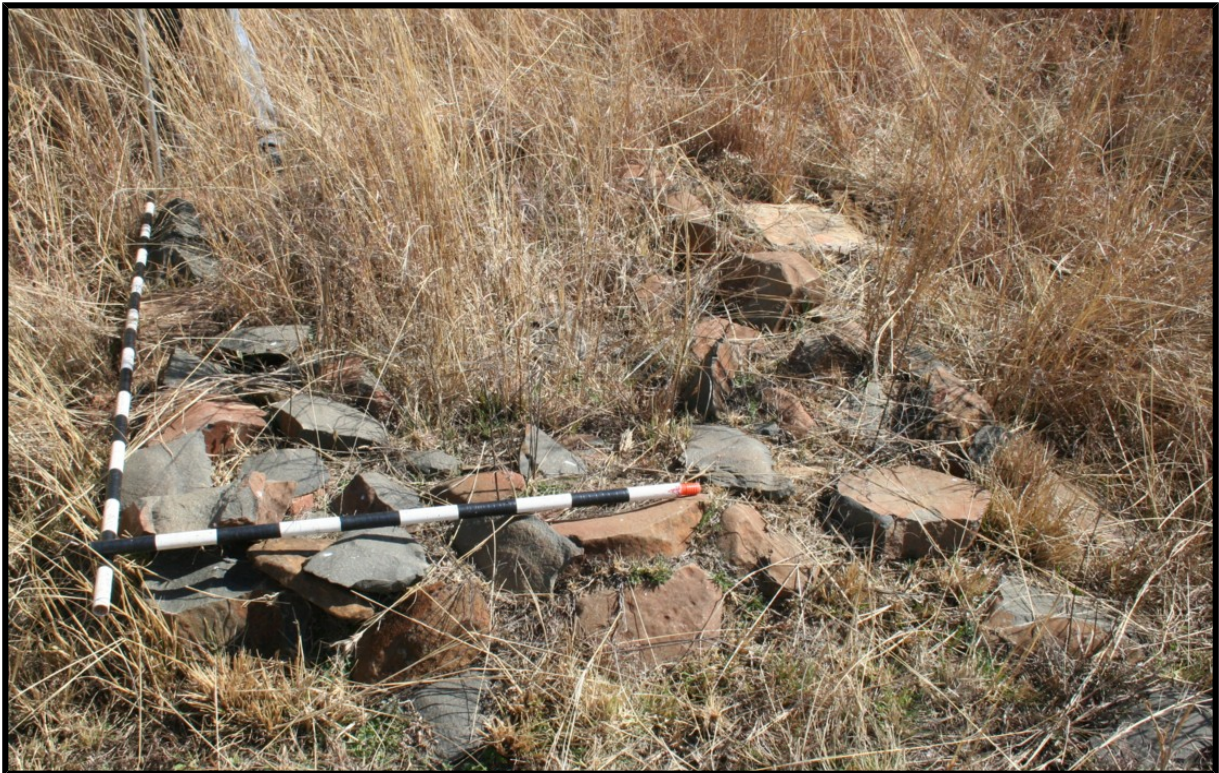
**FIGURE 36: 2009 PHOTOGRAPH OF THE GRAVE**

The grave was demarcated with metal and wooden poles and was fenced off before the RoW clearance (fig. 36 shows the grave IN 2009). Two HIA were on site during RoW clearance. Subsequent to RoW clearance the grave was covered by trenching spoil (fig. 37). This is the first grave of the damaged sites that has definite living descendents. Transnet may need to compensate the descendents.

**Assessment of Damage:** The graves are technically not damaged and they have been cleaned. There was however an infringement on the site and this forms part of the pattern of demarcated heritage sites being ignored by the contractor. The living descendents may claim that the ancestral spirit needs to be appeased.
