**MULILO RENEWABLE ENERGY  
DE AAR 2 (SOUTH)  
WIND ENERGY FACILITY  
PRELIMINARY GEOTECHNICAL INVESTIGATION  
REPORT**

**AUGUST 2012  
J674**

CONSULTING ENGINEERING GEOLOGISTS  
CEGELA HOUSE 20 HOPE STREET HERMANUS 7201 • PO BOX 1321 HERMANUS 7200 SOUTH AFRICA  
TEL [+27 28] 313 0741 • FAX [+27 28] 313 0747 • E-mail: dvrooyen@hermanus.co.za  
DIRK VAN ROOYEN Pr. SciNat BSc (Hons) [Eng Geol] MSAIEG

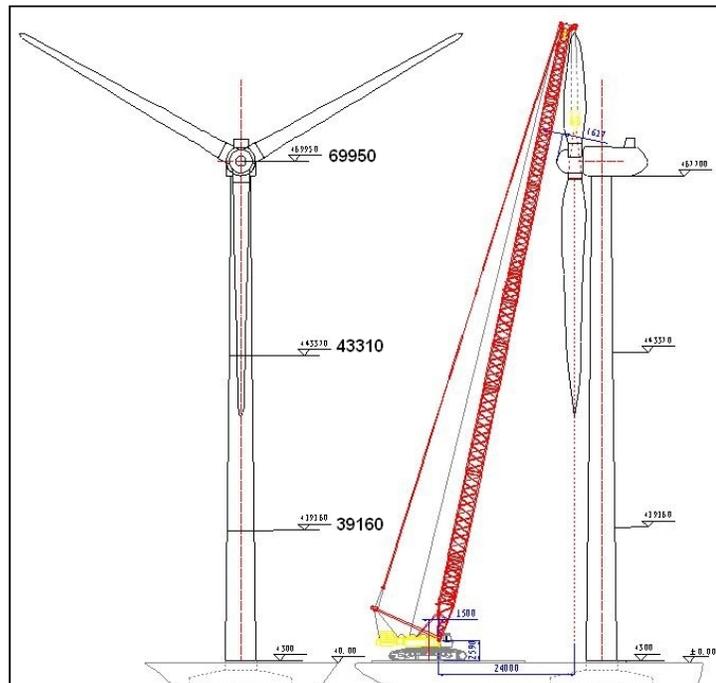
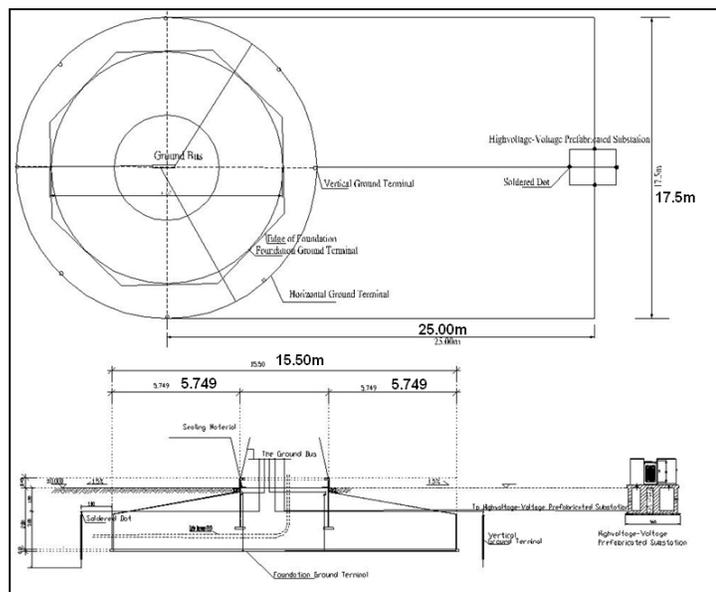
The dimensions of the proposed turbines and their towers in relation to the erection and assemblage plant are illustrated below:-

- (i) 105 three-bladed dynamo-electric constant frequency wind turbine generators; the approximately 70m high towers will be supported on 17,5m diameter and 3,0m thick foundation bases, which, apparently will impose contact stresses of less than 450kPa.
- (ii) Three 400m x 200m construction camps and lay-down areas for both De Aar 2 North and South, will be established on the following farms:-
- Slingers Hoek 2 Portion 2
  - Vendussie Kuil Re/165
  - Slingers Hoek Re/2
- (iii) Eskom's north-east to south-west running powerlines into which the proposed northern facility will feed electricity into the national grid. The details of these powerlines are as follows:-

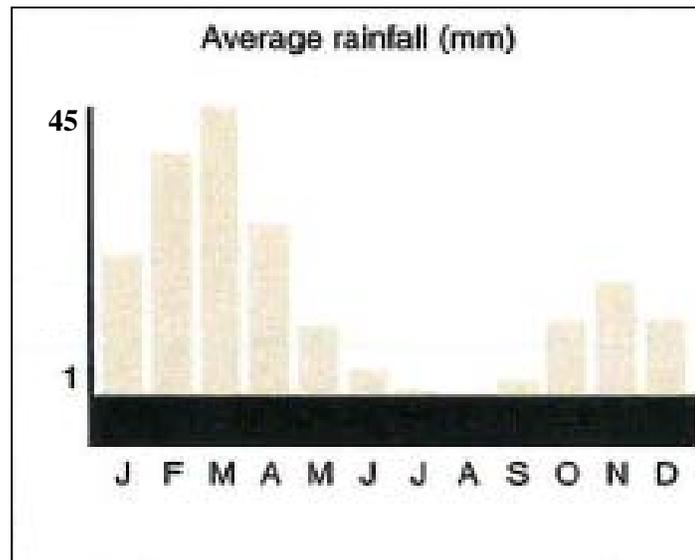
De Aar is reported to receive approximately 196mm of rain per year, and although most of this rain falls during autumn, it includes a few summer thunderstorms. The chart below shows that the average monthly rainfall figures vary between 1mm in August and 45mm in March.

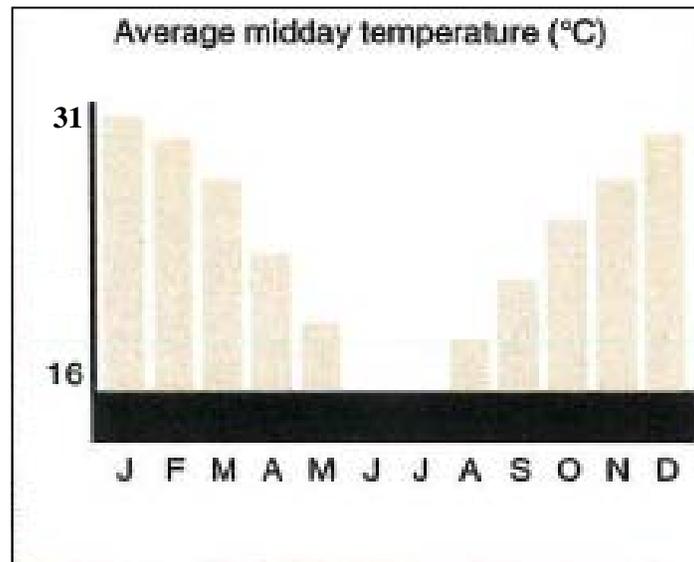
The chart below presents the monthly distribution of the average daily maximum temperatures; it shows the average midday temperatures for De Aar to range from 16°C in June to 30.3°C in January.

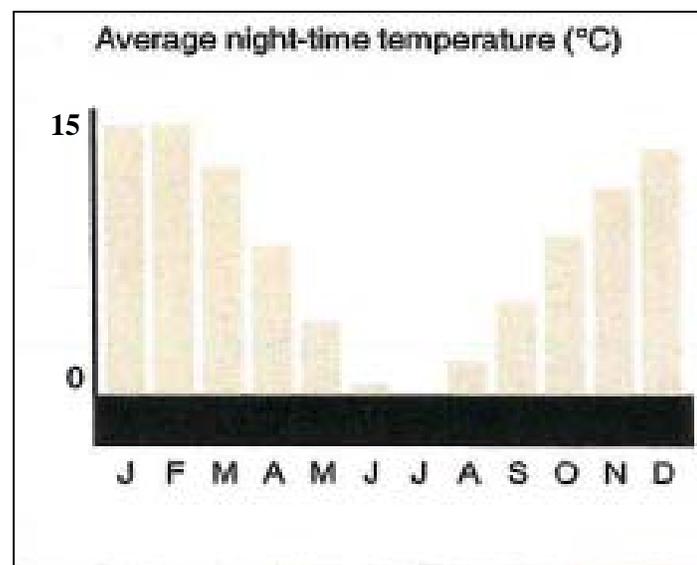
The region is the coldest during July when the mercury drops to 0.3°C on average during the night. The chart below shows the monthly variation of the average minimum night-time temperatures.
