S Hustwick & T Mbambo

Environmental & Heritage Management

COMMENTS ON THE MAINTENANCE MANAGEMENT PLAN FOR THE PROPOSED RESTORATION AND MAINTENANCE OF THE BLUE STONE QUARRY WALL, ROBBEN ISLAND (Feb 2021)

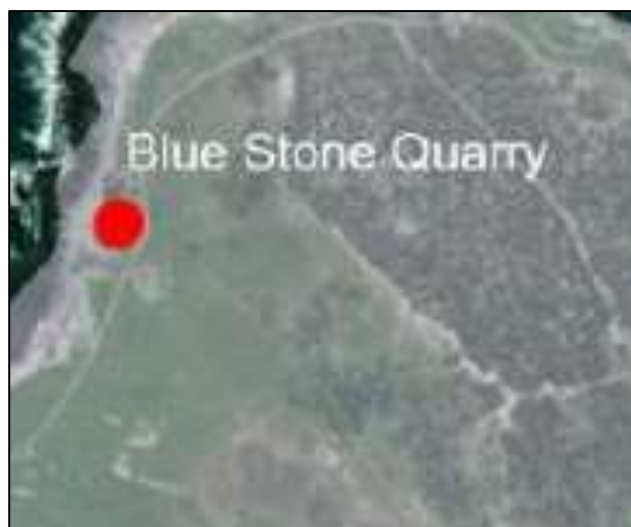
- 6.1 With reference to the "map of the proposed Activity' (Section 2, p10/49), the Sensitive areas map must be in greater detail at 1:1000 scale minimum. The map provided is vague and unhelpful. It does not provide information as to where the sensitive areas are located and if they are avoided or not relative to the construction camp and access routes.

- 6.2 One cannot clearly see the edges of the sensitive bird breeding sites or any demarcation of these areas.
- 6.3 The acronym, 'BSP' protected area, on the legend, must be spelled out in full on the legend of the map for clarity. It is not clear what BSP means.

6. Map of the proposed Activity' (Section 2, p10/49).

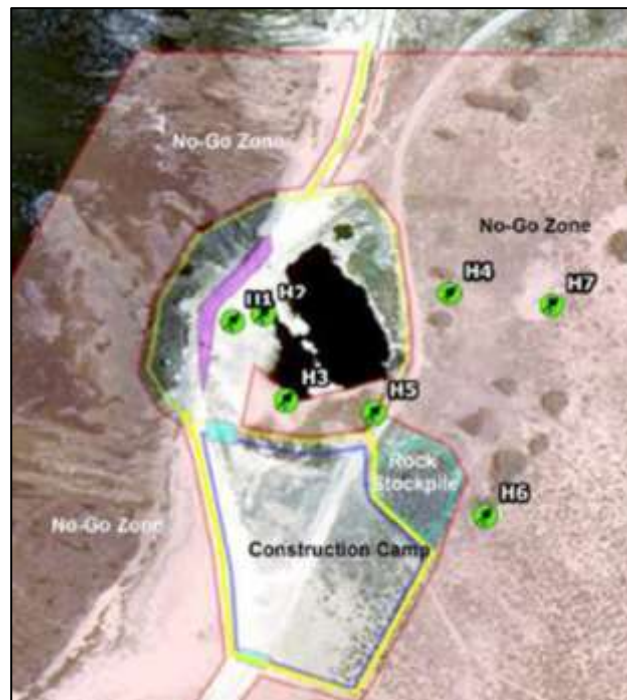
7. Site Layout Map: No go zones: pg17/49:

7.1 It appears from the maps that the no-go zones include the access roads, including the major circular route around the island. This is welcomed and should perhaps be more extensive in order to protect bird breeding areas.

7.2 Vehicle access routes and impacts: The Construction Camp and Construction site are accessed from both sides by an access road. This must be changed to confine the access route to enter the construction site from the north only, and to exit the construction site to the north only. Allowing construction vehicles the liberty to drive through the entire length of the breeding site would be ill advised, and would spread the adverse impacts on the breeding colony too widely. The access road runs parallel to the coast, between the shore and the immediate coastal area and the breeding areas extending further inland of the coast, and the access road is continually crossed by birds walking in both directions either to or from the coast. The breeding site to the south of the construction site must be designated a no-go area so that there is a safe hazard-free area available for breeding pairs and chicks particularly when construction vehicles render the northern extent of the breeding area too disturbed.
