## **uMngeni Water Entrances**

### **Design of New Entrances at Umngeni Water Head Office**

310 & 346 Burger Street, Pietermaritzburg

# **Visual Impact Assessment report**

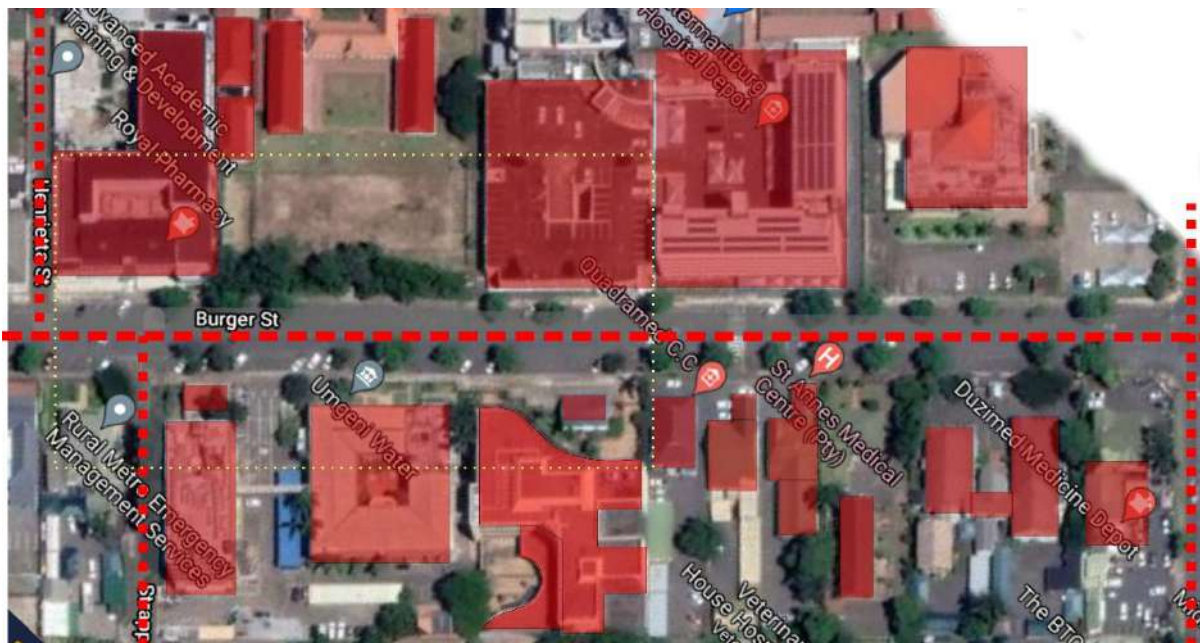
Fig. 1

- Existing buildings along the South side of Burger street are recessed & more sparsely located.
- There is a mix of both modern structures and refurbished heritage buildings. The heights of modern structures vary from 2 stories to 7 stories high (see figure 3)
- Footprint on the opposite end (North) of the street indicate large structures of multiple storeys. These structures are on the edge of the property line and are not recessed. There is however voids of open space between some properties and at least one recessed property at the corner of Burger & Boshof street.

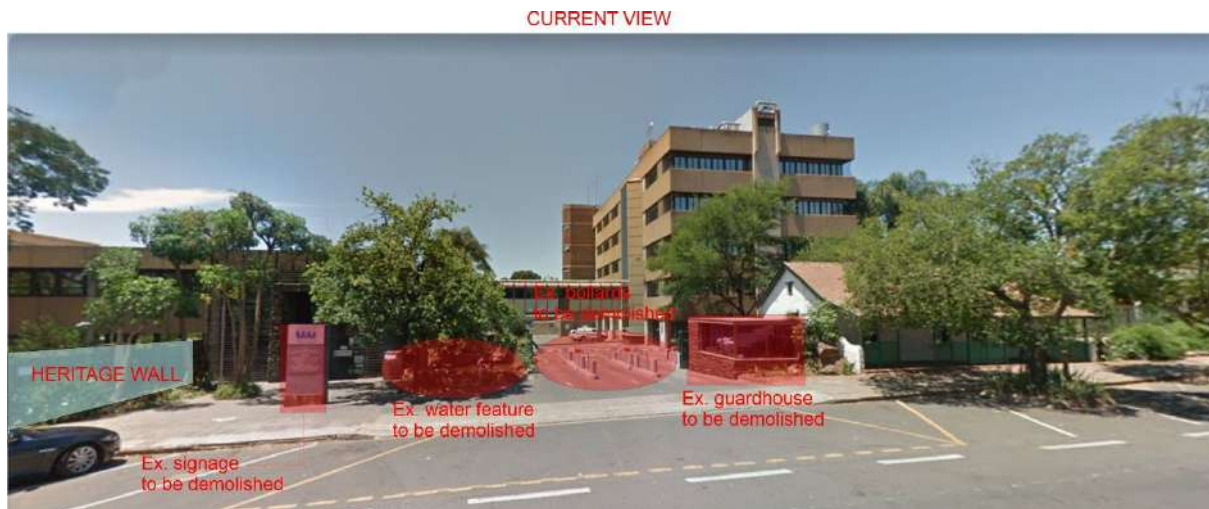
Fig. 13 – Existing demolitions

- Existing guardhouse, water feature, bollards & signage are to be removed.
- Removal of the existing guardhouse makes way for staff driveway which also acts as a buffer between the Voortreker cottage.

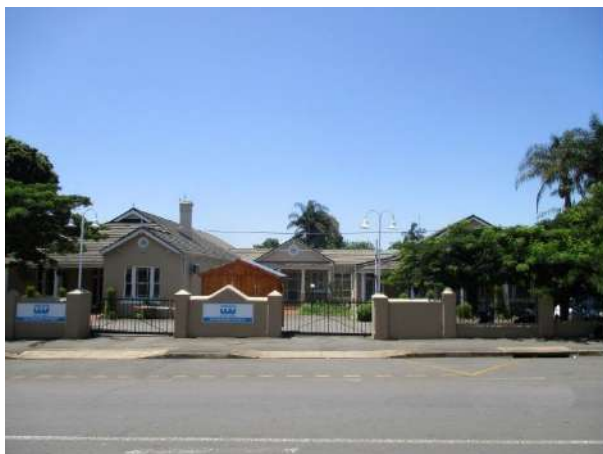
Fig. 24 – Street Elevation\_Existing

- Fig. below indicates existing timber structure currently on site which previously served as a guard house. It does not meet the clients requirement of a formal structure and certainly is not aesthetically pleasing.

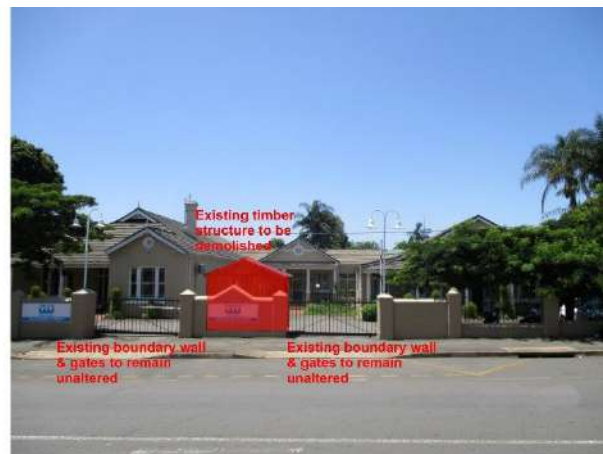
Fig. 25 – Street Elevation\_Demo

- The proposed structure sits on the boundary line and the existing boundary wall and gates will remain unaltered.
