S Hustwick & N Parker

Environmental & Heritage Management

COMMENTS ON THE REVISED MAINTENANCE MANAGEMENT PLAN FOR THE PROPOSED RESTORATION AND MAINTENANCE OF THE BLUE STONE QUARRY WALL, ROBBEN ISLAND (June 2021)

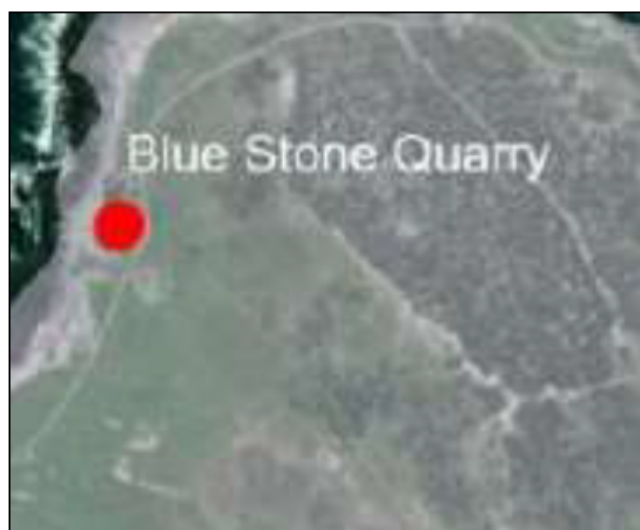
- 6.1 With reference to the "map of the proposed Activity' (Section 2, p10/49), the Sensitive areas map must be in greater detail at 1:1000 scale minimum. The map provided is vague and unhelpful. It does not provide information as to where the sensitive areas are located and if they are avoided or not relative to the construction camp and access routes.

- 6.2 One cannot clearly see the edges of the sensitive bird breeding sites or any demarcation of these areas.
- 6.3 The acronym, 'BSP' protected area, on the legend, must be spelled out in full on the legend of the map for clarity. It is not clear what BSP means.

6. Map of the proposed Activity' (Section 2, p10/49).

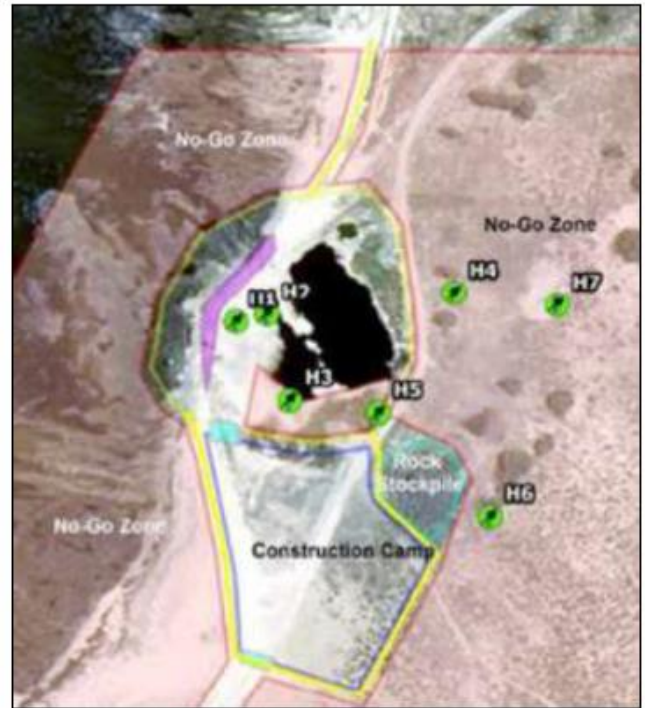
7. Site Layout Map: No go zones: pg17/49:

7.1 It appears from the maps that the no-go zones include the access roads, including the major circular route around the island. This is welcomed and should perhaps be more extensive in order to protect bird breeding areas.

7.2 Vehicle access routes and impacts: The Construction Camp and Construction site are accessed from both sides by an access road. This must be changed to confine the access route to enter the construction site from the north only, and to exit the construction site to the north only. Allowing

construction vehicles the liberty to drive through the entire length of the breeding site would be ill advised, and would spread the adverse impacts on the breeding colony too widely. The access road runs parallel to the coast, between the shore and the immediate coastal area and the breeding areas extending further inland of the coast, and the access road is continually crossed by birds walking in both directions either to or from the coast. The breeding site to the south of the construction site must be designated a no-go area so that there is a safe hazard-free area available for breeding pairs and chicks particularly when construction vehicles render the northern extent of the breeding area too disturbed.

8. The Site Layout Map
