**CONCEPTUAL WATER BALANCE FOR  
IMPALA PLATINUM MINES PHASE 3**

Report Number 414226/4

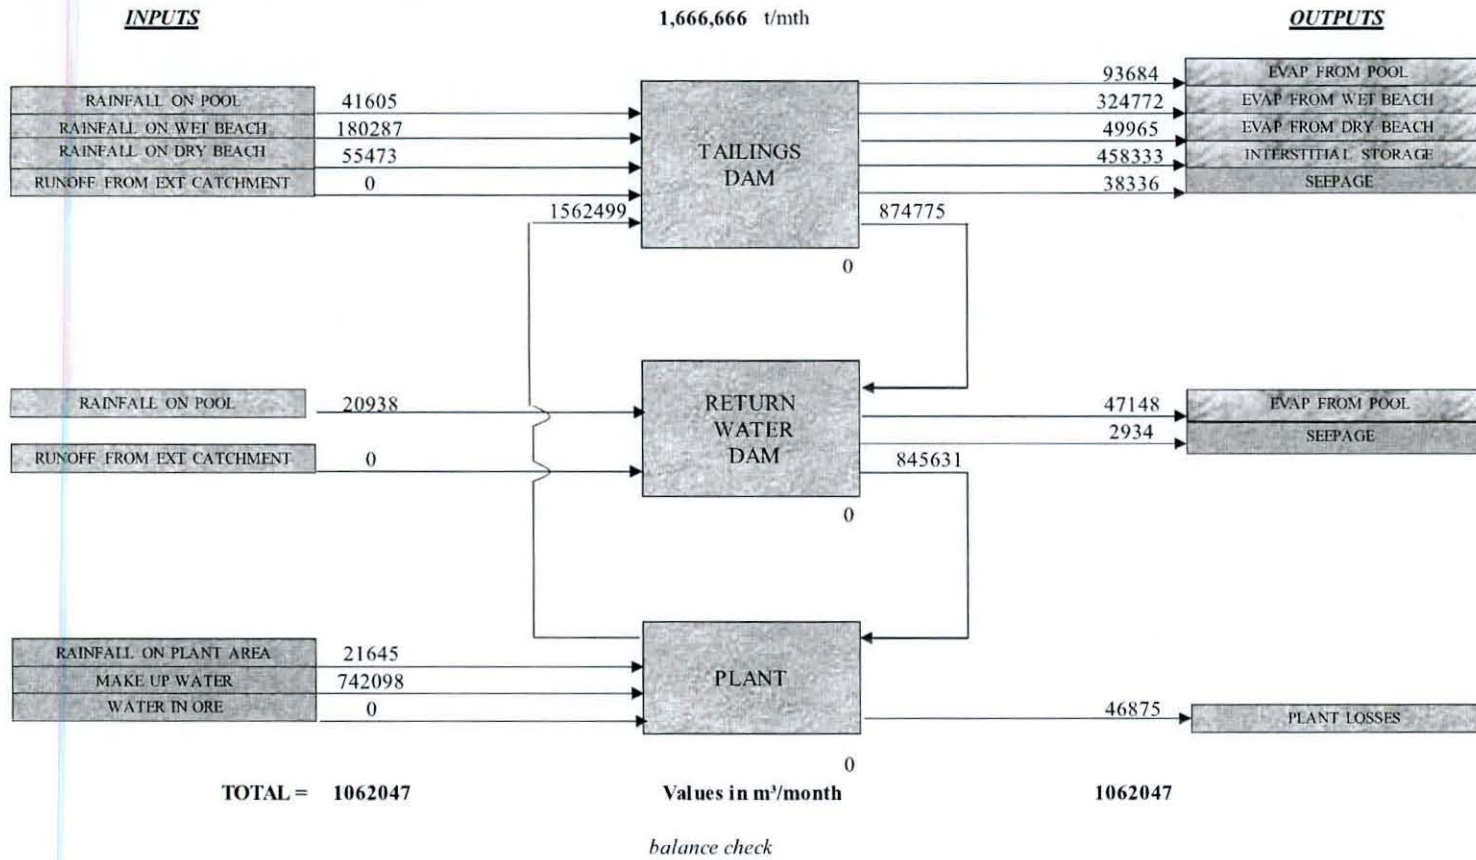
**Figure No**  
12.8

**Figure 12-8: Average Monthly Water Balance for Tailings dam No. 5: basin permeability of 2.9e-9m/s**

\*\*\* The average consumption per month is 0.42m³/t.

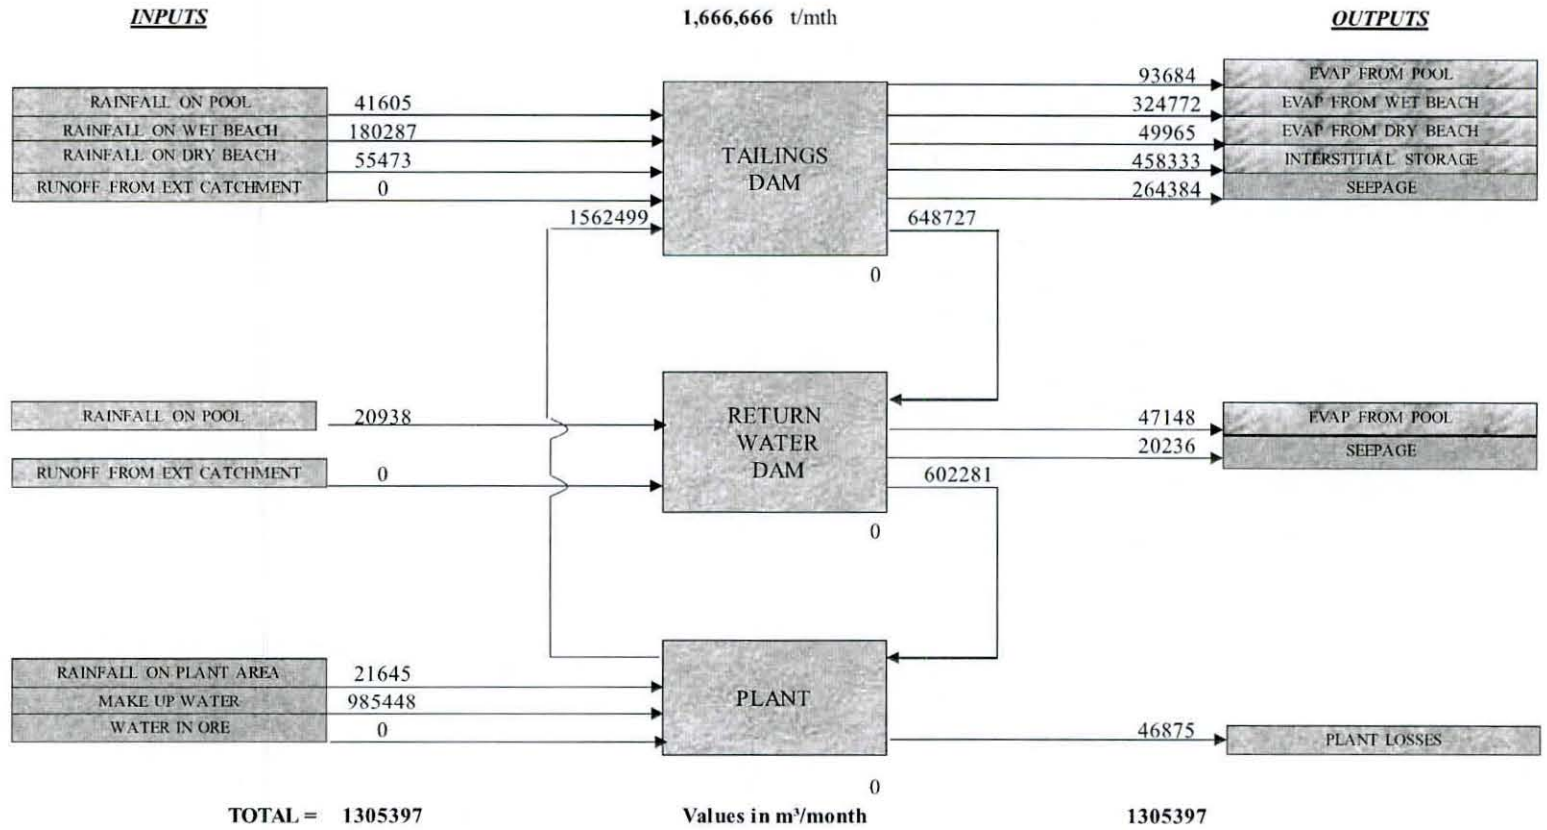
Figure No  
12.9

**Figure 12-9: Average Monthly Water Balance for Tailings dam No. 5: basin permeability of 2e-8m/s**

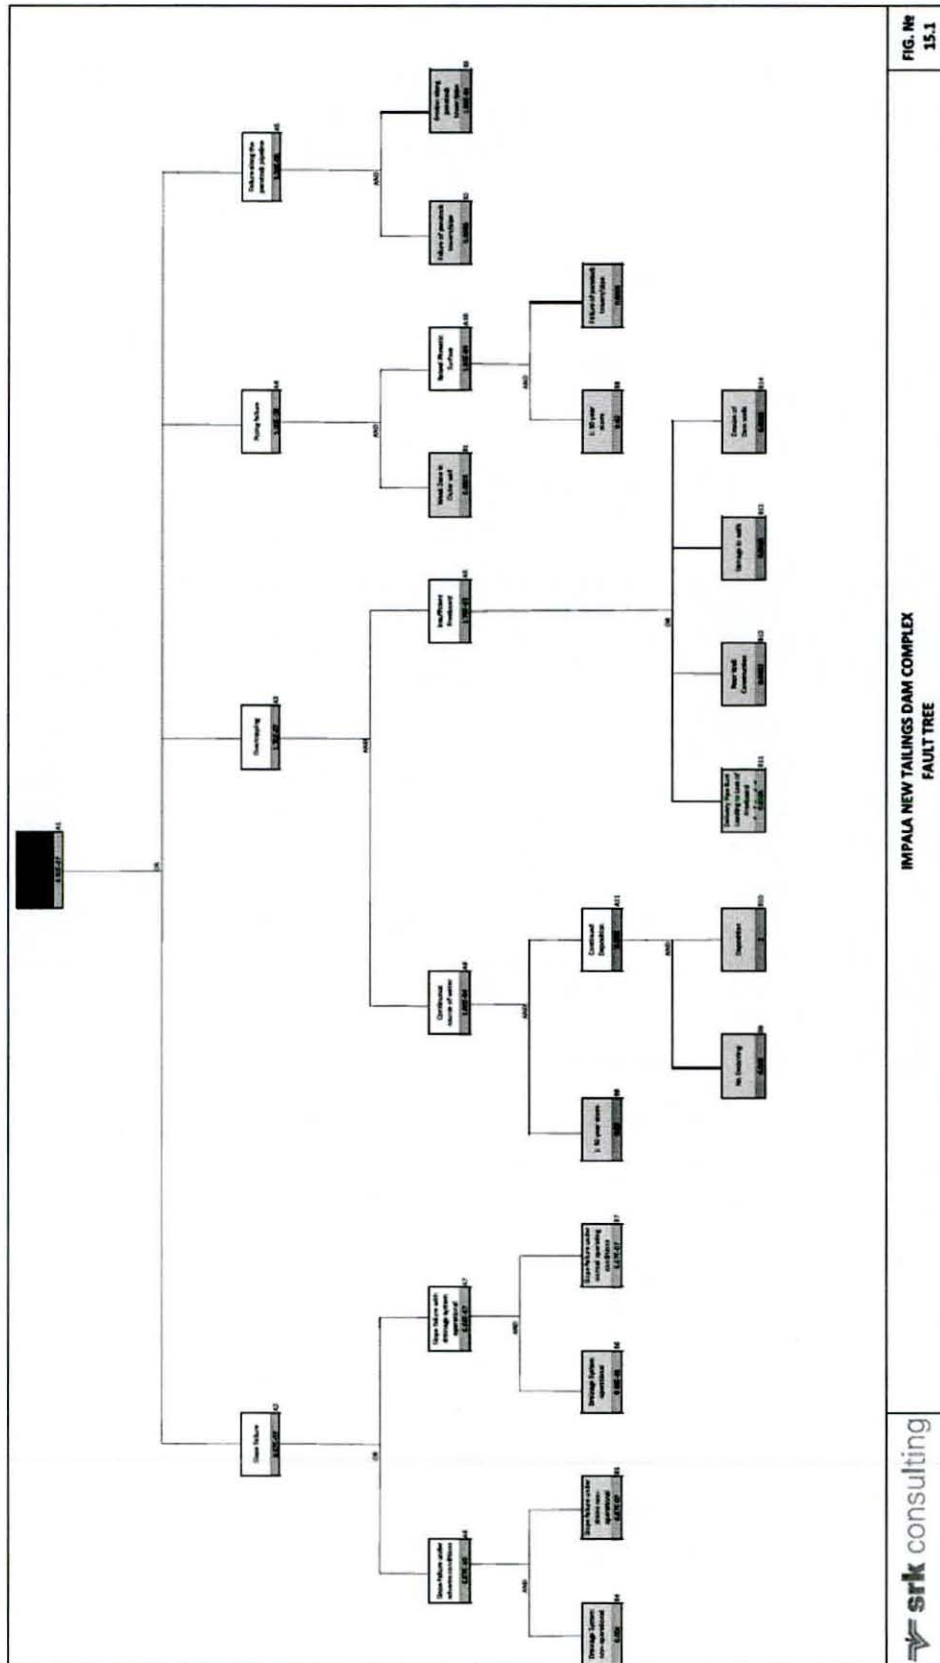
FIG. NR 15.1

Figure 15-1: Fault Tree Analyses

IMPALA NEW TAILINGS DAM COMPLEX FAULT TREE

The fault tree that has been developed for Impala New TSF is shown in Figure 15-1.

For a catastrophic flow failure to occur, the dam perimeter slope has to breach.

The probability of failure of the Impala New TSF is  $8.92 \times 10^{-7}$  (1: 1121627)
