ADDENDUM 2 | RESPONSE TO GDARD'S COMMENTS DATED 26 OCTOBER 2020

Steyn City Properties (Pty) Ltd. plans to develop Riverside View Ext 84 on portions 124 and 185 of the farm Diepsloot 388 JR. The proposed zoning of the development will be *Special for: Place of Instructions, Residential buildings and Offices, including ancillary uses such as restaurants and shops* and aims to provide a school, offices and residential buildings. Private Open space will also be incorporated into the development which form parts of the Steyn City Parkland Residence which has been designed to be a modern, mixed land use and mixed income development.

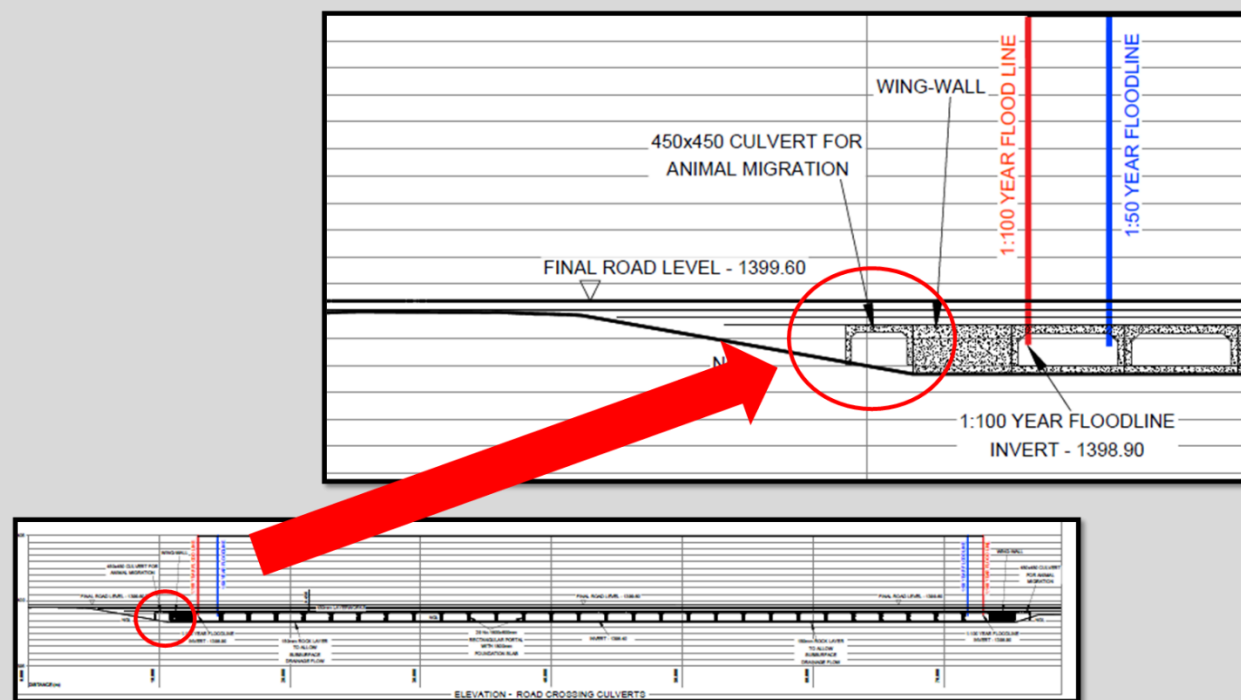
Figure 1: Proposed Wetland Crossing

As per Page 12 of the Stormwater Management Plan (Tekciv, 2020) that was included in the Appendix 14.6.9, "A road-bridge will be constructed which allows for the 1:100 year flow of 8.7 m³/s to pass under the road. The bridge is to be constructed of pre-cast portal culverts and will extend the full width of the flood line. To cater for animal crossings, smaller culverts will be placed above the flood line to allow for migration.

Please refer to **Figure 1** below which indicates the proposed wetland crossing including the smaller culverts which cater for animal crossings outside the floodline.

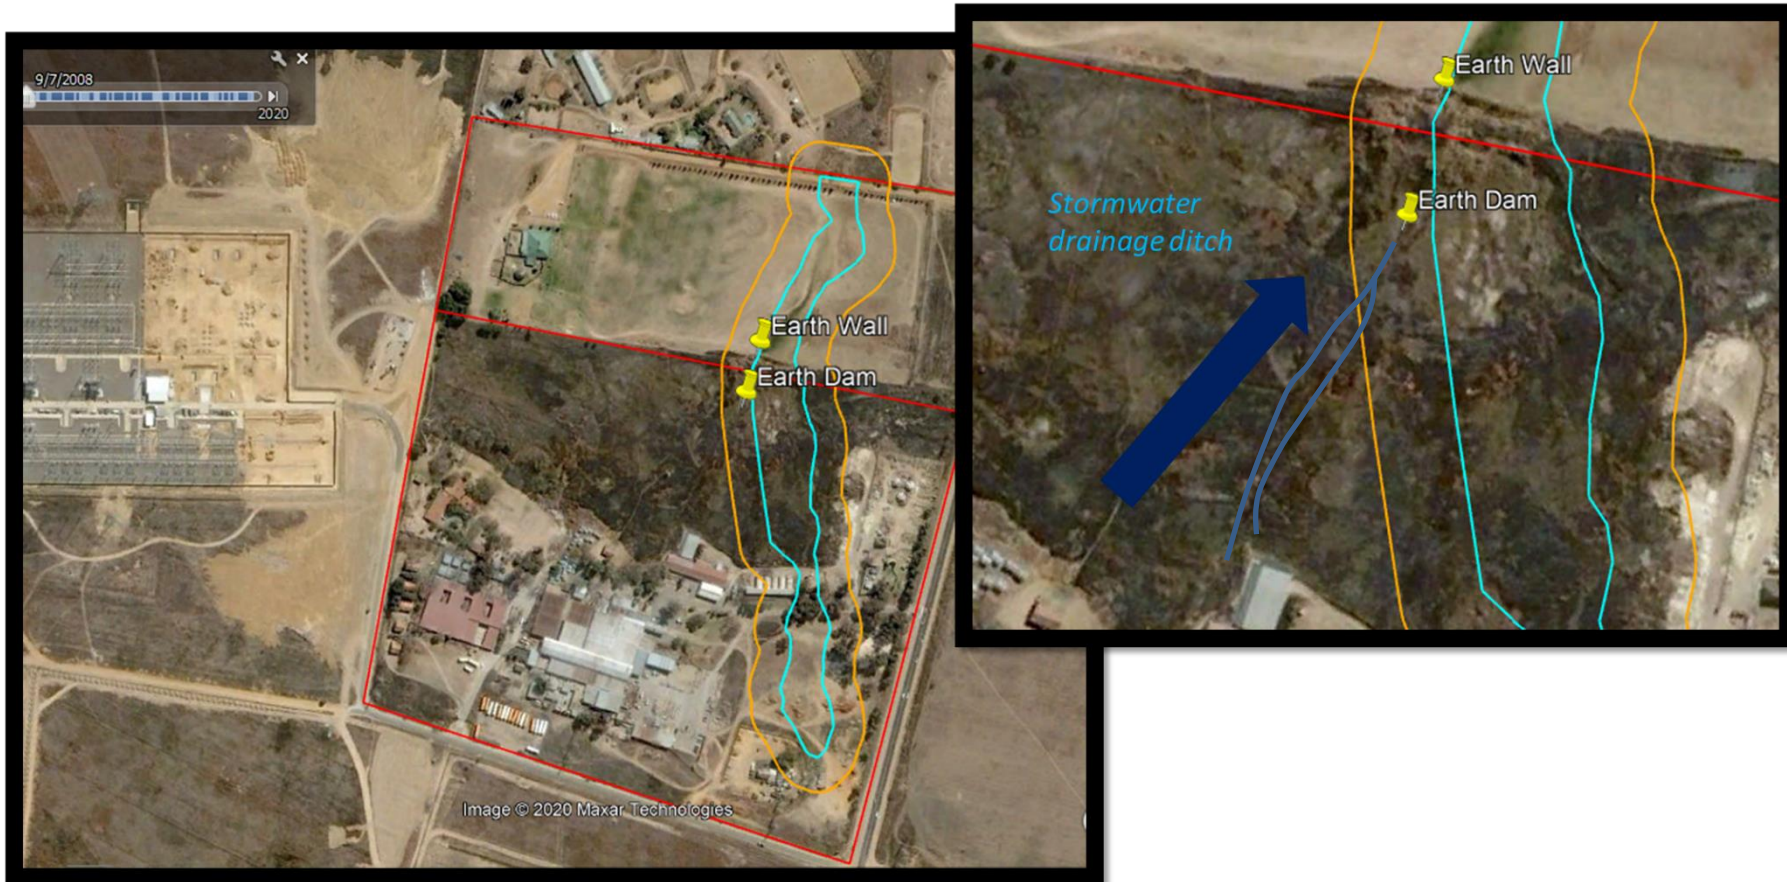
Figure 2: Google Earth Imagery from July 2008

- Portion 124 of the Farm Diepsloot 388 JR
 - The site was developed as a golf driving range with driving tees and sand bunkers as well as a restaurant and club house. Most of the site is cut lawn.
- Portion 185 of the Farm Diepsloot 388 JR
 - The site was developed as a school, panel beating shop, car spray paint business and dimension stone seller. As part of this the southern sections of the wetland were partly developed.
 - In this regard it should be noted that just to the centre of Portion 185, stormwater was released from the school and buildings which affected the vegetation of the site.

Please refer to **Figure 2, 3 and 4** below.

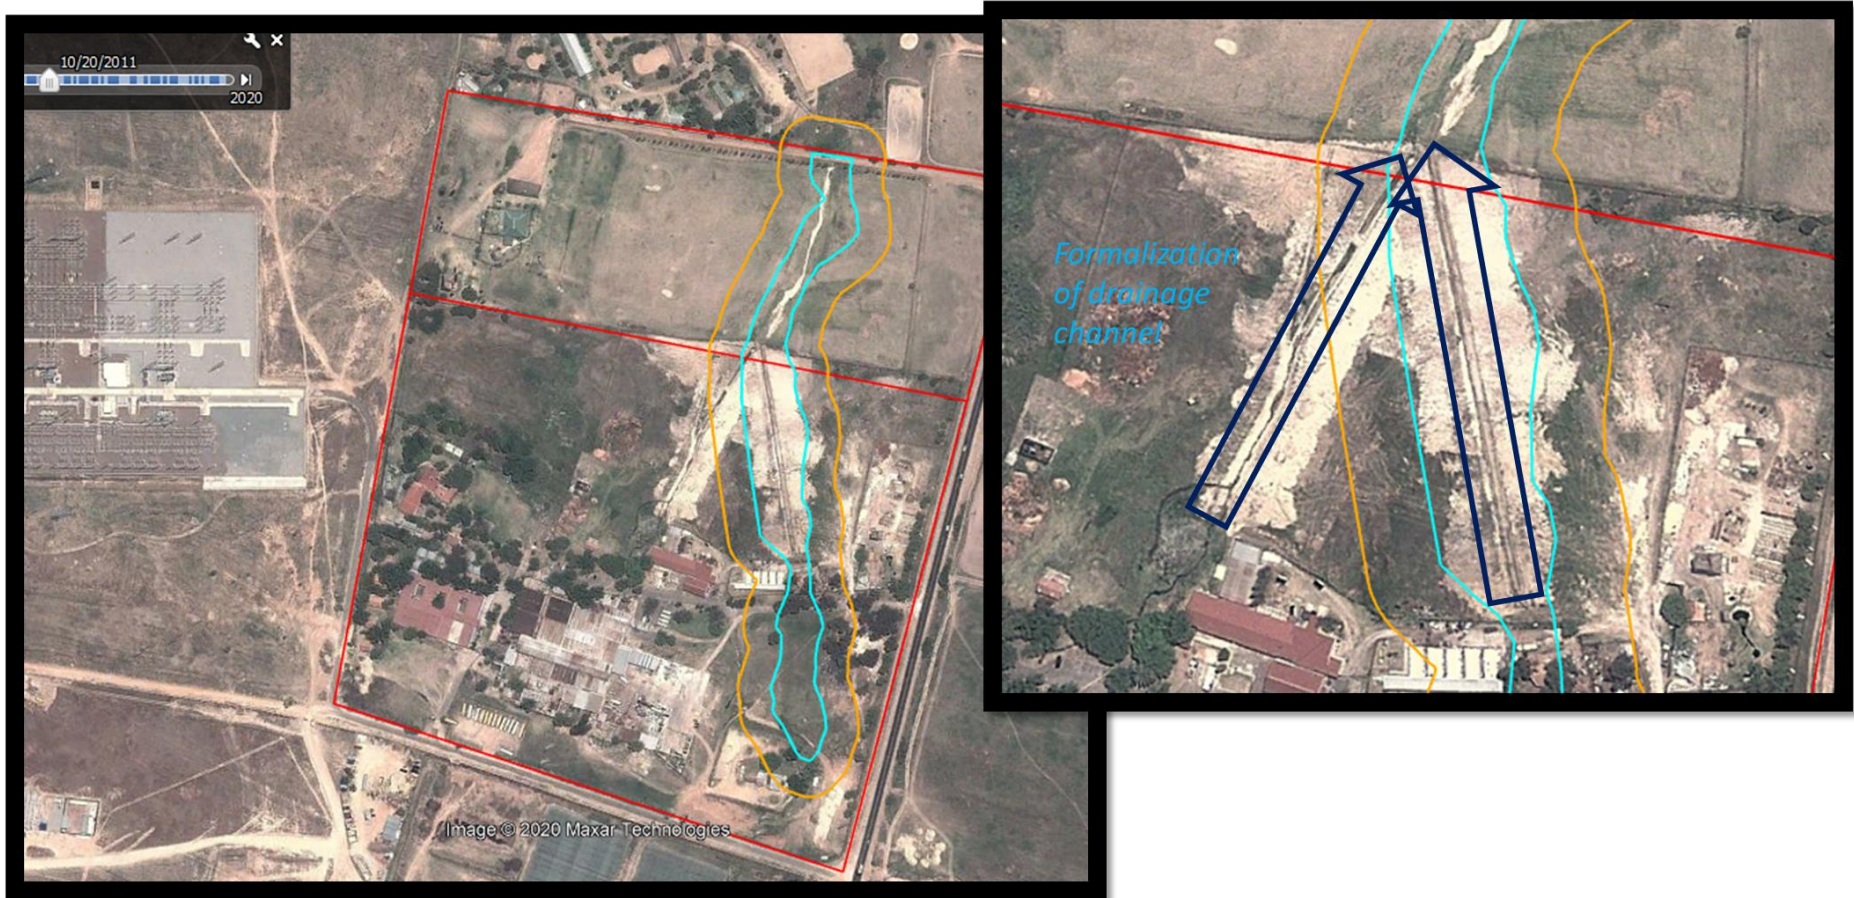
Figure 6: Google Earth Imagery from October 2011

From October 2011 to May 2015, a number of changes to the site took place. These occurred after the Geotechnical Reports and thus are not captured within. The exact details of the changes and why they took place is not available. However, evidence from Google Earth as well as the site visits, indicate that that formal drainage channels were put in place in the wetland.

Furthermore, whilst the school and old buildings on Portion 185 were demolished, the platforms they were built on remain in place and thus still channel stormwater and thus form the artificial source of water. This cannot be classified as a wetland and therefore was excluded from the delineation.

Figure 6, 7 and 8 below provide the Google Earth Imagery from this time.

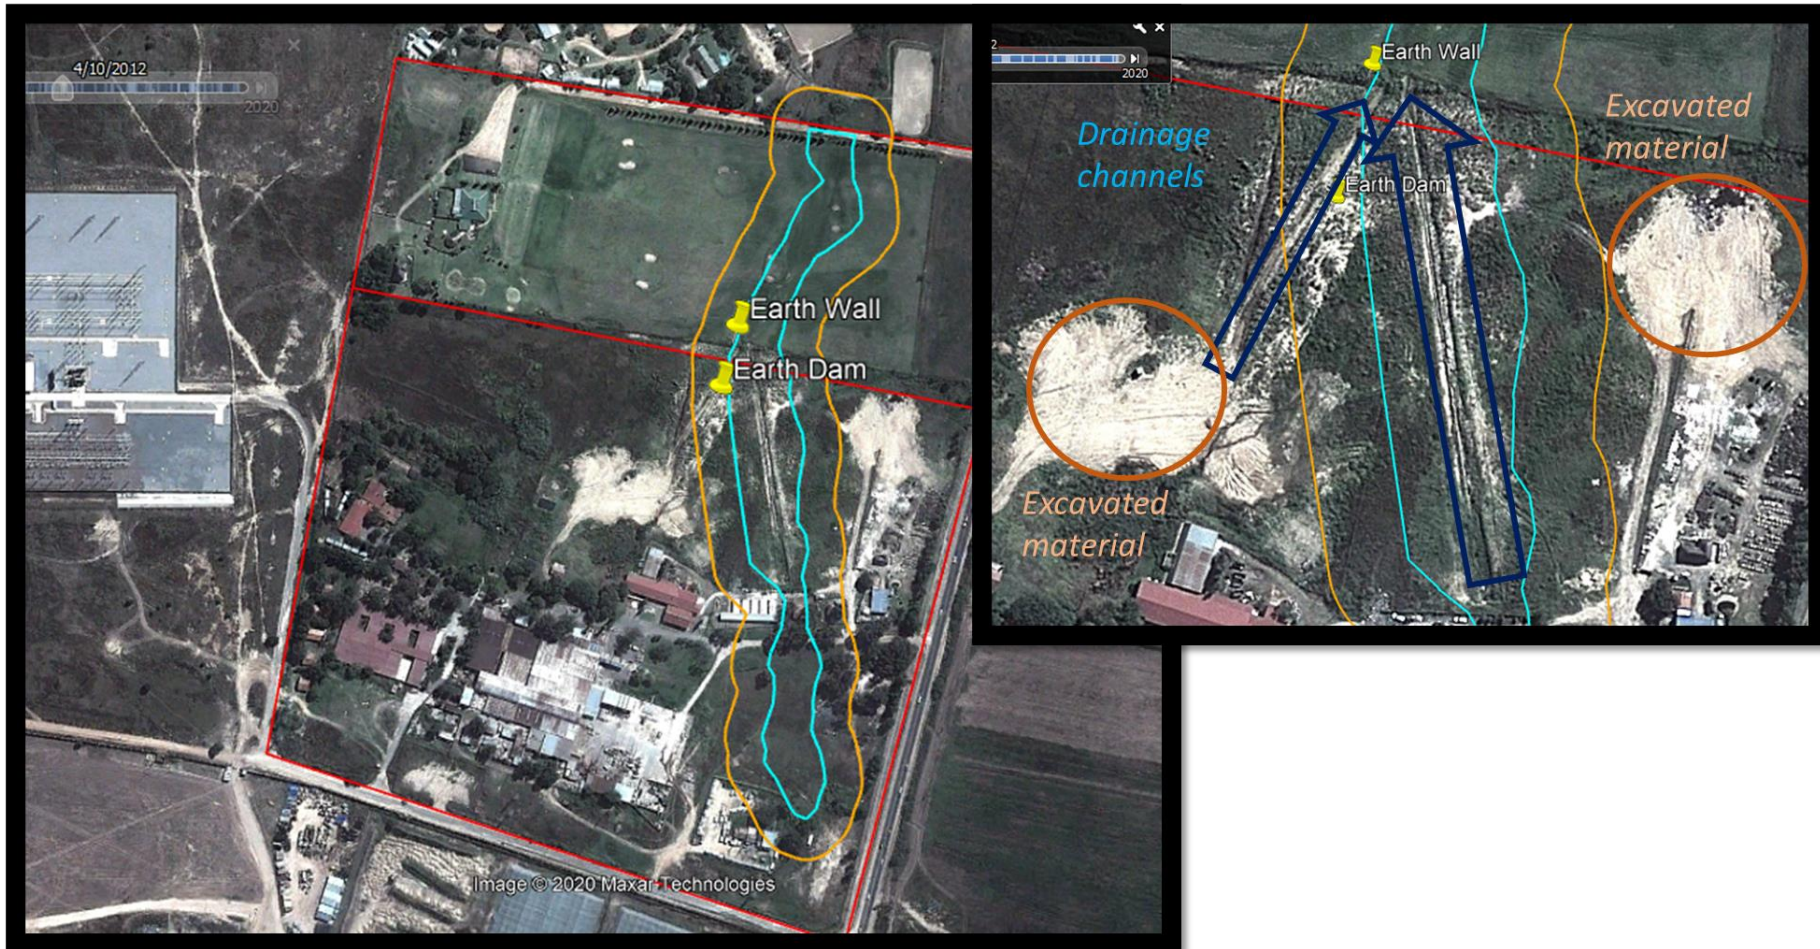
Figure 7: Google Earth Imagery from April 2012

In addition, in April 2012 (prior to the sale of the property to Steyn City), fill material was excavated and was used for construction/upgrades of nearby roads as well as sourcing of material for manufacturing

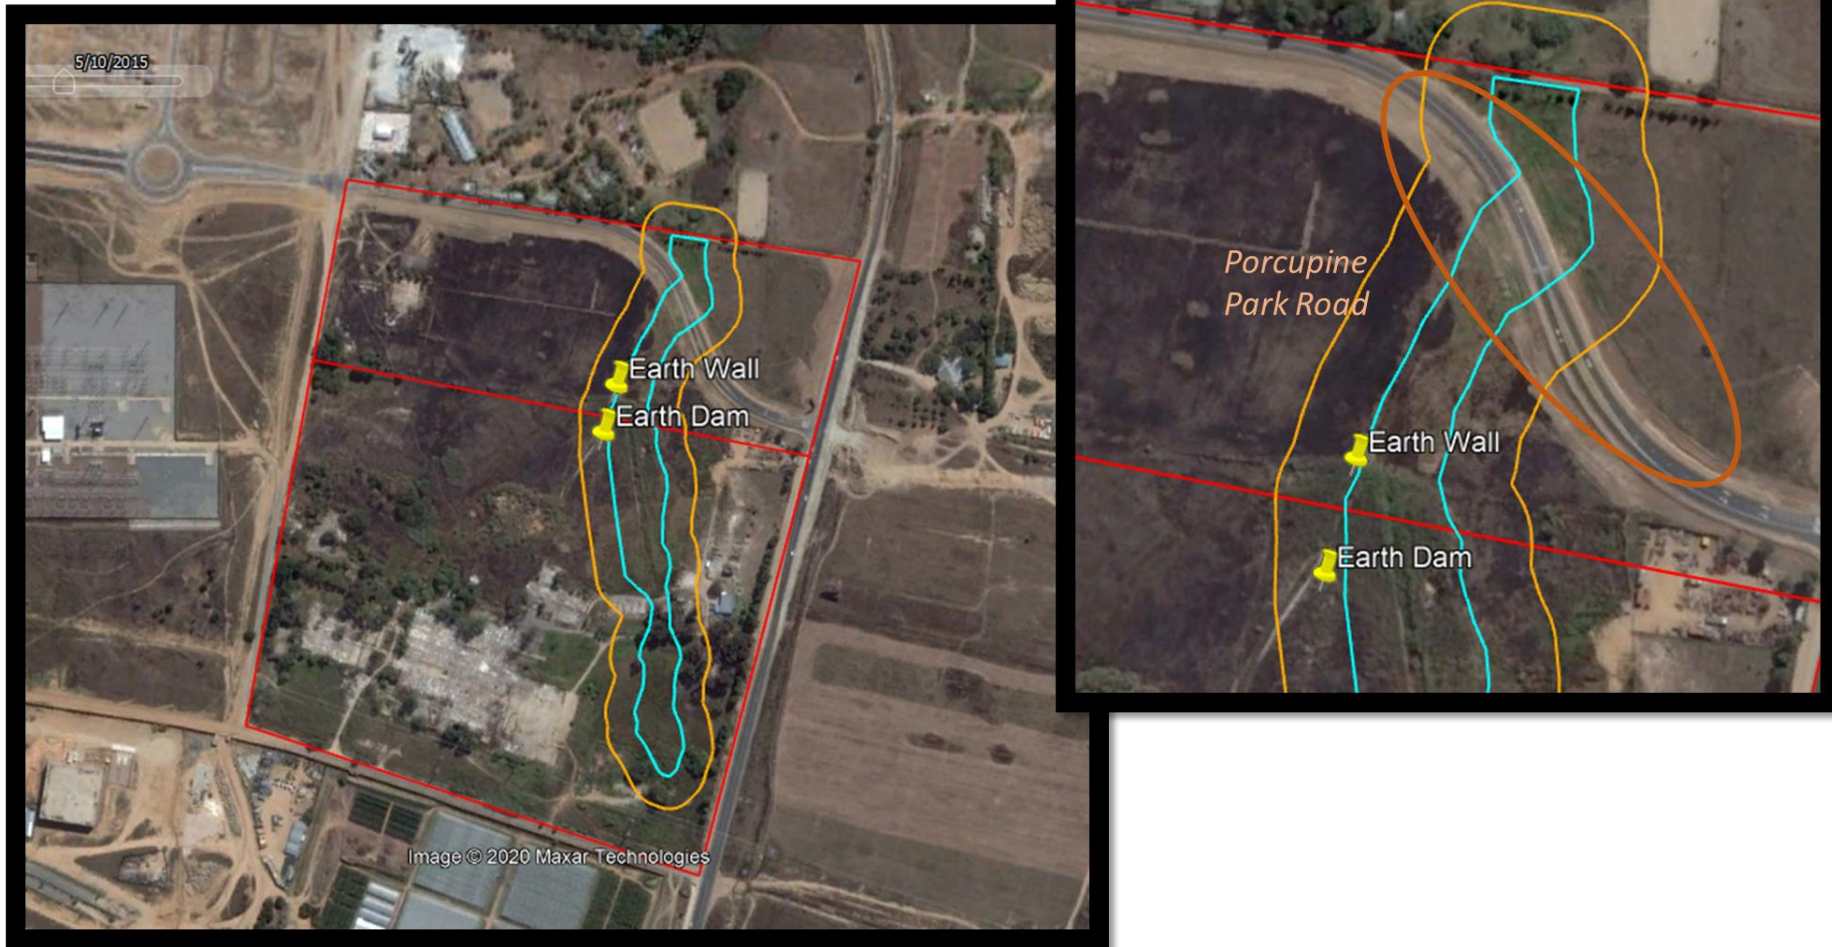
Figure 8: Google Earth Imagery from May 2015

Lastly in 2015, Porcupine Park Road was constructed and crosses the wetland to the north of Portion 124.

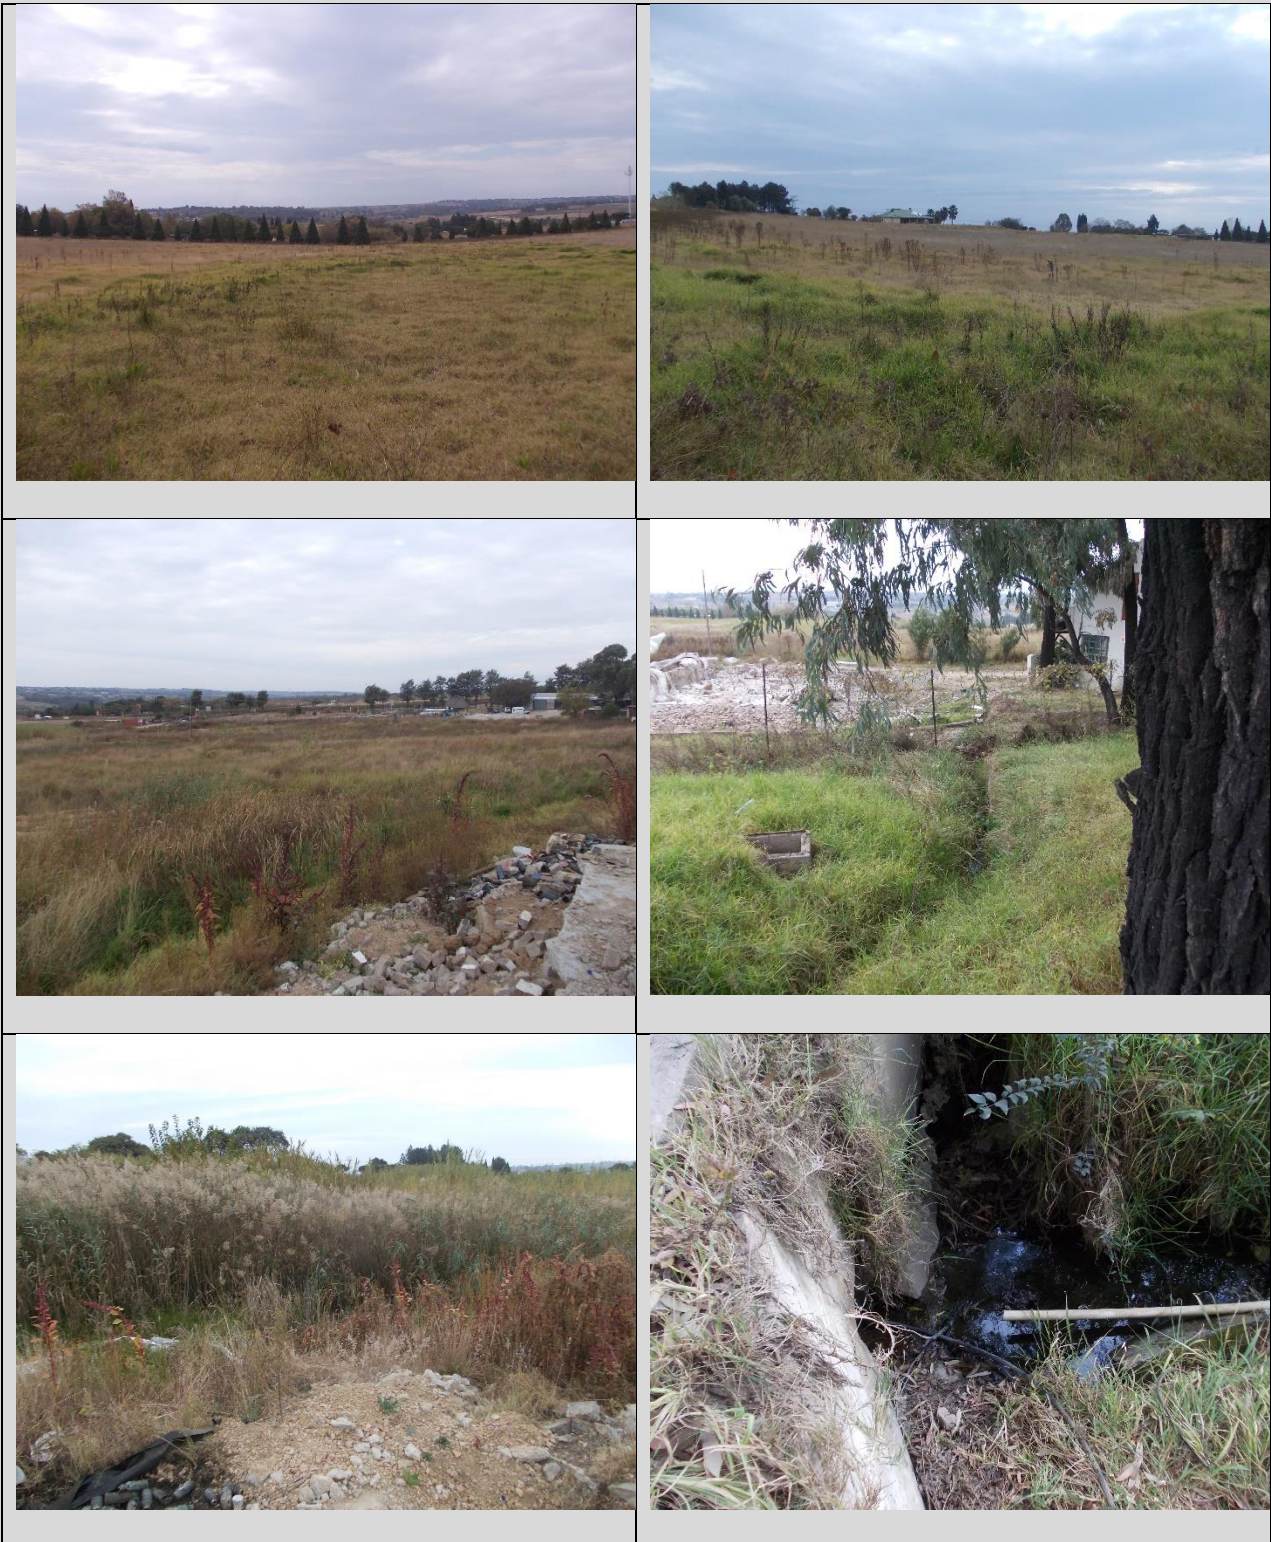
Figure 9: Photos from Initial Site Assessment (circa 2014)

Initial site assessment was undertaken in 2013/2014 and show the degraded state of the site. **Figure 9** below provides the photographs undertaken at this time.

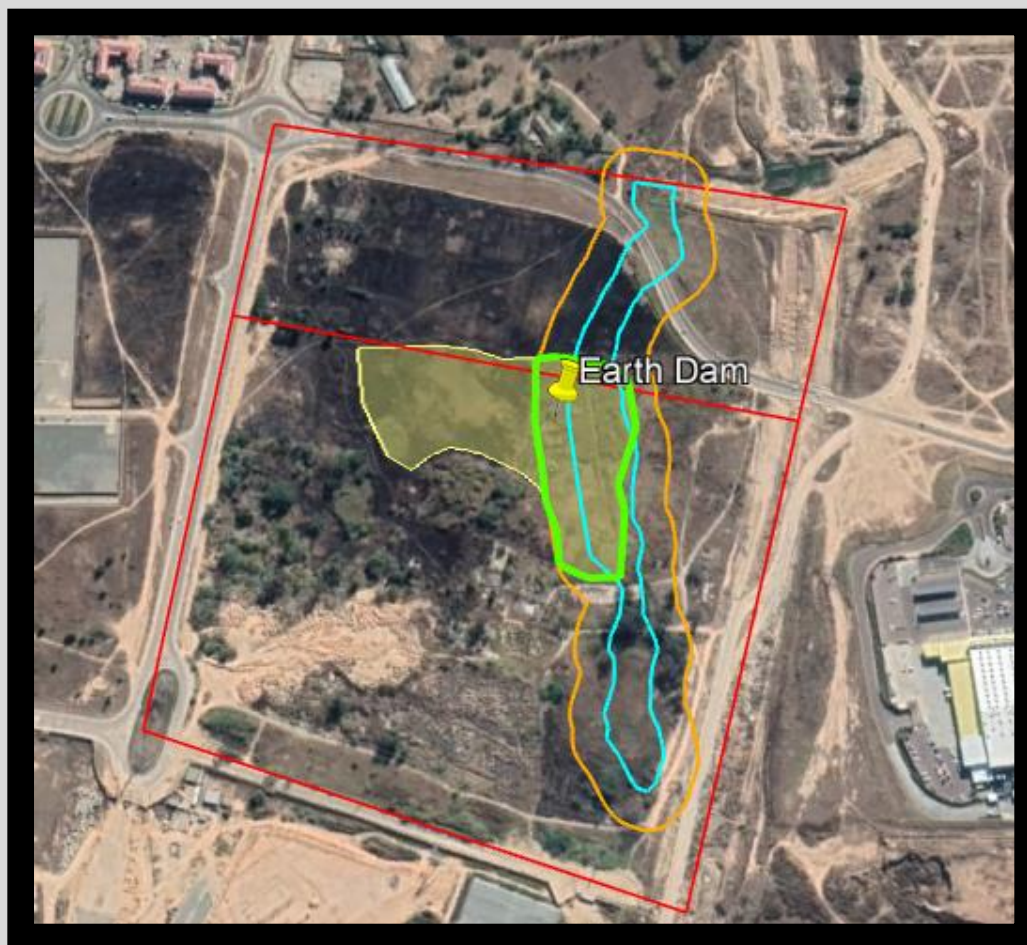
Figure 10: Location of earth dam within degraded grassland

Furthermore, it should be noted that the earth dam occurs within the degraded grassland area which was identified by the Biodiversity Baseline and Impact Assessment and shows its artificial nature.

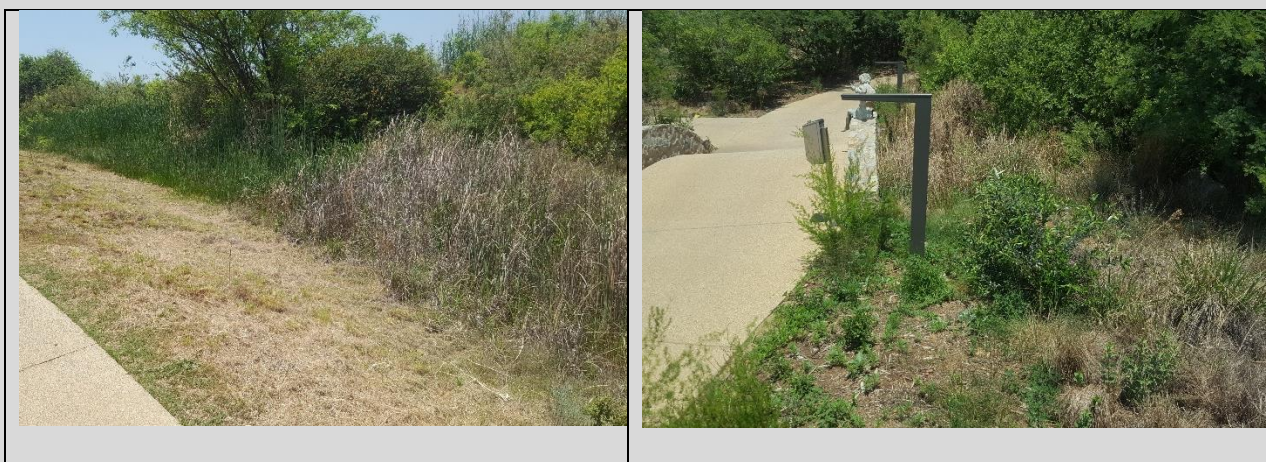
Figure 11: Steyn City Wetland Rehabilitation

Further to the comments, it should be noted that the development will involve the rehabilitation of the wetland and associated wetland buffer in line with the Aquatic Resources Rehabilitation Plan. The current state of the wetland was found to be low and the wetland is highly modified. The wetland and buffer, once rehabilitated will be similar to the wetland systems included in the main Steyn City development (Refer to **Figure 11**).

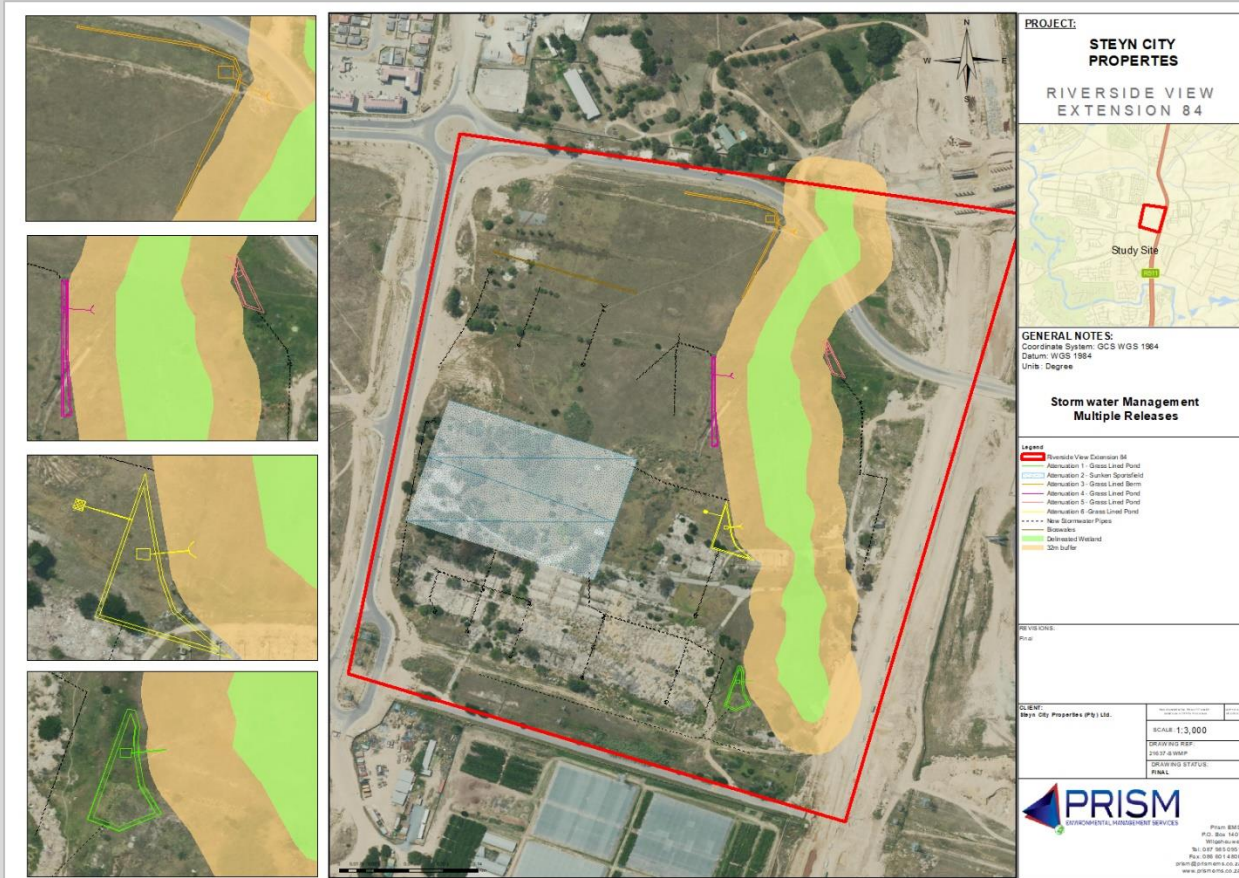
Figure 12: Stormwater Management System showing Multiple Releases

- Grass lined attenuation ponds;
- Use of the soccer field to attenuate stormwater and allow for ground water recharge;
- Bio swales with stone filled sumps to allow for run-off retardation, encourage sheet flow and absorption into the underlying soil;
- Throttled outlet structures; and
- Energy dissipation slabs to limit erosion and encourage sheet flow at outlets.

Figure 12 provides an overview of this plan and highlights that there are 6 separate releases along the wetland buffer at separate locations which mimics the natural flows of the wetland and was recommended in consultation with the specialist.
