# MHI RISK ASSESSMENT ON THE NATURAL GAS PIPE ROUTE AT TETRA4 NEAR VIRGINIA IN THE FREE STATE

June 2022

R1067-2 Tetra4 Pipe Route

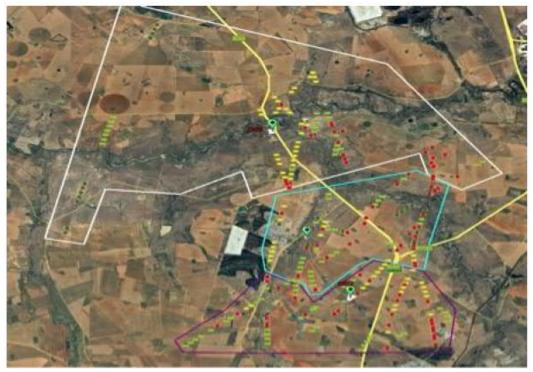
Well locations

Natural gas is obtained from wells at a pressure of approximately 0.3bar and routed to the LNG facility at Tetra4. There are approximately 300 wells. From the wells the natural gas is fed via below surface lines to blowers and from the blowers it is fed to compressor stations at a pressure of 50kPa. From the compressor stations the natural gas in fed via an underground line to the LNG facility at a pressure of 23bar (design 30bar) through a 10inch line.

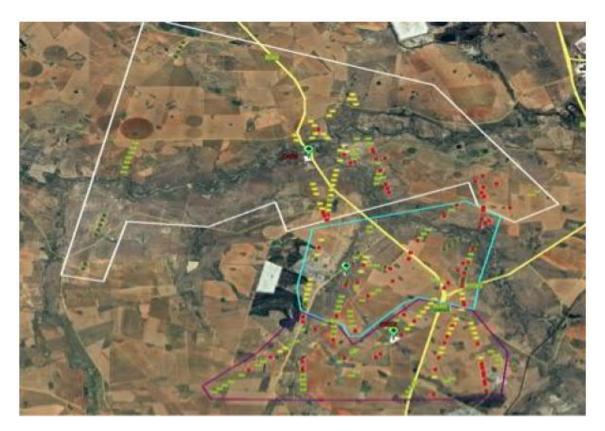
Figure 2.1 Well locations

Natural gas is obtained from wells at a pressure of approximately 0.3bar and routed to the LNG facility at Tetra4. There are approximately 300 wells. From the wells the natural gas is fed via below surface lines to blowers and from the blowers it is fed to compressor stations at a pressure of 50kPa. From the compressor stations the natural gas in fed via an underground line to the LNG facility at a pressure of 23bar (design 30bar) through a 10inch line.

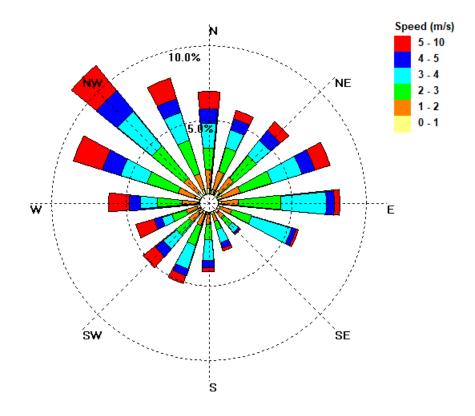
Figure 2.2a Wind rose generated from the meteorological data for Tetra4 for a complete year

Meteorological data was obtained for the site from EScience. The wind rose for a complete year is shown in Figure 2.2 and is superimposed on the Tetra4 site as shown in Figure 2.3. (*Please note that the wind rose indicates the direction from which the wind is blowing*).

- 3B unstable with a wind speed of 3m/s, which will occur mostly in the afternoon on a hot sunny day prevailing at 10.35% of the time
- 5D neutral with a wind speed of 5m/s, which will occur mostly during day time, with some cloud cover and a strong wind blowing prevailing at 43.21% of the time
- 5E- stable with a wind speed of 5m/s which will occur mostly during night time prevailing at 21.11% of the time
- 1.5F very stable with a wind speed of 1.5m/s, which will occur mostly during night time with cloud cover and a moderate wind speed, prevailing at 25.31% of the time

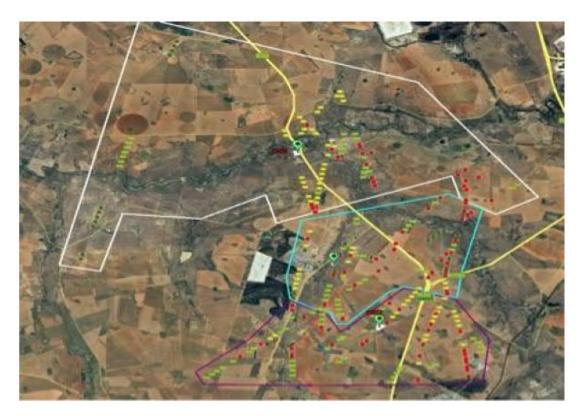
Figure 3.1a Site layout (wells)

The site layout is shown in Figure 3.1.

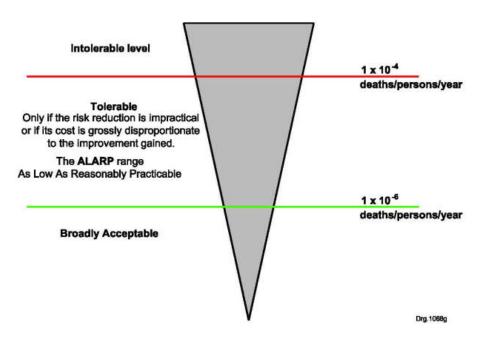
Figure 3.2a The Public ALARP Risk Decision Making Framework

The ALARP (as low as reasonably practicable) risk decision making frameworks as per SANS 1461:2018, are shown in Figure 3.2.
