# Hydrogeological Investigation Report for the Proposed Transnet Railway in Lephalale, Limpopo Province

Draft Report Prepared by  
**NALEDZI WATERWORKS (PTY) LTD**  
**9/6/2018**

Prepared for: Naledzi Environmental Consultant

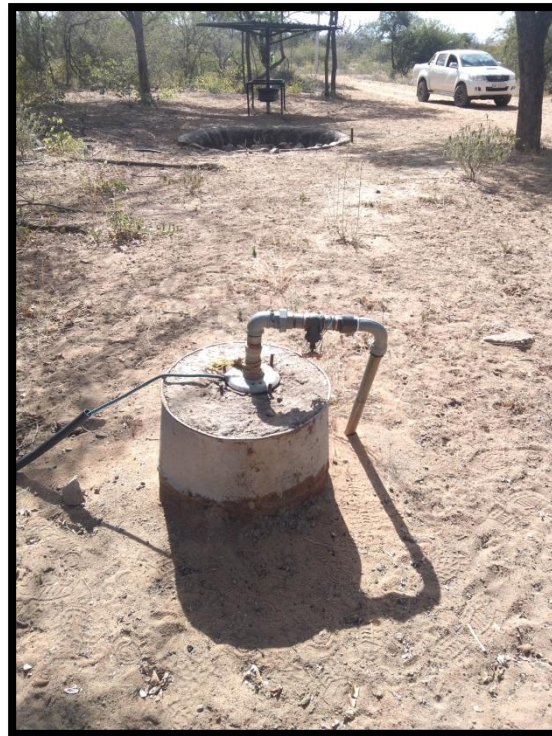
**Figure 5: Existing Borehole and water trough**

The results of the hydrocensus together with the previous hydrocensus by Golder used to determine the baseline water use in the area. The groundwater in the project area is used for domestic and game watering purpose with several boreholes pumping water into the drinking troughs located in the bushes (Figure 5). The details of the visited sites are presented in **Appendix B** and their positions are shown in Figure 6.
