PROPOSED REHABILITATION WORKS OF CASTEEL DAM ADDENDUM TO DESIGN REPORT NO. 12/2/X302-26/D/1/30

TITLE : PROPOSED REHABILITATION WORKS OF CASTEEL DAM
ADDENDUM TO DESIGN REPORT NO. 12/2/X302-26/D/1/30

CASTEEL DAM: MODEL STUDY REPORT

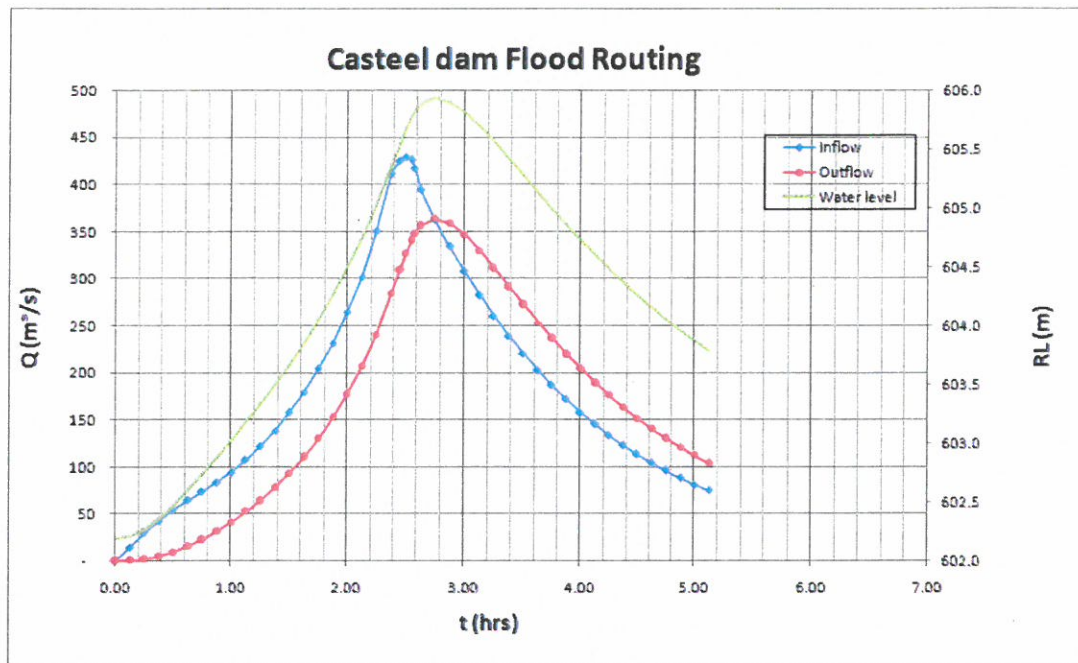
Figure 1.1 : Casteel dam flood routing

Using the determined C_d from the model study, the routed RMF overtopped the non overspill crest by 1.94 m. **Figure 1.1** shows flood routing of Casteel Dam. From the model study it was observed that the weir is the control point.

Results	
Max inflow(m ³ /s)	430
Max outflow (m ³ /s)	364
Max stage (m)	3.81
Depth of overtopping (m)	1.94
duration of overtopping(h)	3.00
Attenuation factor	-15%
Water level (m)	605.94

To accommodate the Regional Maximum flood of 430 m³/s, with the current spillway the dam embankment Noc will have be raised with 2 m .

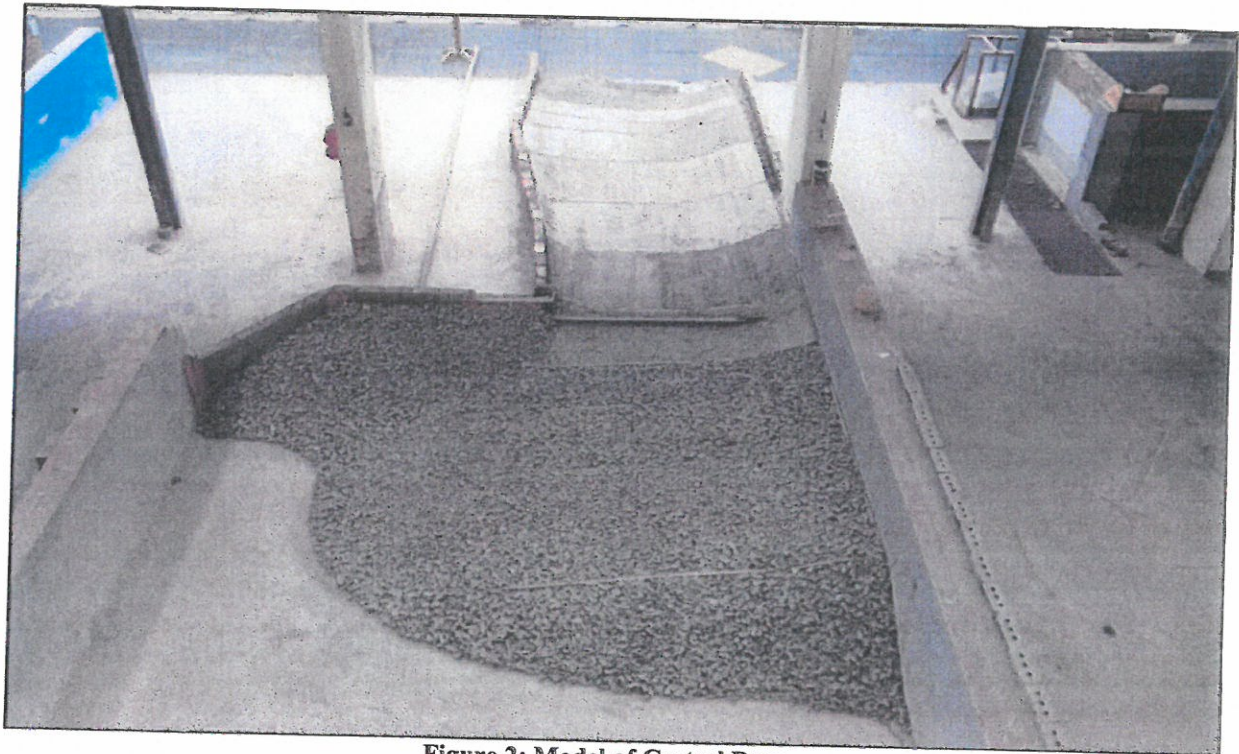
Figure 2: Model of Casteel Dam

An undistorted scale of 1:20 was used to scale down the prototype. The roughness in the prototype is approximately 300mm. In the model the by-wash channel had a concrete lining with a roughness of approximately 10mm that represents only 200 mm in the prototype. This is regarded a non-substantial deviation.

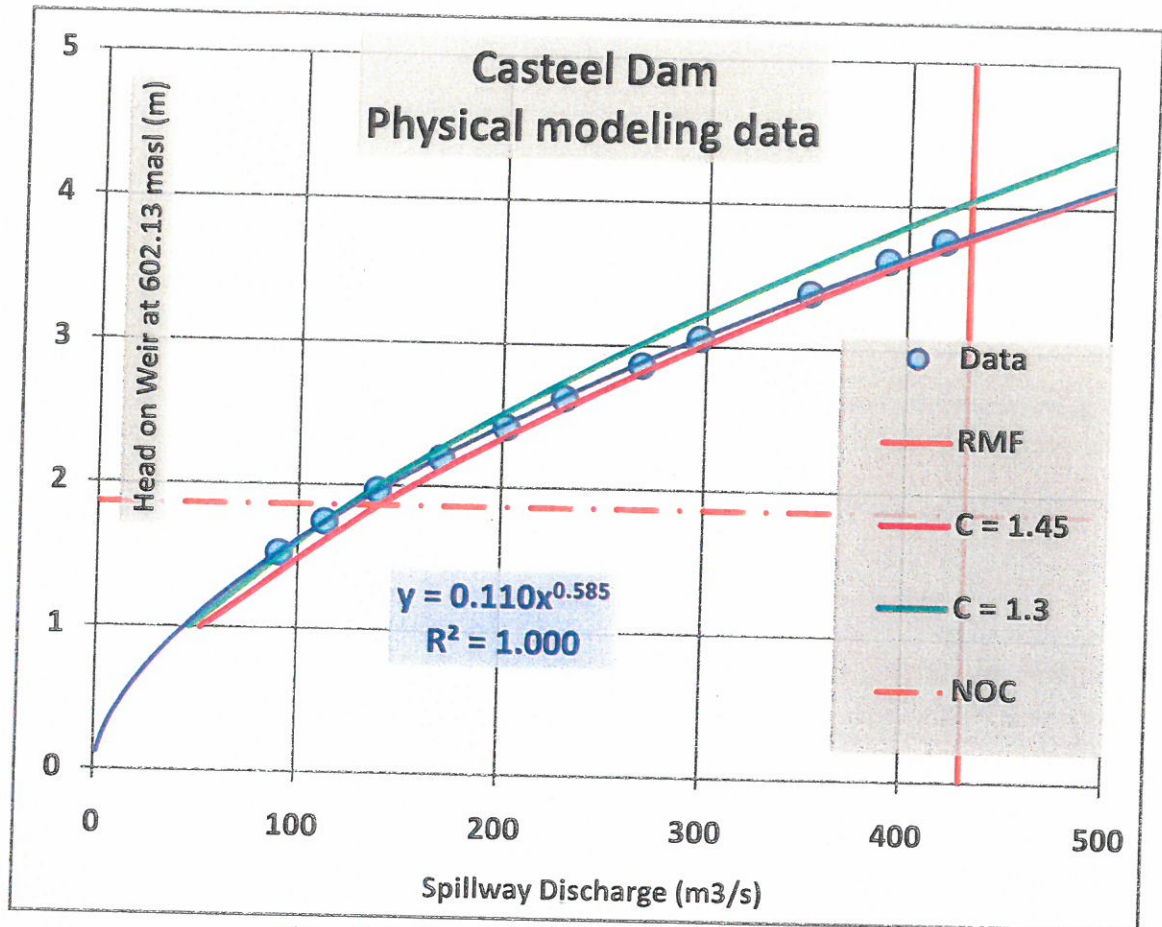
Figure 4: Spillway Discharge Graph of Casteel Dam

The water level was measured with a point gauge in well connected to a relatively stagnant area. The discharge curve was determined from the different water levels and the corresponding flow rates. The discharge coefficient varies very little between 1.30 and 1.45

C_d = varies between 1.30 and 1.4 (**Appendix A** model study report of Casteel dam)
