## BEACH AND COASTAL IMPACT ASSESSMENT

### THE PROPOSED REFURBISHMENT AND CONSTRUCTION OF COASTAL INFRASTRUCTURE WITHIN THE KING SABATA DALINDYEBO LOCAL MUNICIPALITY, COFFEE BAY

**S C Bundy BSc MSc (Pr.Sci. Nat.)  
Sustainable Development Projects cc**

# THE PROPOSED REFURBISHMENT AND CONSTRUCTION OF COASTAL INFRASTRUCTURE WITHIN THE KING SABATA DALINDYEBO LOCAL MUNICIPALITY, COFFEE BAY & HOLE IN THE WALL, EASTERN CAPE

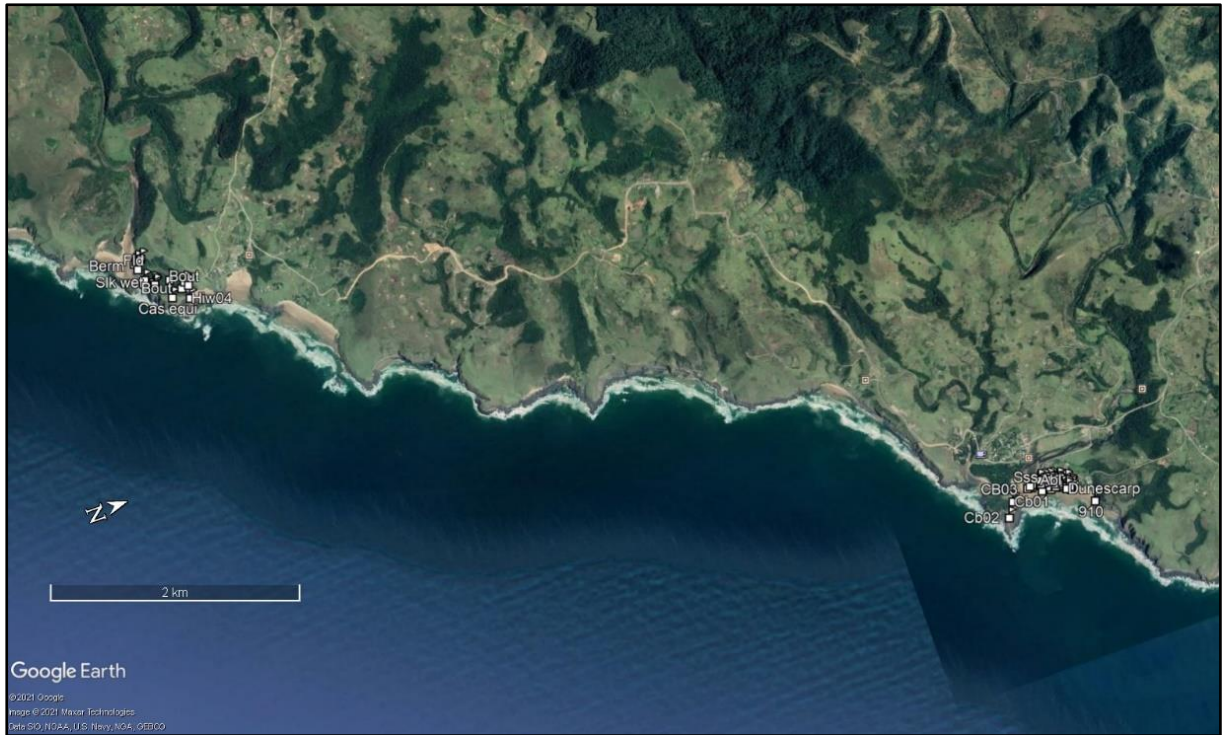
**Figure 4.** Image indicating sampling points across study area.

- Specific features within the supra-tidal environment were identified and logged using a Garmin Montana GPS. Features of significance included various geomorphological features of the sand sharing system including dune, beach and inter tidal environment.
- Consideration was given to riverine and estuarine environments in close proximity to the sites.
- Dominant and significant habitat forms were identified and recorded across the sites.
- General observations were noted along the dune cordon in terms of the gradient of the dune face and the nature and structure of the vegetation at the beach–dune interface.
- Using site knowledge and contour data, the estimated Estuarine Functional Zone (EFZ) at Coffee Bay was defined, as shown in Appendix A5.

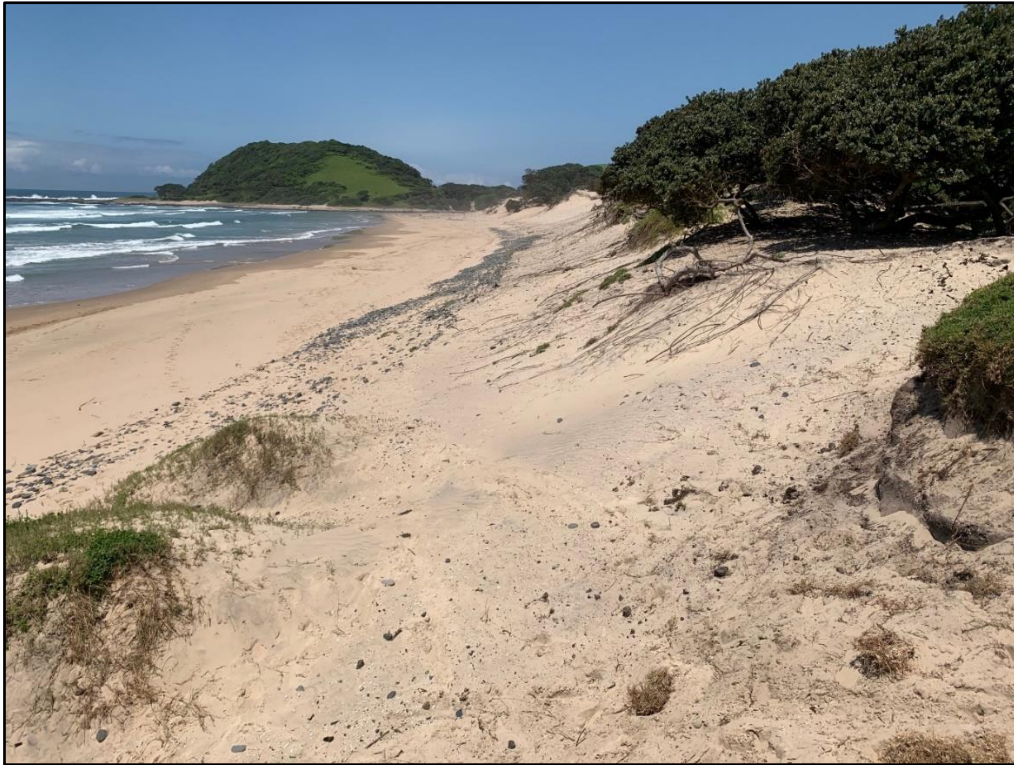
**Figure 11.** Image of beach and dune cordon at Coffee Bay.

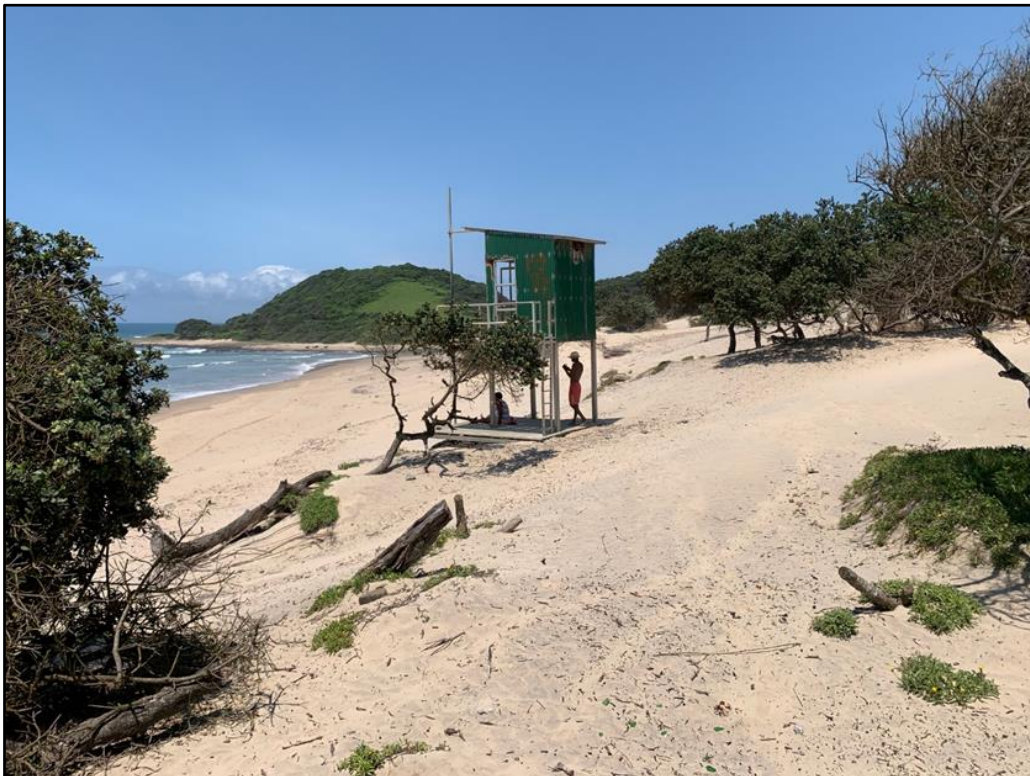
**Figure 11.** Image of lifeguard tower on frontal stoss slope of dune at Coffee Bay.

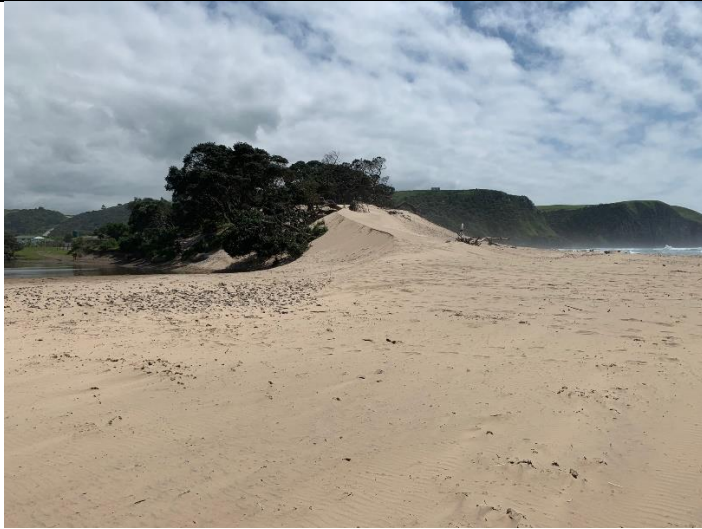
**Figure 12.** Dune positioned seaward of Nenga estuary

The dune cordon at the interface with the Nenga estuary is a recent system (Figure 12). Pebble wash, calcrete concretions (Figure 14) and the presence of marine invertebrates within the dune heel (Figure 15), on the leeward portion of the dune, indicate that the mouth of the river was located further north of its present position. The contemporary, more southerly alignment of the mouth is thus a more recent phenomenon. It follows that the mouth of the Nenga may in the short term, train northwards, undercutting the dune form. Such movement may be a geophysical phenomenon associated with high level sediment deposition into the pocket beach and places the entire extent of the dune into the sand sharing system (Figure 16). It follows that stabilization of the dune system in this area, as well as the placement of structures on the more southerly extent of the dune is not a prudent management decision and should be avoided.

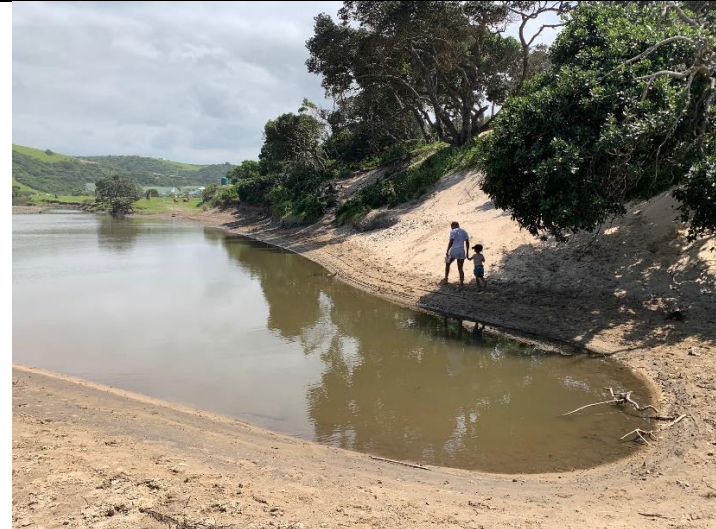
**Figure 13.** The dune heel and Nenga estuary

In addition, the Nenga river, located to the south of the study site, is an open barred (i.e., a supratidal barrier) estuary, with the mouth of this river being maintained by freshwater discharge (Figure 13).

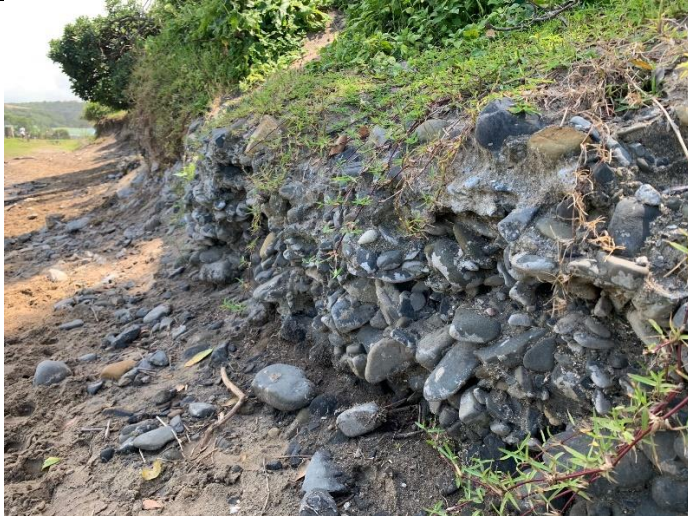
**Figure 14.** Image of pebble wash below dune heel

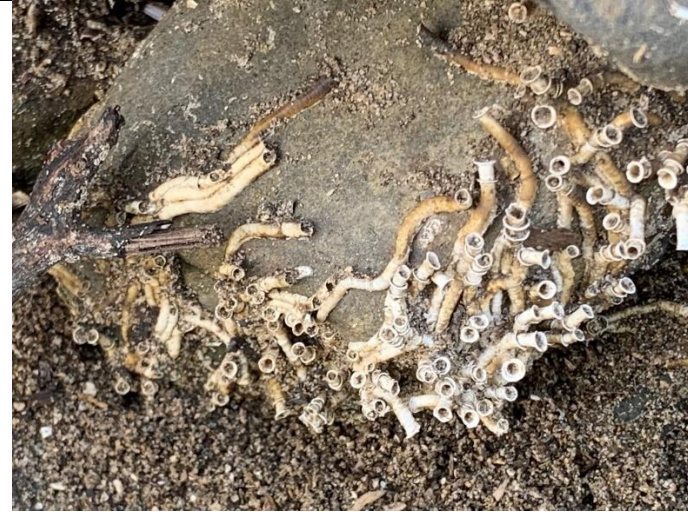
**Figure 15.** Polychaetes (marine species) within concretions at dune heel

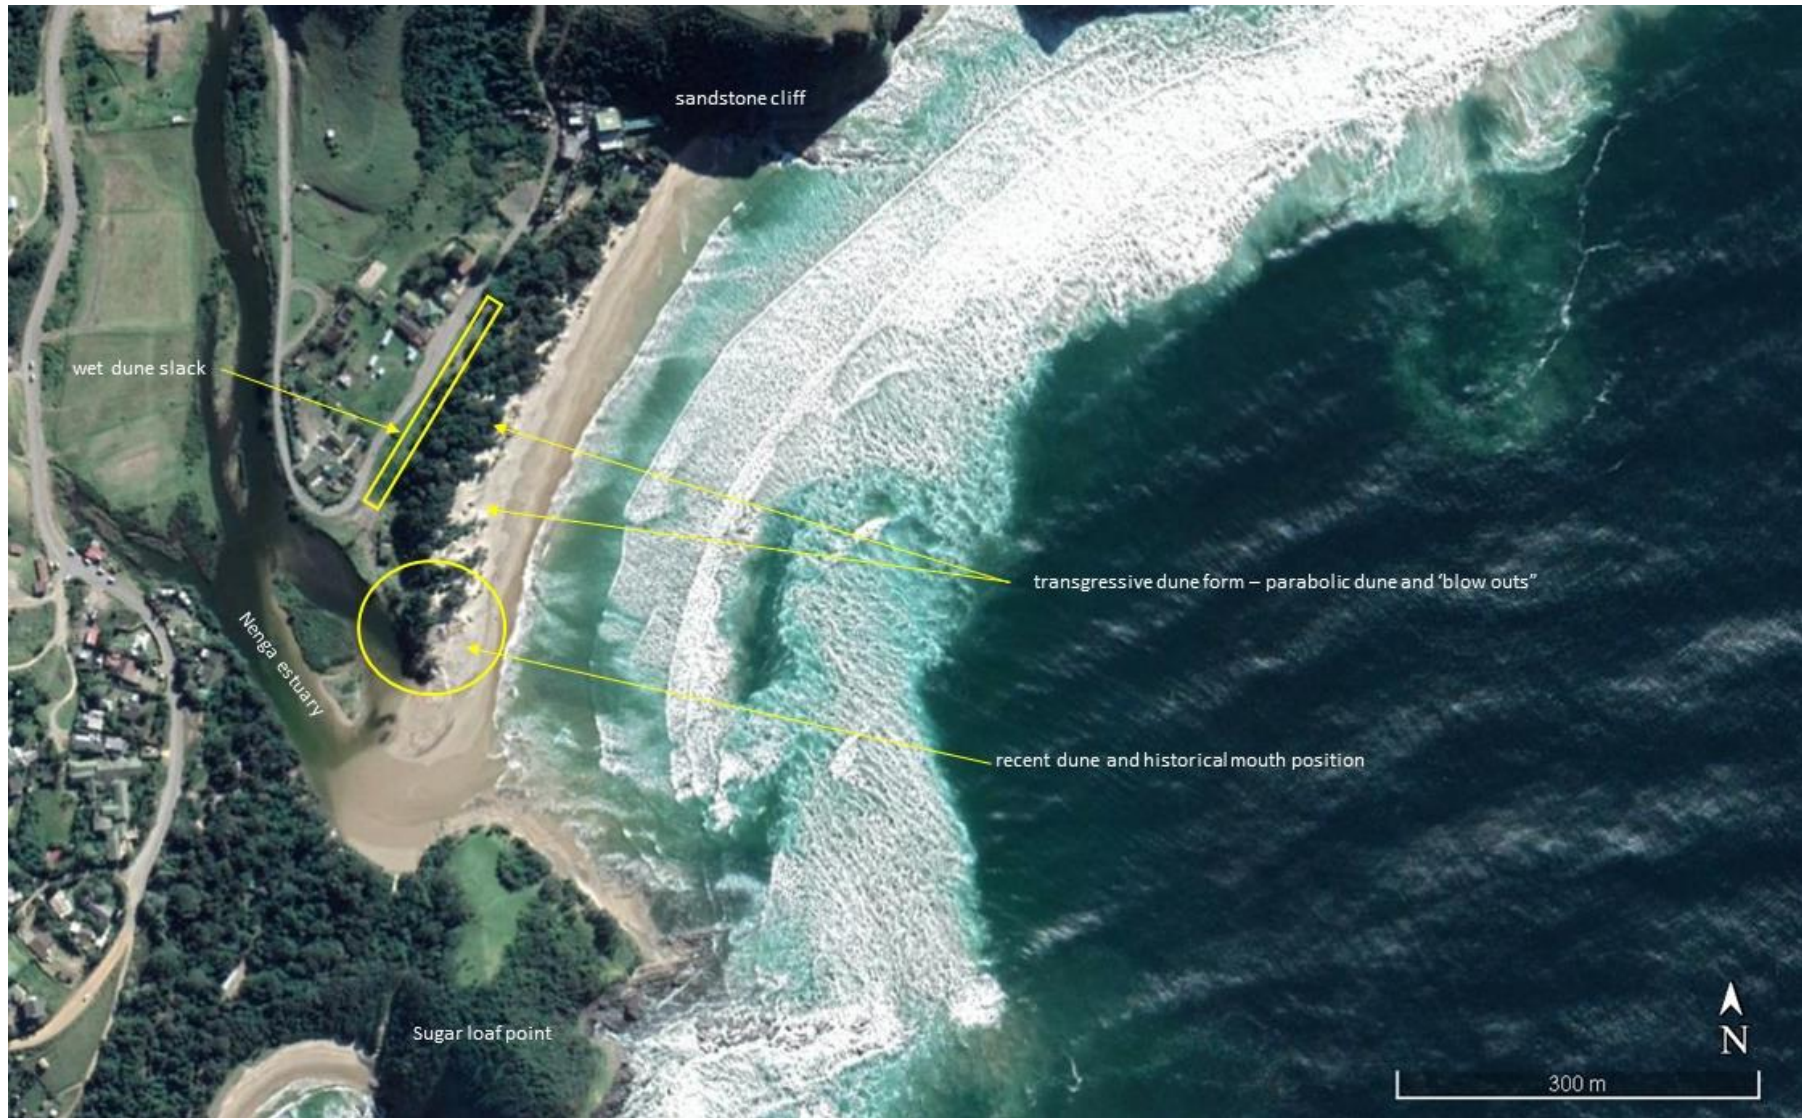
**Figure 16.** Aerial image of the Coffee Bay Main Beach site identifying key features along the subject coastline.

Further to the above, the heel of the dune system is supported by the presence of a wet dune slack (Figure 16). This slack is directly associated with the Nenga estuarine system, with possible sub surface geological control. The slack is an important contributory factor to the sand sharing system, acting as the most proximal freshwater source for dune vegetation and thereby promoting the stabilization of the dune form. Dune vegetation, seaward of the dune crest is sparse, comprising of the white milkwood (*Sideroxylon inerme*) and scandent cover dependent species such as *Sporobolus virginicus*, while to the lee, habitat is more verdant, with *S inerme*, *Mimusops caffra* and numerous graminoids (*Stenotaphrum secundatum* ; *Setaria nemfluensis*) and shrubs (*Chrysanthemoides monilifera*) evident. It is strongly recommended that the dune slack be managed as an open system and is not subject to further disturbance, such as infilling, excavation or hardpanning.

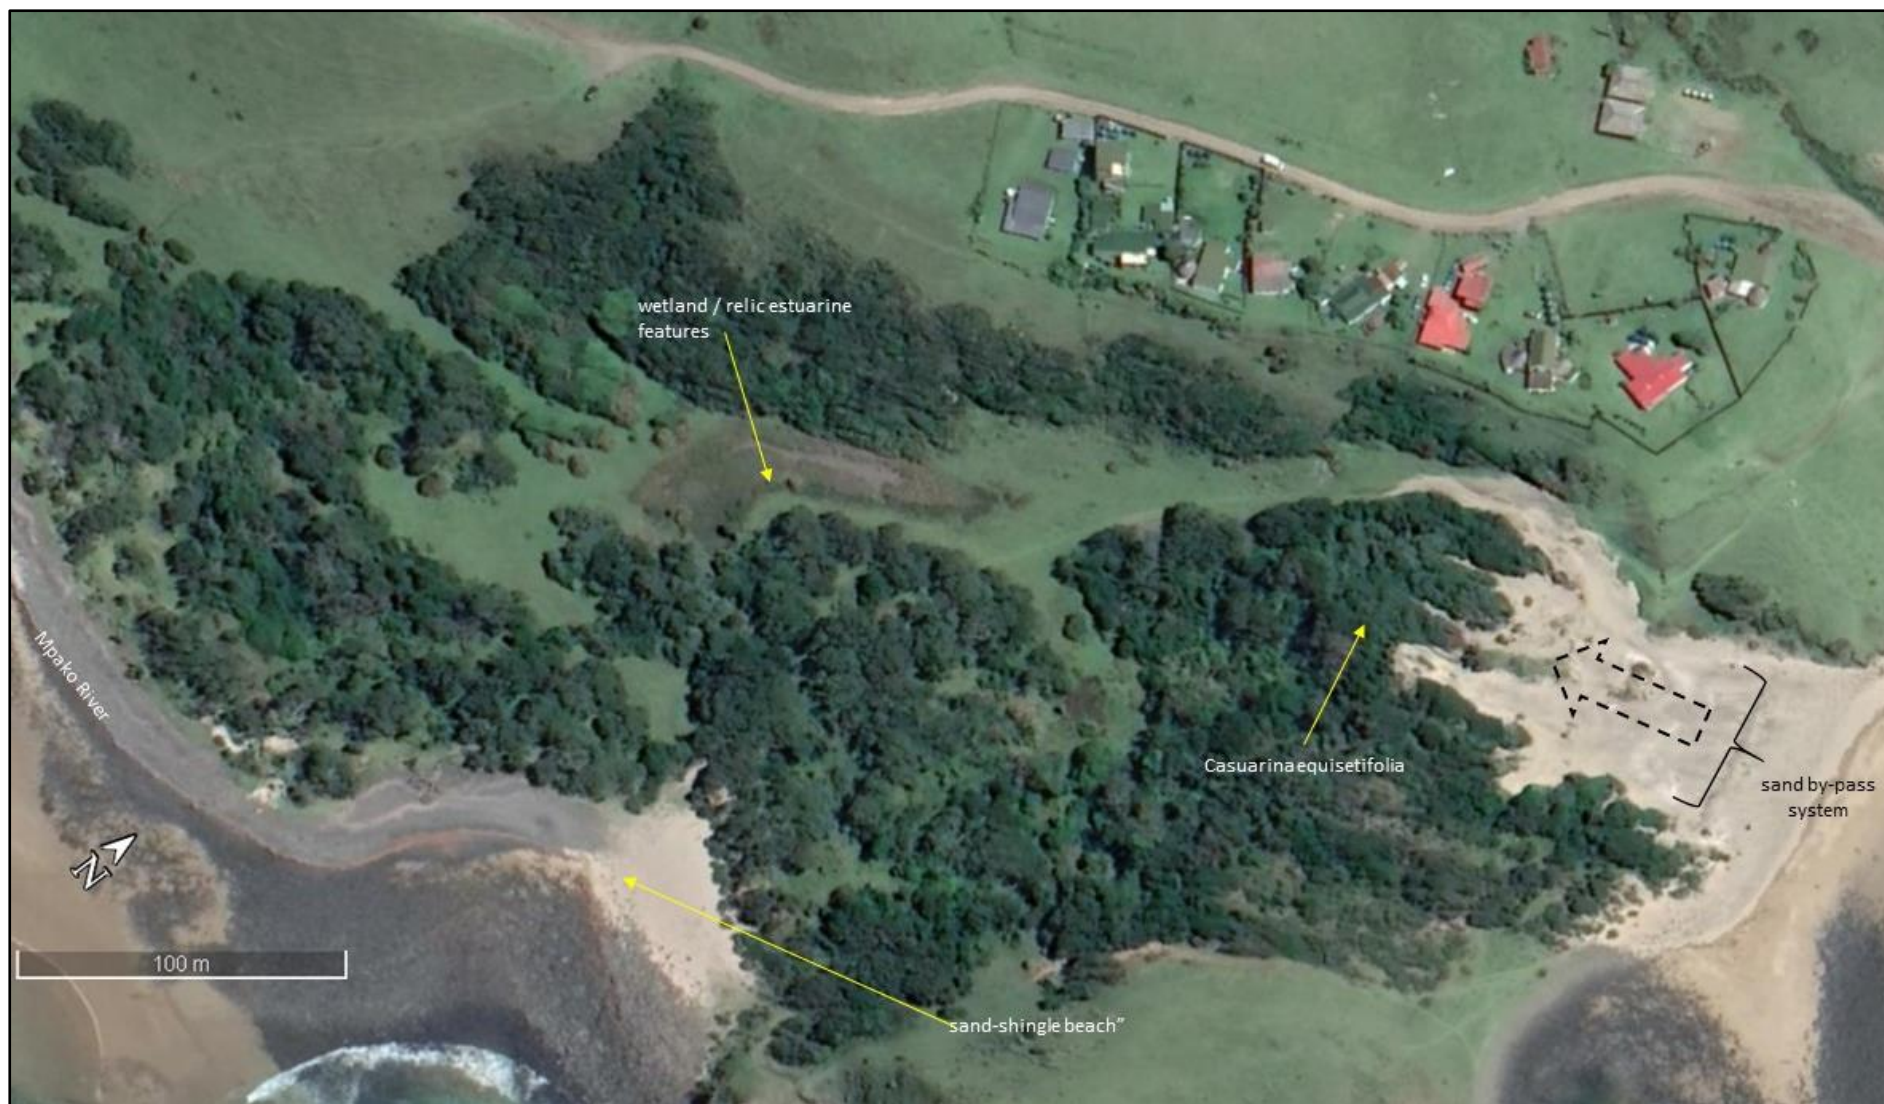
**Figure 18.** Aerial imagery indicating features at Hole in the Wall, in particular sediment by pass and beach environment.

The study site at Hole in the Wall encompasses the flood pan of the Mpako estuary, as well as a sand bypass system associated with the estuary, which is backed by a sequestered wetland system linked with the flood regime of the Mpako and sub surface flow that arises from the leeward sandstone geologies (Figure 17 and Figure 18).

The presence of the wetland feature leeward of the estuary should also be noted (Figure 18). Like the dune slack at Coffee Bay, Main Beach, this feature is of ecological importance within the broader environment.

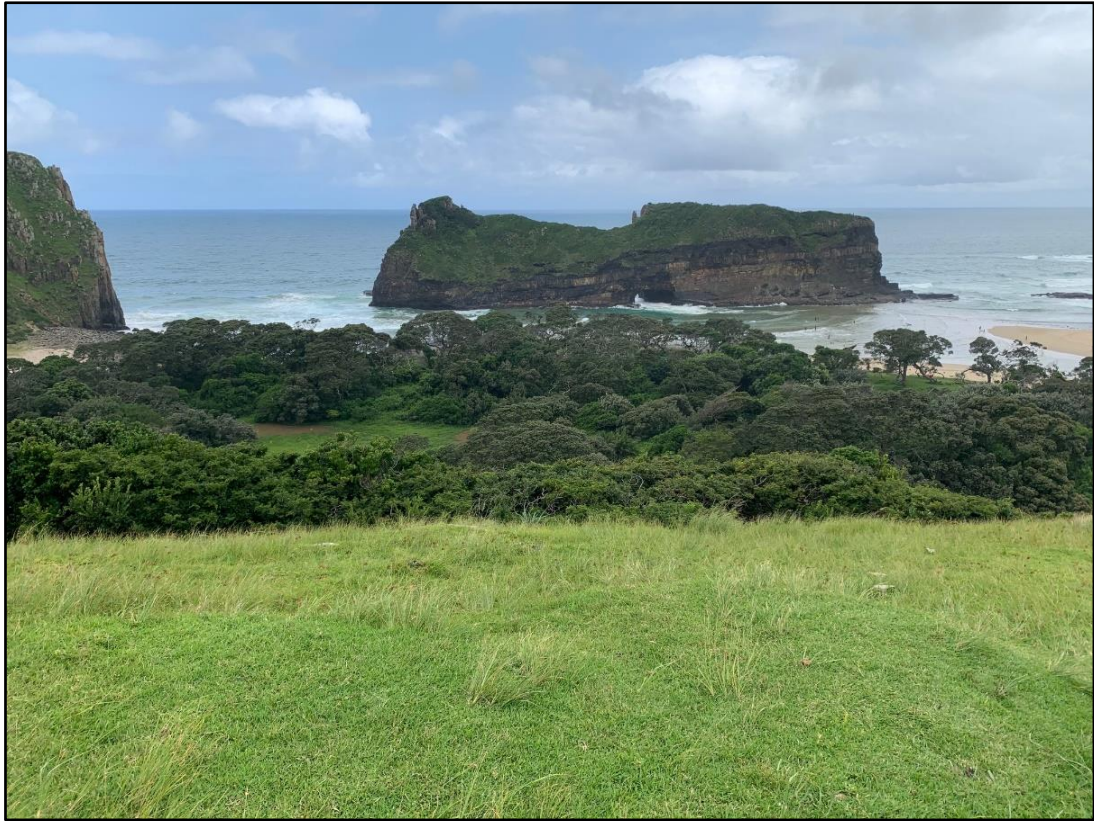
**Figure 19.** Image of the Hole in the Wall site showing estuary and wooded flood terrace in foreground.

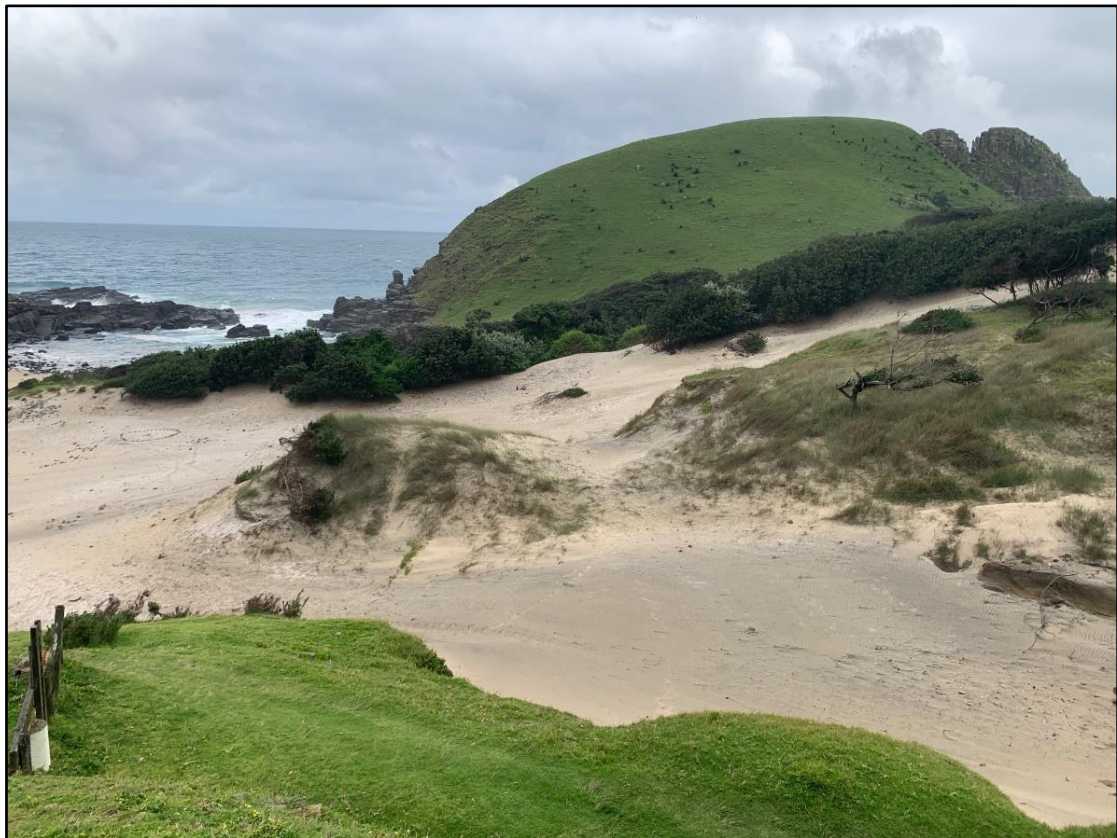
**Figure 20.** Image showing sand bypass, located to the north of the Hole in the Wall site.

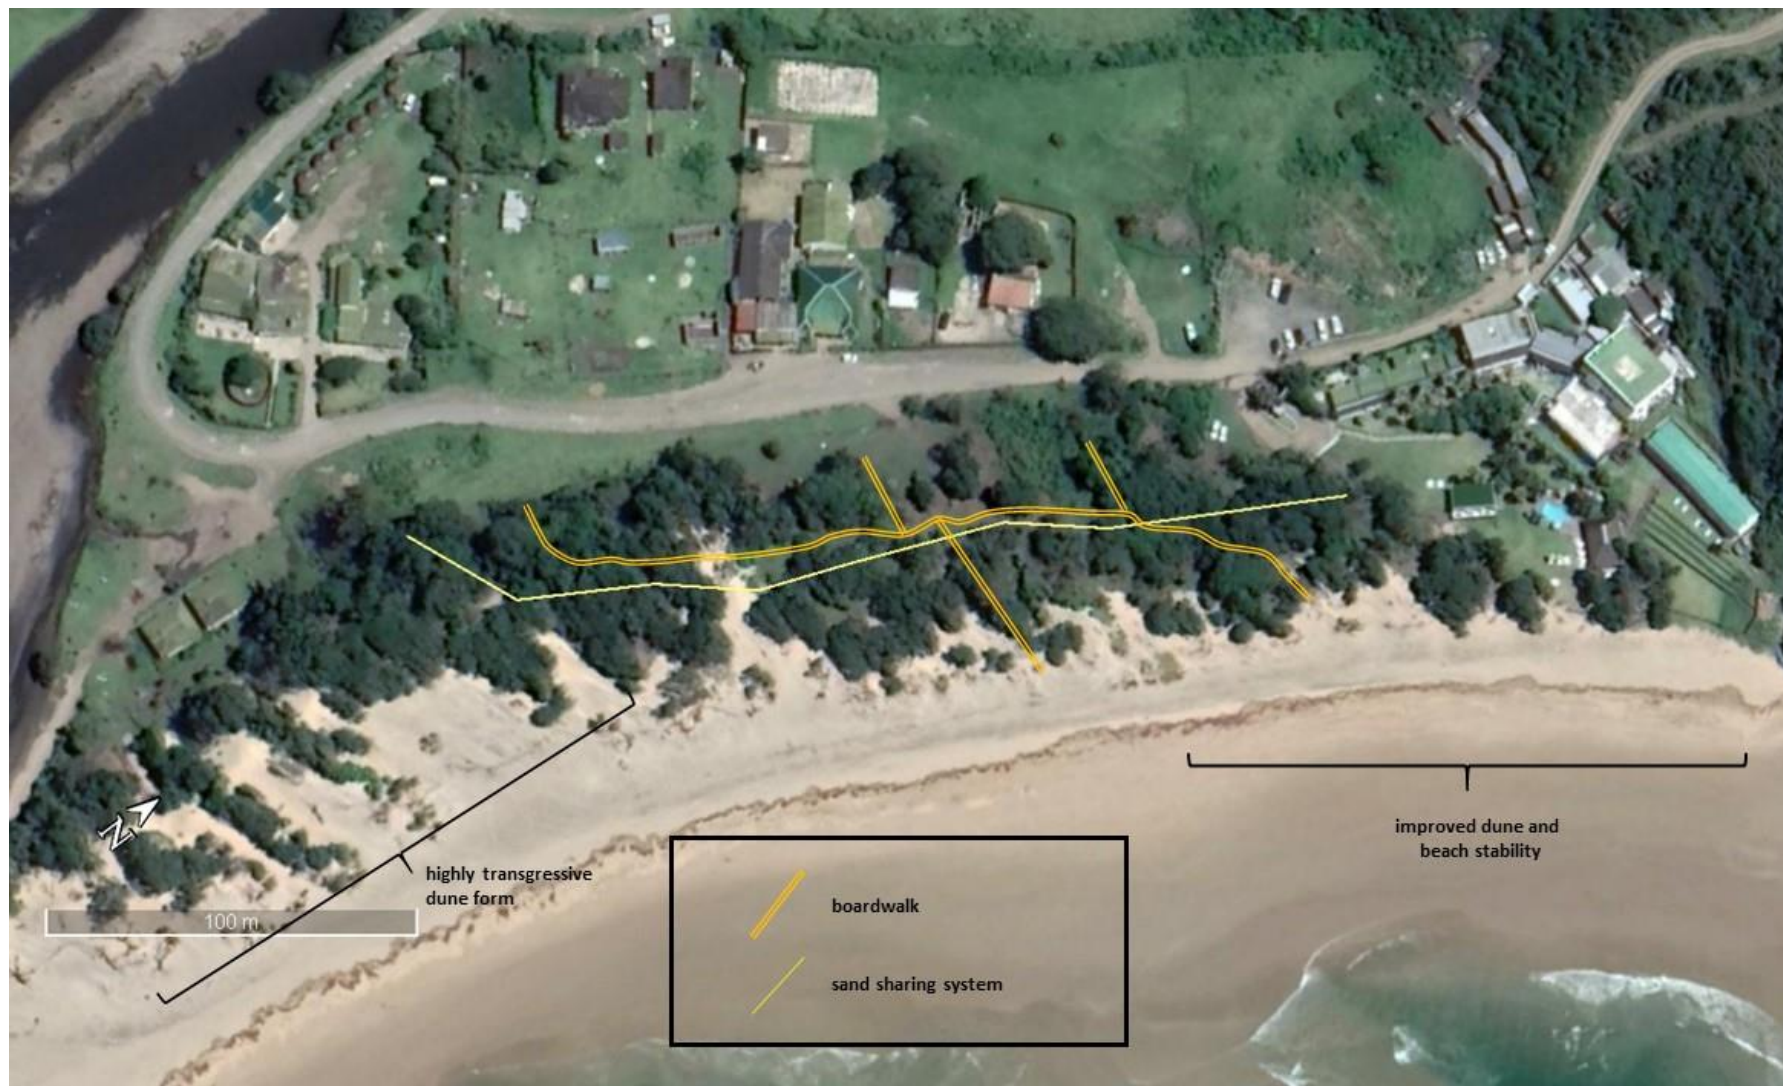
**Figure 21.** Aerial image of Coffee Bay Main Beach showing recommended arrangement of boardwalk in relation to sand sharing system (February 2021).

The most significant features proposed for the Coffee Bay Main Beach are the parking areas, ablution facilities, viewing decks and the boardwalk or beach access routes. A previous version of this report submitted in February 2021 recommended that infrastructure be established at the most distal point from the Nenga estuary to reduce the risk that such infrastructure poses to the eco-morphological state of the dune and beach environment. It was highlighted that this would have a concomitant reduction in risk to such infrastructure from the effects of coastal processes (See Figure 21). In addition, the following aspects and recommendations were discussed:

Figure 21 below, presents a recommended layout discussed in the report submitted in February. In response to the above recommendations, the layout of infrastructure has been revised and is shown in Appendix A2. Notably, the parking facilities effectively avoid the wetland environment. In addition, the formalised walkway is positioned with the dune crest and will function to discourage the traverse of beach visitors across the frontal dune. However, some vegetation clearance is anticipated for the establishment of the new ablution facilities.

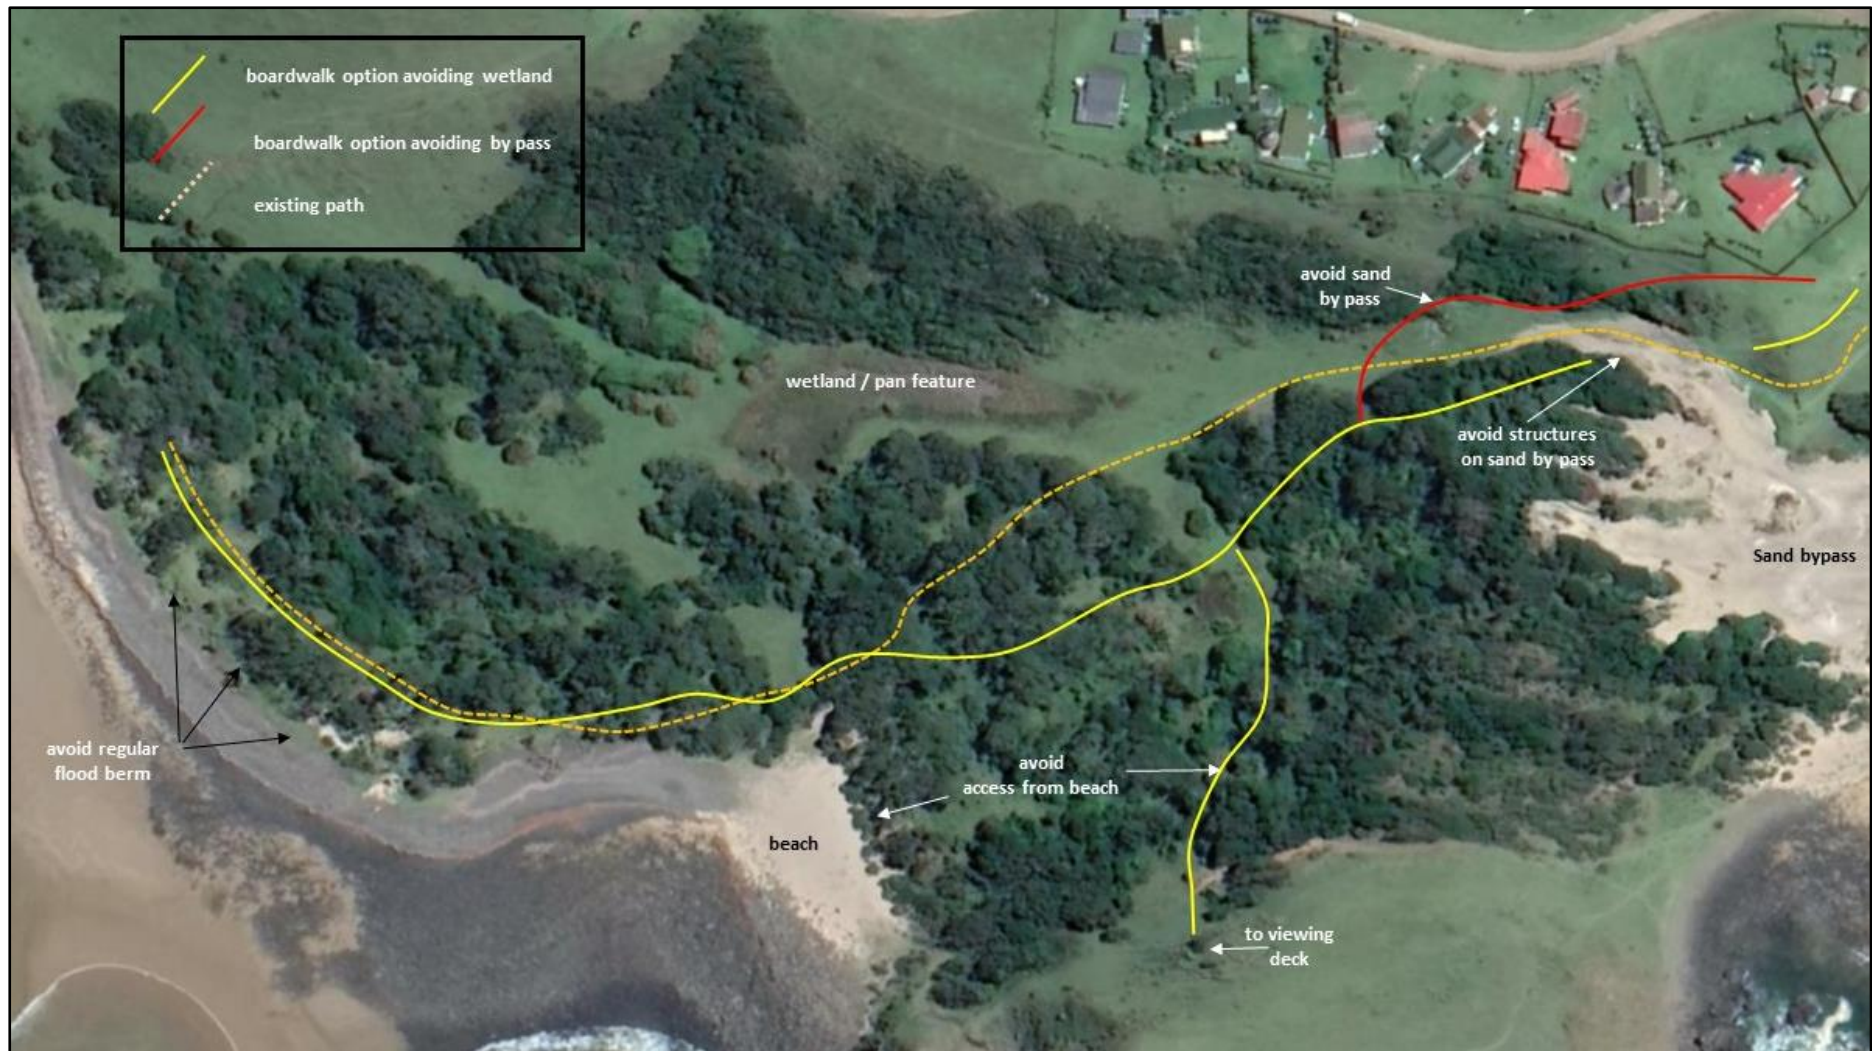
**Figure 22.** Aerial image showing routes of walkways and other features at Hole in the Wall (February 2021).

2. Two options are evident in the routing of the walkway from the north to the south (Figure 22). These options identify that the transgressive sand bypass system to the north may either be avoided, by maintaining the route at an elevated level along the upper bank. Or alternatively, may allow for a break in the boardwalk at the sand bypass and the general avoidance of any structure crossing this mobile environment. The route may be re-established where dune transgression is not occurring. Such approach will avoid the likelihood of increased transgression and possible engulfment of the structure.

3. The route of the walkway should give due consideration to the avoidance of the wetland environment and possible recognition of the extensive inundation of areas around the pan that is flooded from time to time (Figure 22).

Figure 22 below, shows the recommendations proposed in the February report. In response to the recommendations suggested in February 2021, the client has opted to change the boardwalk to a low-impact foot path which will aim to follow existing pathways (Appendix A3). Notably, this footpath will avoid the wetland environment. The client has also removed the proposed viewing deck at the promontory commonly known as “The Whale’s Back”. In addition, low impact poly-timber will be utilised throughout the refurbishments.

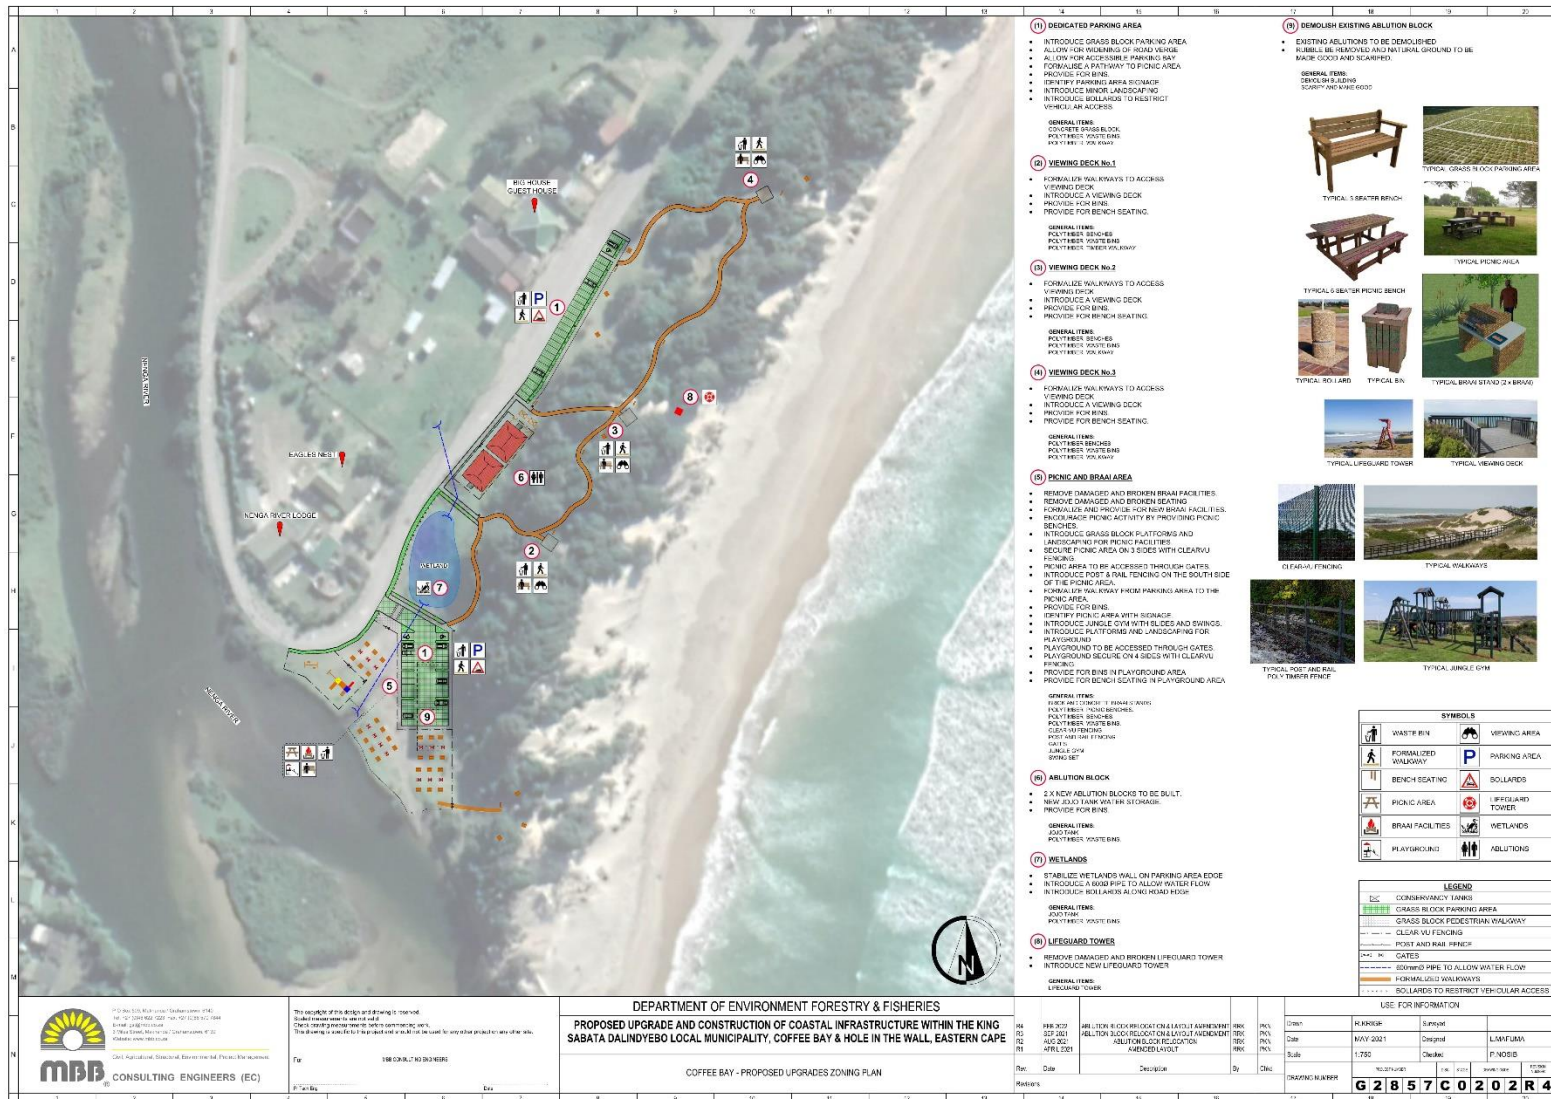
**APPENDIX A2 – The proposed refurbishments for Coffee Bay (revised February 2022)**

This report is a revision of a report dated 17<sup>th</sup> of February. The recommendations discussed in this report have been taken into consideration for the proposed layout of facilities, which are shown in Appendices A2 and A3.

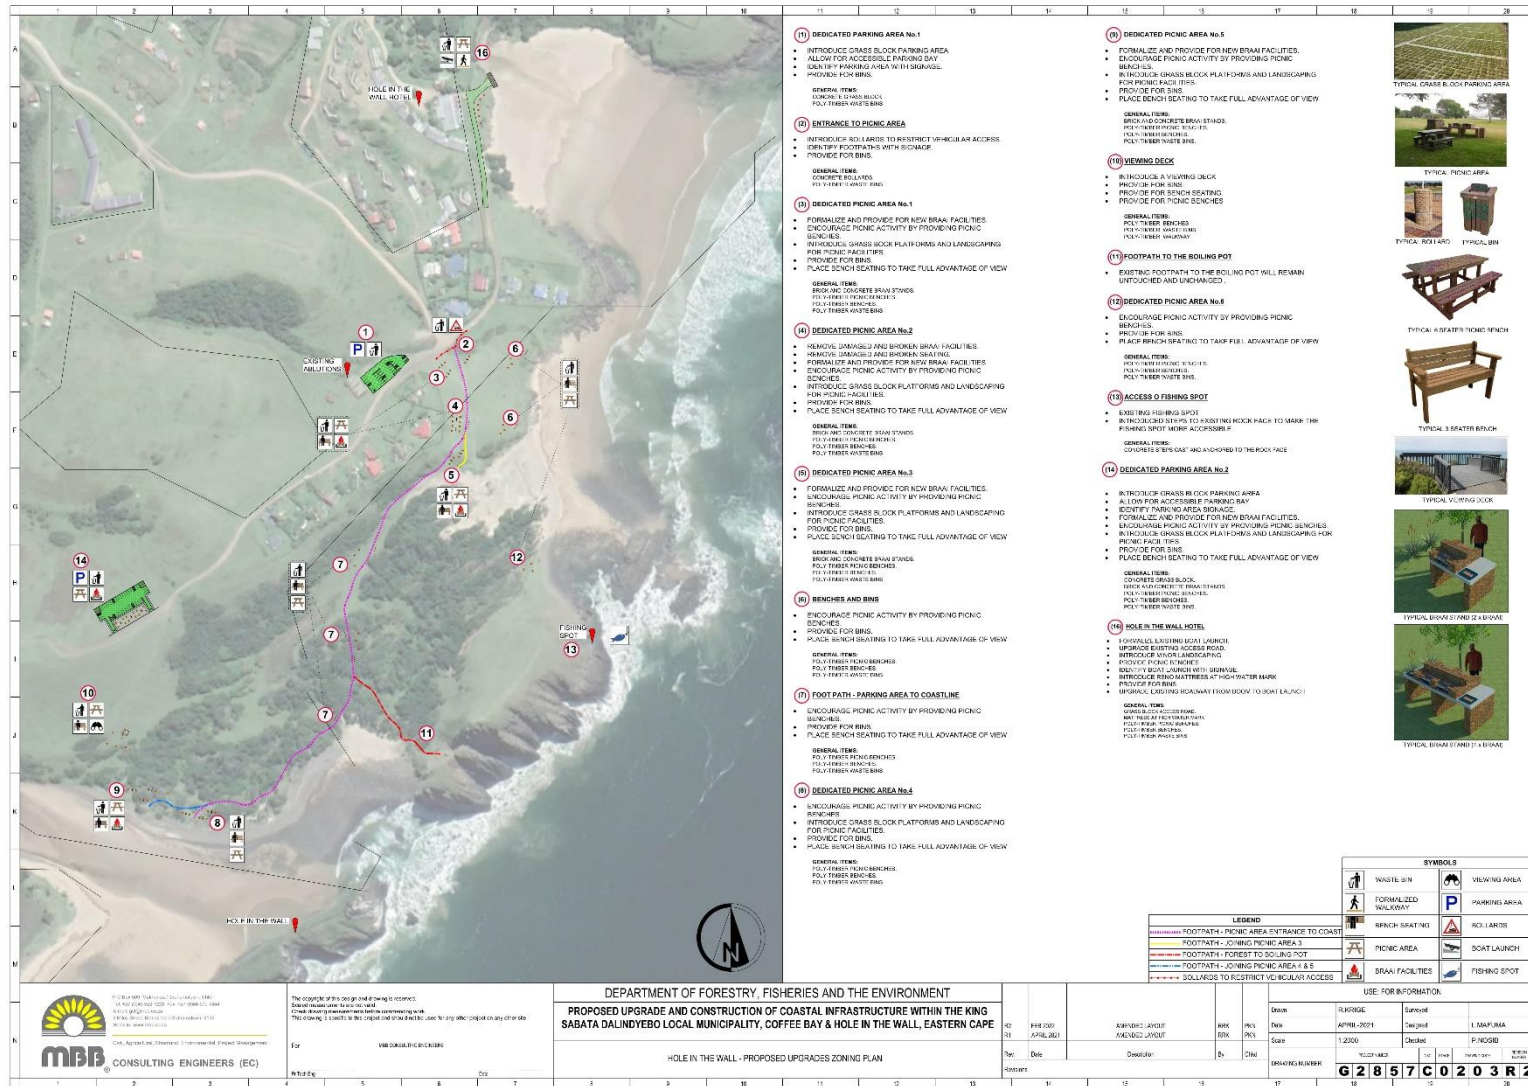
# APPENDIX A3 – The proposed refurbishments for Hole in the Wall (revised February 2022)

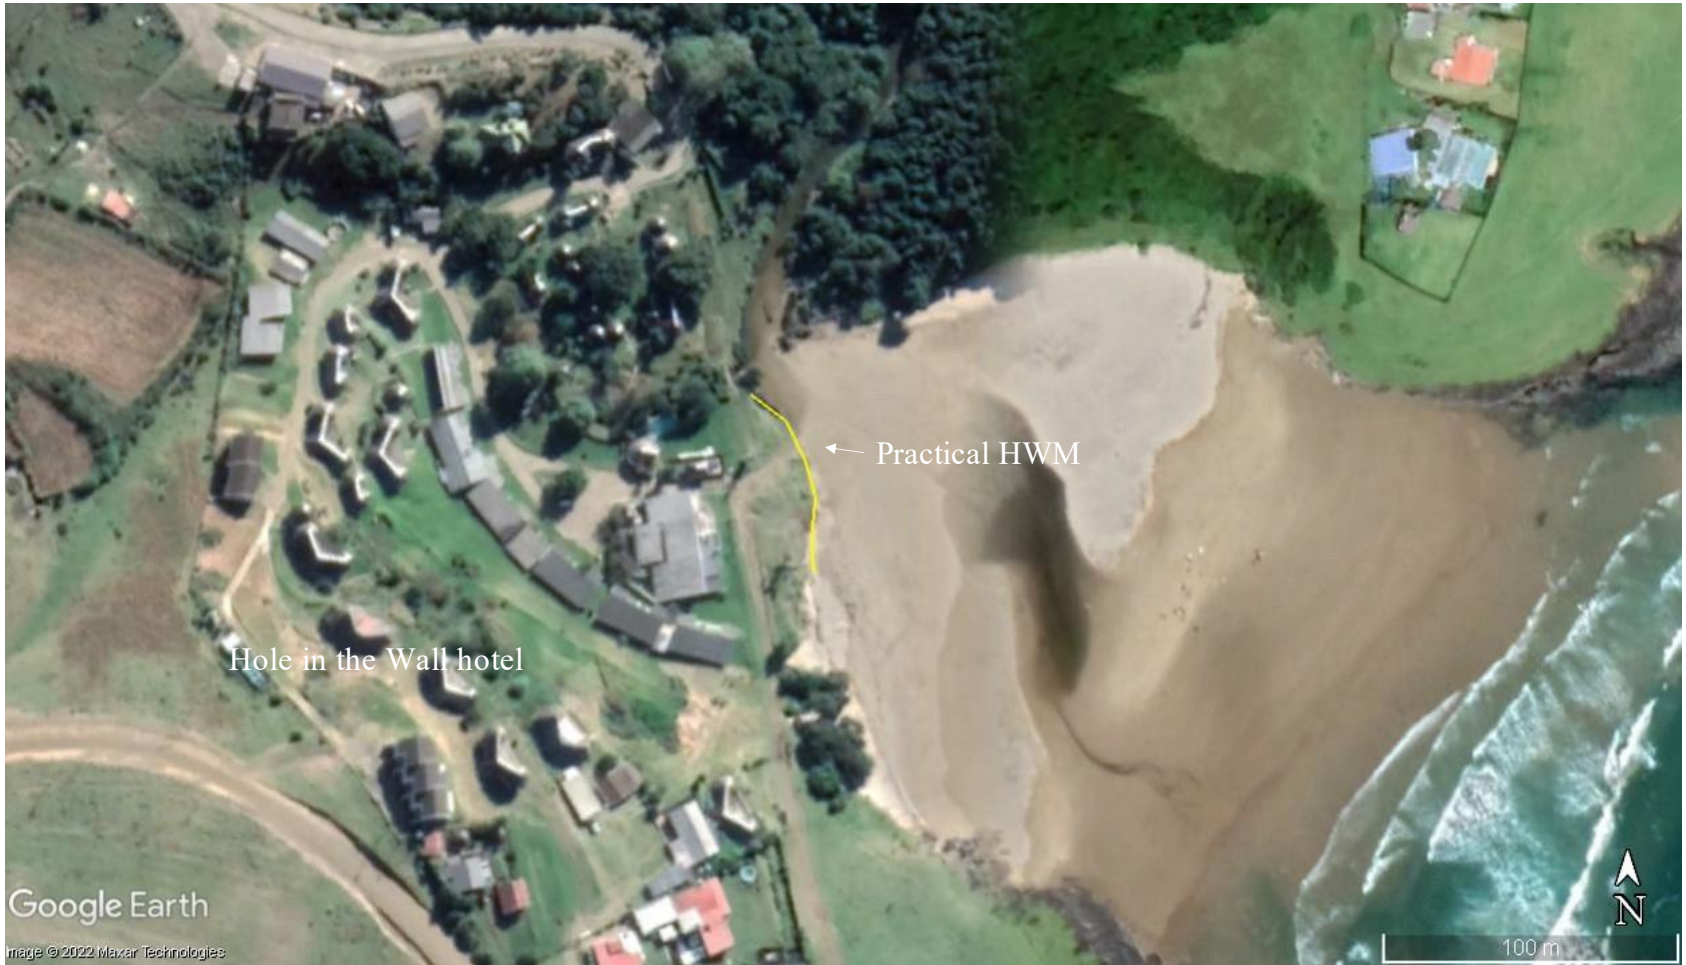
**APPENDIX A4 – The practical high-water mark adjacent to the Hole in the Wall hotel (Google Earth, 2022)**

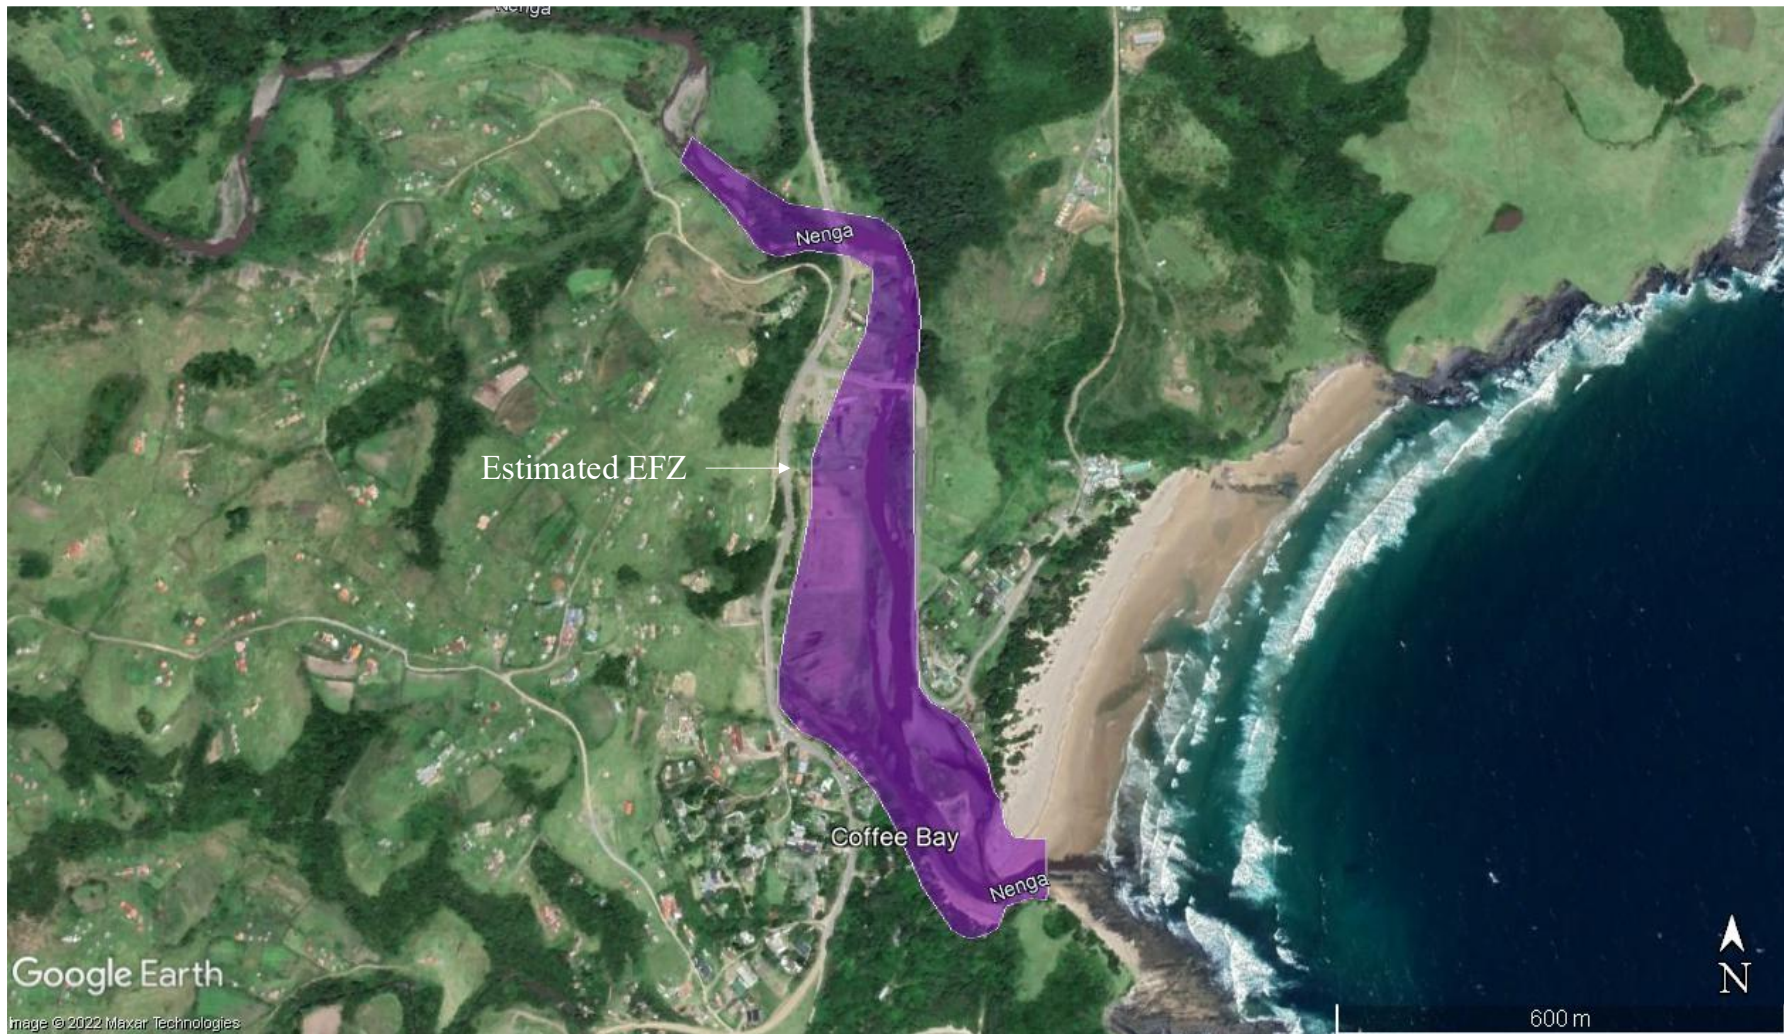
**APPENDIX A5 – The estimated Estuarine Functional Zone (EFZ) at Coffee Bay (Google Earth, 2022)**
