**PROPOSED SU CASA BURIAL ESTATE DEVELOPMENT
TIER 1 GROUNDWATER RISK ASSESSMENT**

Eaglesage (Pty) Ltd

November 2022

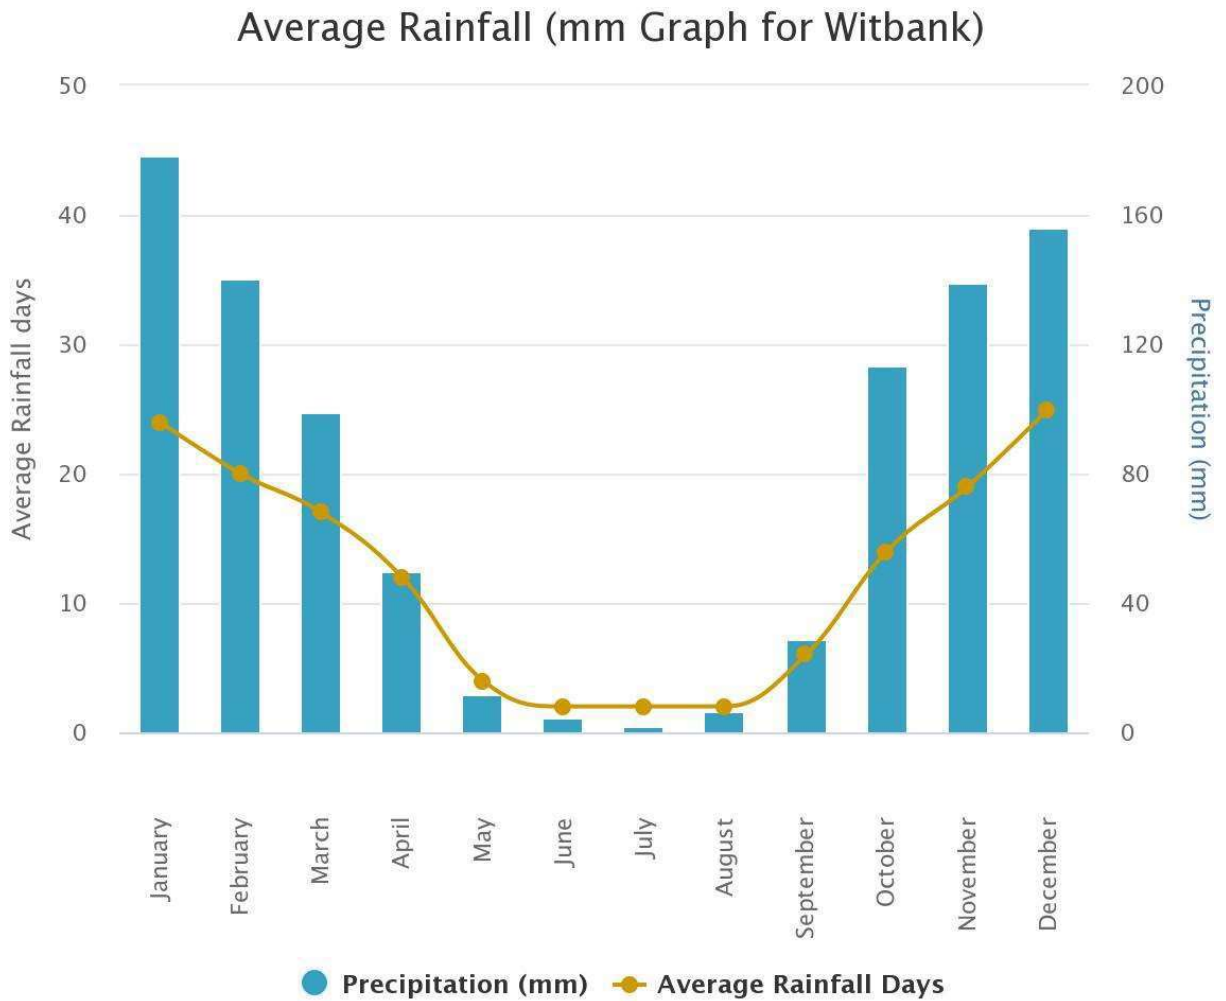
Graph 1: Average Monthly Precipitation at Witbank

The site falls within the summer rainfall region of South Africa and has a warm temperate climate. Mean Annual Precipitation (MAP) is 790 mm at Witbank with the wettest months being October to March and the driest month being June. Average temperature low/high is 16/28°C in January and 7/19°C in June. The monthly distribution of the mean annual precipitation (MAP) at Witbank is shown graphically below (**Graph 1**).
