**PROJECT: Lichtenburg Solar PV Projects.**

**SUBJECT: Geotechnical Desktop Review - Tlitseng Solar 1, Alternative 1 & 2**

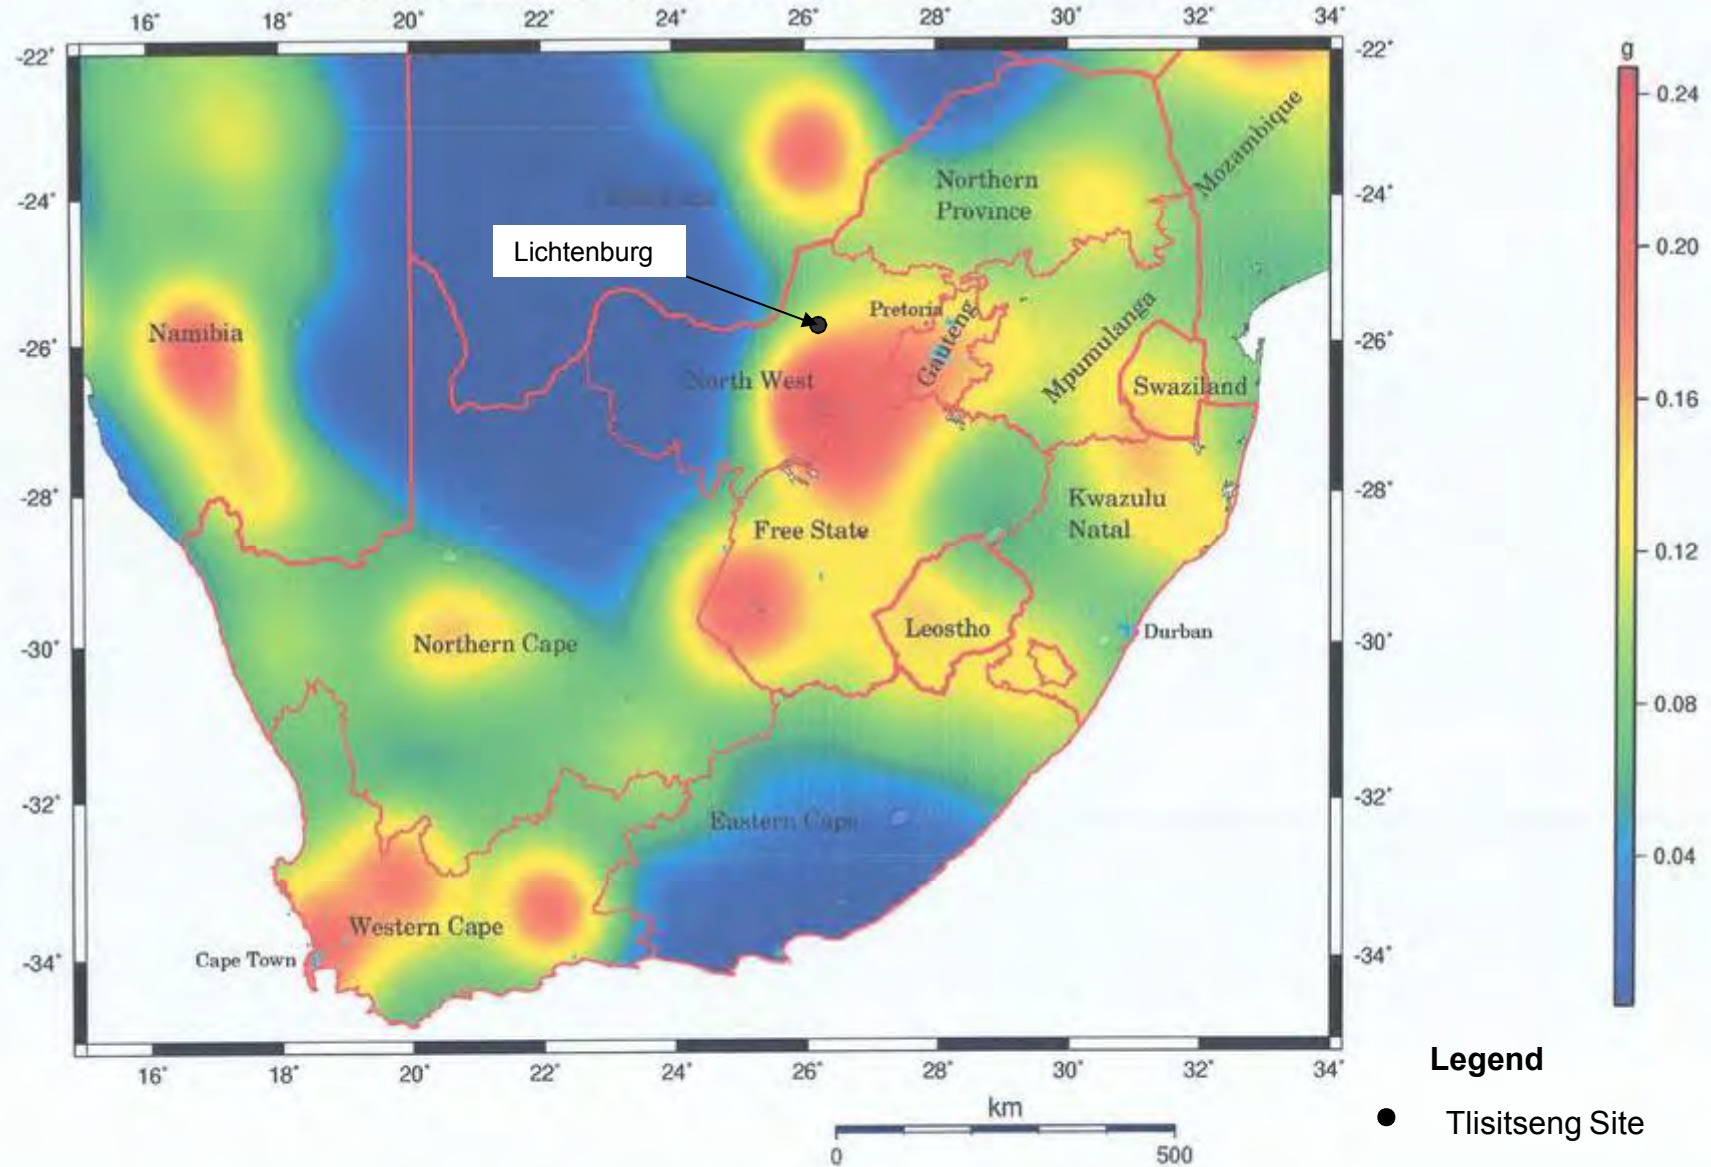
#### 4.1 MAP 1: SEISMIC HAZARD MAP OF SOUTH AFRICA

Peak ground acceleration (g) with a 10 % probability of being exceeded in a 50 year period

According to the seismic hazard map of South Africa, the site is situated in the area where peak

ground acceleration with a 10% probability of being exceeded in a 50 year period falls between 0.12g and 0.16g as seen on the seismic hazard map of South Africa, located in appendix 4.
