# Geotechnical Consult Services

## **Geological assessment: Remaining Extent of the Farm Geel Kop No 456, Siyanda District Municipality, Northern Cape Province**

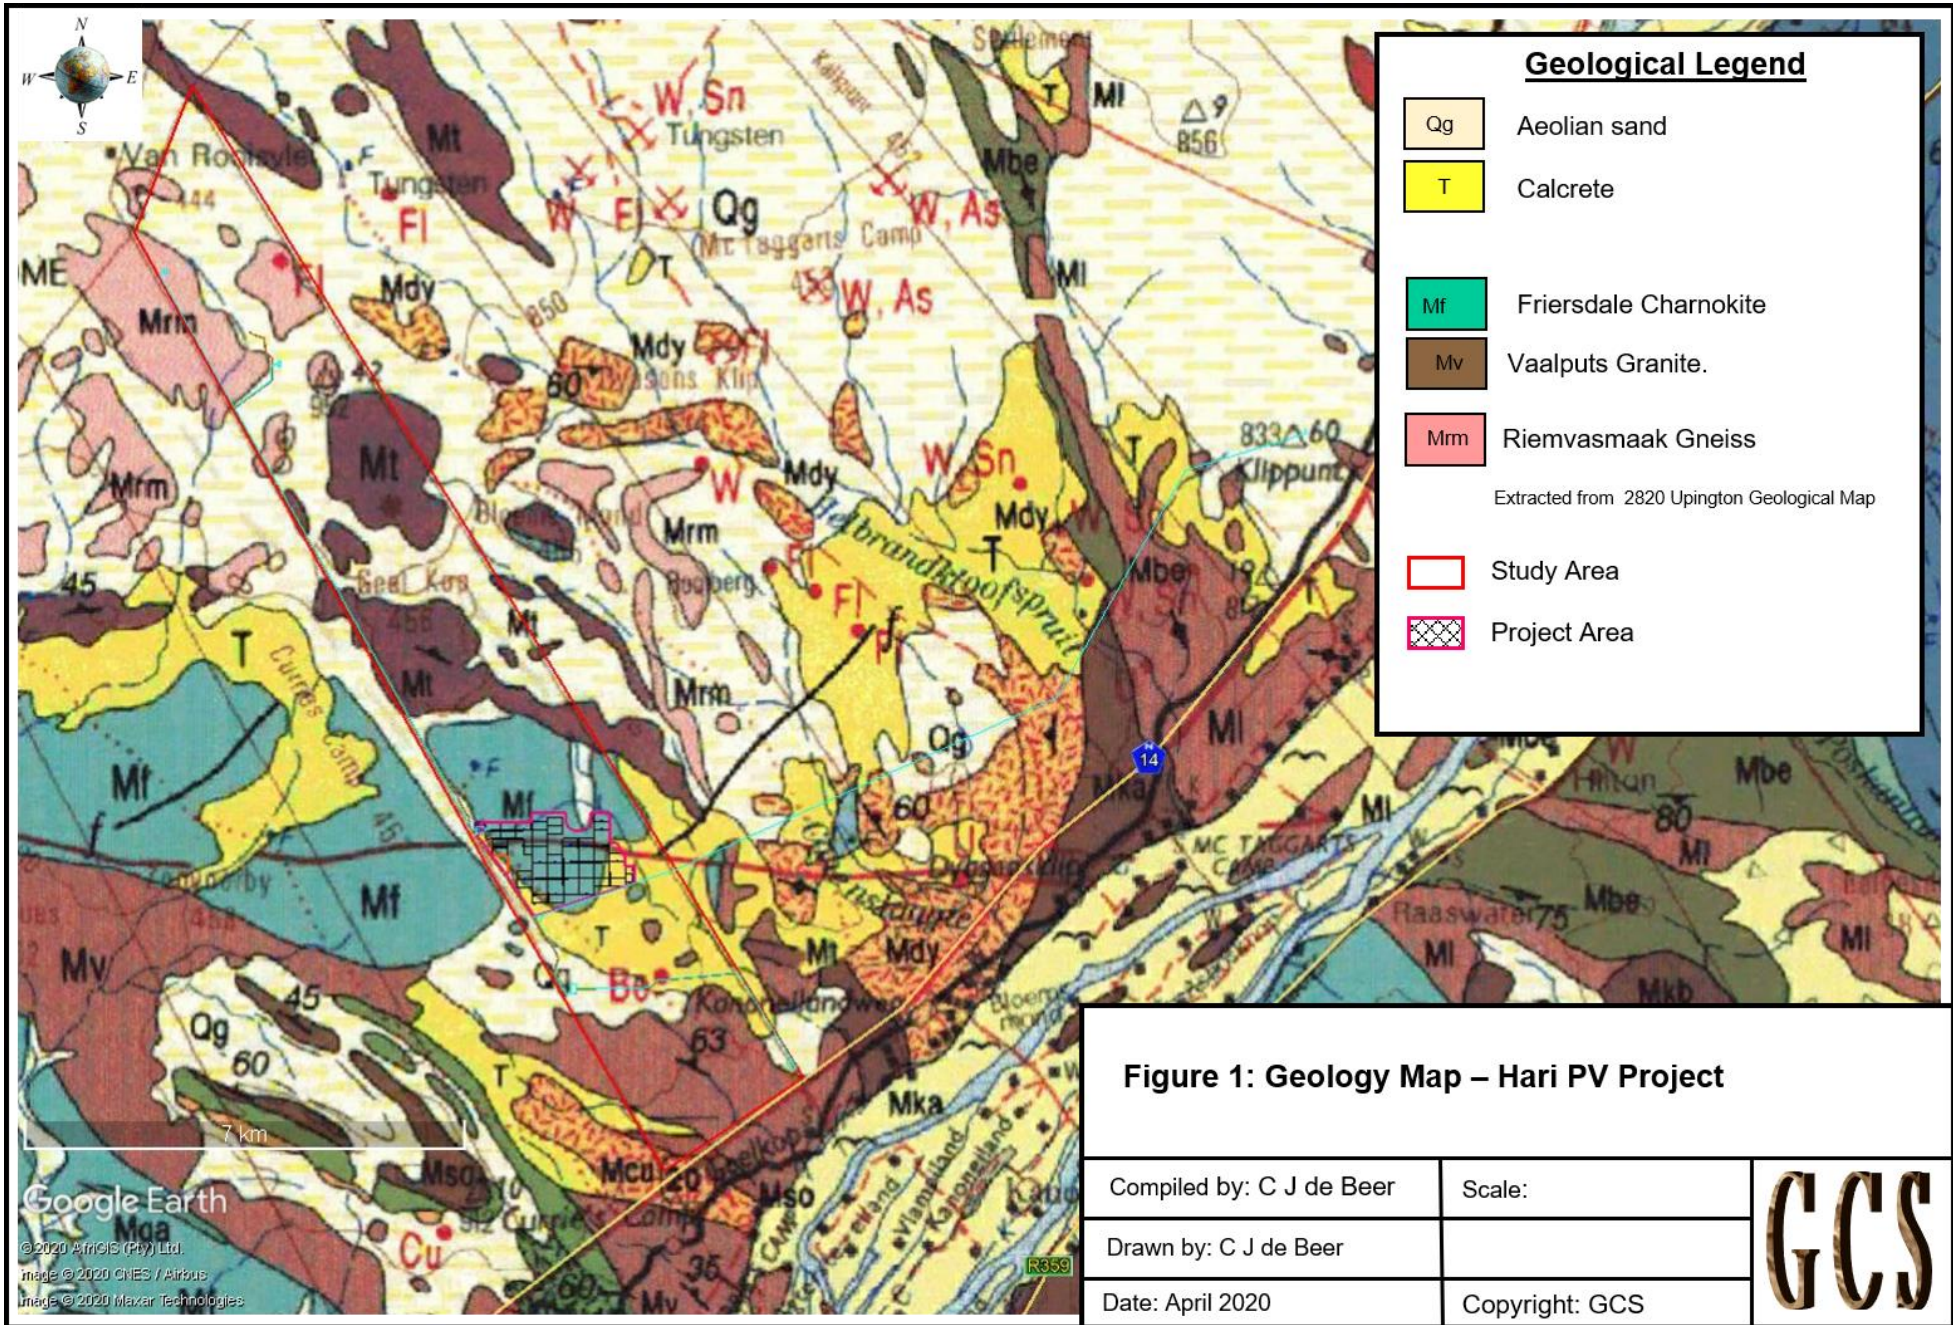
The Property is underlain by recent quaternary (Qg) unconsolidated sand and Tertiary, semi-consolidated calcareous sediment (T) overlying intrusive felsic rocks. The Friersdale Charnockite (Mf), a granofels containing orthopyroxene, quartz and feldspar and felsic rocks (Vaalputs Granite -Mv) and the Riemvasmaak (Mrm) Gneiss. (Figure 1).

Figure 1, shows mineral occurrences identified on 1:250 000 geological map 2820 Upington with the solar PV project area shown. Mineral occurrences to the east of the farm include tungsten (W), Fluorite (Fl), Arsenic As and tin (Sn) associated with the Dysons Klip Gneiss. There are old mine workings on the farms Mc Taggerts Camp and Dysons Klip. Minor occurrences of tungsten, tin and fluorite are associated with the Riemvasmaak formation with an occurrence of Fluorite noted on Geel Kop Farm. An occurrence of beryl (Be) is also noted on Geel Kop. The occurrence is associated with the Vaalputs granite.

An undifferentiated intrusion of diabase (Mga) occur close to the NE-SW trending fault (*f*). There is a NW-SE trending young diabase intrusion (Jd) cutting through the Charnockite.
