Comments received on withdrawn Application

RE: EXPANSION OF LIQUID OXYGEN AND DIESEL STORAGE AT THE AIR PRODUCTS FACILITY LOCATED WITHIN THE COEGA SPECIAL ECONOMIC ZONE, PORT ELIZABETH, EASTERN CAPE PROVINCE

The effects of a 23m3 diesel tank on a Food Manufacturing Facility

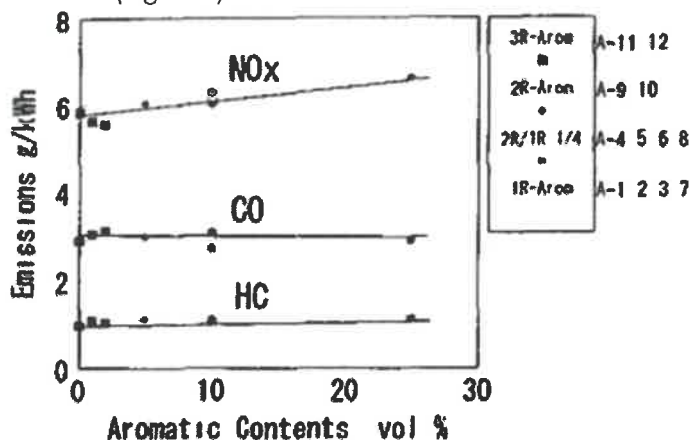
Figure 1. Emissions from an older generation diesel engine. The emissions are displayed in g/kWh on the y-axis with the percentage of aromatic contents, such as hydrocarbons, being displayed on the x-axis [1].

We would like to raise the following concerns regarding this project. If our understanding of the project is incorrect, we would welcome additional information and cordial communication between our business ventures to address this miscommunication or misunderstandings. The initiator intends to use the 23m3 tank as a fuel point for trucks. These trucks would emit high concentrations of exhaust emissions into the surrounding area. This area is located less than 50m away from our raw material collection point. It has been noted that exhaust smoke from diesel engines introduce unburned hydrocarbons, carbon monoxide, sulphur dioxide, nitrogen oxide and particulate matter into the atmosphere [1]. Carbon monoxide is of concern due to its effect on biological systems. Additionally, it has been acknowledged that the age of the engine plays a major role in the degree of pollution with older models introducing higher quantities of such gasses. Likewise, the quality of the diesel also effects these emissions with low centane diesel facilitating higher emissions (Fig 1 - 3).

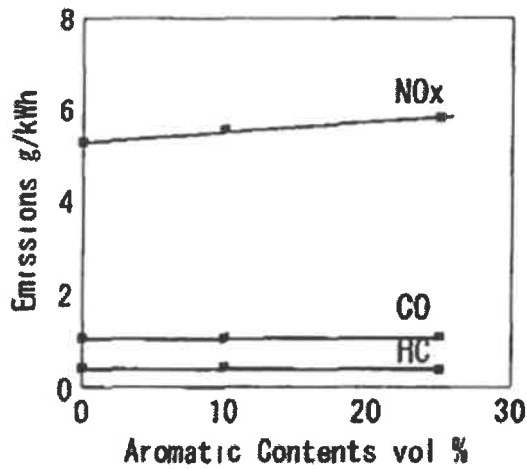
Figure 2. Emissions from a newer generation diesel engine. Figure displayed as per figure 1 [1].

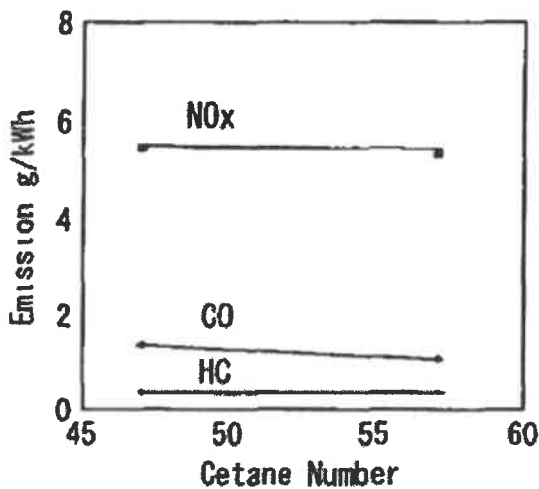
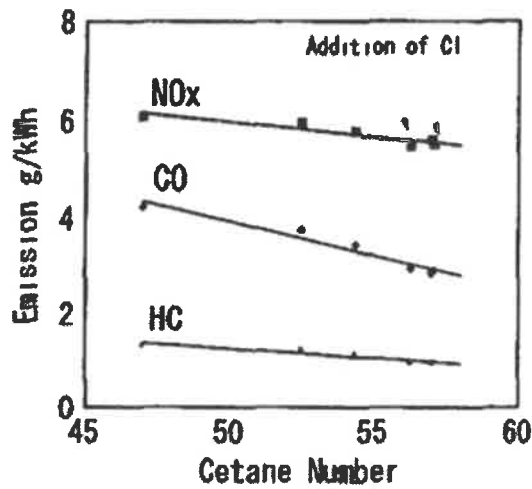
Figure 3. The effects of diesel quality on emission generation represented by cetane number of diesels. The cetane number is represented on the x-axis whilst the emissions in g/kWh are represented by the y-axis as in figure 1 [1].

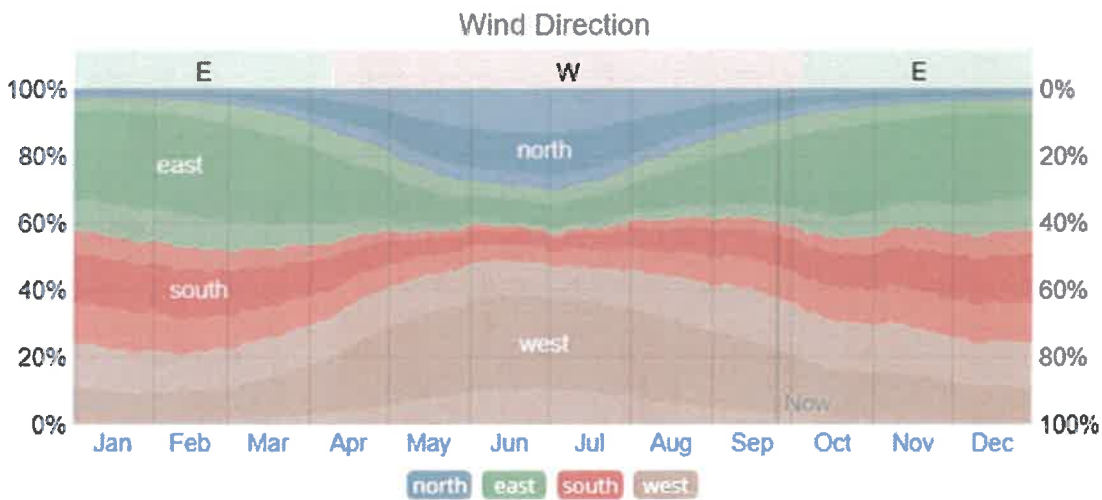
Figure 5. Percentage of time from which wind direction spent in a direction during 2018 within Coega.

From an operational healthy and safety aspect, some of our maintenance and raw material personnel frequently operate in this area. As stated in the Major Hazard Installation report, the tank was not to be placed near the guard house on the initiator's premises due to the presence of the building and personnel. We would like if this courtesy were extended to encompass our own personnel who work in the area. The Major Hazard Installation report also reflects that wind is likely to blow vapours in the direction of the bulk cryogenic storage facility, however, this appears to be unlikely. Data gathered from two differing sources (Fig 5 [4] and 6 [5]) indicate that, for most of the year, wind direction maintains a South to South West consistency. Our storage facility and collection point lie at South-West: 202° whilst our location for storage of old equipment lies at South: 207°.

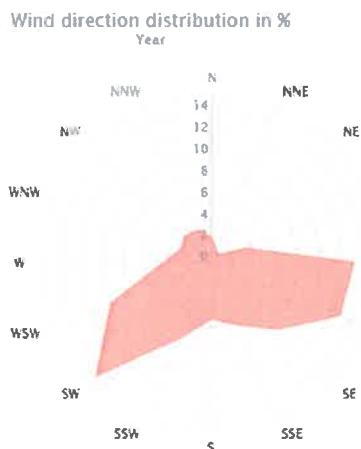
Figure 6. Percentage of time from which wind direction spent in a direction during 2018 within Coega.
