## **A REPORT ON GEOTECHNICAL CONDITIONS ON STAND 11883 IN VRYBURG: A REPORT FOR THE PROPOSED CONSTRUCTION OF A NEW SHOPPING MALL**

Soilkraft cc was appointed by Mr D Freislich on behalf of the Eris Property Group (Pty) Ltd to undertake a geotechnical investigation for the proposed establishment of a new shopping complex in Vryburg, North West Province. The shopping complex is to be known as the Mall of the North West.

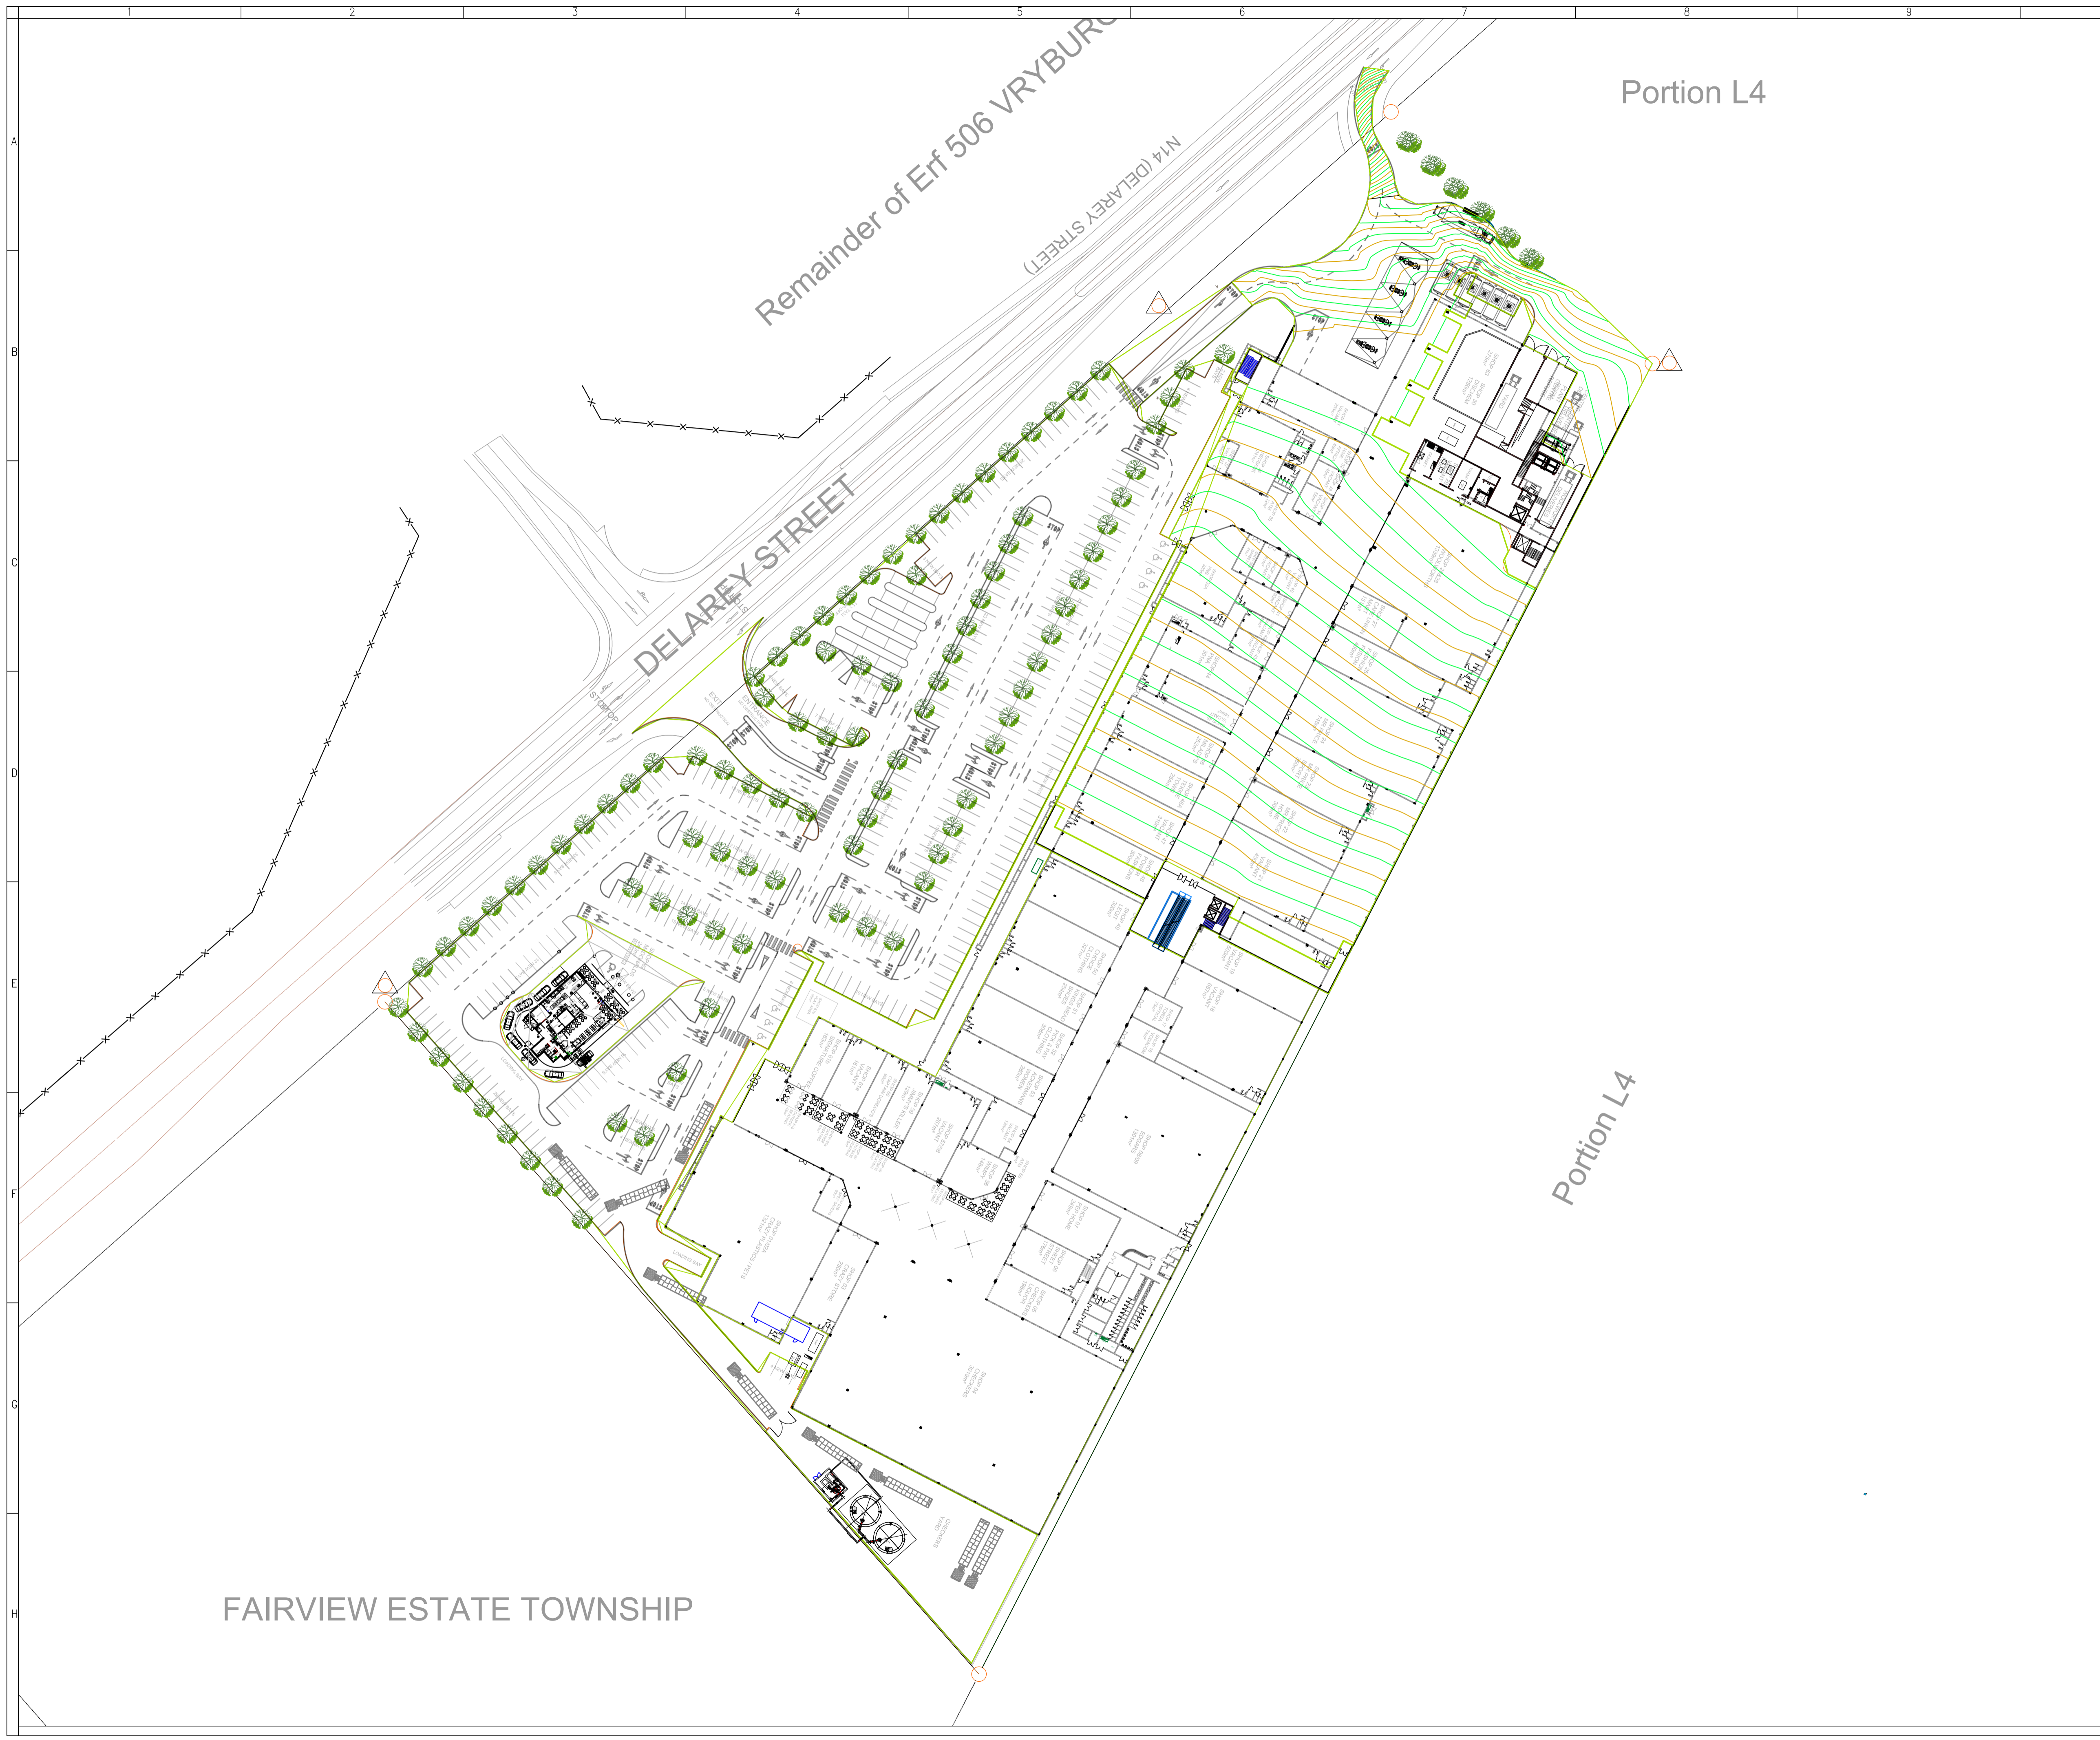
Drawing Number : P0078-150-003

FAIRVIEW ESTATE TOWNSHIP
