NID supporting document: Hermanus Cliff Path Extension

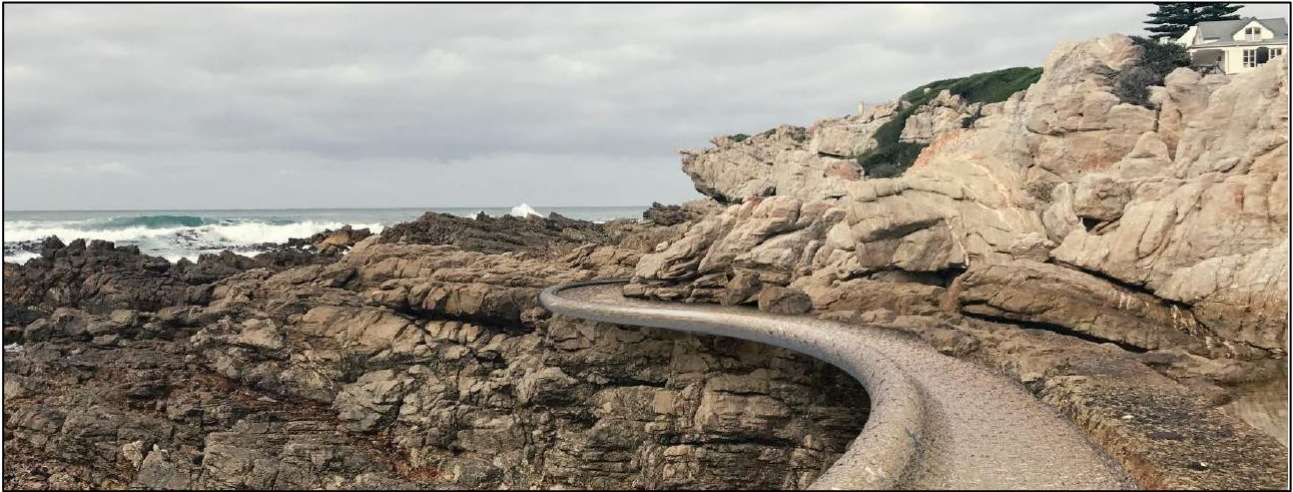
Architect's impression of doveled section (source: Mark Thomas Architects and Henry Fagan & Partners)

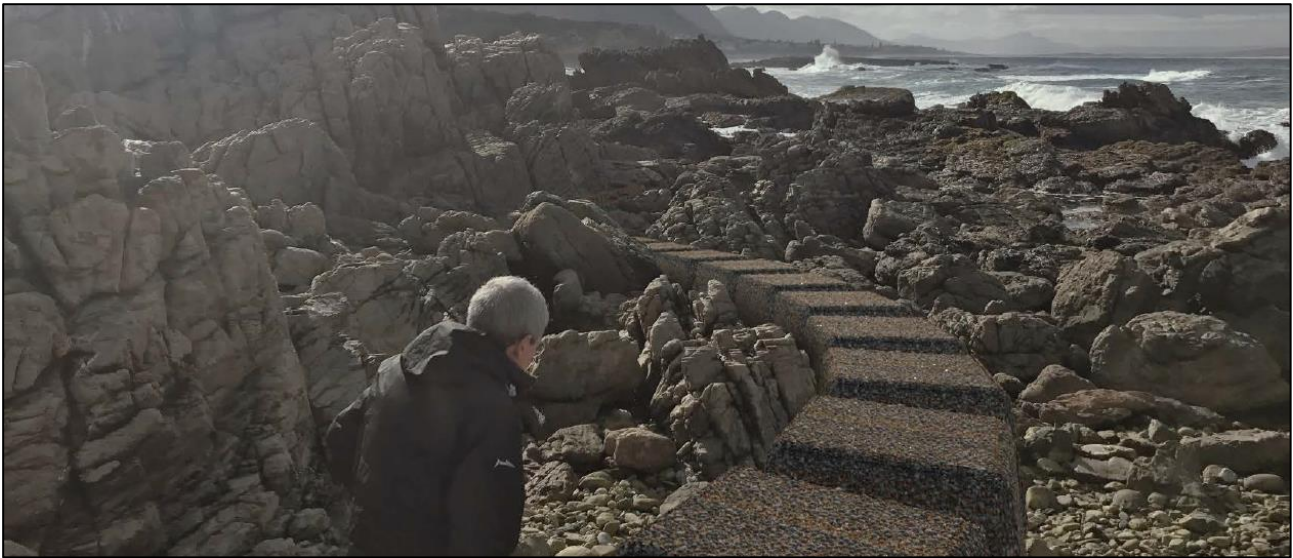
Architects impression of stepping stone section (source: Mark Thomas Architects and Henry Fagan & Partners)

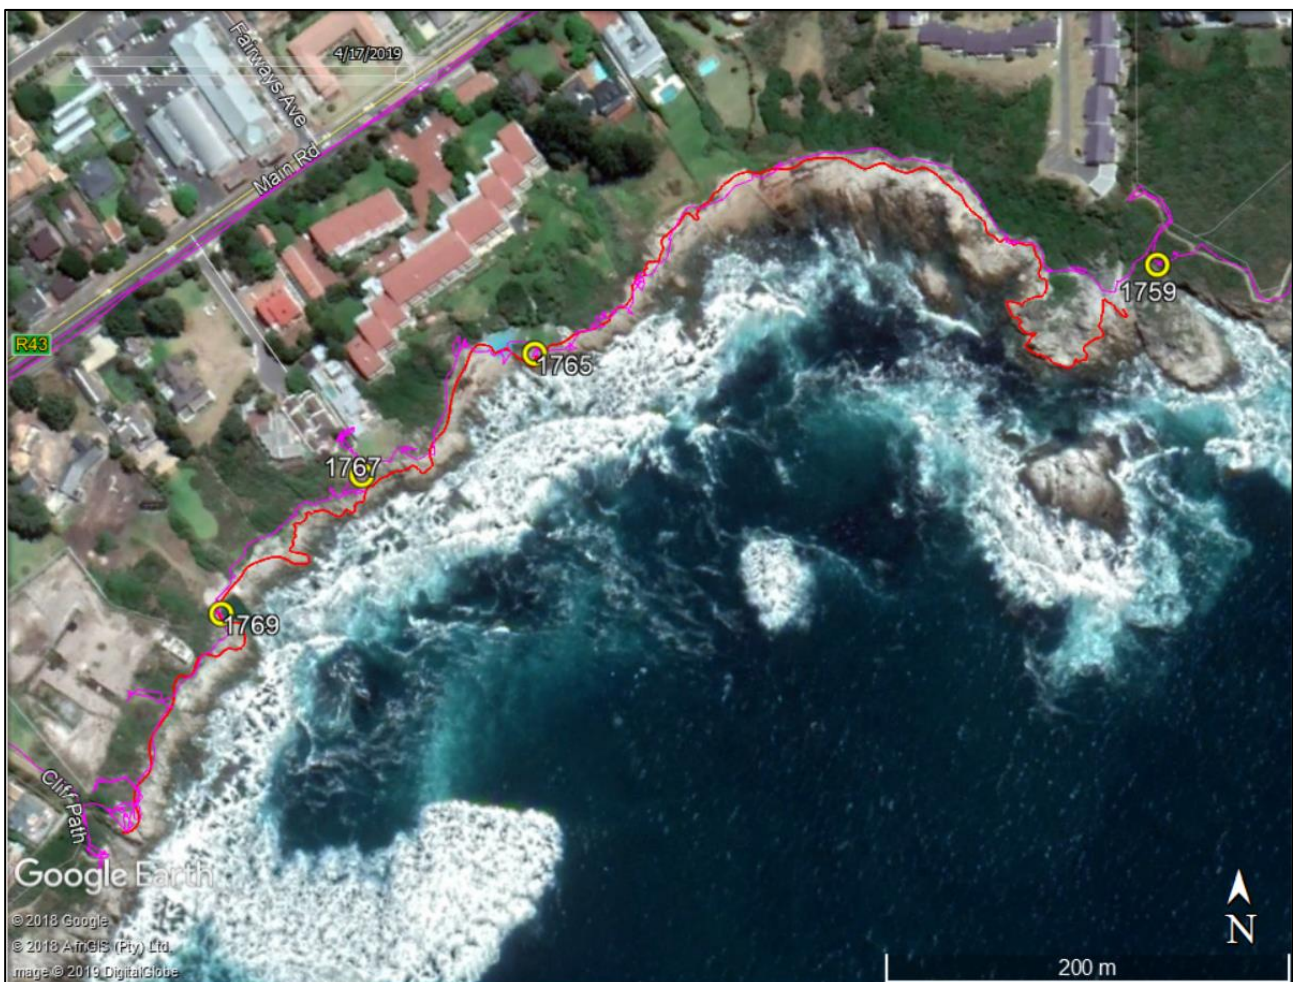
Aerial view of the study area showing the recently surveyed high water mark (red line; still to be approved by the Surveyor General), the survey tracks (purple line) and the waypoints mentioned in this application (numbered yellow symbols).

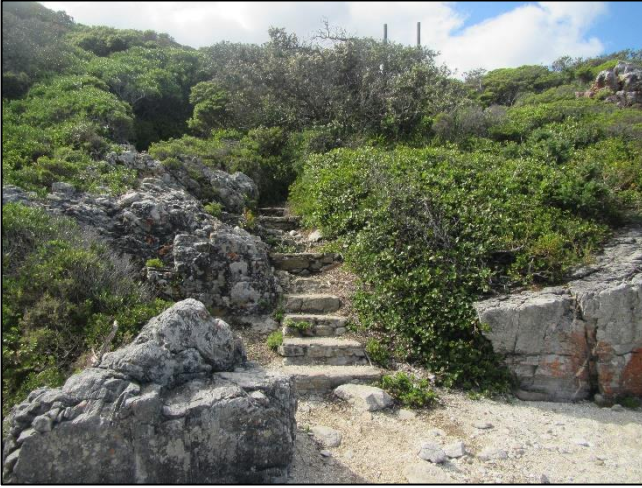
Part of the old walkway with steps made of stones and cement. This is just before the section where the new path would begin. This part may be upgraded as part of the new project but the path would not be widened.

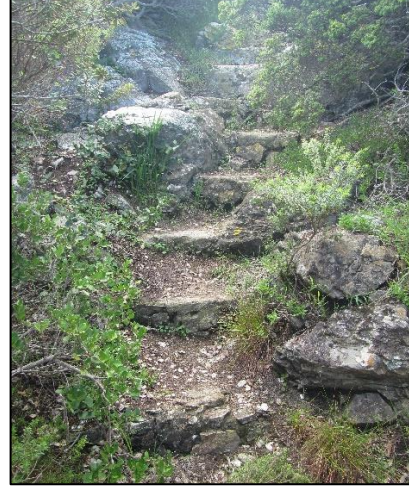
Another section of old walkway just east of the proposed new section. There are two sets of stairs leading down from the high ground towards the coast.

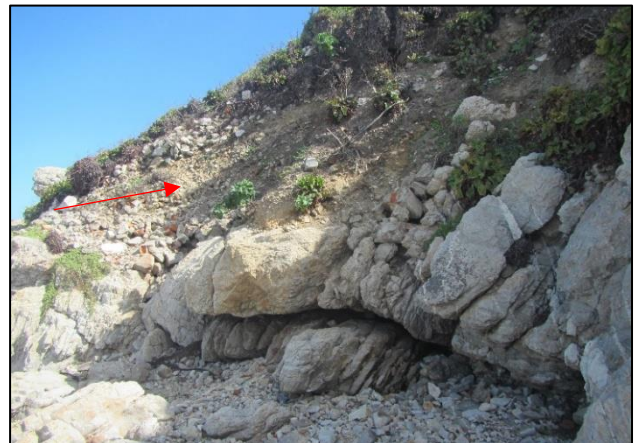
A rocky area below the old Bay View Hotel site with much building rubble (red arrow) that was pushed down towards the coast, presumably after the demolition of the older building. Many water-rolled bricks lie in the boulder beach area below the rocks.

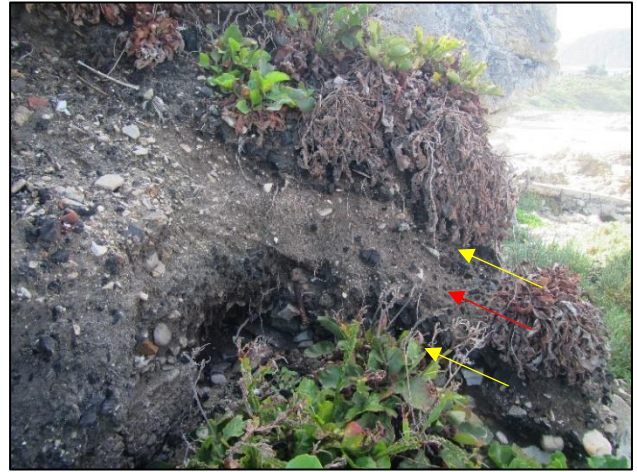
Two layers of charred debris and charcoal (yellow arrows) separated by a soily horizon (red arrow) below the old Bay View Hotel site. The angled stratigraphy shows that the debris was pushed down the slope from above.

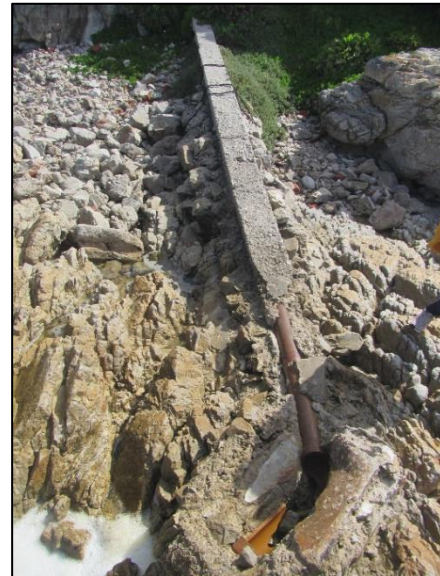
Remnants of old pipeline on the rocks below the old Bay View Hotel site. Several examples were seen, largely in disuse.

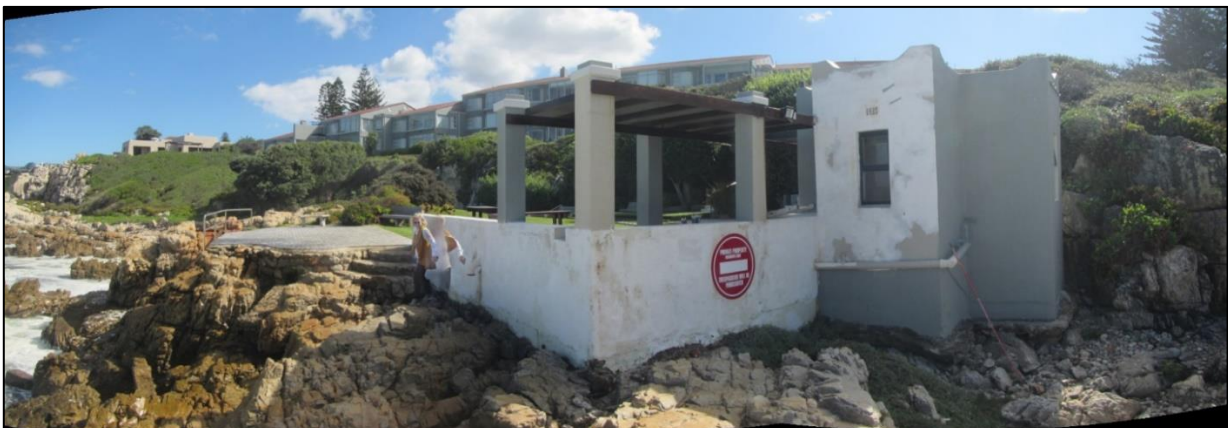
Mid-late 20th century structure related to the swimming pool at waypoint 1765. It is absent from the post-1941 photograph above.

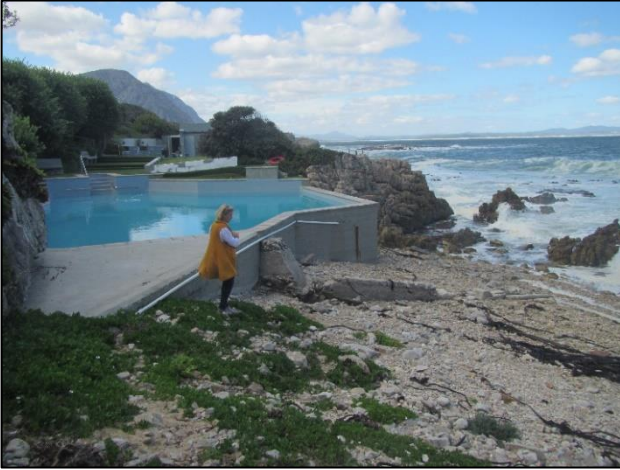
Swimming pool that once belonged to the Bay View Hotel. It has been modernised and now belongs to the Bay View Apartments that were built in 1985.

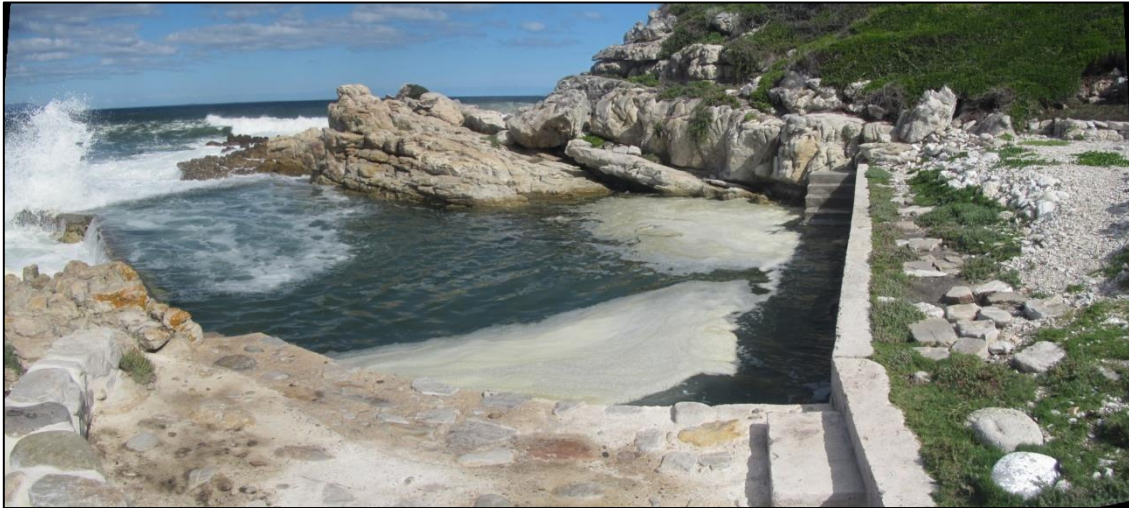
Old tidal pool located at waypoint 1769 near the south-western end of the study area and below the mapped HWM. It has been recently repaired and refurbished.

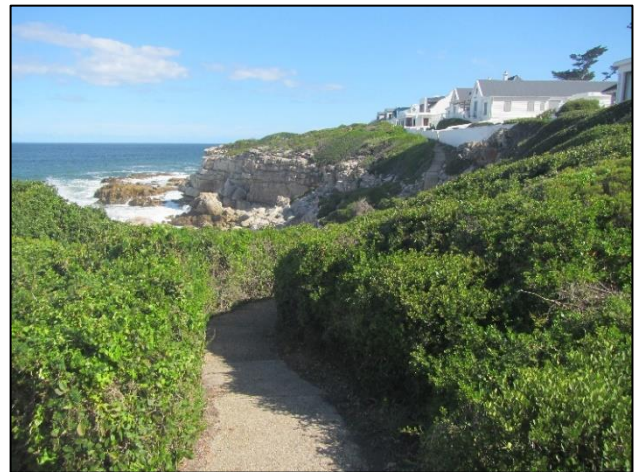
View towards the southwest along the existing Cliff Path showing the nature of the path (concrete with exposed aggregate).
