GUIDELINES
FOR MAINTENANCE, IMPROVEMENTS
AND NEW BUILDINGS
IN
BOKAAP

PREPARED FOR THE
NATIONAL MONUMENTS COUNCIL
BY
PENNY PISTORIUS

1998

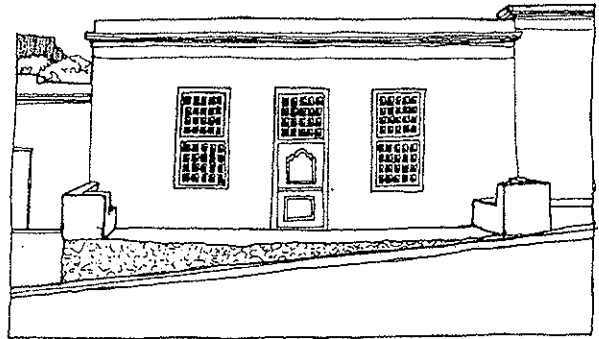
Fig 8. Cape Dutch house with parapet

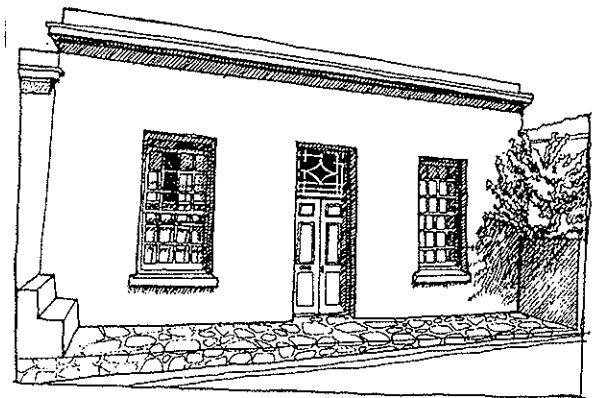
Fig 9. Typical Georgian house with parapet

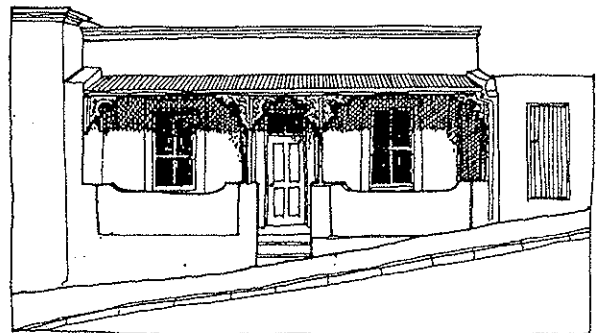
Fig 10. Parapeted Victorian cottage with a fine cast iron verandah

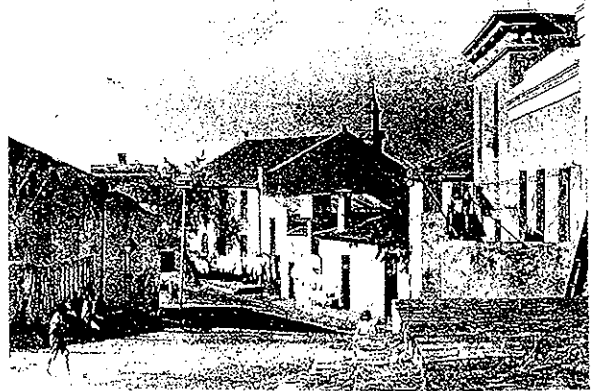
Fig 11. These rare double-storied semi-detached early Victorian houses with a pitched slate roof, which used to stand in Pentz Street, were unfortunately demolished in the 1970s (Arthur Elliot, Cape Archives)

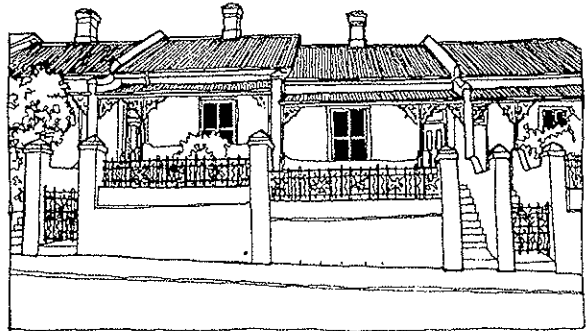
Fig 12. Victorian row houses

These are similar to the parapeted row houses, but with double-pitched corrugated iron roofs. Some have small gables over each pair of entrance doors, and some have returned gable ends at each end of the row. Verandahs and plaster decoration are the same as for the parapeted variants. Some rows are set back slightly from the street, allowing for a small front garden, usually with a plastered boundary wall with capped posts. Double storey examples are also found.

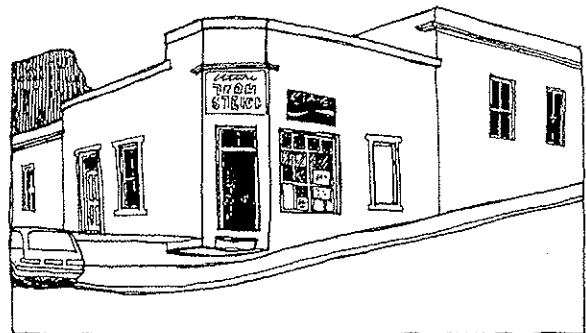
Fig 13. Corner shop with attached dwelling

A variation on the above types is the building on the corner of a block, with the corner cut away at 45°. They usually have an entrance on the corner and are often (but not always) used as shops. Both parapeted and pitched-roof variations exist, and some are double-storey. The stoep or verandah usually follows the outline of the building around the frontage, giving access to the dwelling on one side.

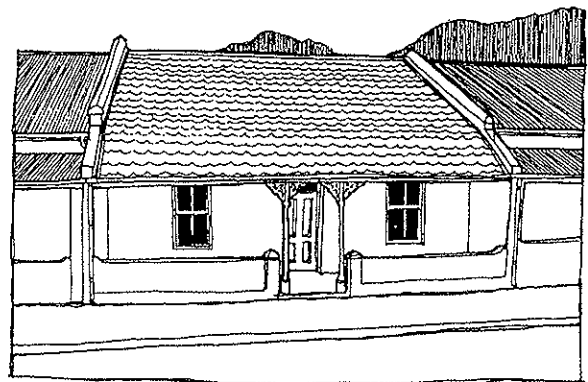
Fig 15. Pressed metal roof tiles have a disturbing texture and, if carried over the verandah, change the shape of the roof.

When replacing the roof, avoid carrying the sheeting over house and verandah in an unbroken line if the main roof and verandah roof were originally separate. (See Fig. 15)

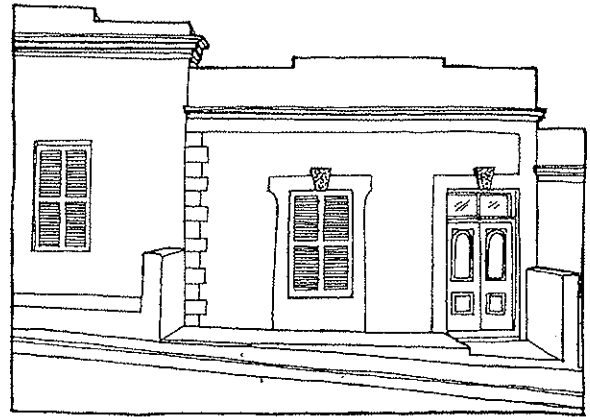
Fig 16. Plaster mouldings add to the character of the house.

Cornices, plaster surrounds to door and window openings, quoins and rustication are all important features of the houses of Bokaap, and should not be removed. If mouldings are damaged, do repair them rather than trying to remove and replace them. If the cornice has crumbled so badly that it is impossible to tell its outline, a copy can be made from a house in the area with similar detailing to yours.

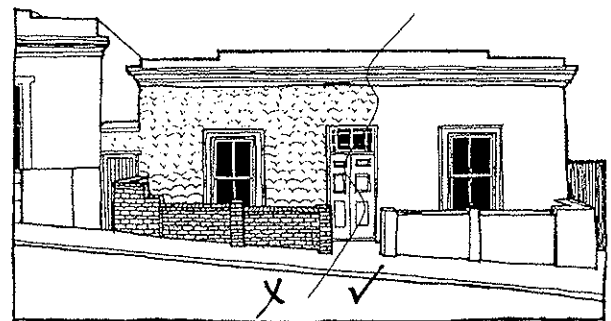
Fig 17. Avoid textured plaster and facebrick.

Use a wooden trowel or float for new plasterwork, as metal ones give too hard a finish. Avoid textures such as “Spanish” plaster and spatterdash, and claddings such as facebrick, artificial stone or tiles, which are not appropriate in Bokaap. If facebrick was used in the past, it should preferably be plastered and painted.

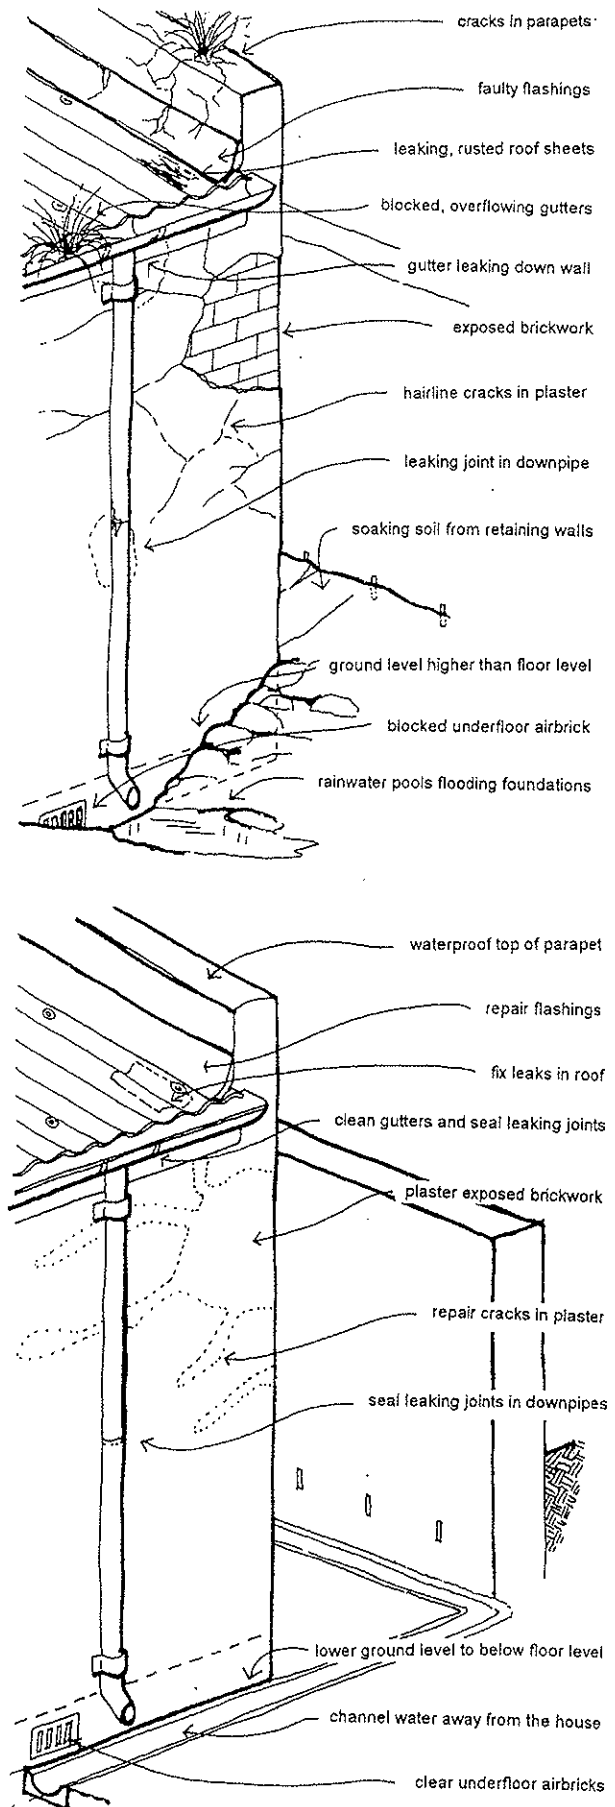
Fig 18. Some common causes of damp and how to cure them.

If the roof, gutters and downpipes, flashings and plaster are all in good repair and the walls are still damp, it is likely that the water is rising up from the ground. The houses in Bokaap do not have damp proof courses, and rising damp is consequently a common problem. Foundations are usually of stone rubble, which provides some barrier to damp if the mortar is of lime. However, clay mortar was often used between the stones, and damp from the ground rises easily through the clay.

The following simple and cheap methods may improve the situation. If possible, lower the level of the ground and paving around the house to at least 150mm below the level of the floor. Slope the ground so that rainwater does not pool against the walls, and check that drains and water pipes are not leaking below the surface of the ground. If the house backs into the slope, it is best to dig out the ground for a metre from the house (sloping the ground or building a retaining wall if necessary) and lay a surface channel so that water running down the slope is carried clear of the house, and does not dam up against the walls.

Victorian houses usually have air bricks below floor level in the outer walls: make sure that they are not covered or blocked, as air circulating in the underfloor space will help to dry the foundations and prevent rising damp. If there are no air bricks, inserting one to each room should help to prevent damp.

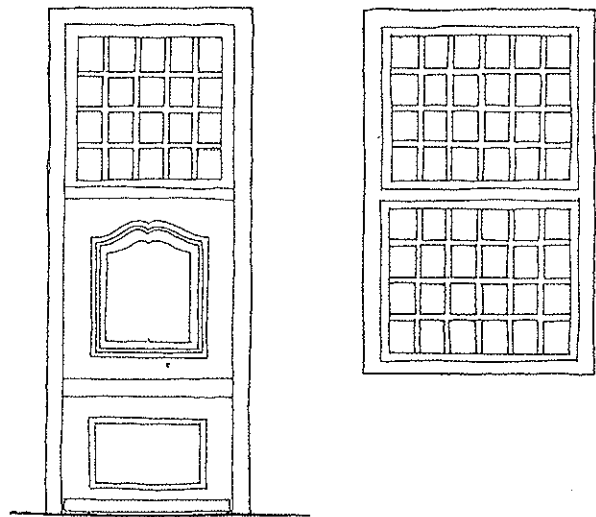
a) Cape Dutch: woodwork flush with the outside wall; bo-en-order door with square small-pane fanlight; window with fixed top sash, small panes and heavy glazing bars; width between $\frac{1}{2}$ and $\frac{2}{3}$ of its height.

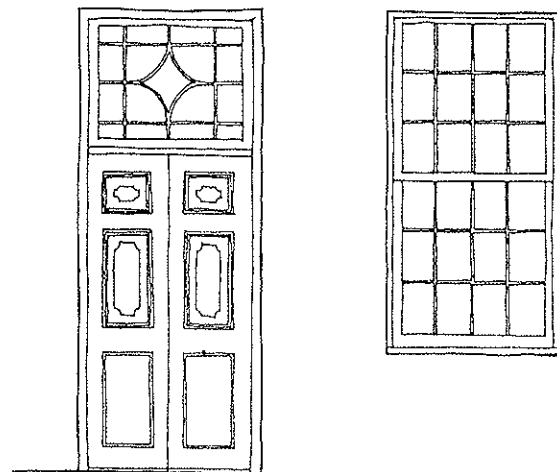
b) Georgian: woodwork recessed; double doors with six or eight panels and ornate fanlights; windows at least twice as tall as they are wide with large panes of glass and slender, deep glazing bars; internal folding or external louvred shutters.

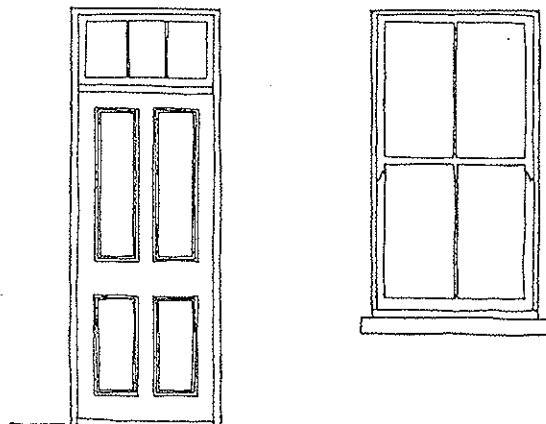
Fig 19. Typical doors and windows.

c) Victorian/Edwardian: doors with four or six panels; windows with two or six panes and horns under the top sash; louvred shutters.

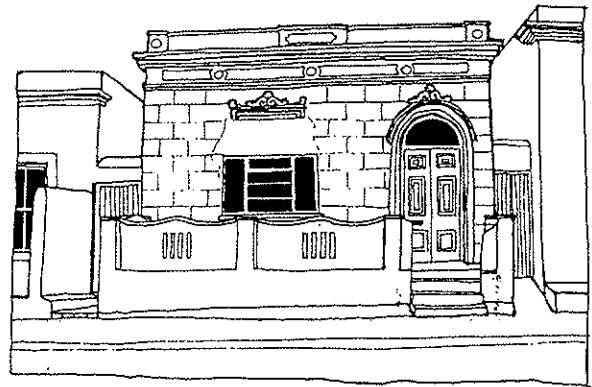
Fig 20. The plaster surround is damaged and the facade spoilt when a sash window is replaced with a horizontal casement.

Many old houses have already been spoilt by horizontally-proportioned windows, with the remains of plaster mouldings indicating the size and shape of the originals. If possible, do consider replacing the horizontal windows with new ones which would fit into the old mouldings, and repairing the plaster surrounds. It would restore the dignity and elegance of the facade and increase the value of the house.

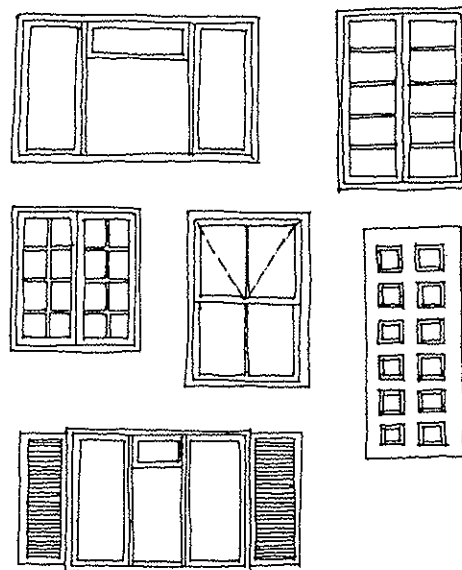
Fig 21. Some inappropriate windows and doors which should not be used in Bokaap

- horizontally-proportioned windows
- windows and doors with horizontally-proportioned subdivisions
- cottage-pane windows
- windows and doors of varnished wood
- steel windows
- mock "sash" windows which are actually top-hung casements
- false shutters attached to the facade
- ornate carved or panelled doors
- modern coloured or obscure glass.

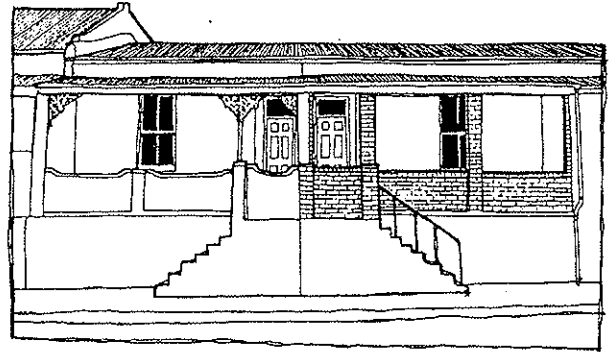
Fig 23. Facebrick walls and columns are not compatible with the architecture and should preferably be plastered and painted.

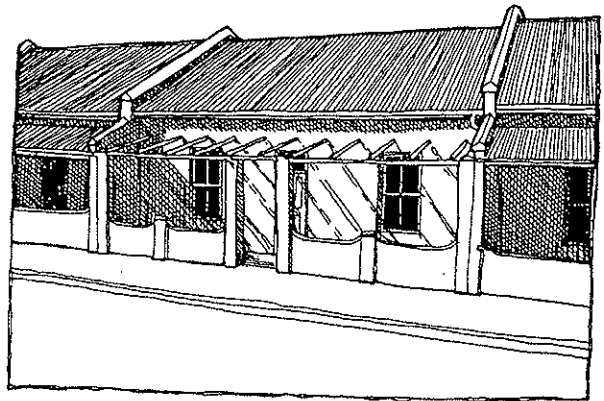
Fig 24. Replacing the verandah roof with a pergola disturbs the pattern of light and shade along the street.

Avoid replacing the corrugated iron verandah roof with a pergola. If more light is needed in the front rooms, rather replace the corrugated iron above the windows with a few sheets of translucent fibreglass.

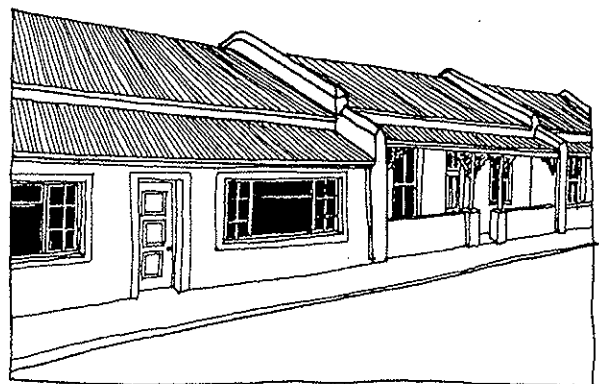
Fig 25. Avoid enclosing the verandah, particularly with unsympathetic materials.

Avoid enclosing the verandah.

Do retain the verandah as an intermediate space between the house and the street. Avoid enclosing the verandah, particularly with unsympathetic materials such as facebrick and steel windows. If the extra space is absolutely necessary, try to design the enclosure so that it could be removed again in the future, and use designs and materials which fit in with the style of the house, such as a light timber and glass screen.

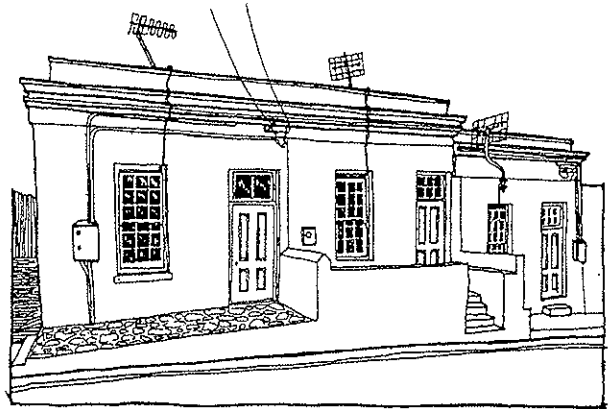
Fig 27. Television aerials and cables, prominent electrical boxes and surface-mounted cables clutter the streetscape.

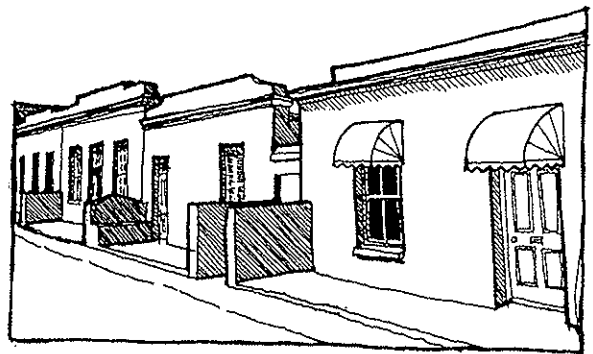
Fig 28. Canvas awnings are not traditional and should preferably be avoided.

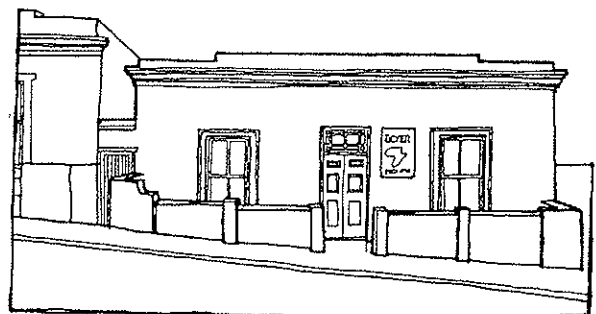
Fig 29. A simple sign board attached to the facade is appropriate for a house used as commercial premises.

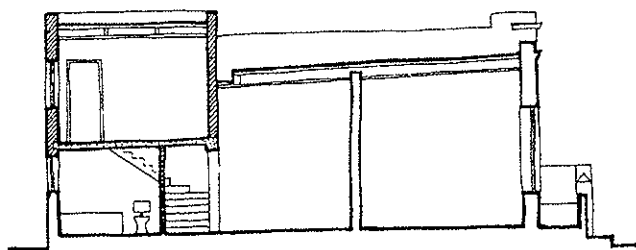
Fig 30. Adding on a rear extension does not affect the main structure.

If the house has a large enough back yard, the first option should be to add on at the back, where the addition will be least visible from the street.

Even in houses with small yards, it may be possible to add a floor over the back rooms, which will leave the main structure untouched.

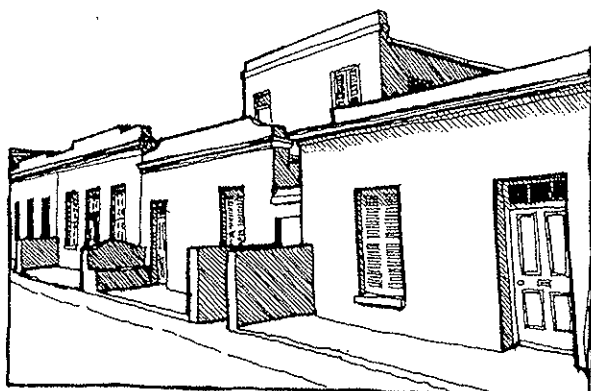
Fig 31. A set-back first floor has a minimal impact on the streetscape.

The openings in the set-back facade should preferably line up with the original openings on the ground floor. Painted timber windows and doors with vertical proportions should be used, but they need not be identical to the originals.

The set-back first floor is usually a preferable choice because the extension has less of an impact on the streetscape and, if the building is historical, the original facade and cornice are conserved.

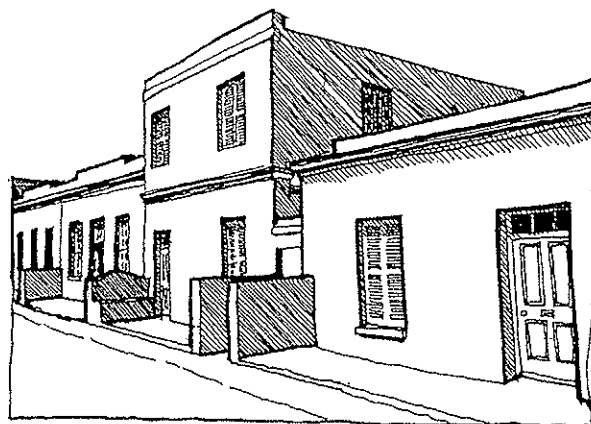
Fig 32. A double storey addition over the whole house has a significant effect on the streetscape and the facade of the house.

2) The second option is to build a second floor over the entire house. While this gives more accommodation, it is not usually suitable for historical buildings as it is a drastic change to the facade and raises problems of how to treat the cornice. Original cornices should be conserved as they are evidence of the great craftsmanship of the initial Muslim artisans and are a very important part of the architectural and cultural heritage of the area. However, retaining the cornice and extending the parapet upwards for another storey spoils the proportions of the building and can have a serious visual impact on the neighbourhood.

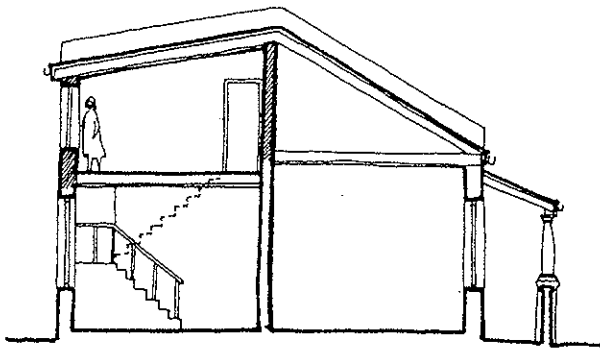
Fig 33. Raising the eaves at the back of the house can provide loft accommodation without affecting the streetscape.

In some cases it is possible to provide extra accommodation in the existing loft space under a pitched roof by modifying the arrangement of the trusses.

Try to keep changes to the front of the roof as unobtrusive as possible. It may be possible to raise the eaves at the back of the house, without affecting the front facade or the streetscape at all.

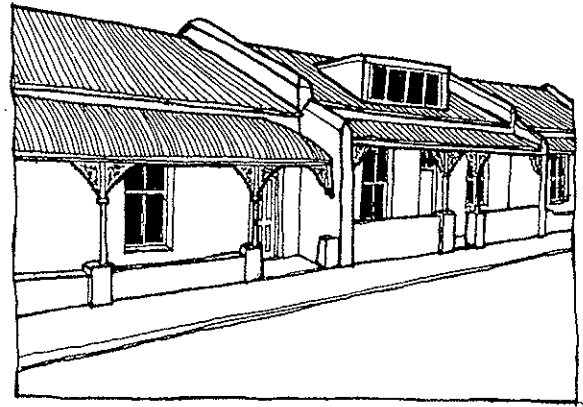
Fig 34. Long, horizontal dormers at the front of the house are inappropriate; rather face them towards the rear.

Dormer windows are another way of lighting the loft space. Vertically-proportioned triangular dormers are the most suitable, but they should be carefully scaled so that they are not overwhelming (particularly if the house has a projecting gable).

Avoid long, horizontal dormers facing towards the street; they have a major impact on the streetscape and should only be used on the rear slope of the roof.

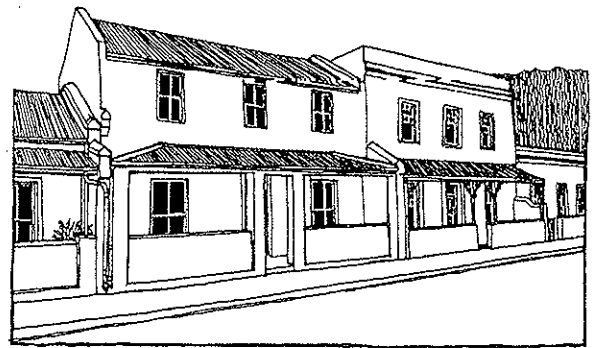
Fig 35. Adding a second floor in a similar style to the ground floor may be appropriate in streets with a variety of houses.

In some cases it may be possible to add another floor in the same style as the original house, matching the roof slope, proportions, spacing of openings and type of windows used on the ground floor.

As with parapeted houses, the impact of making the whole house double storey should be carefully considered with respect to the building itself and the impact on the streetscape. Before planning such an extension, do consult the City Council or the National Monuments Council to check whether it is a viable option.

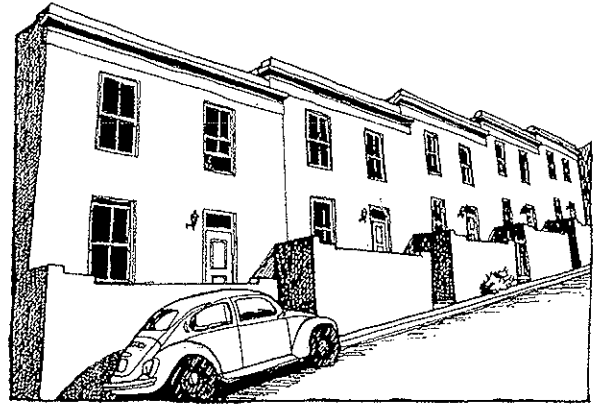
Fig 36. Infill houses built by the City Council use traditional forms, features and materials, but the detailing is modern

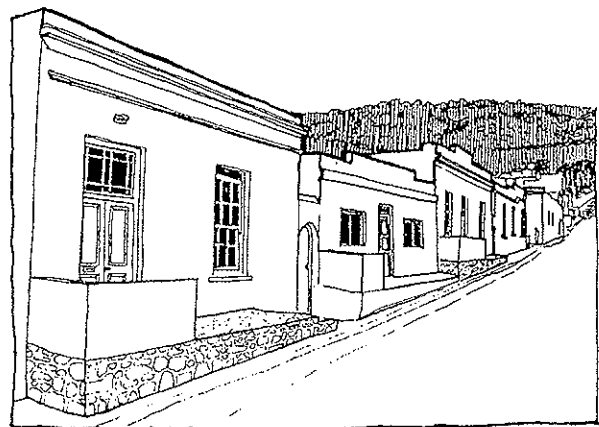
Fig 37. A building which is too low is as disturbing as one which is too high. The horizontal window proportions make the building look even more squat.

The height of a new building should not vary too greatly from that of its neighbours, and should generally not be greater than two storeys on the side facing the street. If the new building is part of a pre-existing group, dominant features in the facade such as the lintel height, parapet and cornice, or roof ridge and guttering should be lined up with those of adjacent buildings. If the site is on a sloping street, follow the regular way that these features step down the slope. (See also Facade Proportions, below)

Facade proportions: The proportions of the building as a whole should be similar to buildings in the vicinity. Because the floor to ceiling height in modern buildings is usually less than in old buildings, unless care is taken a new building frequently looks low and squat in relation to its historical neighbours. Particular attention should be paid to the height of the eaves or cornice above the openings, the size of the cornice and the height of the parapet in relation to the rest of the facade. By manipulating elements such as these it is usually possible to correct the proportions of the facade, even if ceiling heights are low.

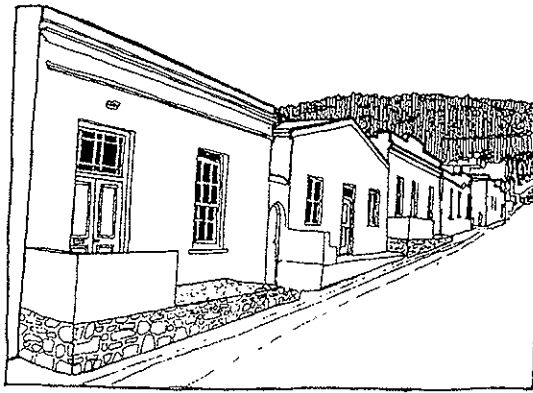
Fig 38. The angled silhouette of a gable in a row of parapets is inappropriate.

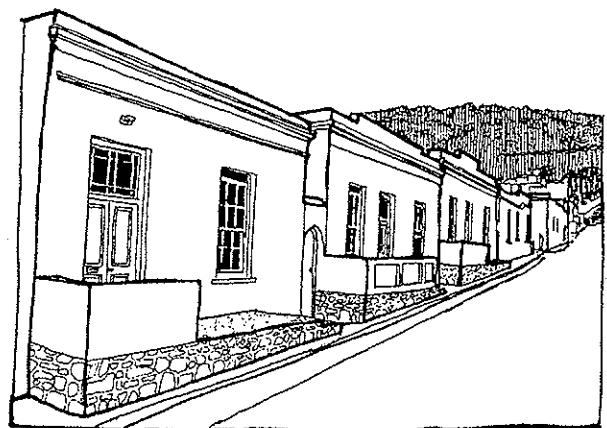
Fig 39. The repetition of narrow facades with elements such as cornices, tall openings and stoeps establishes a regular rhythm in the streetscape.
