ENVIRONMENTAL MANAGEMENT PLAN

**Improvement of National Route 2 Section 18
Between Sitebe Komkhulu and Viedgesville
Eastern Cape:
Associated Borrow Pits**

**The South African National Roads Agency Limited
(SANRAL)**

Report Number: 2010-R386
August 02, 2010

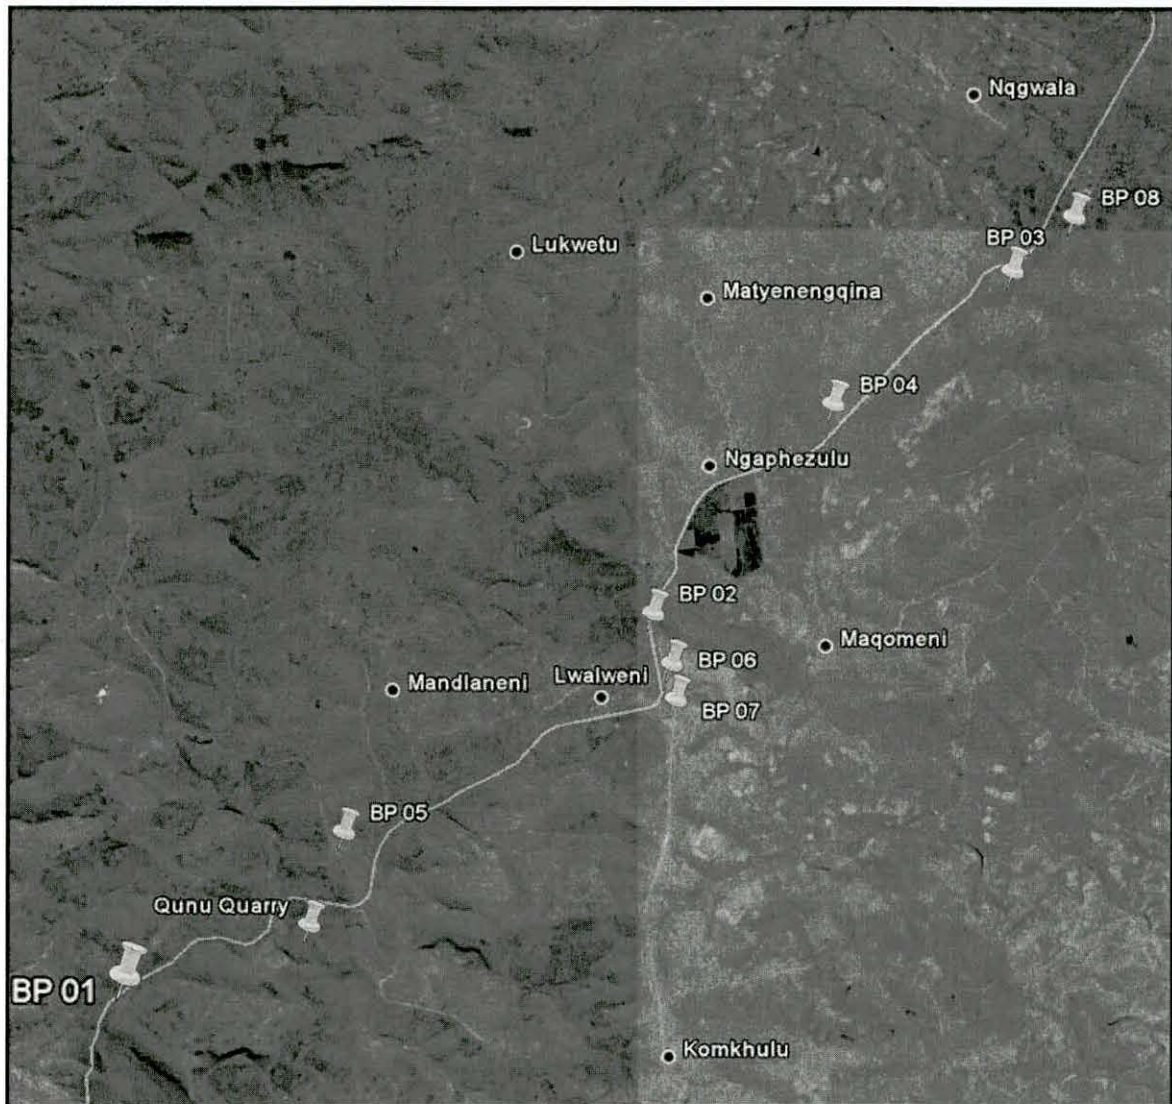
Figure 1: Aerial View - Borrow Pits & Quarry Site locations.

It is proposed that material sources required for the project will be sourced from eight (8) borrow pits located throughout the area (**Figure 1**).

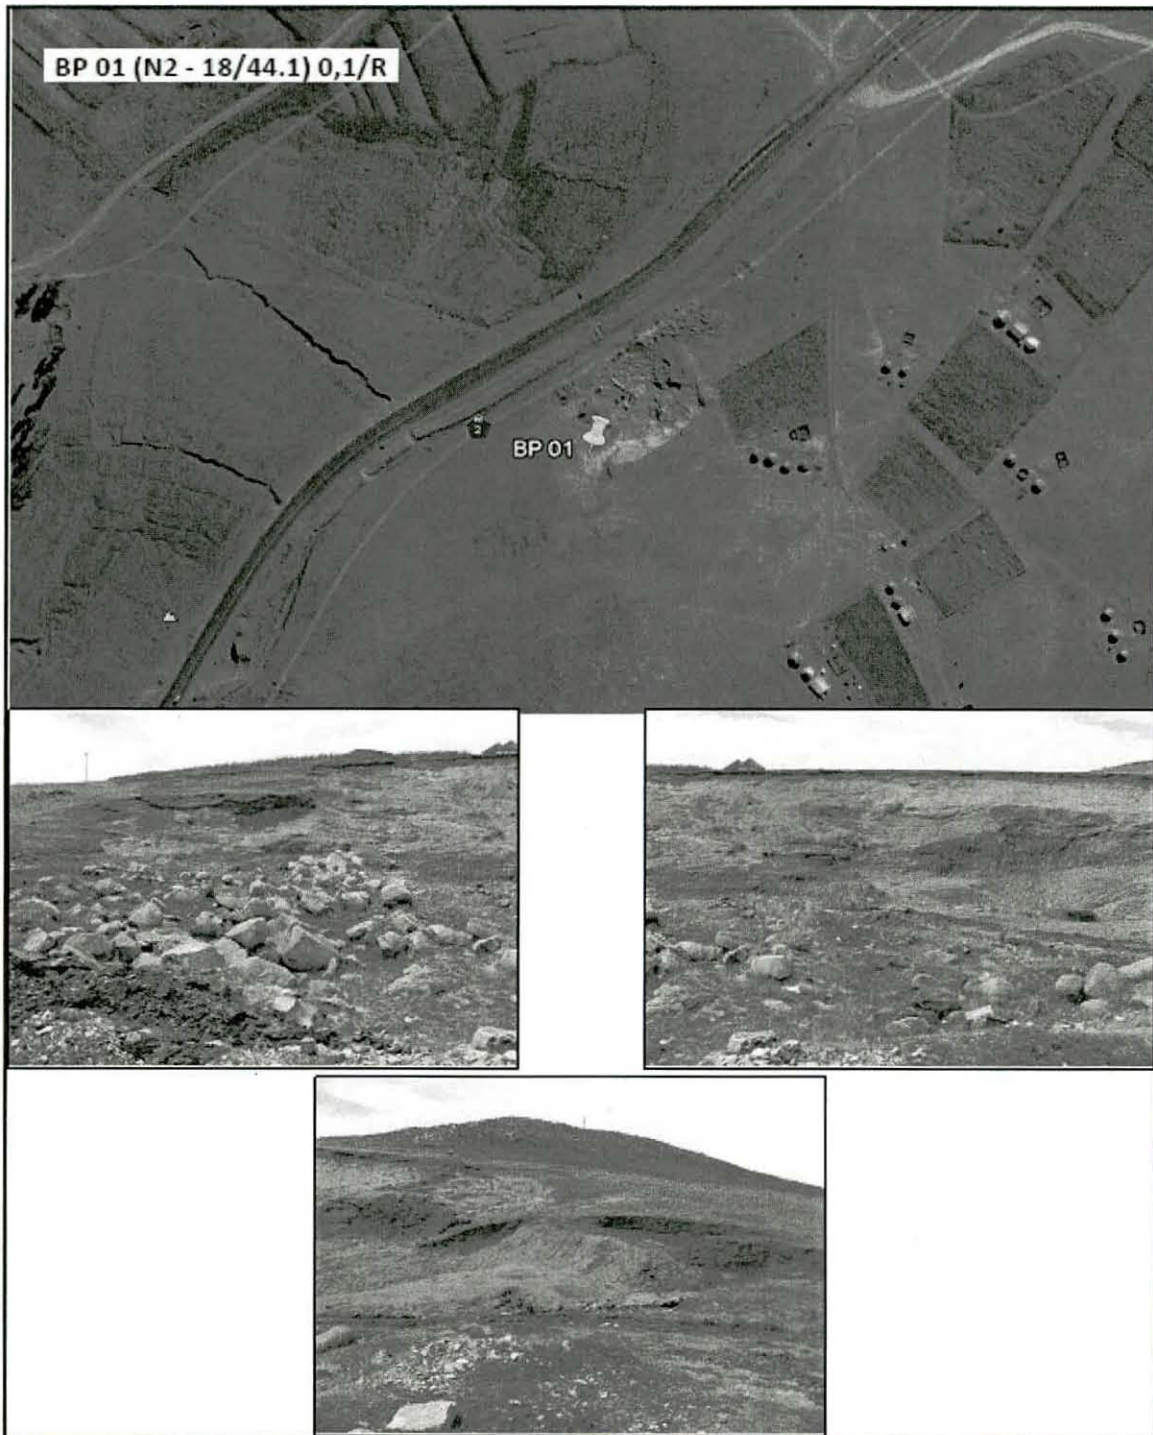
Figure 4: Borrow Pit 01.

Borrow Pit 1 is an existing borrow pit which has been used extensively in the past as a source for road building material (most probably for the local municipality and the provincial Department of Roads & Transport). It is located on the side of a relatively steep north-west facing slope adjacent to the N2 and is access from the Sitebe Komkhulu turnoff road. The mining plan is attached under **Appendix A**.

- Mining may commence by full face removal of material from the southwest face of the existing pit and extending the excavation in that direction.
- The un-mined dolerite has an overburden, including topsoil (0.5m thick) with a thickness of about 1.5m.
- The approximate volume from this pit is approximately 180 000m³. It has been assumed for the calculations of these volumes that no large core-stone/in-situ boulders will be encountered.
- The final extent of mining should be determined by the volume of material required at any one time.
- Mining should take place by advancing from the existing face towards the proposed limit of mining.

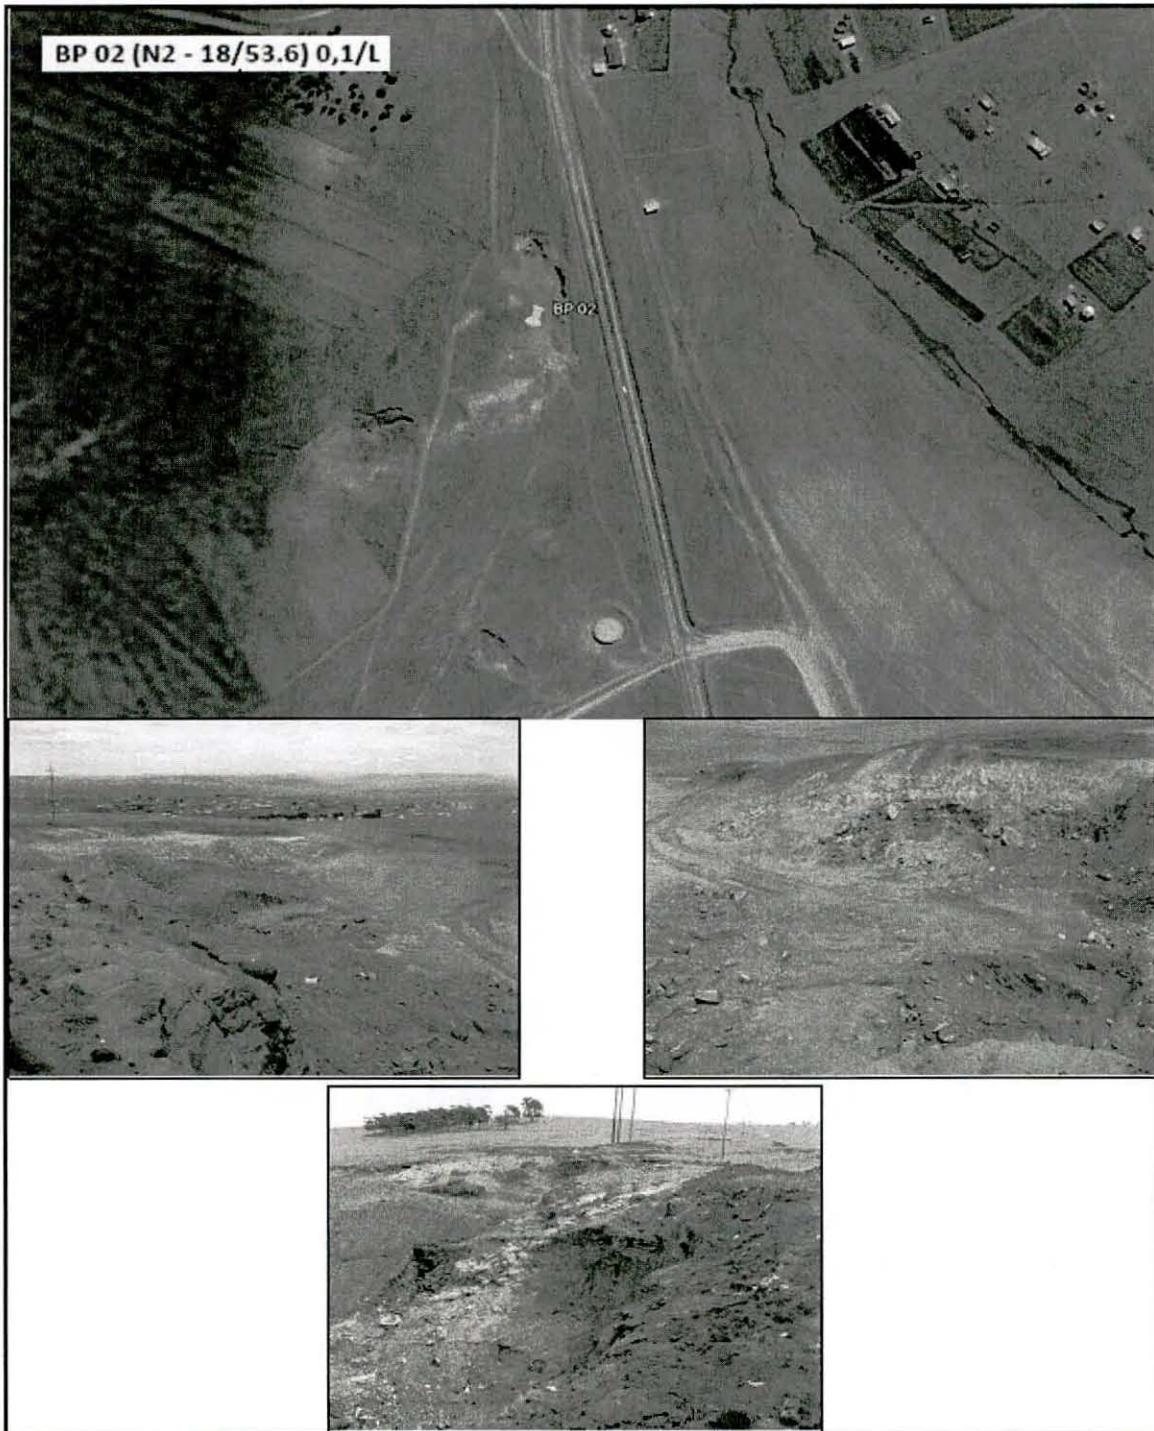
Figure 5: Borrow Pit 02.

Borrow Pit 2 is an existing borrow pit which has been used extensively in the past as a source for road building material. It is located on gently sloping landscape adjacent to the N2 and consists of a series of deep excavations and near vertical slopes on the road side. The site is accessed by a side road leading off the access road toward Lalweni village. There is an Eskom power line which passed over the borrow pit, and it might be necessary to realign a section of the Eskom powerline in order to avoid damage during the construction phase. The mining plan is attached under **Appendix A**.

- Mining may commence by removing material from the dolerite occurrence, and then the sandstone could be exploited in a series of layers, each about 5m thick.
- The dolerite has no overburden. The sandstone resource has an overburden of topsoil with a thickness of about 0.2m.
- The approximate volume from this pit is approximately 36 000m³. It has been assumed for the calculations of these volumes that no large core-stone/in-situ boulders will be encountered.
- The extent of final mining should be determined by the volume of material required at any one time.

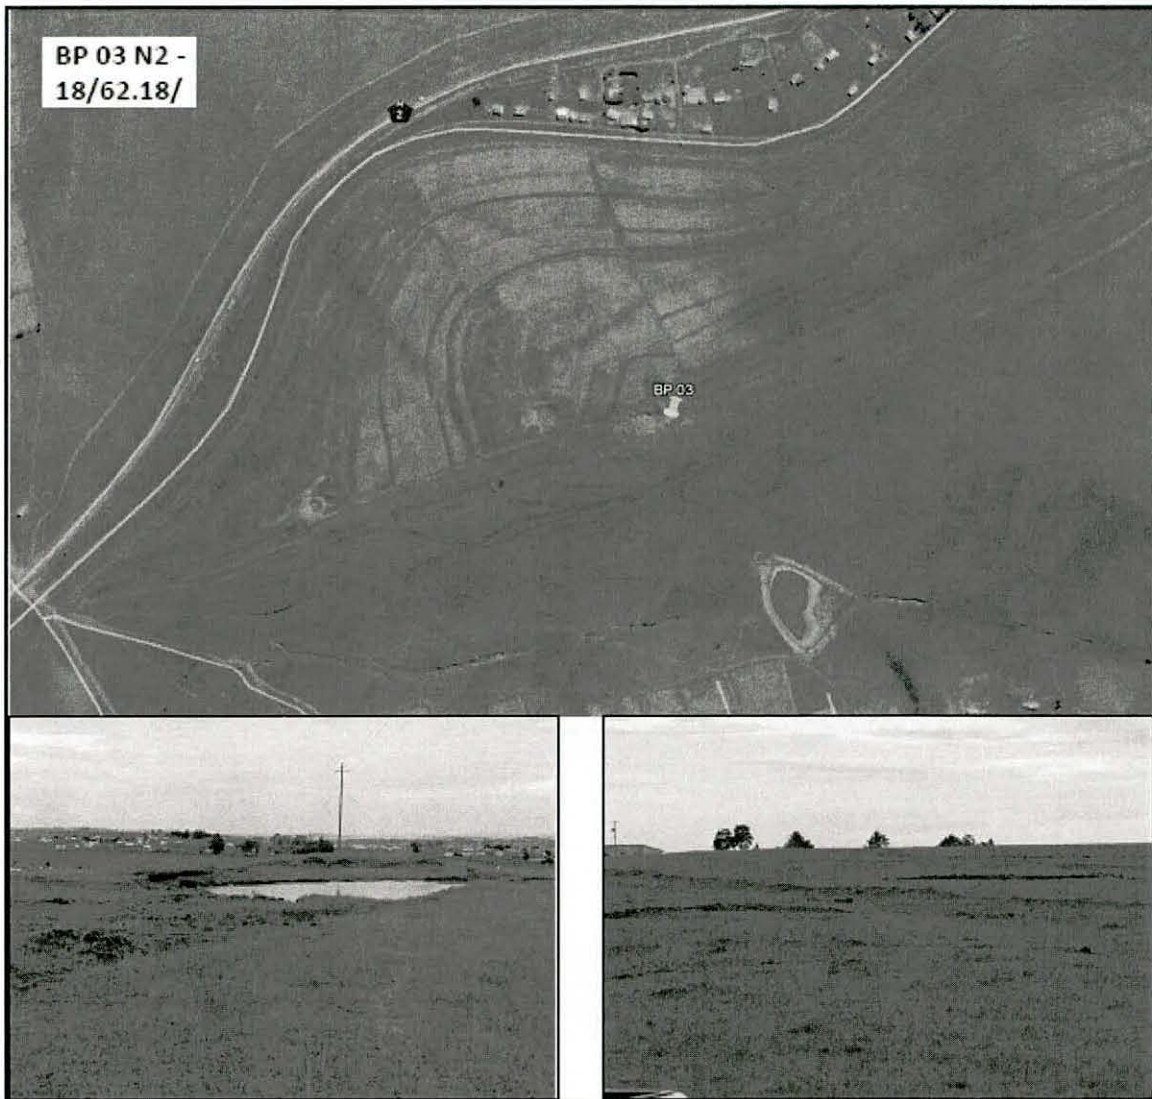
Figure 6: Borrow Pit 03.

Borrow Pit 3 is an existing borrow pit which has been used to small extent in the past as a source for road building material. It is located on a relatively flat landscape adjacent to a previously cultivated field. The site is accessed via the access road leading off the N2 towards the Kotishini village. There is a low capacity Eskom power line which passed over the borrow pit, and it might be necessary to realign a section of the Eskom powerline in order to avoid damage during the construction phase. The mining plan is attached under **Appendix A**.

The material to be mined is weathered dolerite of Karoo Age, which occurs at this site in the form of a dyke with an approximate 60m width and an unknown, but limited depth with lateral limitations. The resource materials lie beneath an overburden that is about 1.5m thick, of which the upper 0.5m to 0.7m is topsoil.

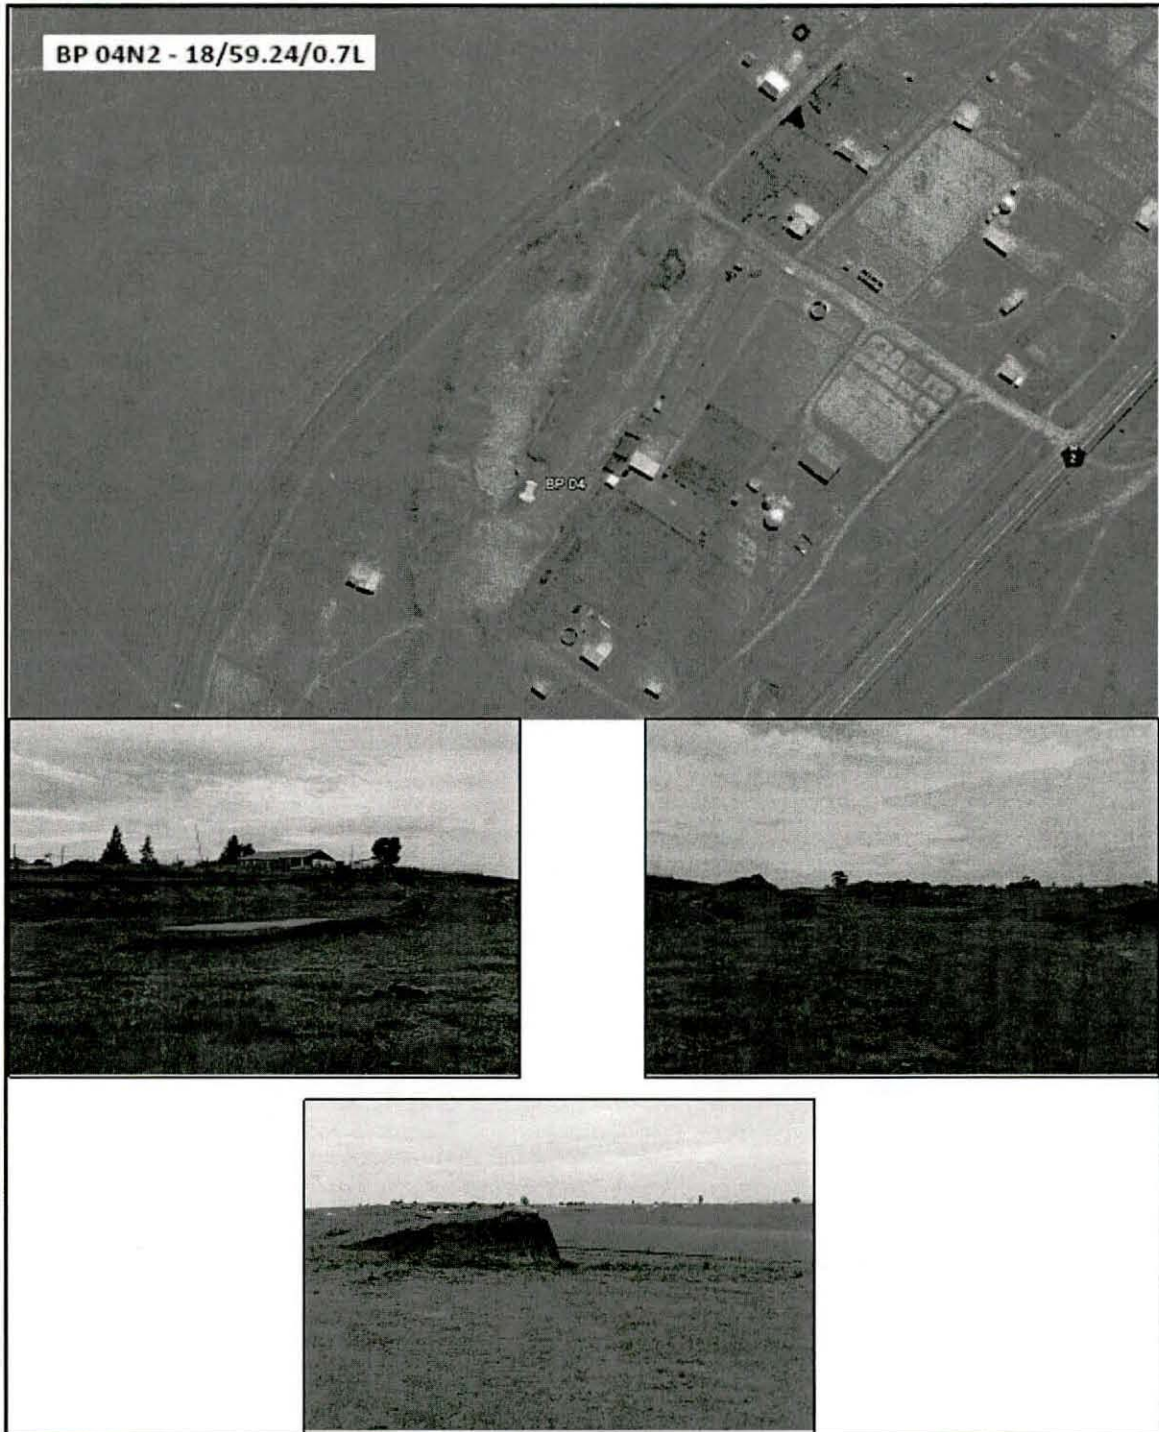
Figure 7: Borrow Pit 04.

Borrow Pit 4 is an existing borrow pit which has been used to extensively in the past as a source for road building material. It is located on a relatively flat landscape adjacent to existing residential houses. Although the borrow pit is located in close proximity to houses, it will not be necessary to relocate any of the households. The site is accessed via the access road leading off the N2 towards the Mareko village. The train tracks leading from Mthatha to Idutywa is located adjacent to the borrow pit area. The mining plan is attached under **Appendix A**.

The material to be mined is highly weathered dolerite of Karoo Age. The dolerite is in the form of a sill, with lateral mining limitations, and has already been exploited. It lies largely exposed because nearly all of the overburden has been removed.

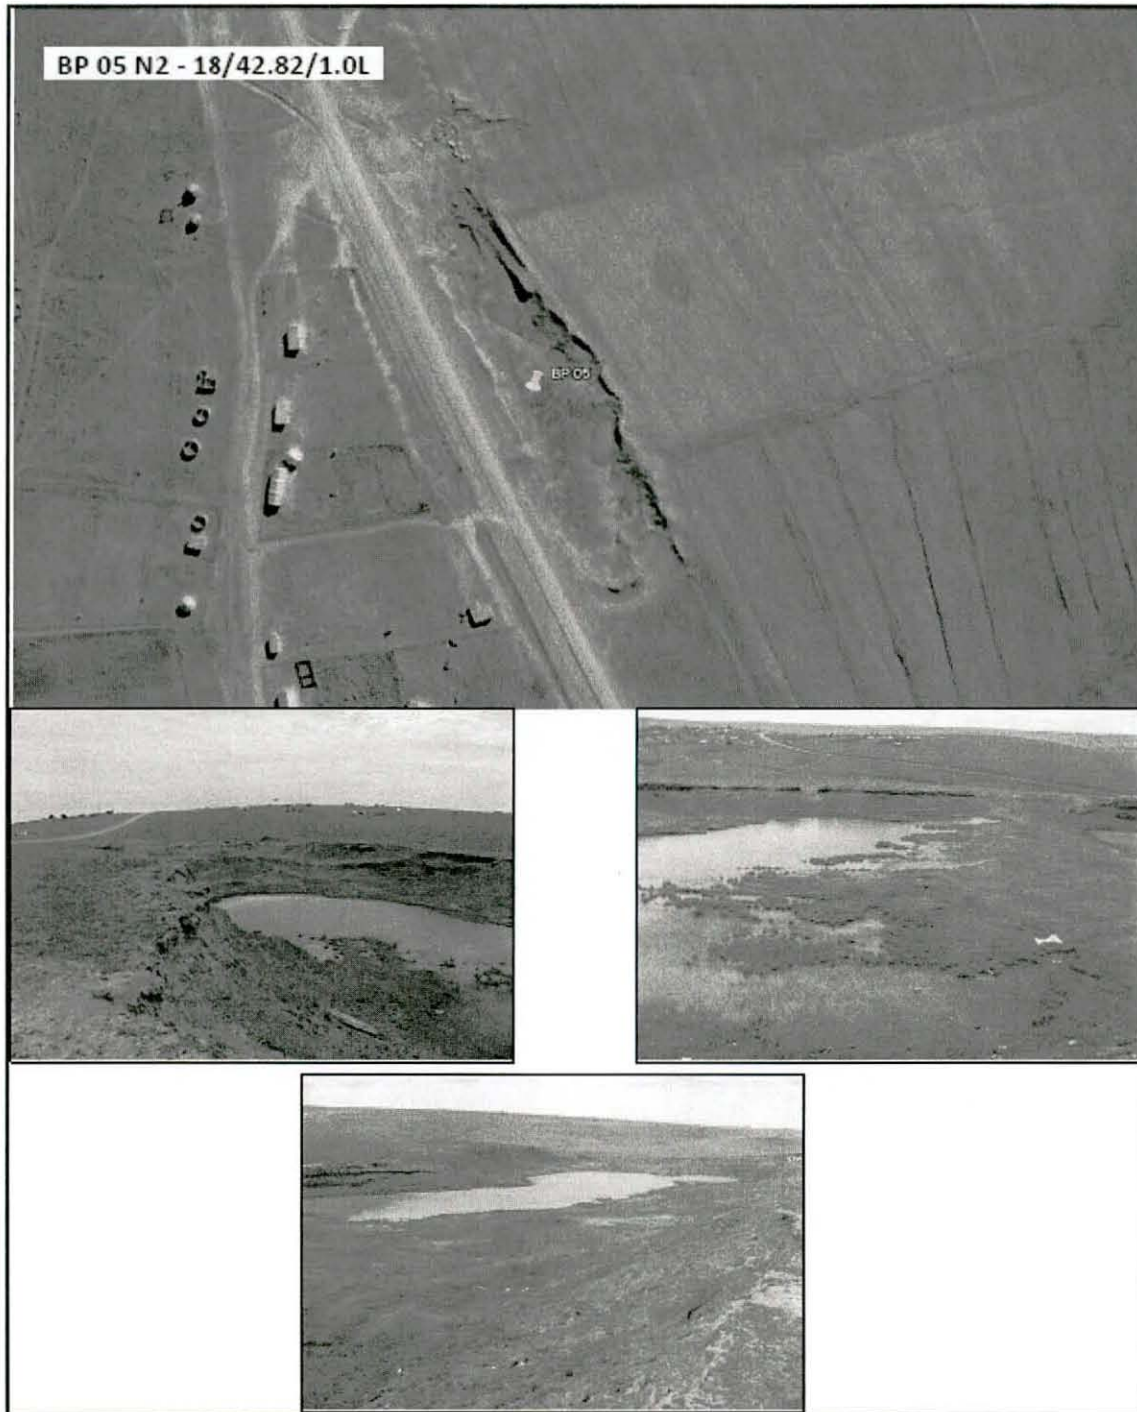
Figure 8: Borrow Pit 05.

Borrow Pit 5 is an existing borrow pit which has been used extensively in the past as a source for road building material (most probably for the local municipality and the provincial Department of Roads & Transport). It is located on the side of a relatively steep north-east facing slope adjacent to the N2 and in close proximity of some residential houses of the Ngqunge village. Although the borrow pit is located in close proximity to houses, it will not be necessary to relocate any of the households. Some ponding of water has developed at the base of the borrow pit which are used by the local populace for washing clothes and watering of stock. The borrow pit is accessed from the Bityi village turnoff road leading off the N2. The mining plan is attached under **Appendix A**.

The material to be mined is weathered mudstone and sandstone of the Beaufort Group, which occurs at this site with lateral limitations. It lies partially exposed because nearly all overburden has been removed. The resource materials are partly exposed by mining and partly covered by topsoil and overburden stockpiles up to about 1.5m deep. Unlearned topsoil is about 0.2m thick.

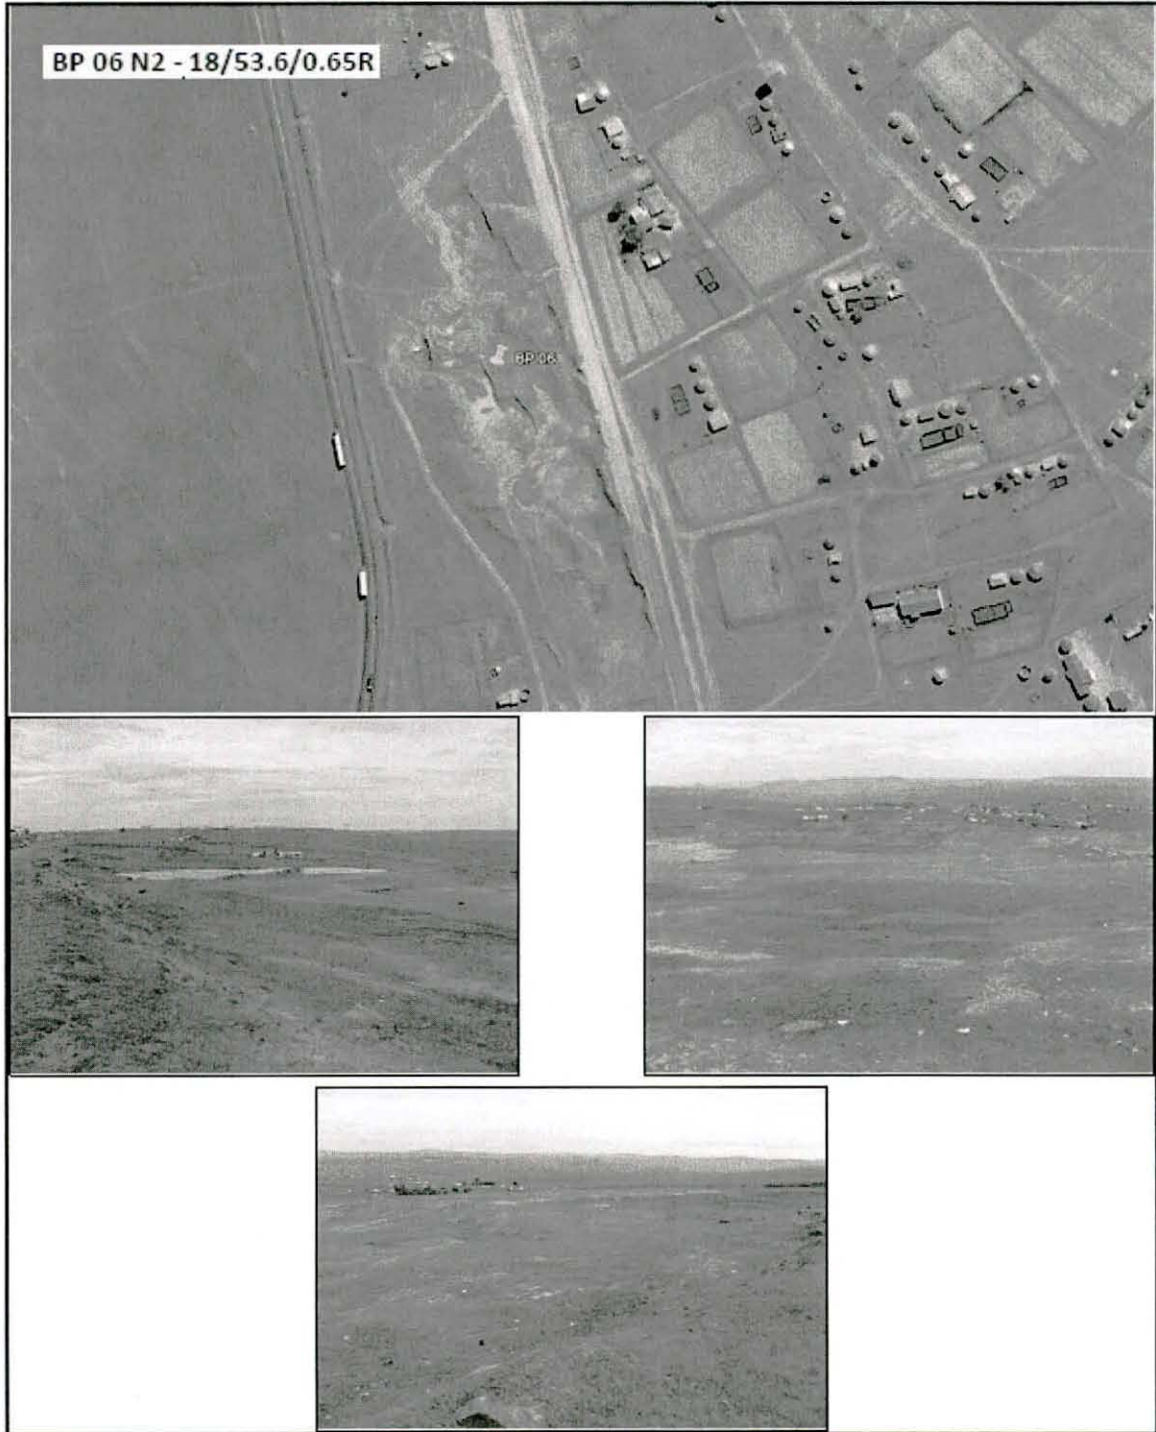
Figure 9: Borrow Pit 06.

Borrow Pit 6 is an existing borrow pit which has been used extensively in the past as a source for road building material. It is located on the side of a moderately sloping landscape adjacent to the N2 and in close proximity of some residential houses of the Zinyoka village. Although the borrow pit is located in close proximity to houses, it will not be necessary to relocate any of the households. One small area of ponding has developed at the southern base of the borrow pit which is used by the local residents for washing clothes and watering of stock. The borrow pit is accessed from the Bityi village turnoff road leading off the N2. The mining plan is attached under **Appendix A**.

The material to be mined is weathered mudstone and sandstone of the Beaufort Group, which occurs at this site with lateral limitations. It lies partially exposed because nearly all overburden has been removed. The resource materials are partly exposed by mining and partly covered by topsoil and overburden stockpiles up to about 1.5m deep. Unlearned topsoil is about 0.5m thick.

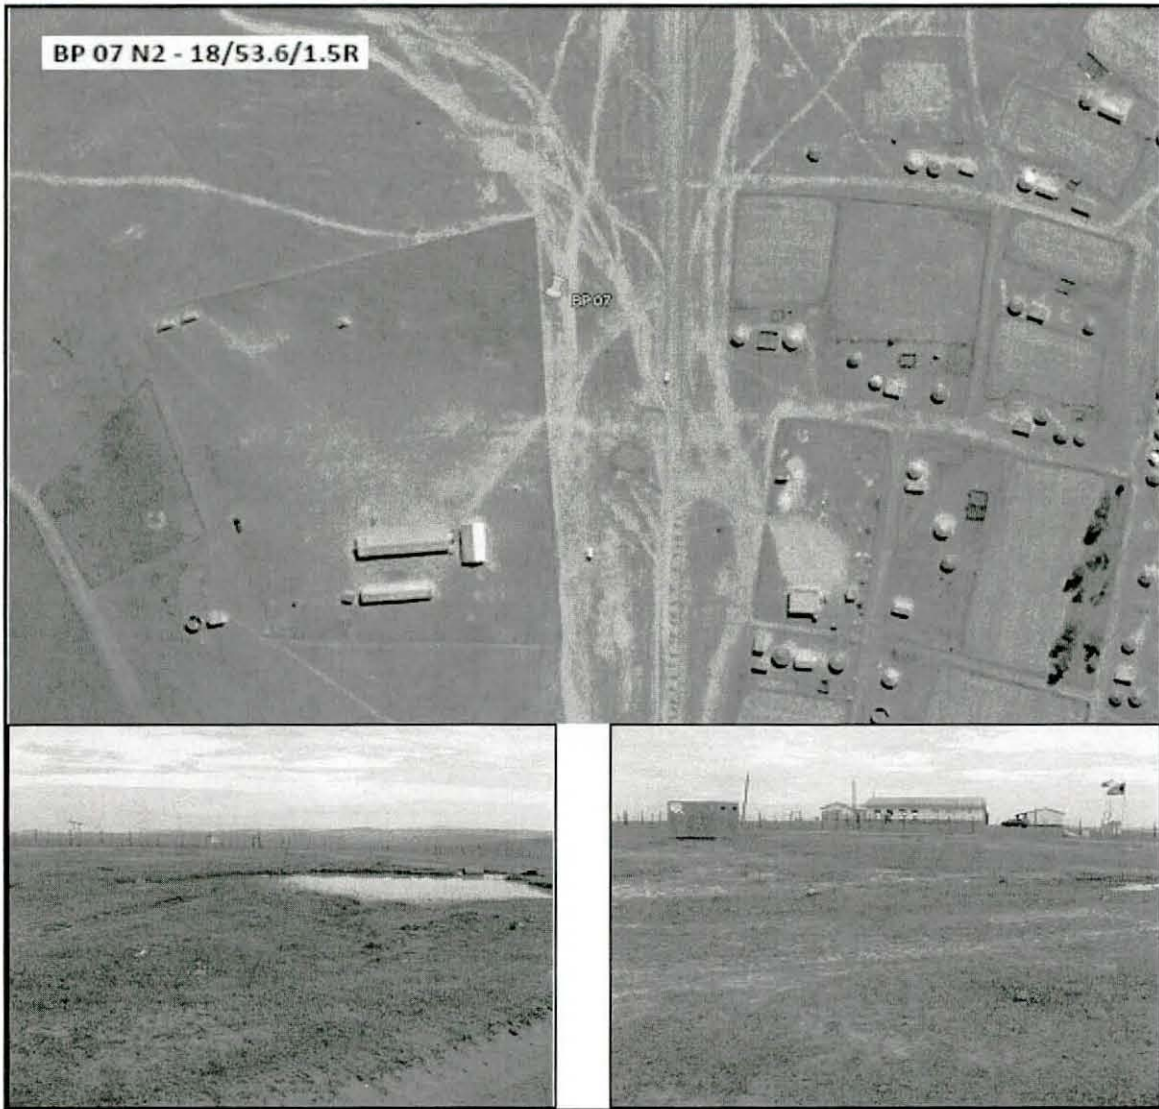
Figure 10: Borrow Pit 07.

Borrow Pit 7 is the only new borrow pit proposed for the improvement of N2: Section 18. It is therefore a "greenfields site", however the area has been severely degraded by footpaths and tracks formed by the people and livestock, which has led to minimal vegetation cover. The borrow pit is located on a flat landscape adjacent to some residential houses of the Kuse Mnkalana village and the school. Although the borrow pit is located in close proximity to the houses and school, it will not be necessary to relocate any of the households or the school. The borrow pit is accessed via the road leading to the KuNkalana village which is accessed off the N2 approximately 1.2km north of the site. The mining plan is attached under **Appendix A**

The material to be mined is weathered sandstone of the Beaufort Group, which occurs at this site with lateral limitations. The resource material is covered by a topsoil layer of about 0.2m thick.
