DRAFT ENVIRONMENTAL SCOPING REPORT

**PROPOSED REHABILITATION OF THE PIT ON PORTION 15 OF THE
FARM JAGERSFONTEIN 14 BY INFILLING OF FINE AND COARSE
TAILINGS AND SAND FROM THE DIAMOND EXTRACTION PROCESSING
PLANT, FAURESMITH RD, FREE STATE**

April 2018

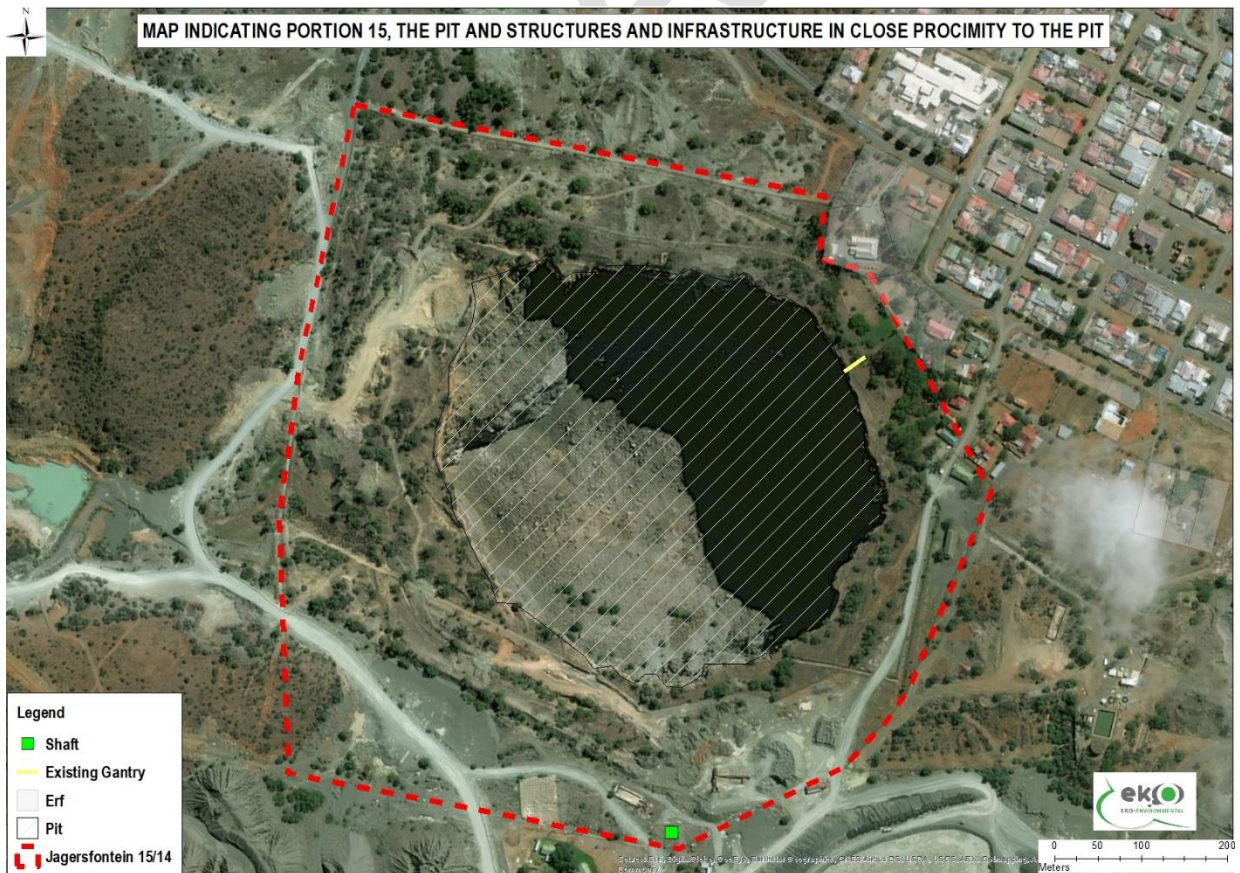
Figure 1: Map indicating the locality of the existing gantry and shaft in relation to the Pit and Portion 15
