NKANGALA DISTRICT MUNICIPALITY

***RAISING OF DULLSTROOM DORP SE DAM
PRELIMINARY DESIGN REPORT***

FEBRUARY 2014

SCIP ENGINEERING
GROUP

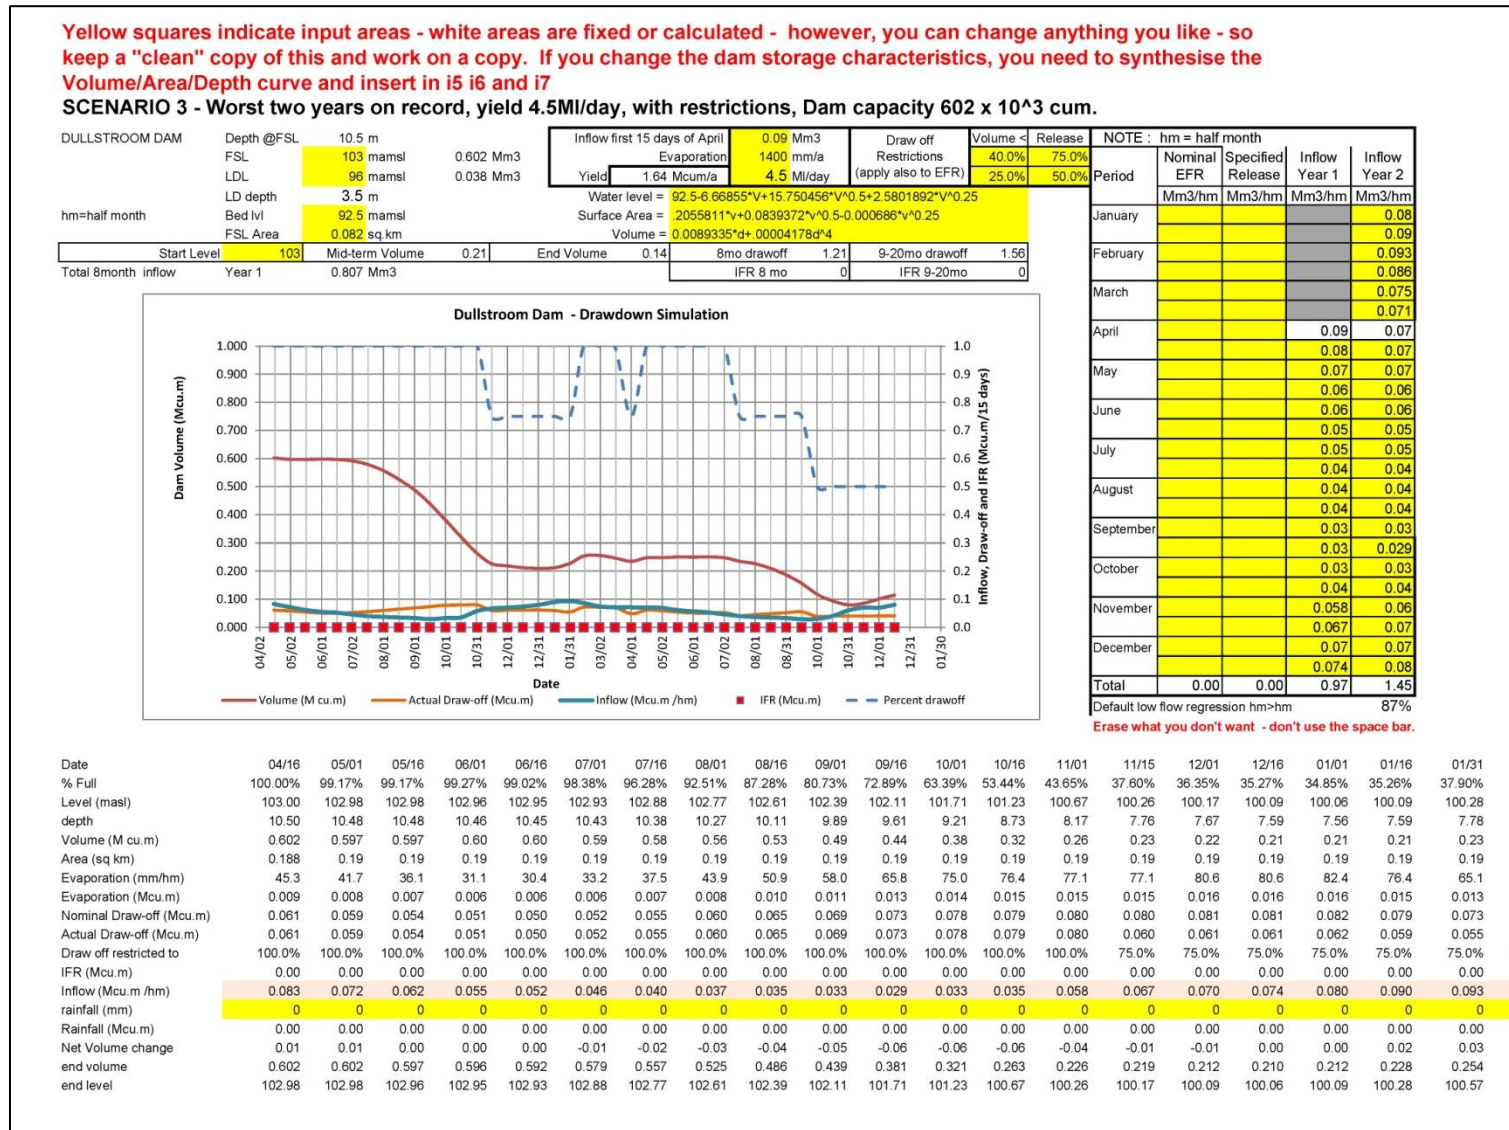
Figure 4-8 : Simple Dam Yield Model (spreadsheet – excludes part of model period) –

Original streamflow data have been patched

The raised dam volume is approximately 15.7% of the estimated MAR, which is unusually small. The conventional methods of estimating the safe yield of a dam is to simulate the volume of the dam being drawn down over a number of low-inflow years to augment the received inflow. With such a small dam, in terms of the %MAR, this method is not applicable because the critical period is reduced to the tail end of the natural flow regression, where the volume of the dam is effectively depleted over two or three months.

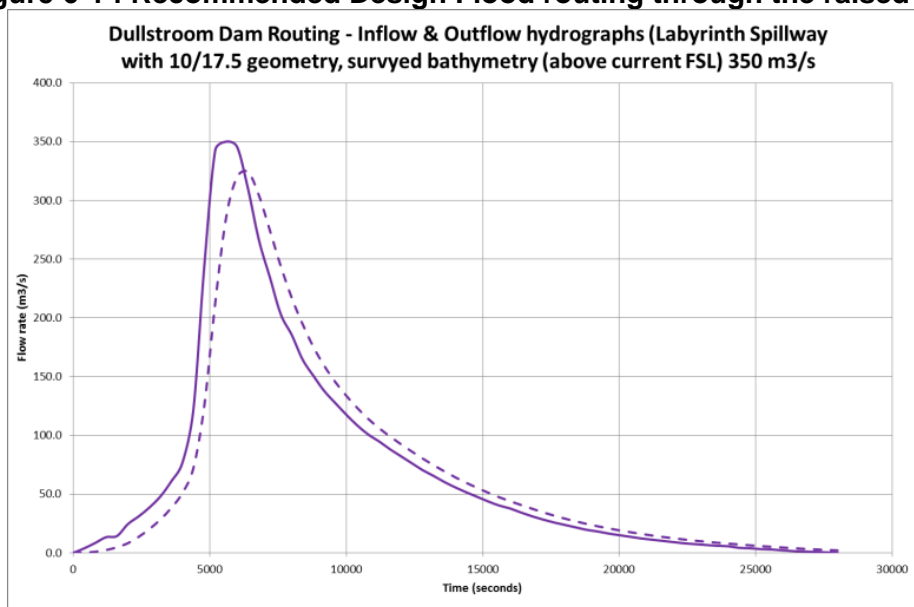
Figure 6-1 : Recommended Design Flood routing through the raised dam.

Flood	Peak Inflow (m ³ /s)	Peak Outflow (m ³ /s)	Water Level Rise (m)	Attenuation (%)
RDF	350	324	1.4	7.3%
SEF	740	690	2.3	6.8%

It is recommended that the un-routed RDF of 350 m³/s is used as Recommended Design Discharge for sizing the spillway and not the routed RDF of 324 m³/s.

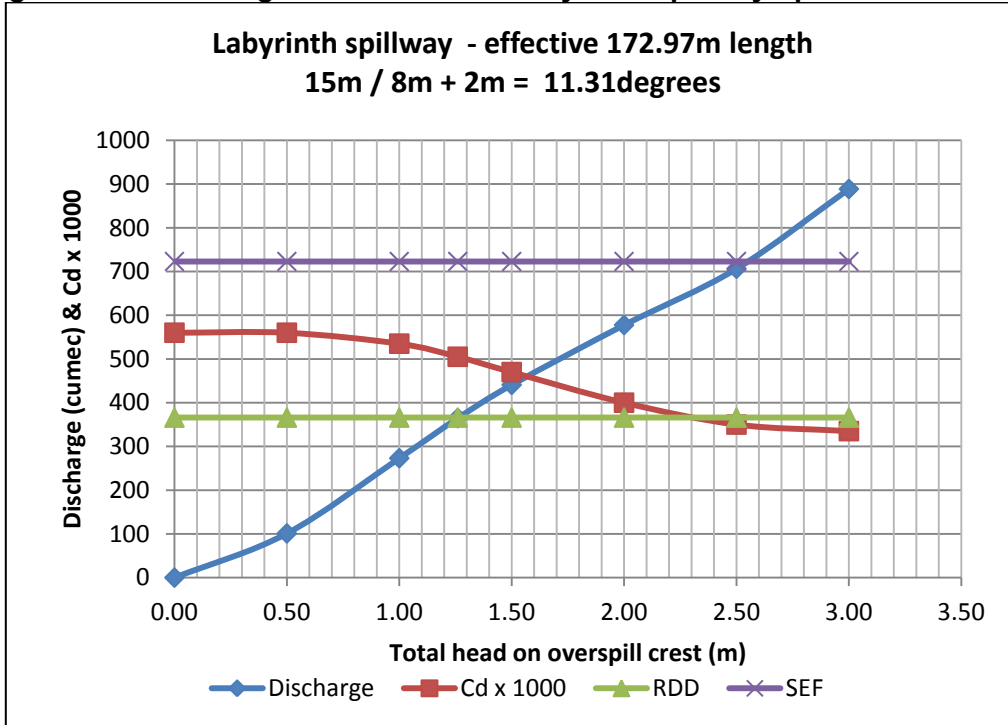
Figure 7-2 : Discharge over 15m wide Labyrinth Spillway option

Discharge coefficients vary with depth and angle of incidence, depth of overflow and width of bay. Calculations for the two options selected showed the following (Table 7-1) as illustrated in Figure 7-2 and Figure 7-3 .

Width	Angle	Effective Length	Overspill Depths	
			RDD	SEF
15.0 m	11.31 ⁰	173.0 m	1.26 m	2.56 m
17.5 m	9.73 ⁰	197.6 m	1.18 m	2.36 m

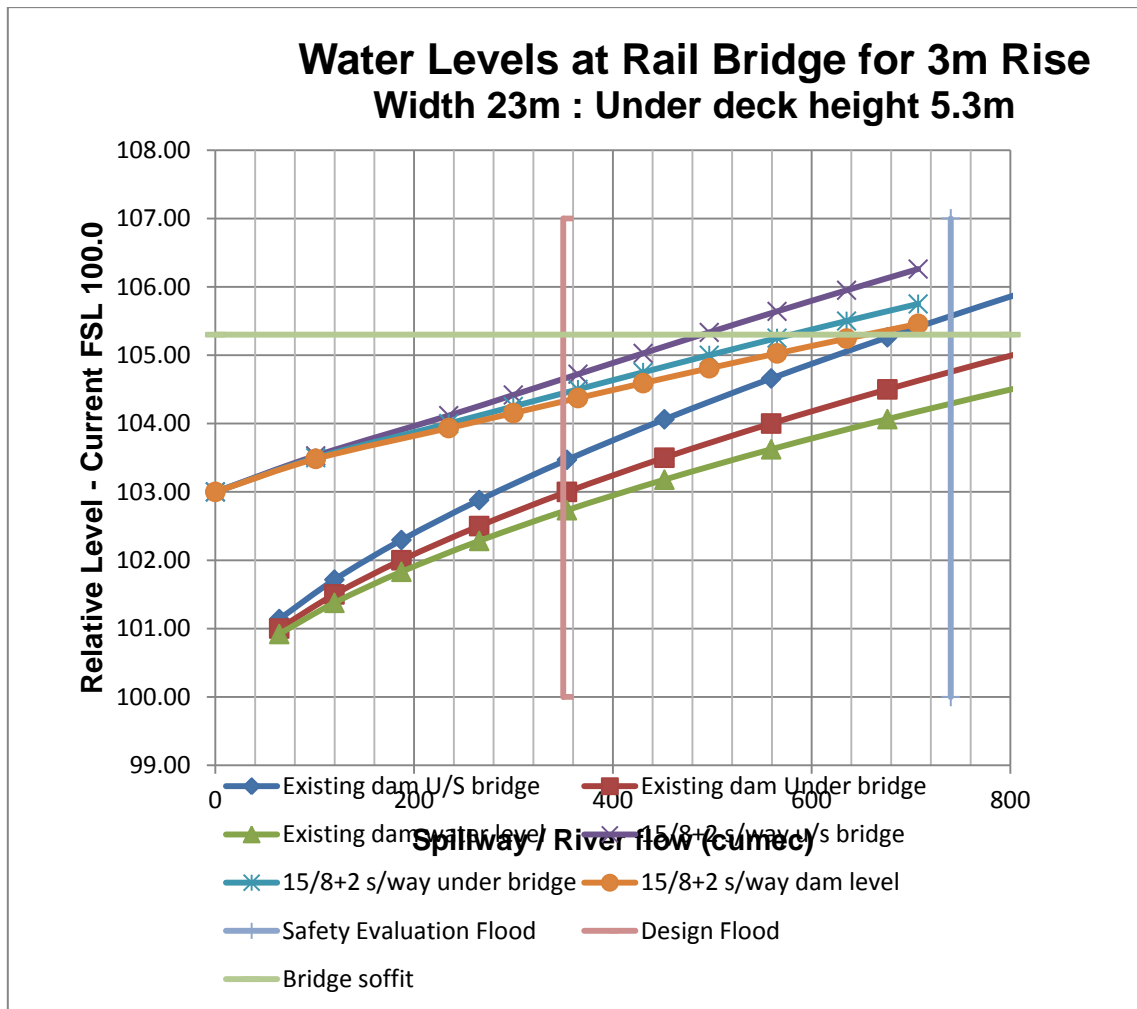
Figure 8-1 : Water Levels under Rail Bridge before and after dam raising

The existing dam reservoir full supply level is the same as the stream low flow level at the bridge, with a very shallow stream flow depth. The effect of dam raising at the railway bridge will therefore be significant, raising the no-flow water level by the proposed 3.0m and creating a backwater under flood flow conditions.

These conditions are illustrated in Figure 8-1, which shows two families of curves illustrating the water levels upstream of the bridge, through the bridge structure, where the water is accelerated and therefore lower than upstream, and the dam water level downstream of the bridge. The design 1:200 flood will be safely accommodated but the safety evaluation flood will be just above the level of the bridge deck underside. The adoption of the 17.5m labyrinth would lower the SEF level by 0.2m. It is not considered necessary to increase the size of the spillway to accommodate the catastrophic flood below the bridge deck.

As would be expected, flow velocities under the bridge are reduced because of the deeper flow. At the estimated 1:200 year flood, the velocity reduces from 5.1m/s to 3.5m/s with the raised dam.

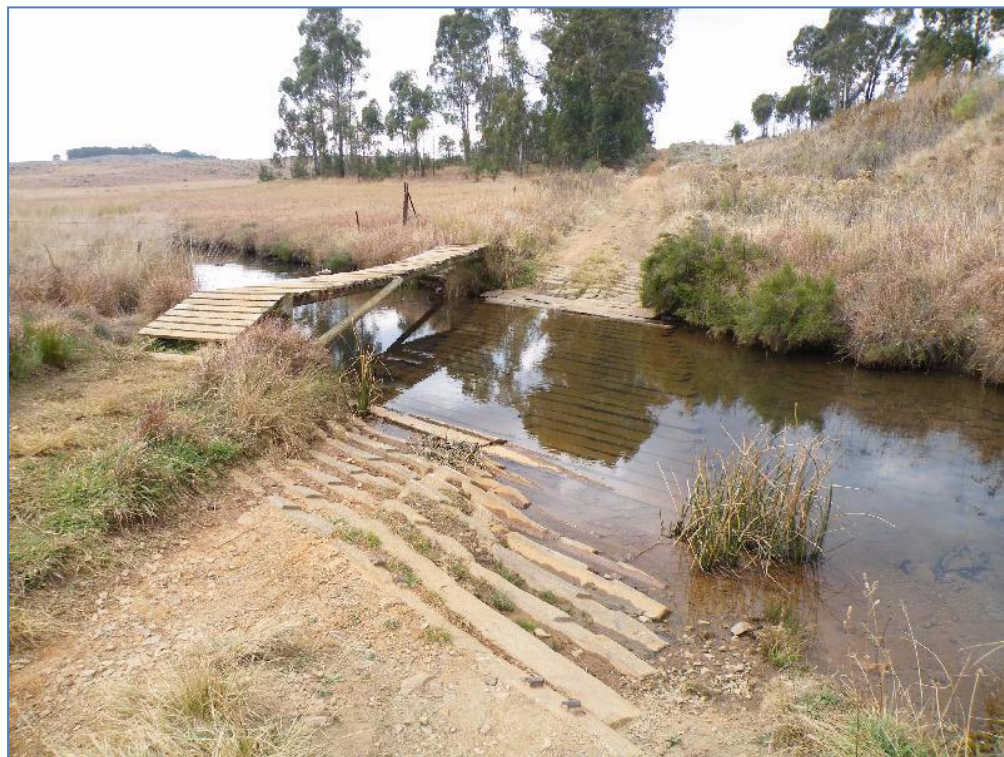
Figure 8-4 : Service road drift and upstream footbridge

The railway service road crosses the watercourse above the rail bridge, through a drift, which is not passable at any significant river flow. There is also a small plank footbridge downstream of the rail crossing.

- A service road bridge will be required with a minimum deck level of 0,5m above final full supply level. This should be upstream of the rail bridge and should be as slender as possible, to minimize impeding flood flows.
- The rail bridge embankment should be thickened up – the side slopes are too steep for permanent inundation and need to be at 2:1 slopes. The embankment should also be armoured for 30m on either side of the bridge aperture in the same way as the dam embankment is protected by riprap.
- The river bed should be cleared of any obstructions, such as large boulders. However, care should be taken not to disturb the bridge abutment footings. The footings should be assessed and – if necessary – additional protection provided against scour.
- Footpaths and styles over fences should be in place to permit a circular walk of the dam reservoir area, as is the case now.

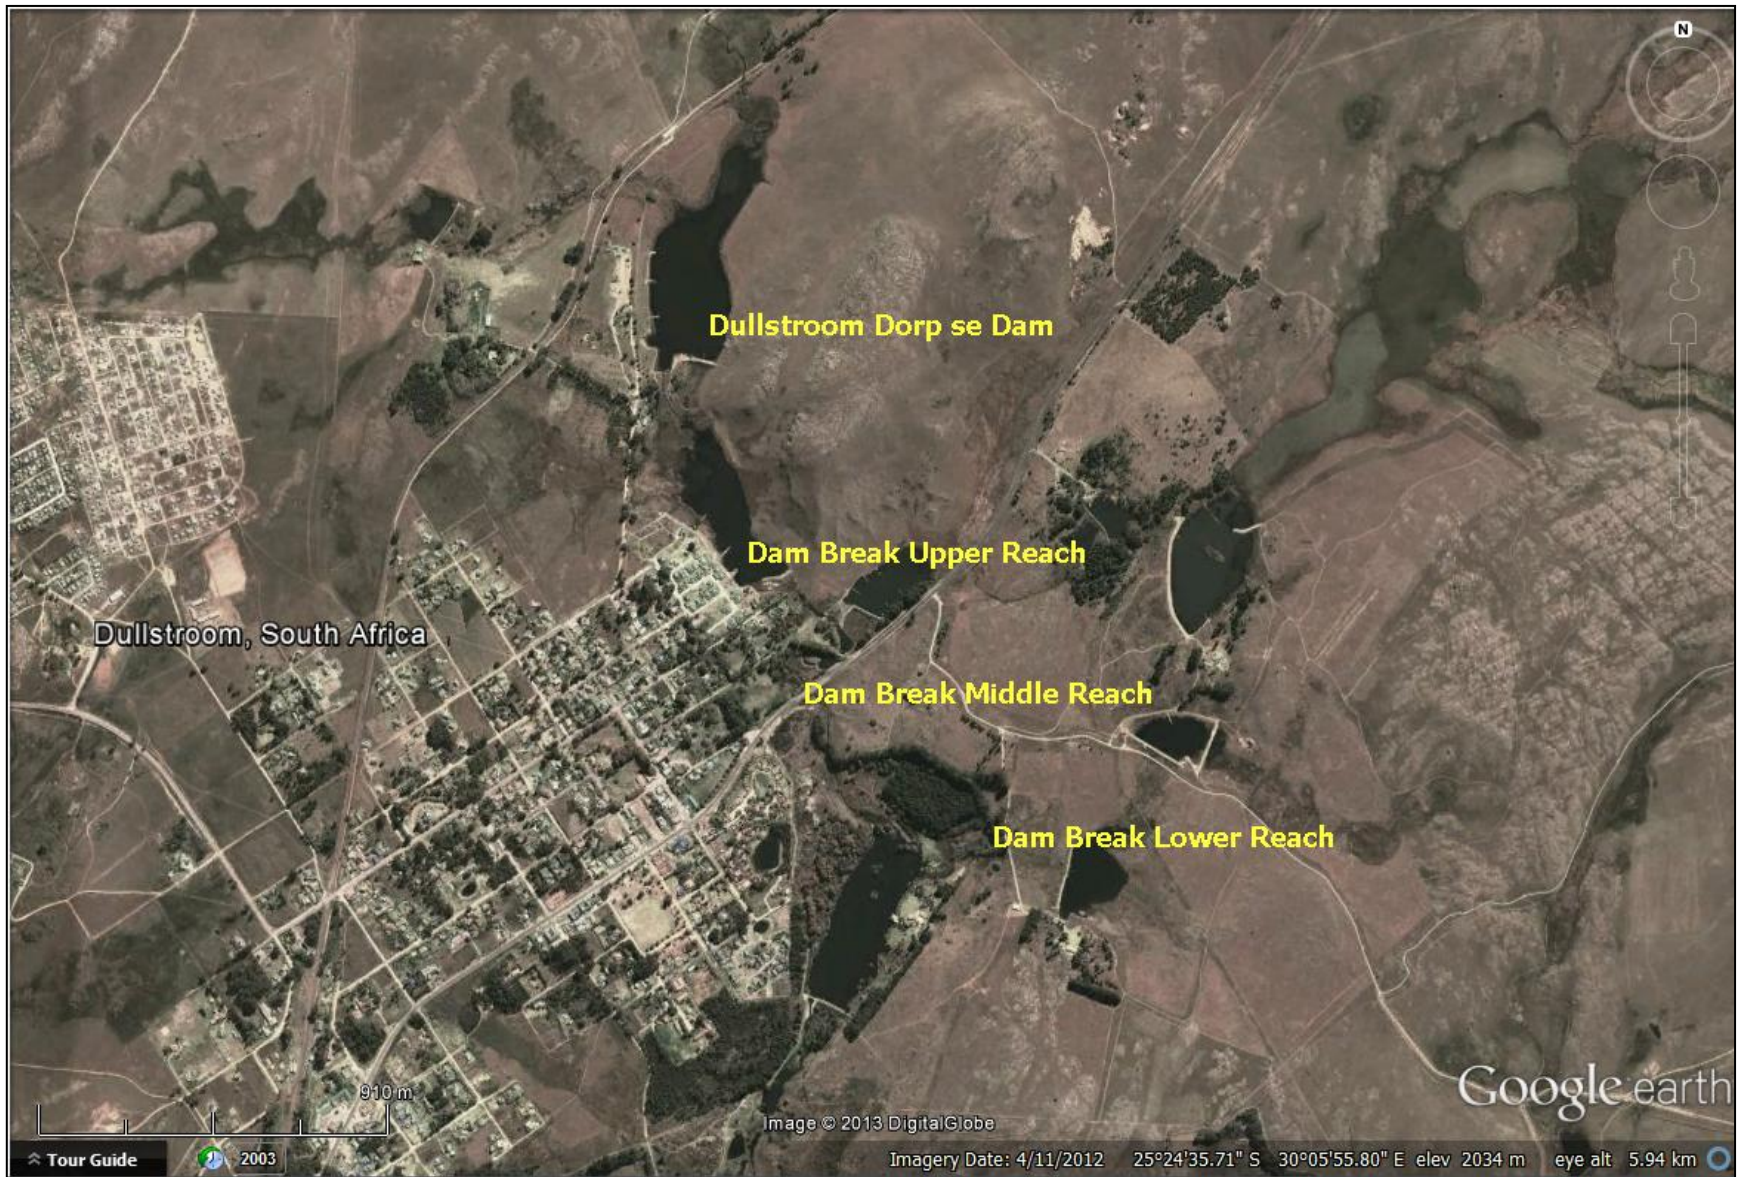
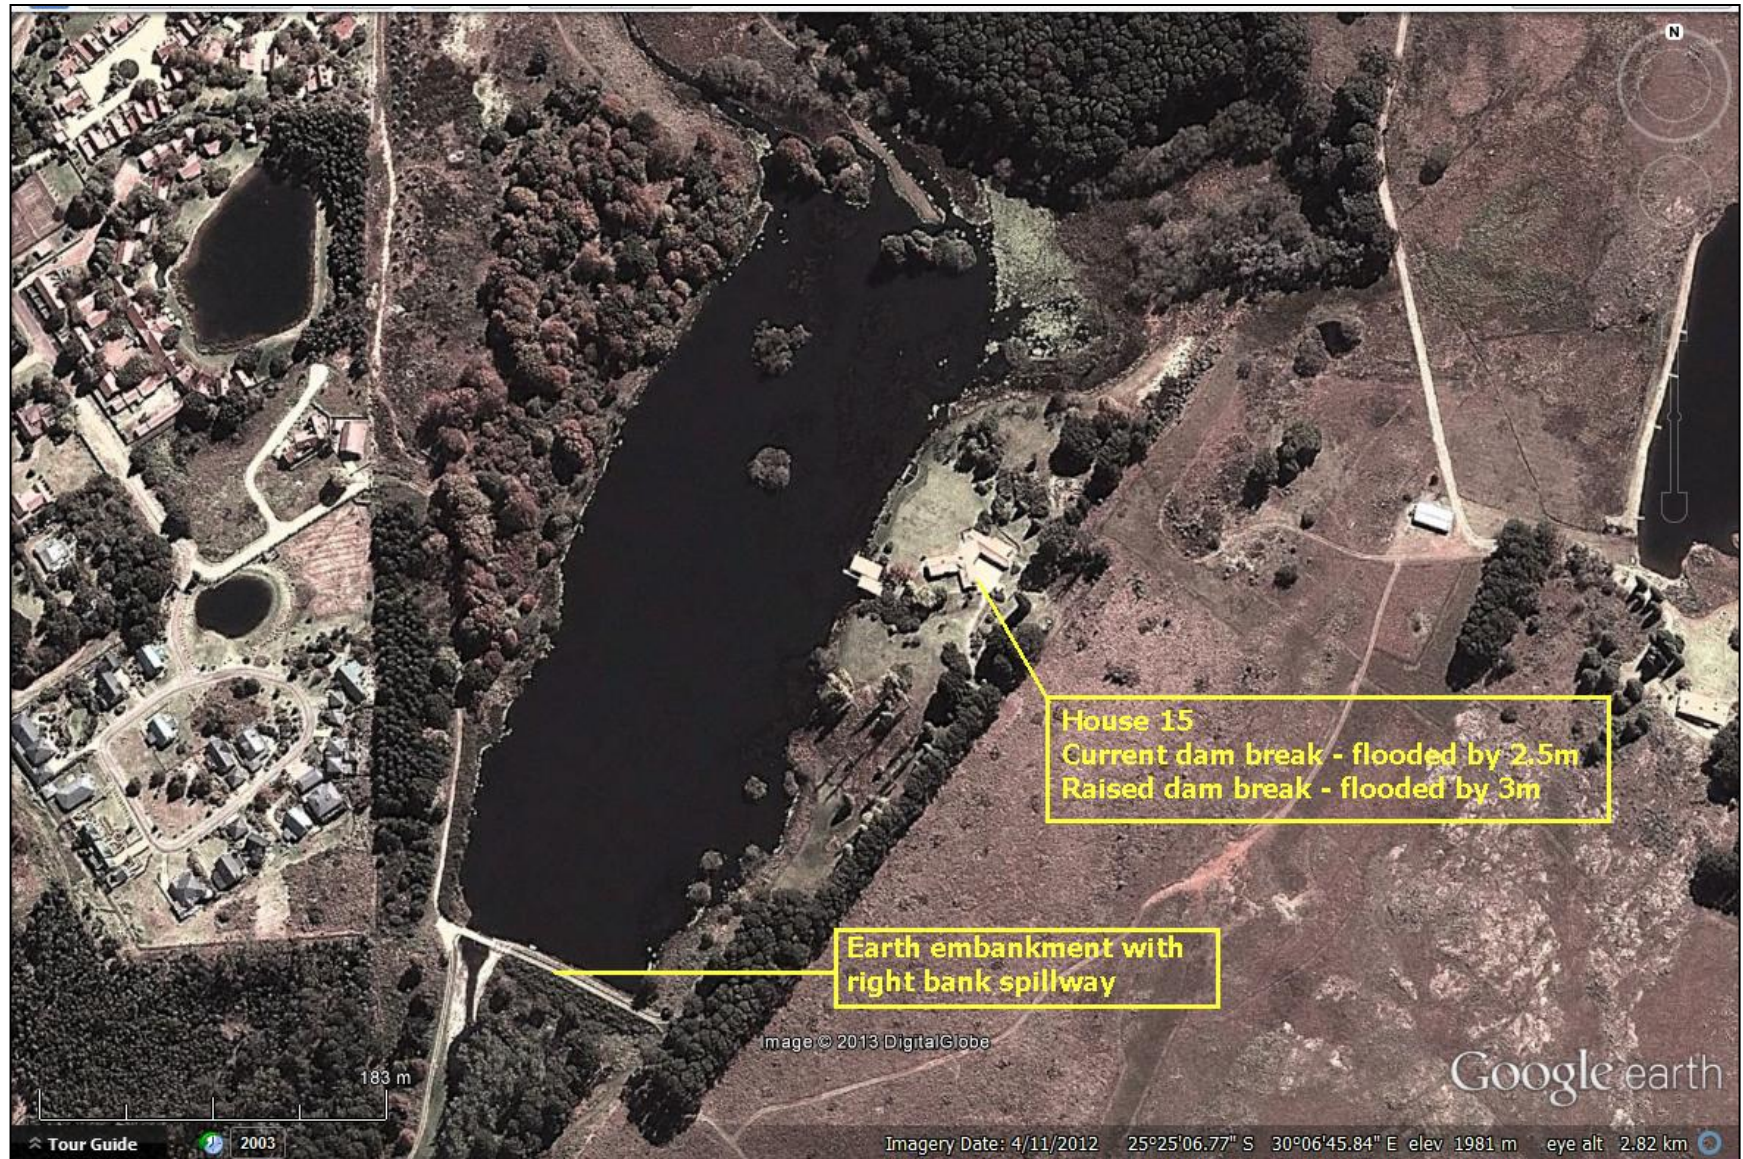
Figure 9-1 through Figure 9-4 indicate the flooding risk indicated in flow depth at specific houses for both scenarios of the existing dam failing and the raised dam failing.

The increase in flow depth at the 4 areas modeled varies from 0.5m to 1m. The increased flooding during the dam break of the raised dam compared to the existing dam is estimated as follows:

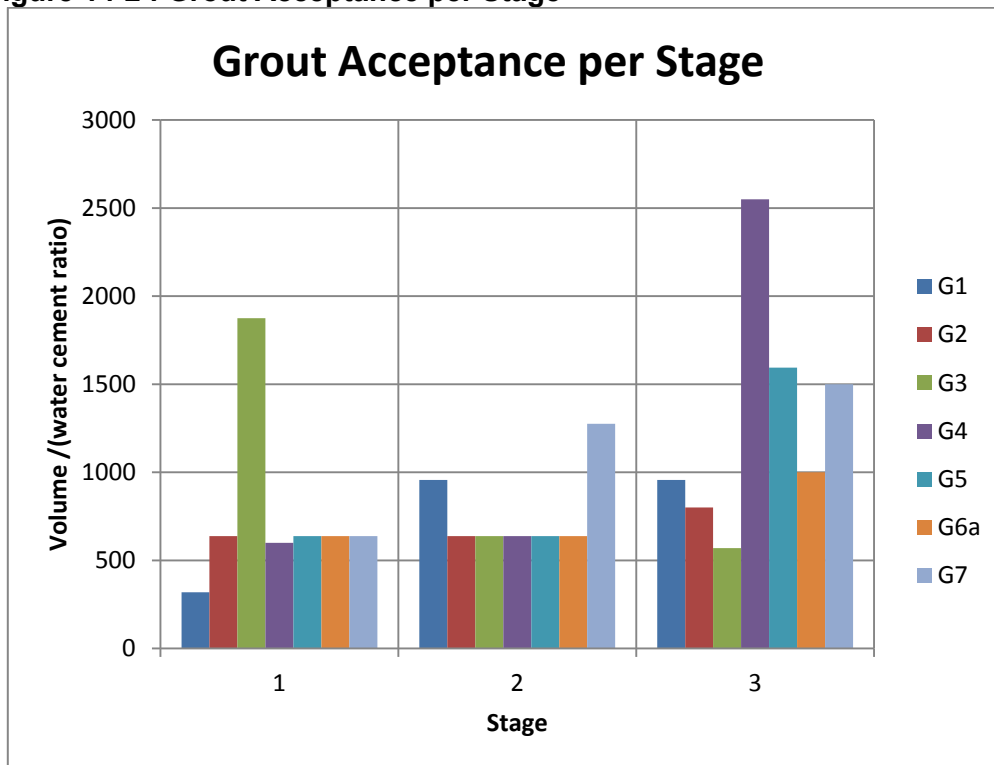
Figure 14-2 : Grout Acceptance per Stage

From Figure 14-2, it can be seen that hole G3 is very pervious in the top 3m, while hole G1 is far less pervious. Hole G4 is extremely pervious at depth and Holes G5 and G7 (originally G6) are also vey pervious at depth.

- the existing dam foundations were probably grouted, as evidenced by lesser grout takes and permeability of holes G1 and G2 and the fact that the area immediately downstream of the embankment shows no seepage.
- The area between the existing dam and the spillway has moderate to high permeability, shown by holes G3 and G4, and as evidenced by the seepage through the right flank of the existing dam.
- The sandstone foundations and flanks will require systematic close spaced grouting.

- The right flank and spillway area, although apparently in deep clays situated along a fault zone between the quartzitic sandstones to the east and shales to the west, has high potential for grout take and therefore high seepage flows. This must be associated with piping developed over time from the existing dam. This area will require a deep cut-off and close spaced grouting to ensure that there are no pipe seepage zones.
- The squeezing nature of the ground indicates low foundation strength under saturated conditions, which will require special consideration during design and construction stages.
