FINAL BASIC ASSESSMENT REPORT FOR:

BASIC ASSESSMENT FOR THE EXISTING PERSBERG DAM WALL ON PERSBERG FARM (PORTION LINDE NO 4733) SITUATED IN THE HELPMEKAAR AREA, LOCATED WITHIN THE MSINGA LOCAL MUNICIPALITY AND THE UMZINYATHI DISTRICT MUNICIPALITY, KWAZULU-NATAL

EA Reference Number: DC24/0002/2019: KZN/EIA/0001069/2019

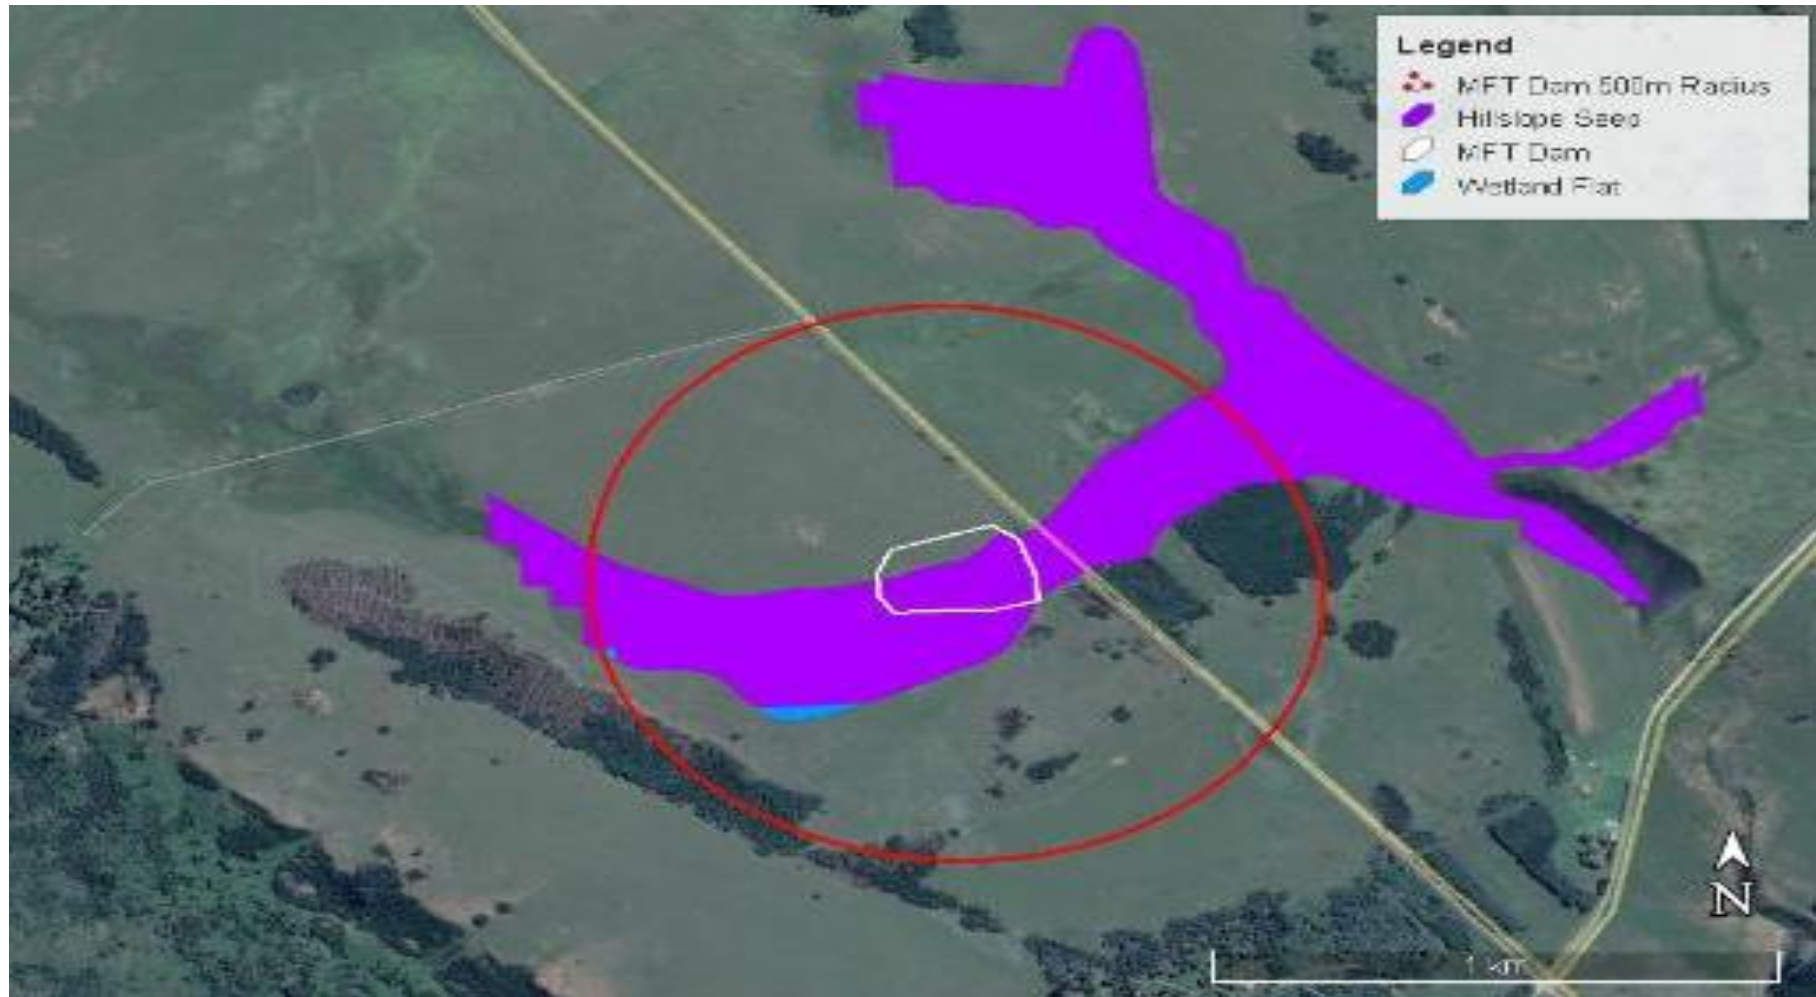
Figure 5: NFEPA wetlands located within the 500m of the dam.

Two (2) FEPA wetlands were identified within the 500m radius of the dam. The FEPA wetlands in the vicinity of the dam are shown in **Figure 5**.

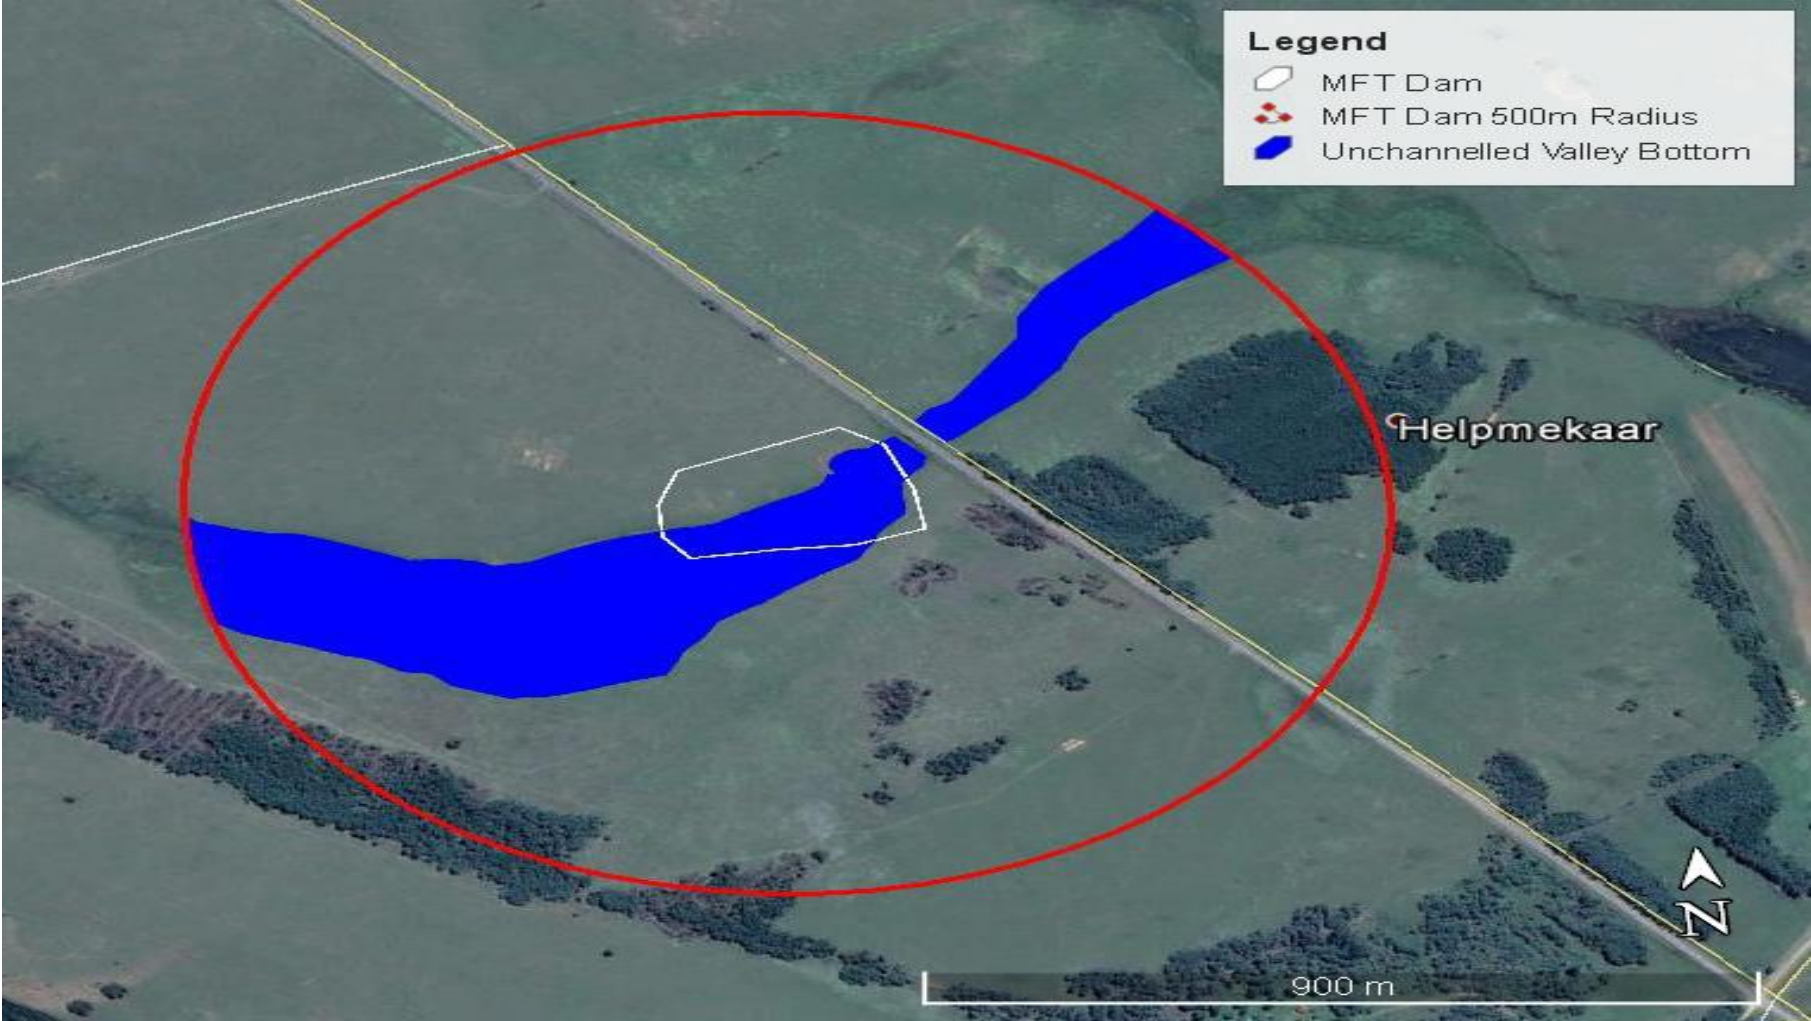
Figure 6: Wetland Delineation within the 500m assessment buffer

The wetland delineation is shown in Figure 6 and the hydrogeomorphic (HGM) units in Figure 7, with the wetland classification as per SANBI guidelines (Ollis, et al., 2013).

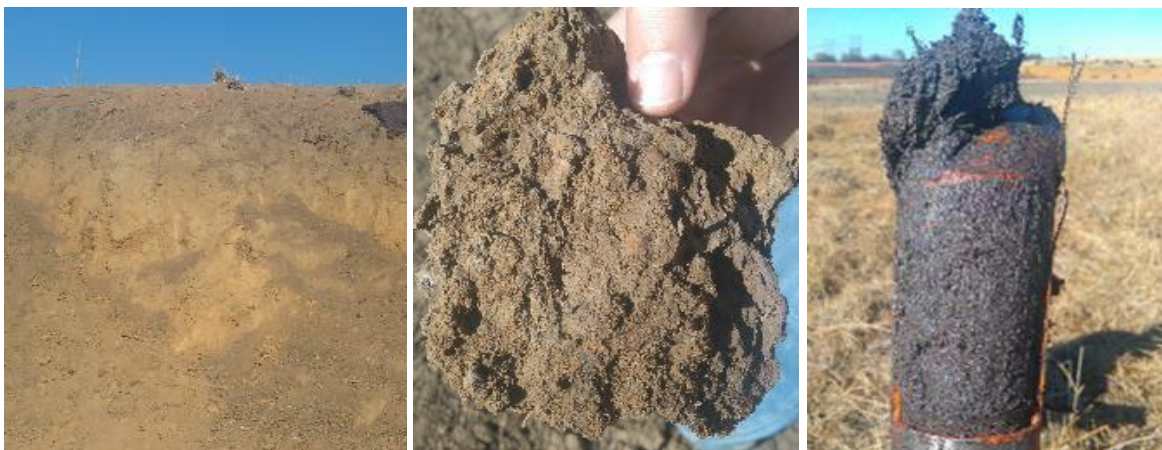
The soils are shallow Mispah soils on the northern banks, with slopes in excess of 10%. The southern bank is flatter in slope and the soils are deeper with Clovelly and Hutton soils dominating the midslope positions in the landscape. The valley bottom shows a transition from Clovelly soils (midslope), to Westleigh soils (foot slope), to Katspruit soils (valley bottom).

Photograph 1: Depicting soils present from left to right (Clovelly, Westleigh and Katspruit)

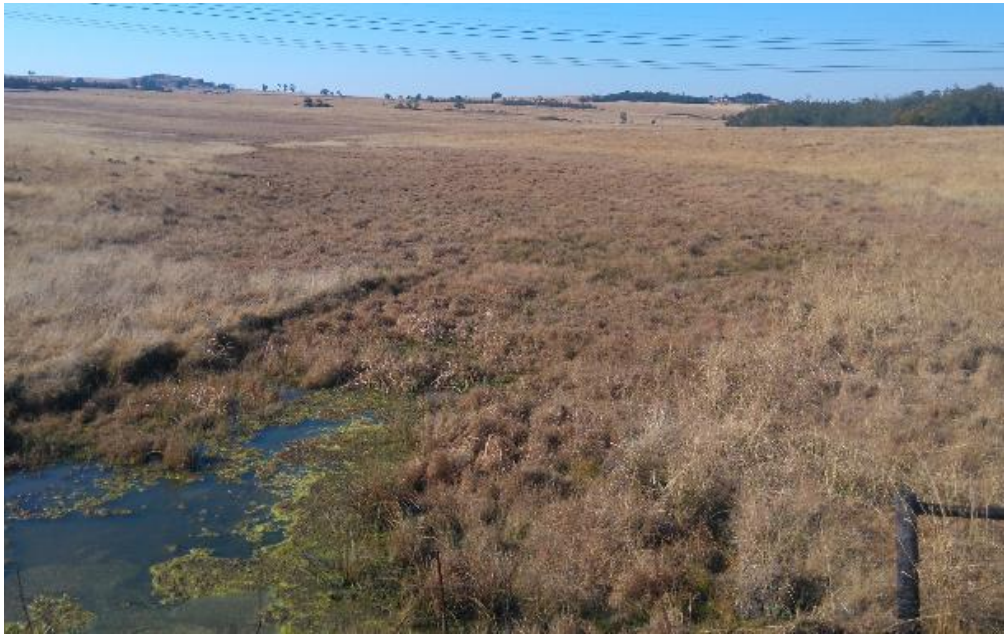
Photograph 2: Depicting the unchannelled valley bottom.

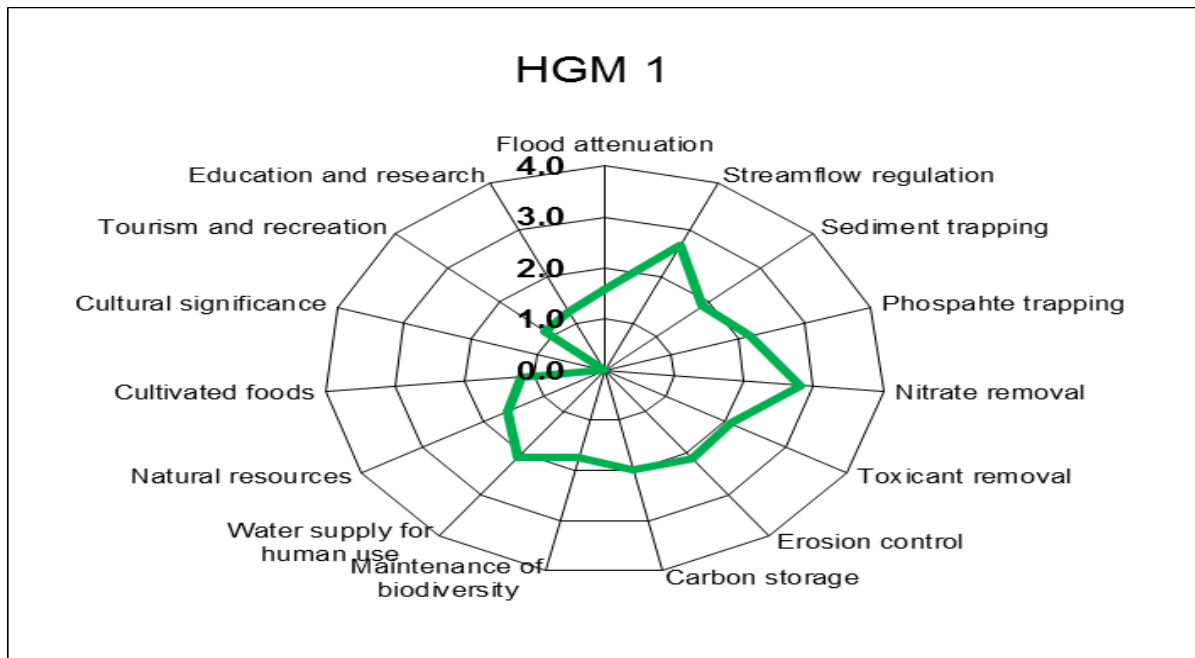
Figure 8: The spider diagram illustrating Ecosystem Services provided by the HGM 1

The Ecosystem services provided for the HGM unit present at the site were assessed and rated as per **Table 7** using the WET-Eco Services method (Kotze, et al., 2009). The results for HGM 1 have been summarised in **Table 8** and have been illustrated with the spider diagram (**Refer to Figure 8**).

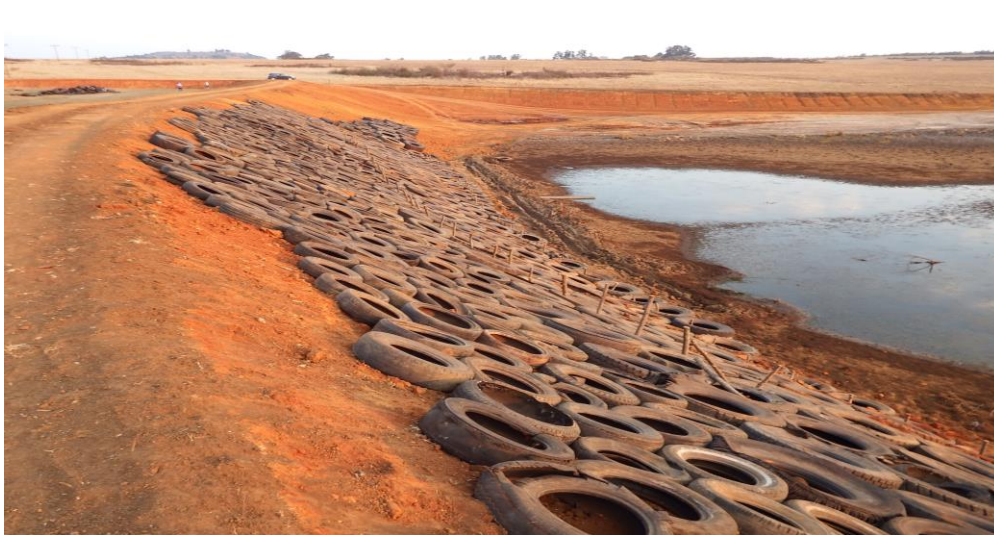
Tyres are used as riprap on the upstream side of the wall (**Refer to Photo 3 and Photo 4**). Bricks are further placed from the FSL to the crest, on top and into tyres.

Photograph 3: Tyres used as rip rap along the upstream side of the wall during construction

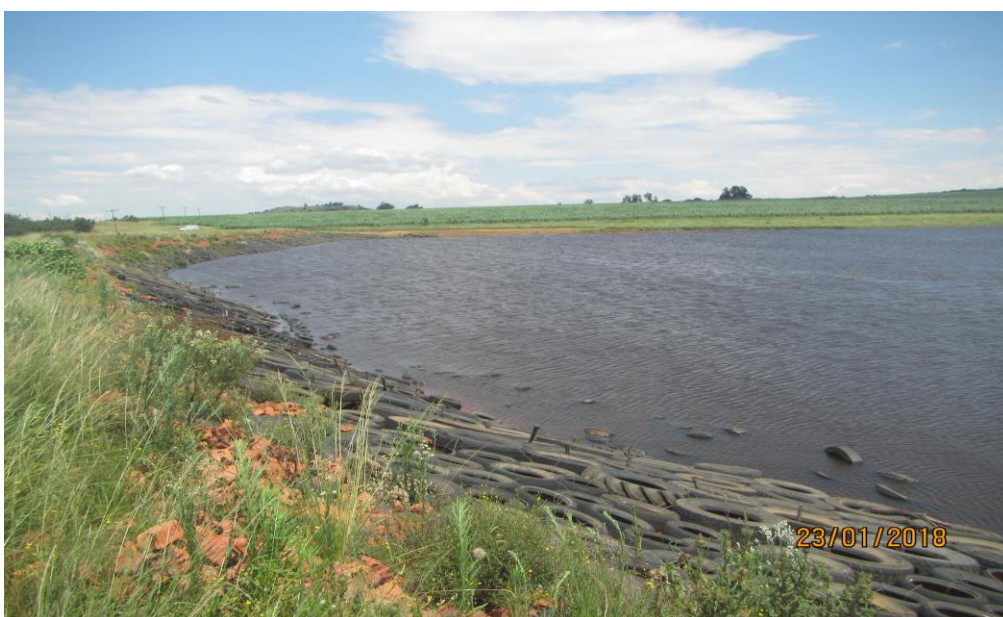
Photograph 4: Tyres used as rip rap along the upstream side of the dam wall after construction

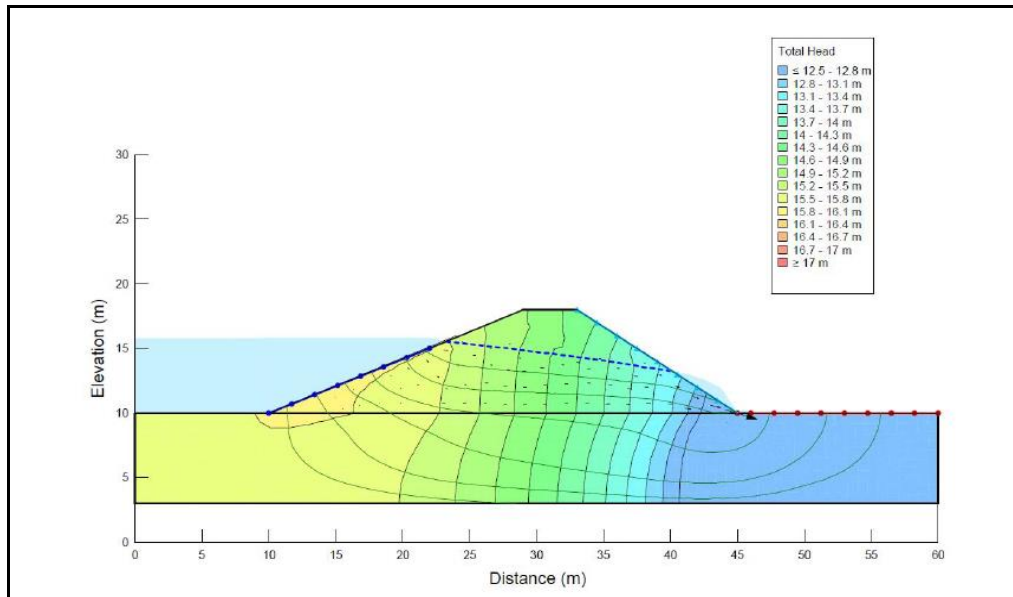
The phreatic surface was determined using a permeability of 9.306×10^{-8} cm/sec for the natural ground and 1.083×10^{-5} cm/sec for the embankment. The analysis was done before a vertical filter was installed and indicated that the phreatic surface will appear on the downstream face at a height of approximately 2 m from the ground level, in the absence of a vertical filter or toe drain. It was noted that a filter consisting of granular material sandwiched between geotextile layers has since been cut into the downstream toe of the wall at a location on the

wall where the vertical height is 2 m from ground level. A 110mm drainage pipe was placed at the bottom of the filter to allow the water to drain.

Figure 10: Phreatic surface and seepage through dam wall.

Using the above phreatic surface and slope stability of the dam was analysed to determine if it would be stable during operation

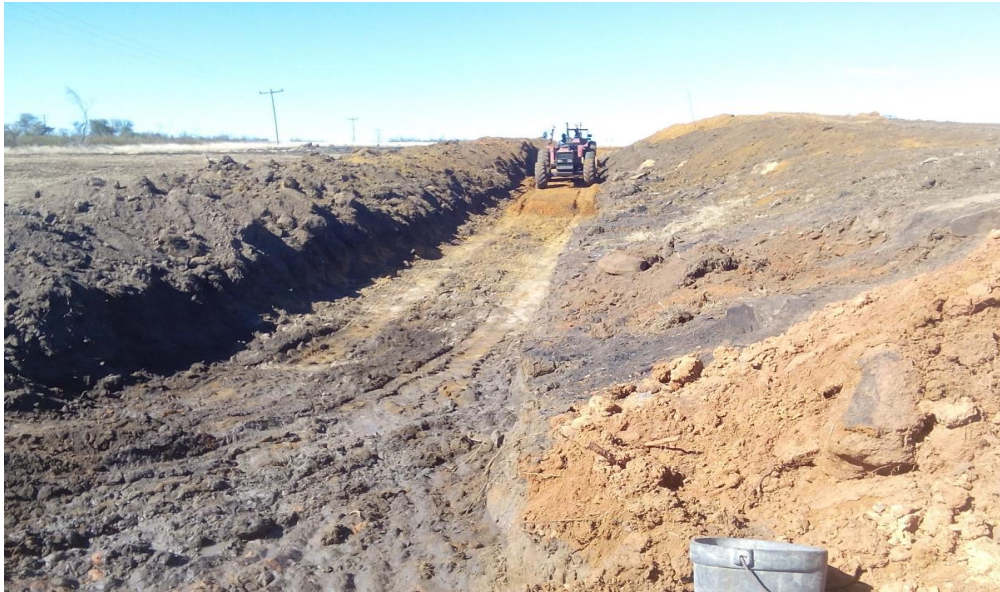
A 1.5 m deep by 3 m wide cut-off trench was constructed and clay material was compacted in layers in the centre of the dam wall, just downstream of the remains of the old existing dam wall (Refer to Photo 5 and Photo 6).

Photograph 5: 1.5m deep and 3m wide cut of trench during construction of the dam wall.

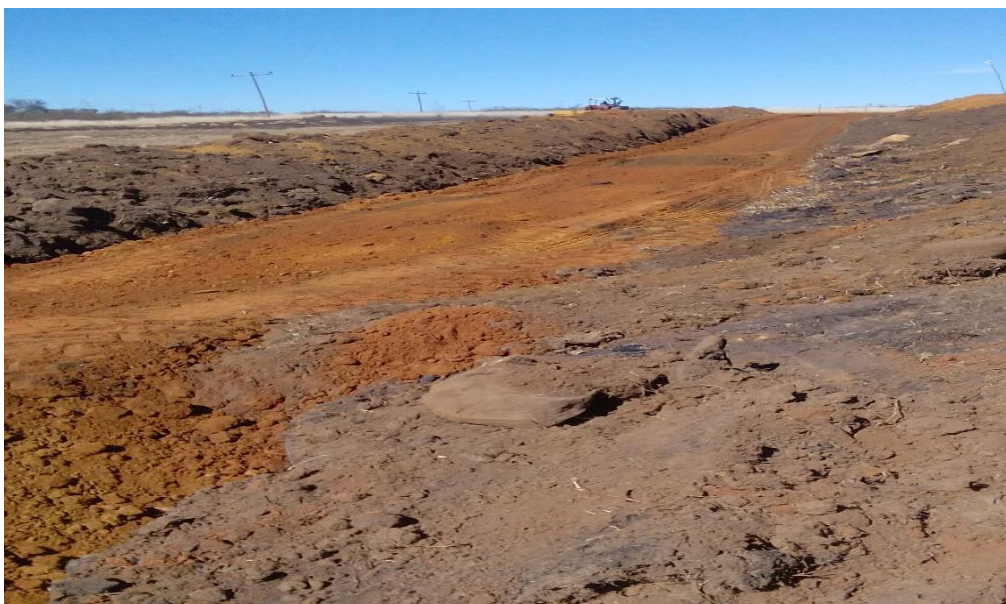
Photograph 6: Dam cut of key.

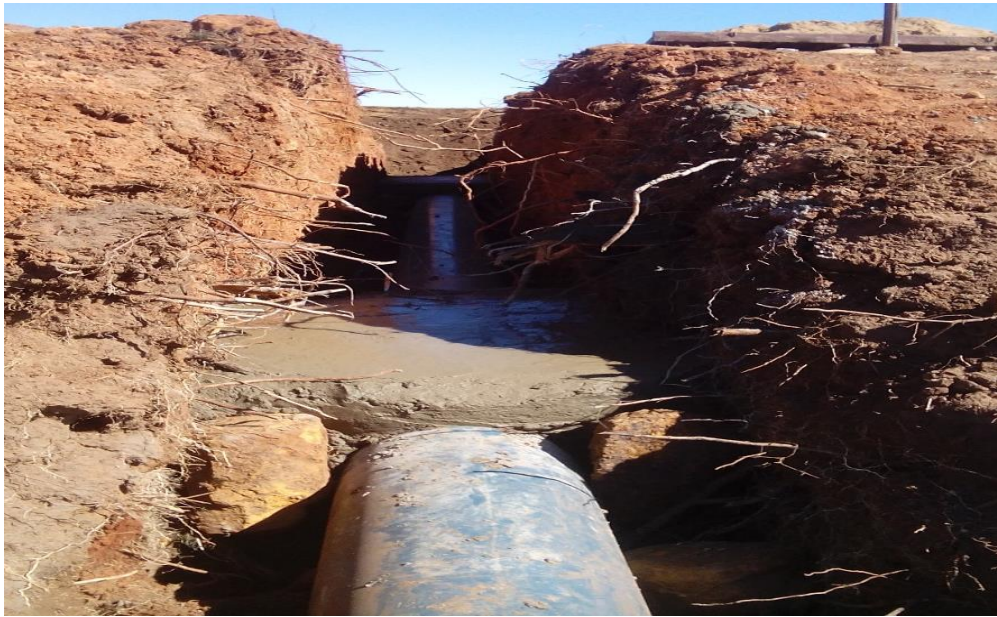
A 300 mm PVC pipe was also installed at the bottom of the dam during construction. This allows “normal stream” water to be released through the pipe instead of flowing over the spillways, thereby preventing erosion of the spillways (Refer to Photo 7 and Photo 8).

Photograph 7: Outlet pipe during construction of the dam wall.

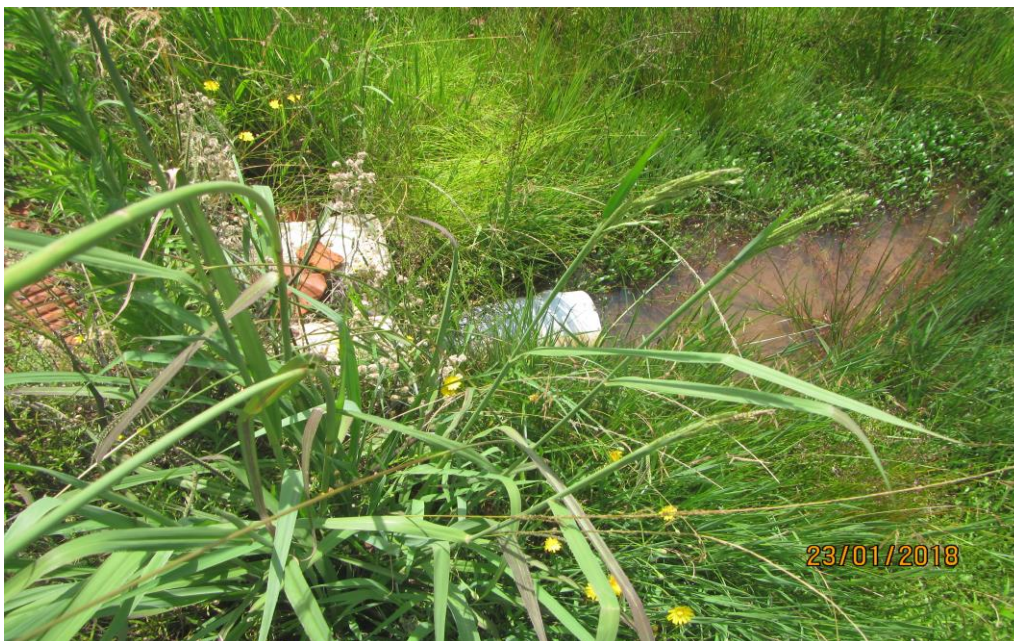
Photograph 8: Outlet pipe after construction of the dam wall.

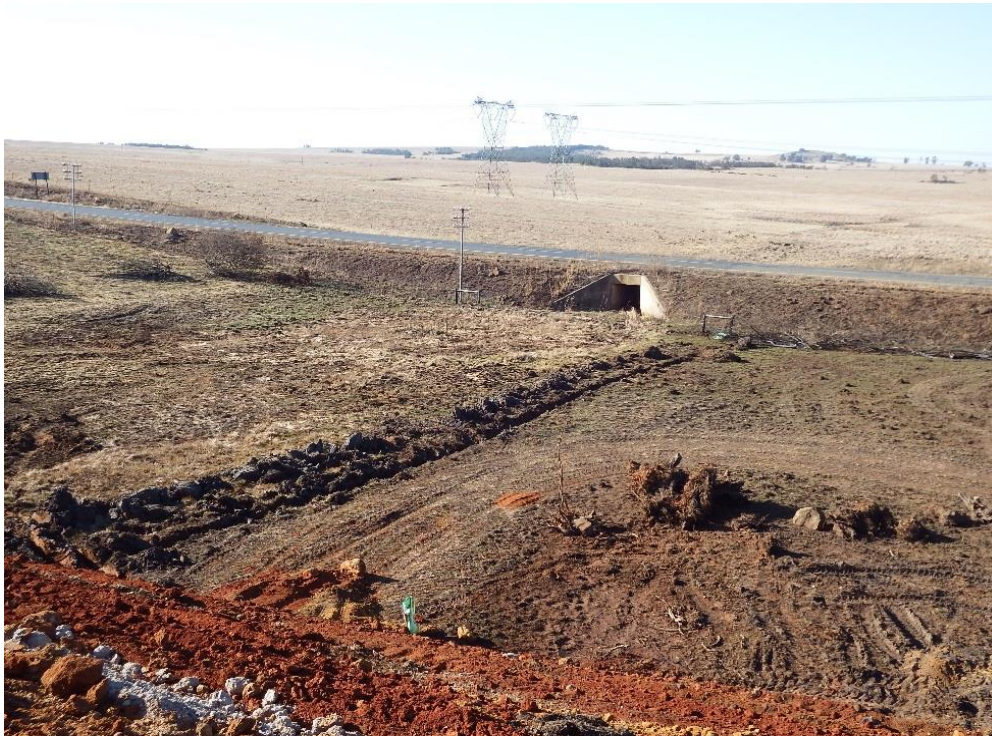
Photograph 9: View downstream of the dam wall during construction.

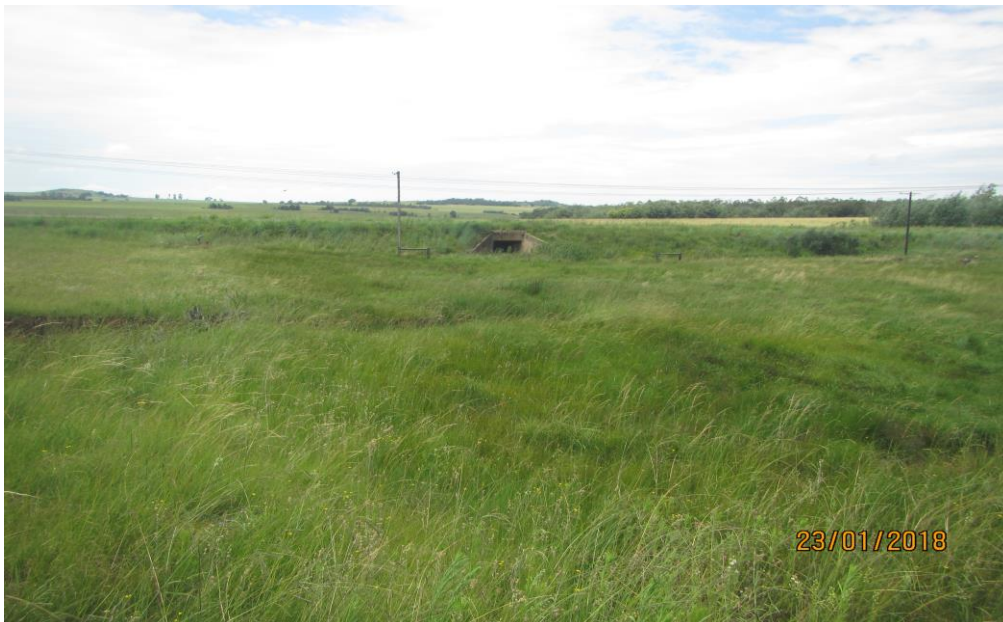
Photograph 10: View downstream of the dam wall after construction
