**GEOTECHNICAL INVESTIGATIONS  
OF SITE 1: BOKSBURG MINING BELT.**

**IR823 addendum**

**IR823 ad  
MAY 2007**

## GEOTECHNICAL INVESTIGATIONS OF SITE 1: BOKSBURG MINING BELT : ADDENDUM

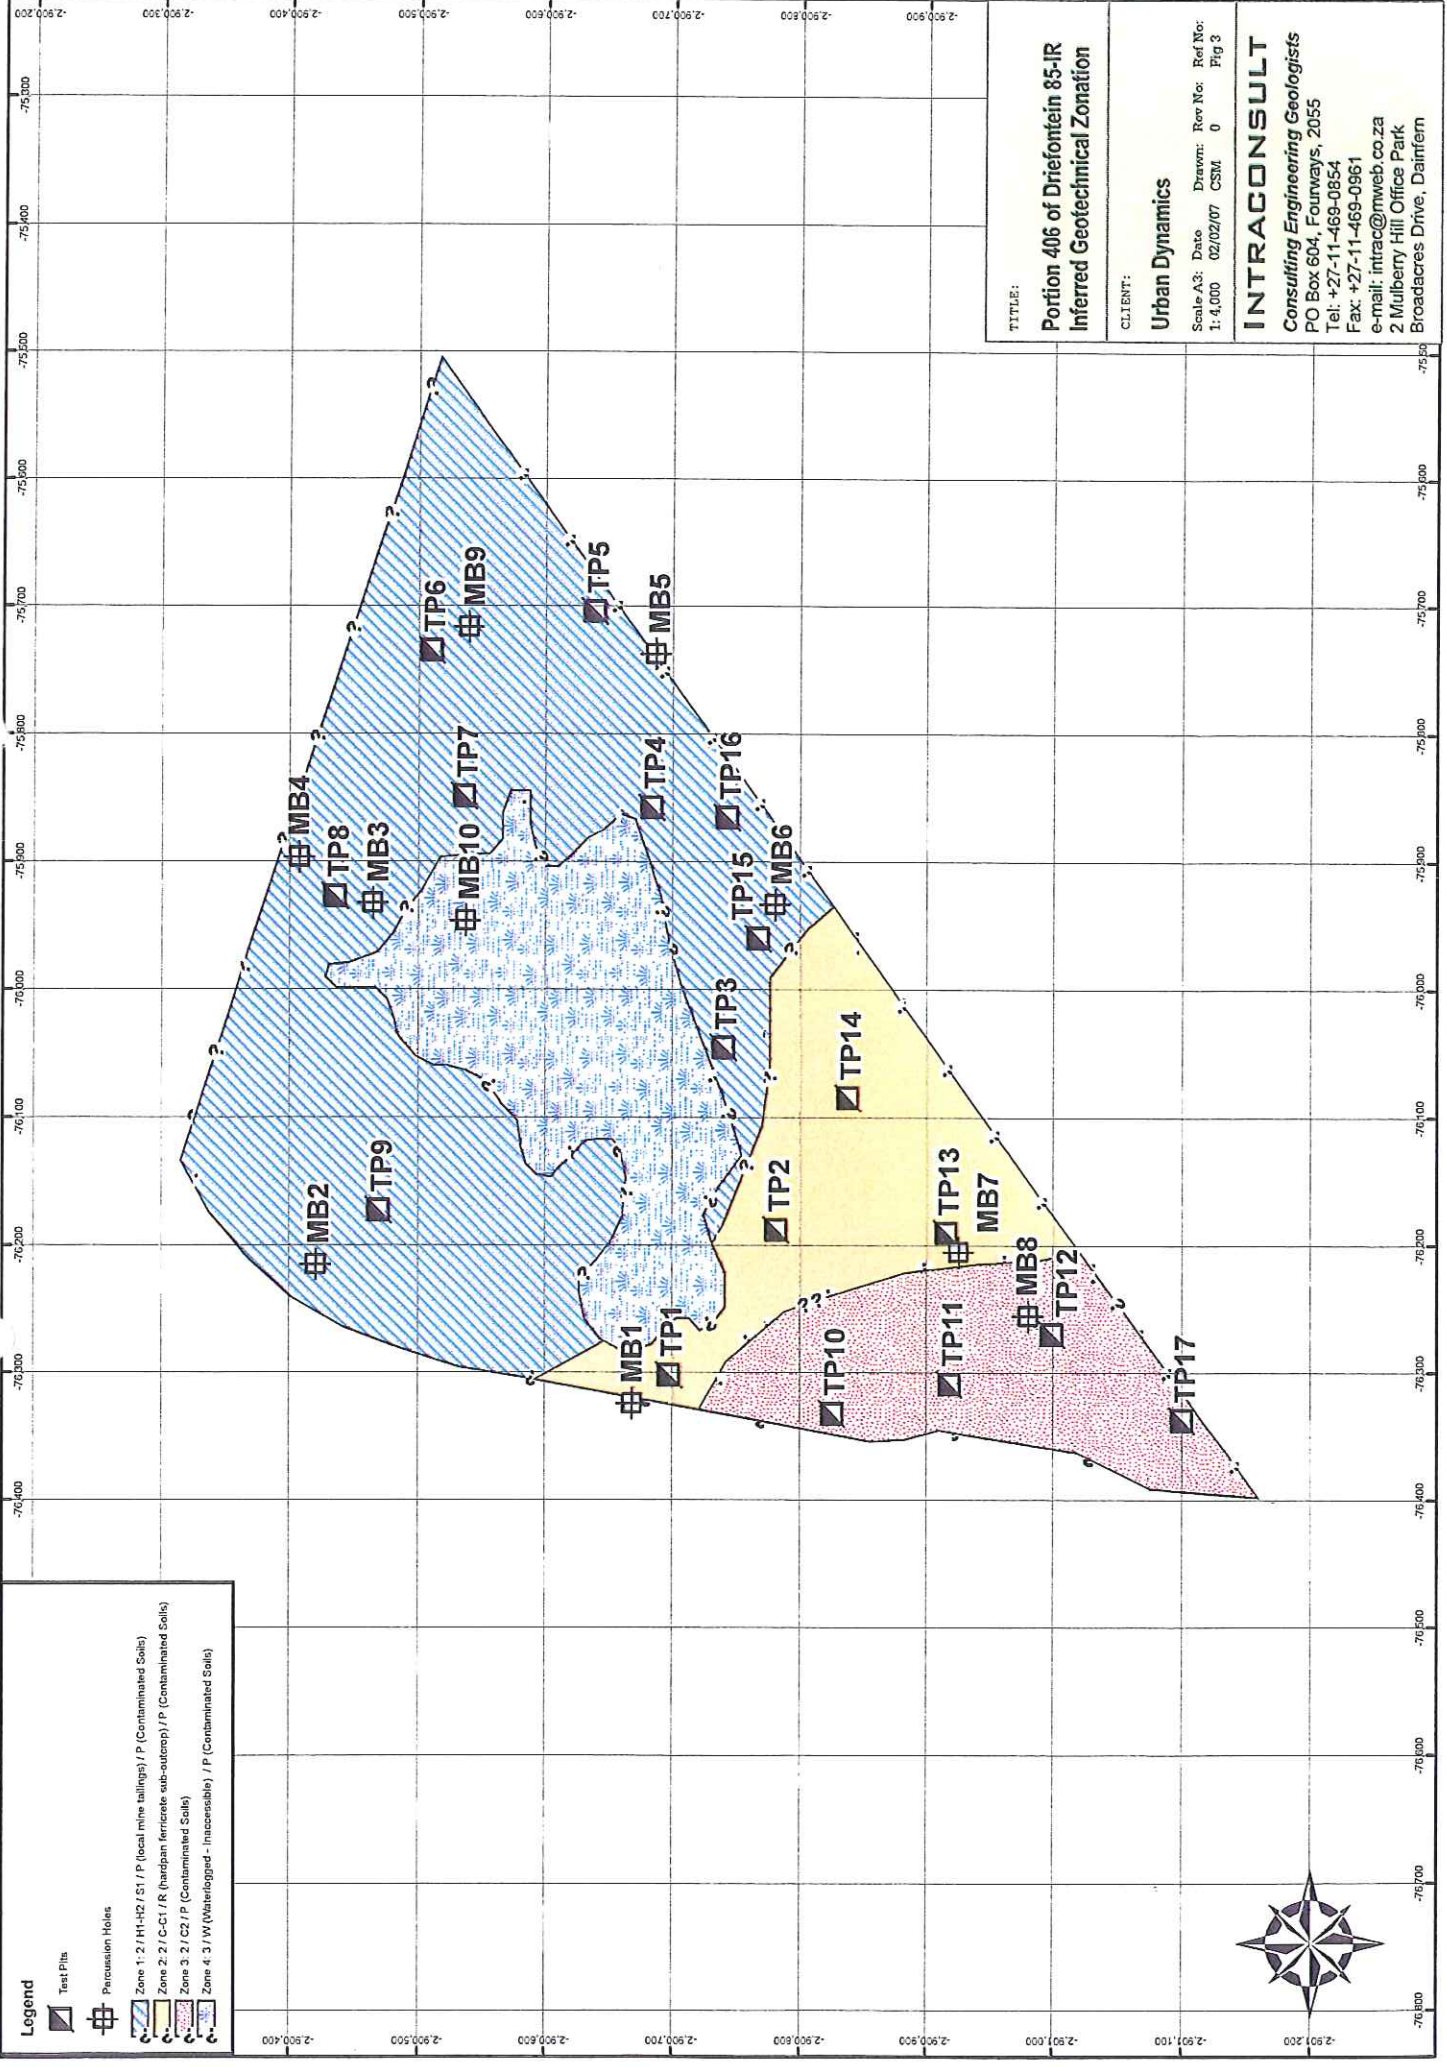
- Test Pits
- Percussion Holes
- Zone 1: 2 / H1-H2 / S1 / P (local mine tailings) / P (Contaminated Soils)
- Zone 2: 2 / C-C1 / R (hardpan ferricrete sub-outcrop) / P (Contaminated Soils)
- Zone 3: 2 / C2 / P (Contaminated Soils)
- Zone 4: 3 / W (Waterlogged - Inaccessible) / P (Contaminated Soils)

During the initial GFSH-1 geotechnical investigation in January 2007, the project site was divided into four geotechnical zones, as defined and graphically presented on Figure 3, Revision 0 of report IR823R. Zones 1 to 3 classified the site into areas with common engineering and founding conditions, while Zone 4 was demarcated as an area inaccessible to test pitting, due to essentially waterlogged ground conditions, which could not be formally evaluated and classified.

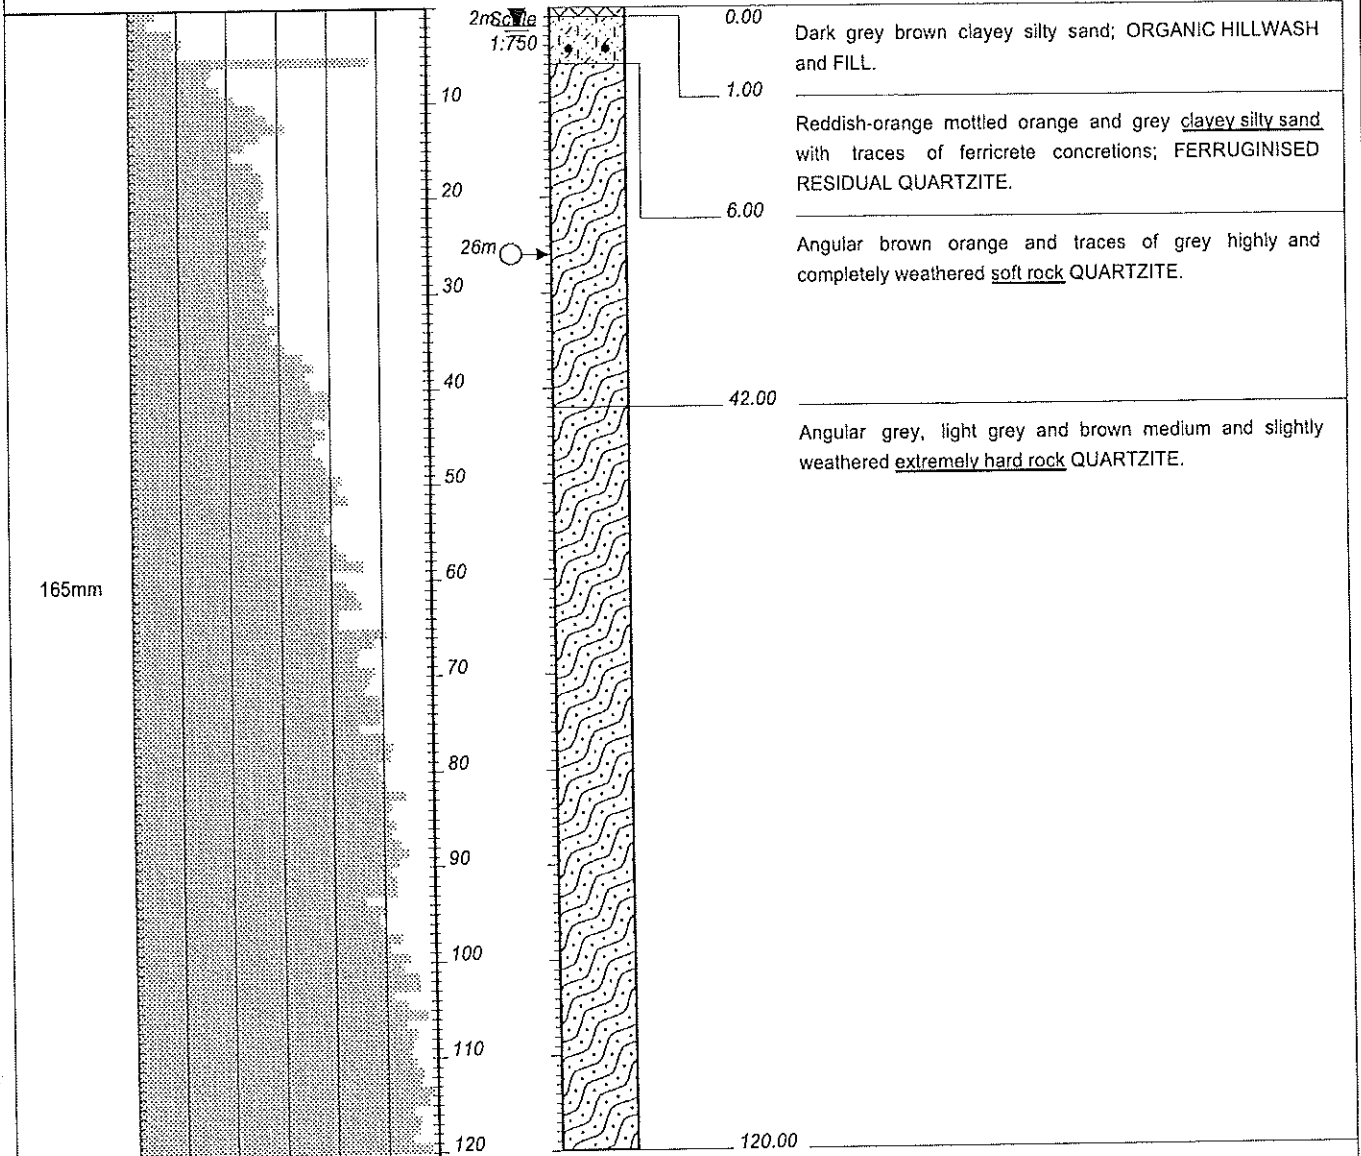
- 1) Water strike at 26m.
- 2) Groundwater rest level 2m.

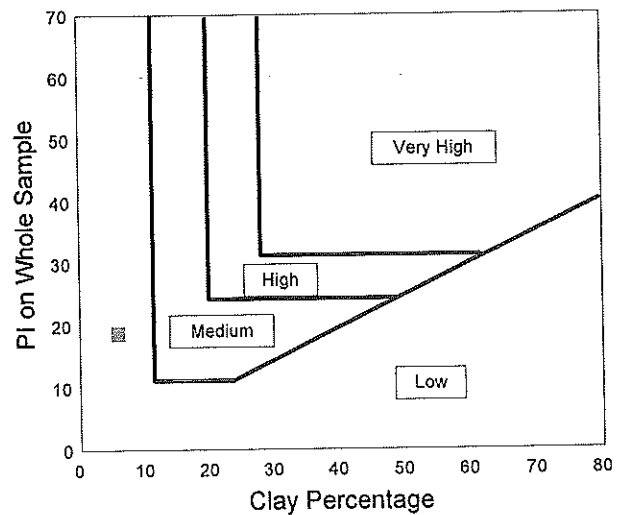
Liquid Limit	39
Plastic Limit	19
Plastic Index	20
Linear Shrinkage	10
Grading Modulus	0.27
Moisture Content	34.67
PI on Whole Sample	19

### ACTIVITY CHART

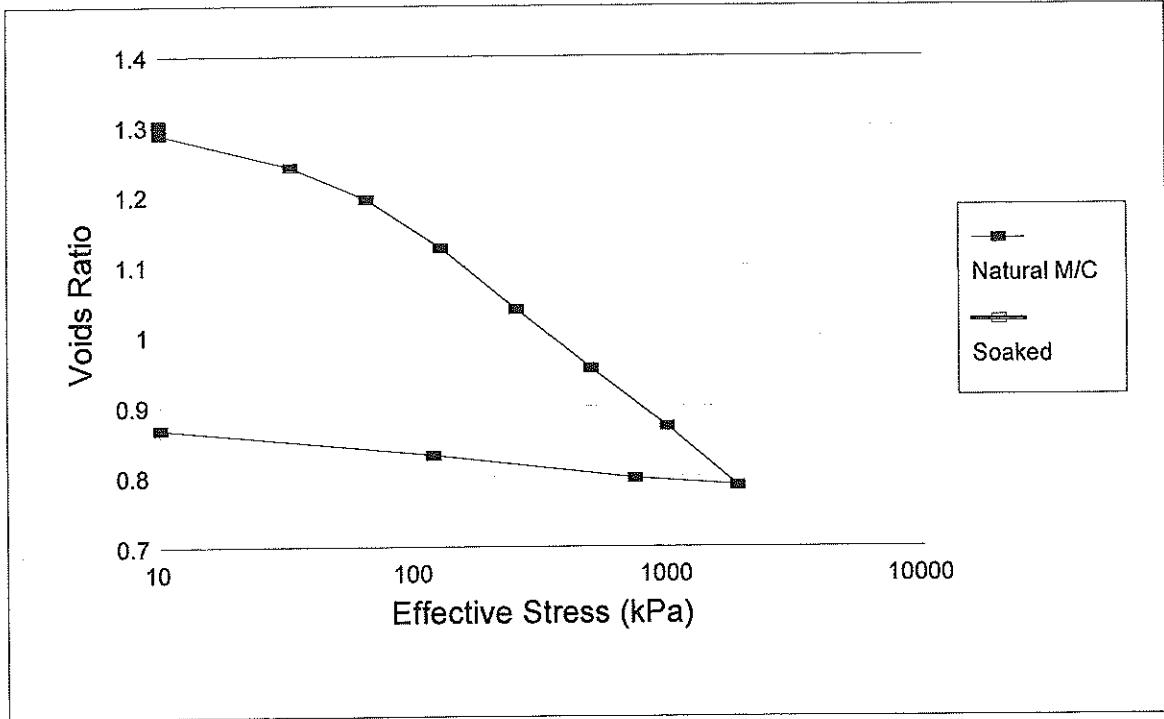
Test No: 357

**SINGLE OEDOMETER CONSOLIDATION - SOAKED AT 10 kPa**

### VOIDS RATIO v EFFECTIVE STRESS

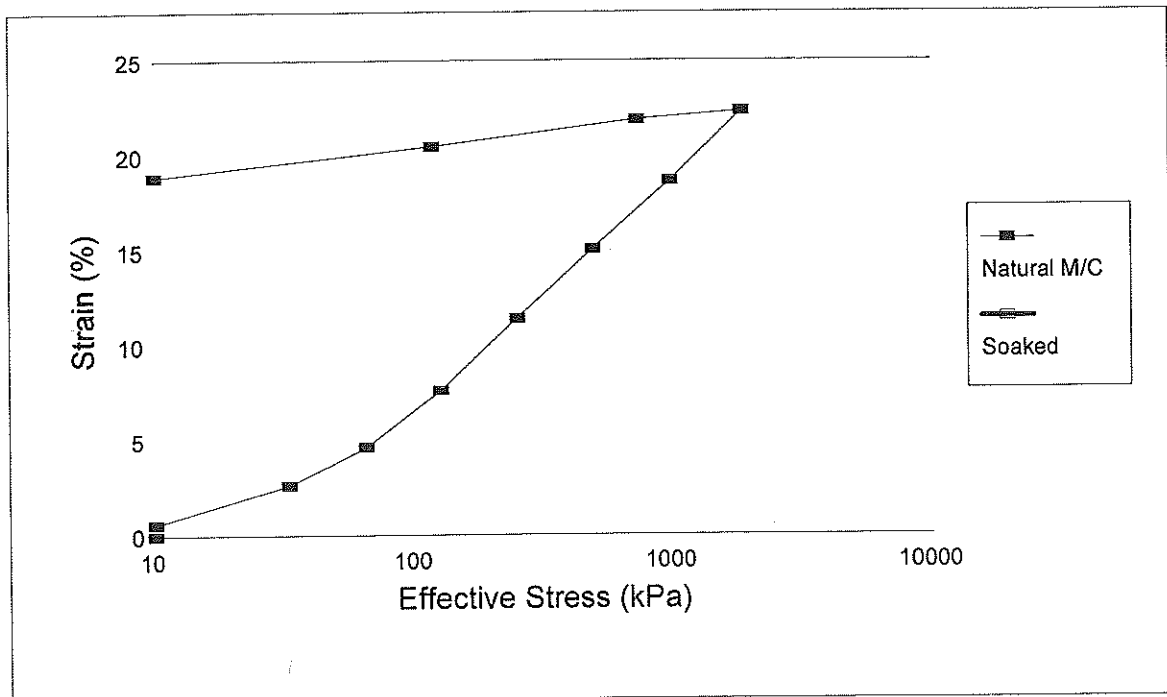
Test No: 357

### STRAIN v EFFECTIVE STRESS

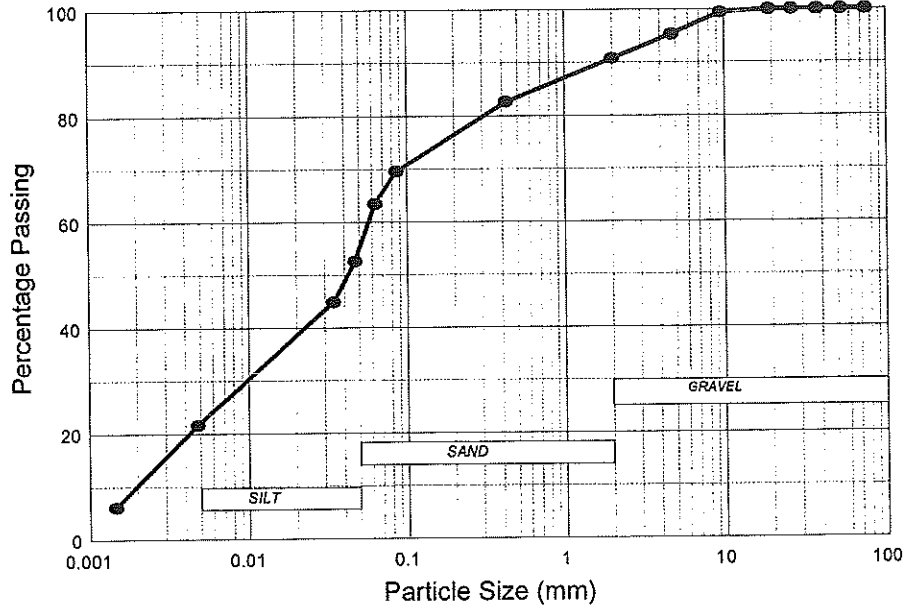
Sieve Size (mm)	Total Passing (%)
75.00	100.00
53.00	100.00
37.50	100.00
26.50	100.00
19.00	100.00
9.50	99.37
4.75	95.32
2.00	90.77
0.425	82.68

### GRADING ANALYSIS

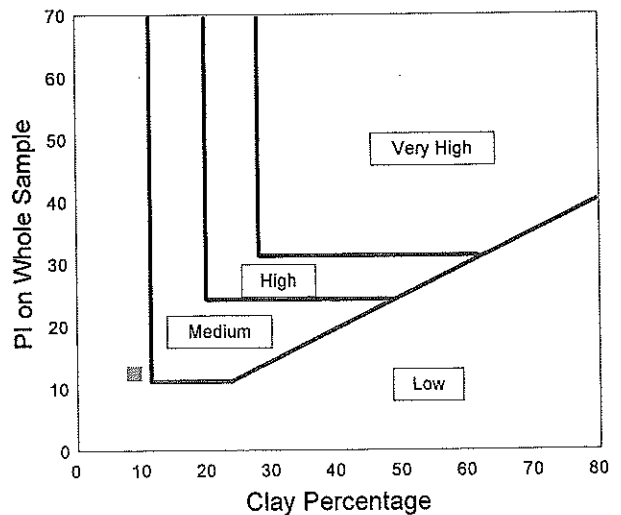
Liquid Limit	32
Plastic Limit	17
Plastic Index	15
Linear Shrinkage	8
Grading Modulus	0.57
Moisture Content	16.16
PI on Whole Sample	12

### ACTIVITY CHART

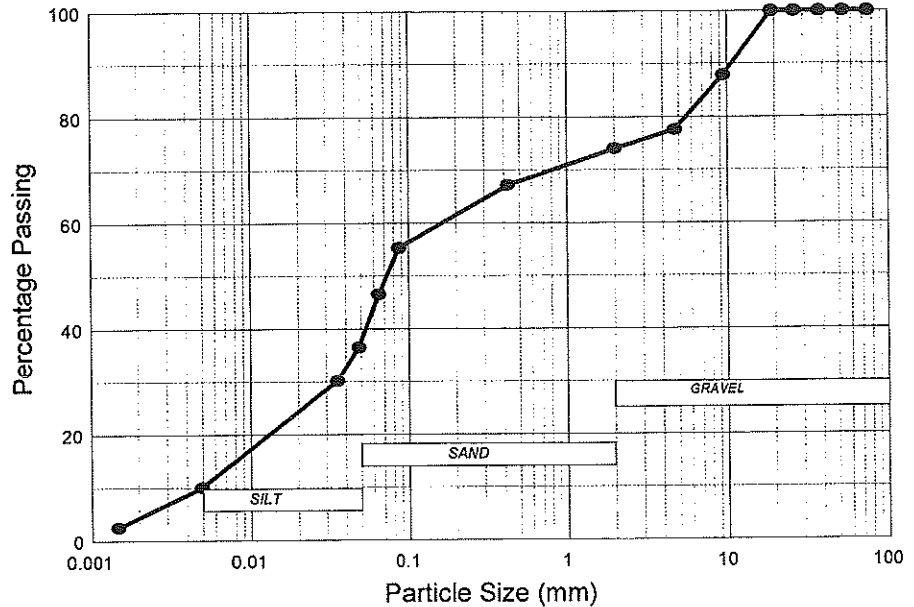
Sieve Size (mm)	Total Passing (%)
75.00	100.00
53.00	100.00
37.50	100.00
26.50	100.00
19.00	100.00
9.50	87.90
4.75	77.60
2.00	74.09
0.425	67.27

### GRADING ANALYSIS

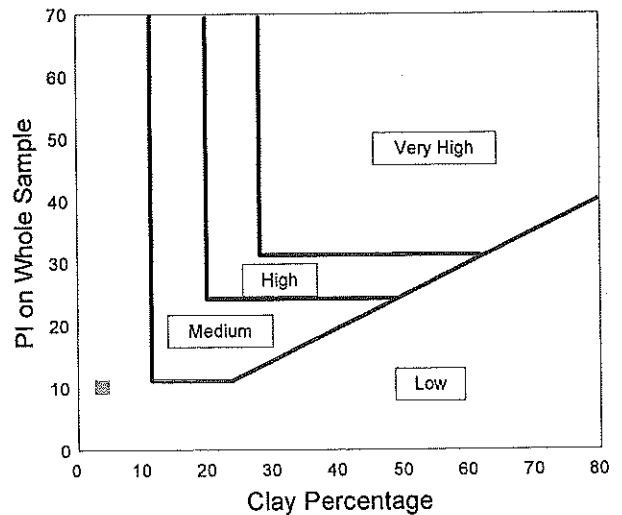
Liquid Limit	31
Plastic Limit	16
Plastic Index	15
Linear Shrinkage	7
Grading Modulus	1.03
Moisture Content	12.38
PI on Whole Sample	10

### ACTIVITY CHART

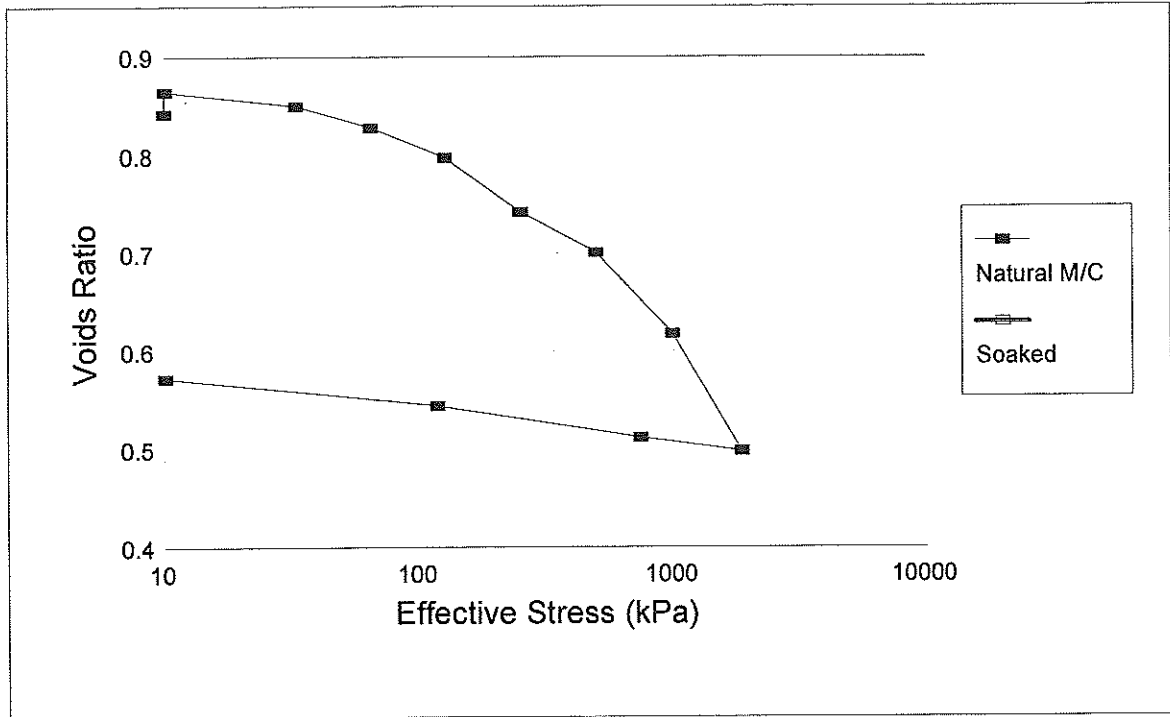
Test No: 360

**SINGLE OEDOMETER CONSOLIDATION - SOAKED AT 10 kPa**

### VOIDS RATIO v EFFECTIVE STRESS

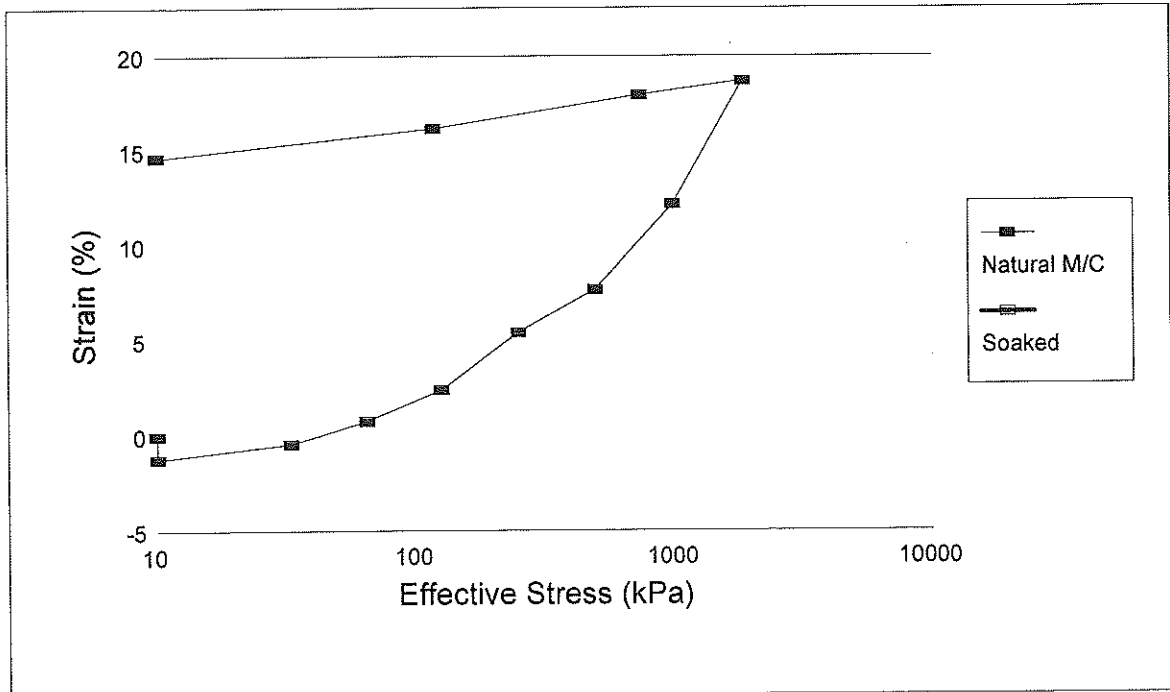
Test No: 360

### STRAIN v EFFECTIVE STRESS

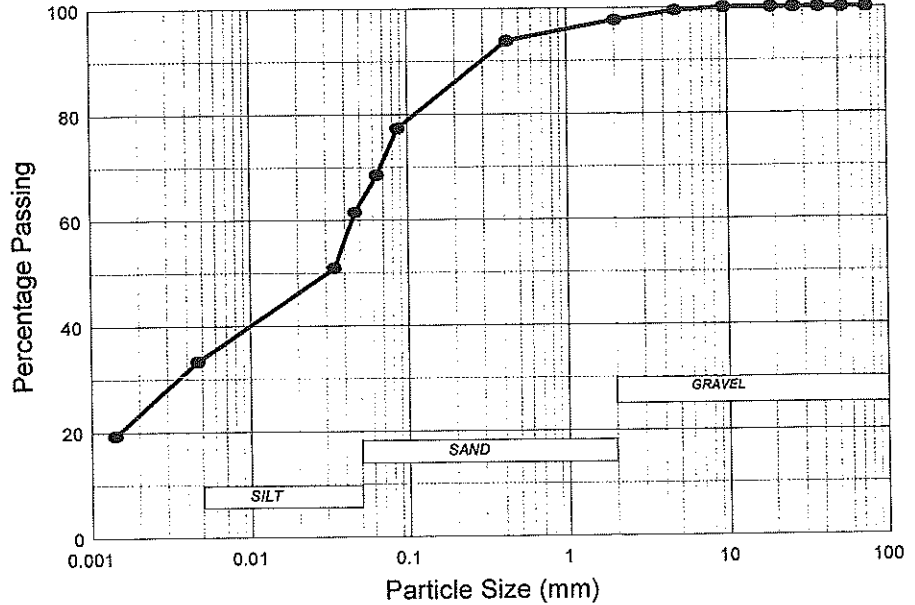
Sieve Size (mm)	Total Passing (%)
75.00	100.00
53.00	100.00
37.50	100.00
26.50	100.00
19.00	100.00
9.50	100.00
4.75	99.46
2.00	97.71
0.425	93.89

### GRADING ANALYSIS

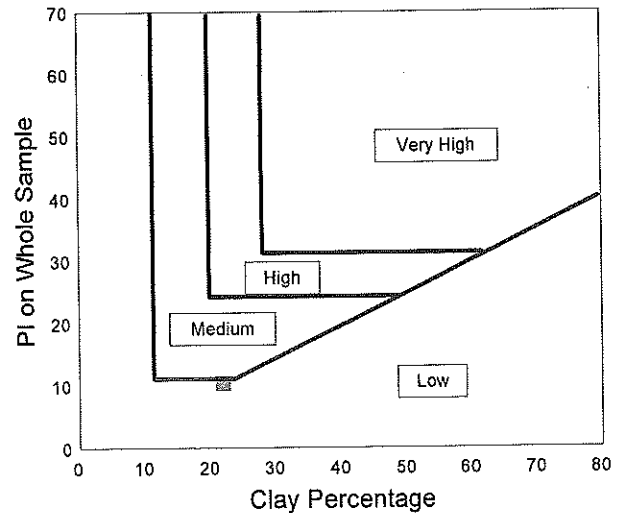
Liquid Limit	27
Plastic Limit	16
Plastic Index	11
Linear Shrinkage	5
Grading Modulus	0.31
Moisture Content	12.33
PI on Whole Sample	10

### ACTIVITY CHART

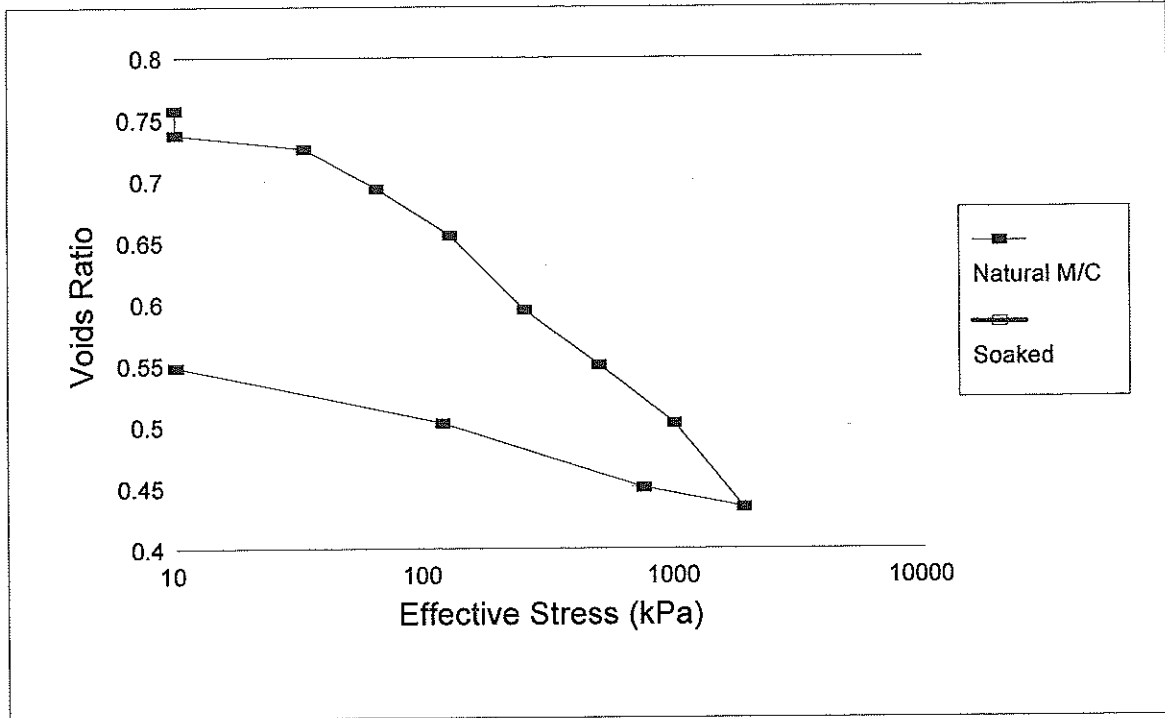
Test No: 362

**SINGLE OEDOMETER CONSOLIDATION - SOAKED AT 10 kPa**

### VOIDS RATIO v EFFECTIVE STRESS

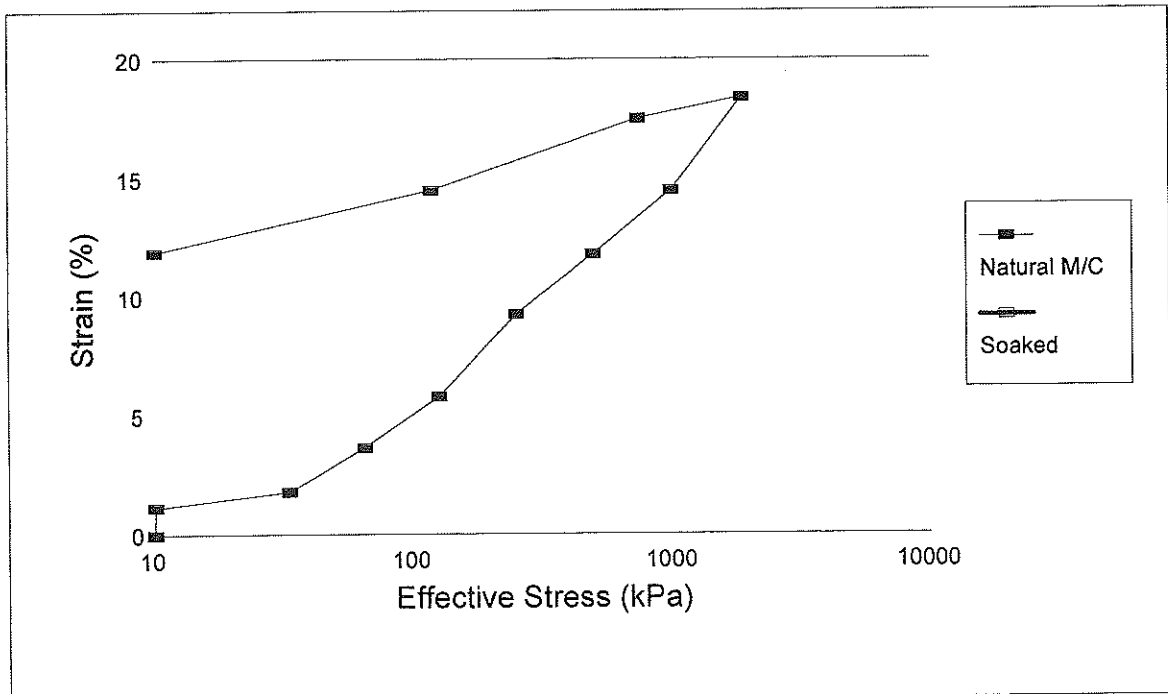
Test No: 362

### STRAIN v EFFECTIVE STRESS

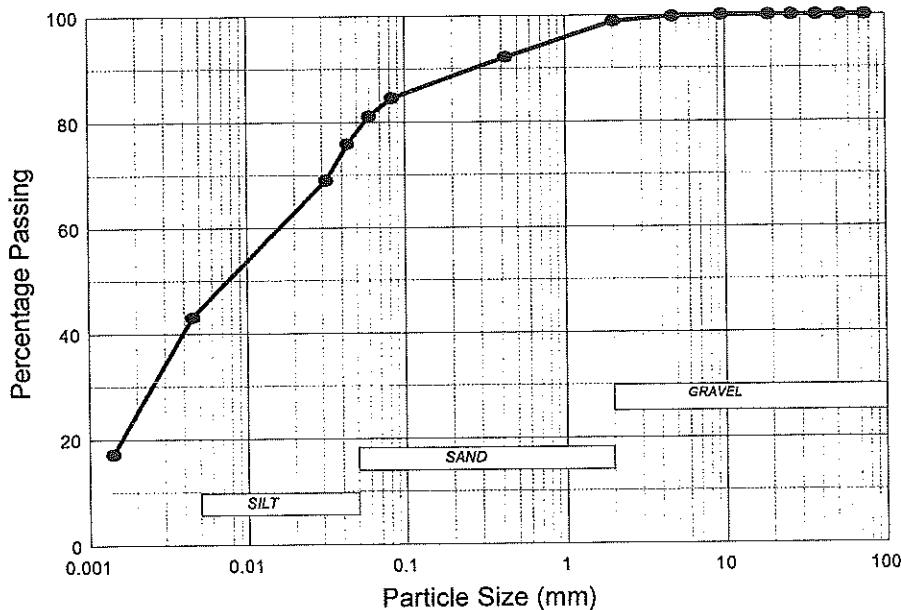
Sieve Size (mm)	Total Passing (%)
75.00	100.00
53.00	100.00
37.50	100.00
26.50	100.00
19.00	100.00
9.50	100.00
4.75	99.75
2.00	98.91
0.425	92.17

**GRADING ANALYSIS**

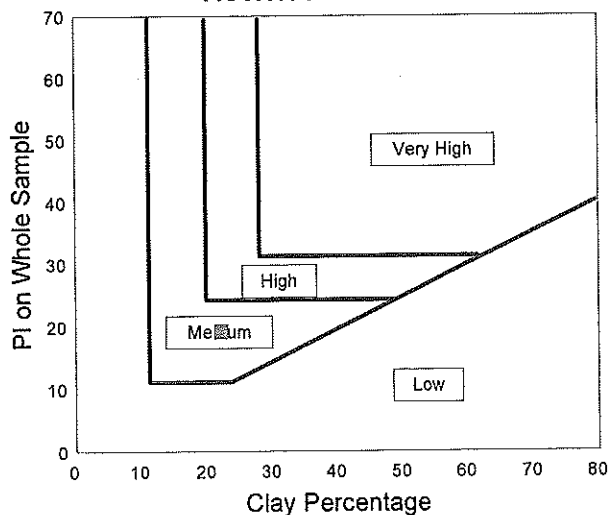
Liquid Limit	43
Plastic Limit	22
Plastic Index	21
Linear Shrinkage	11
Grading Modulus	0.24
Moisture Content	20.36
PI on Whole Sample	19

**ACTIVITY CHART**

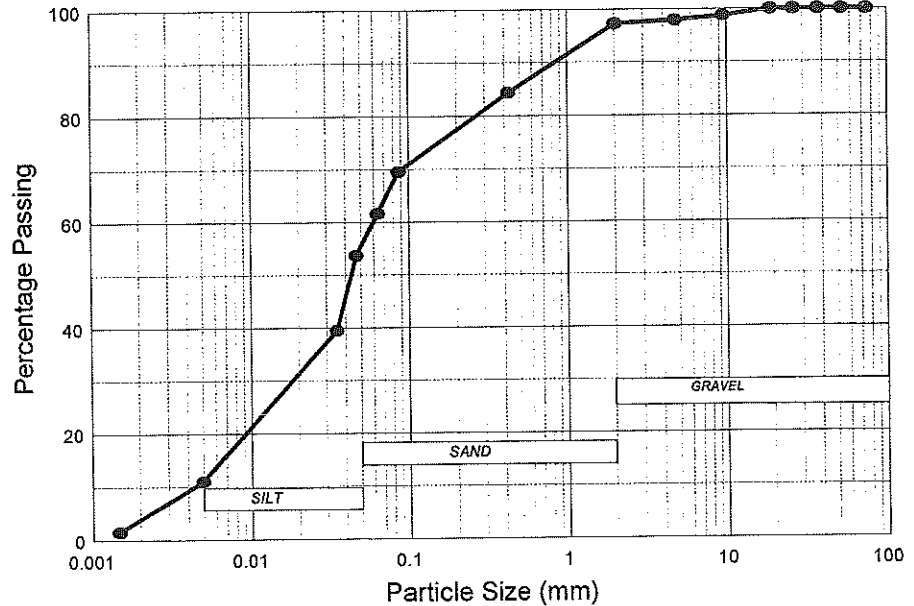
Sieve Size (mm)	Total Passing (%)
75.00	100.00
53.00	100.00
37.50	100.00
26.50	100.00
19.00	100.00
9.50	98.75
4.75	97.96
2.00	97.34
0.425	84.42

### GRADING ANALYSIS

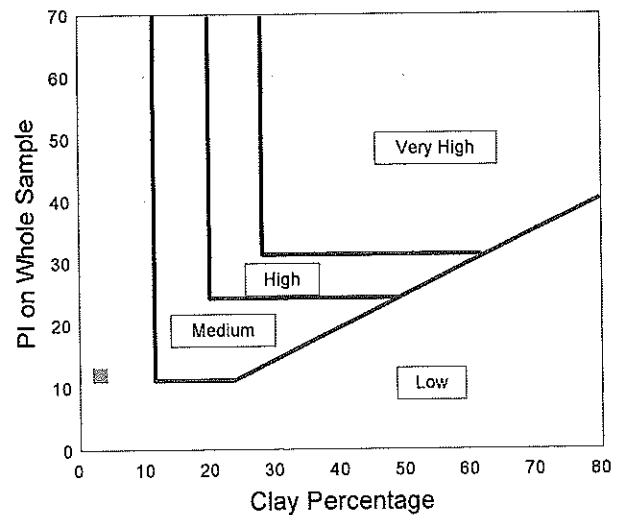
Liquid Limit	29
Plastic Limit	15
Plastic Index	14
Linear Shrinkage	7
Grading Modulus	0.49
Moisture Content	18.38
PI on Whole Sample	12

### ACTIVITY CHART

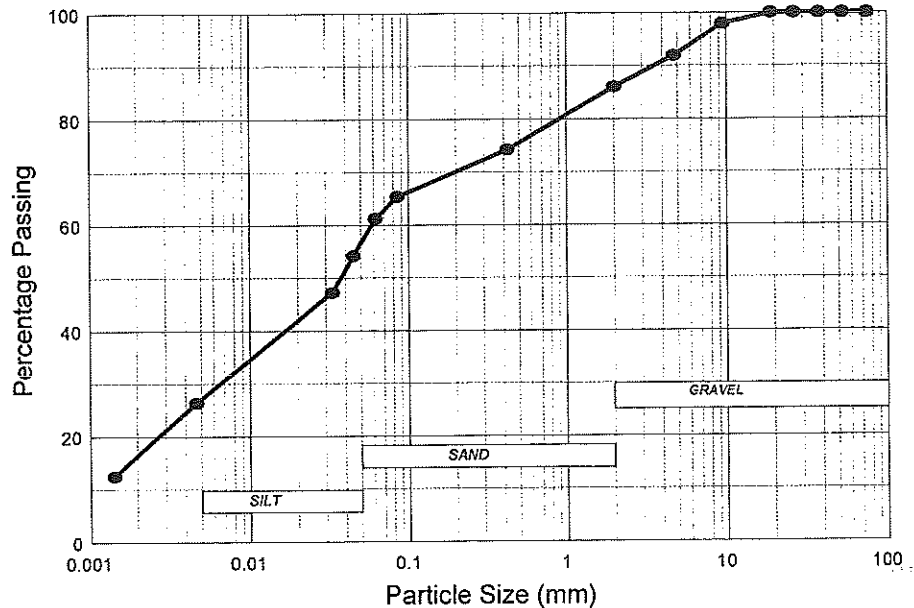
Sieve Size (mm)	Total Passing (%)
75.00	100.00
53.00	100.00
37.50	100.00
26.50	100.00
19.00	100.00
9.50	97.94
4.75	91.95
2.00	86.08
0.425	74.30

### GRADING ANALYSIS

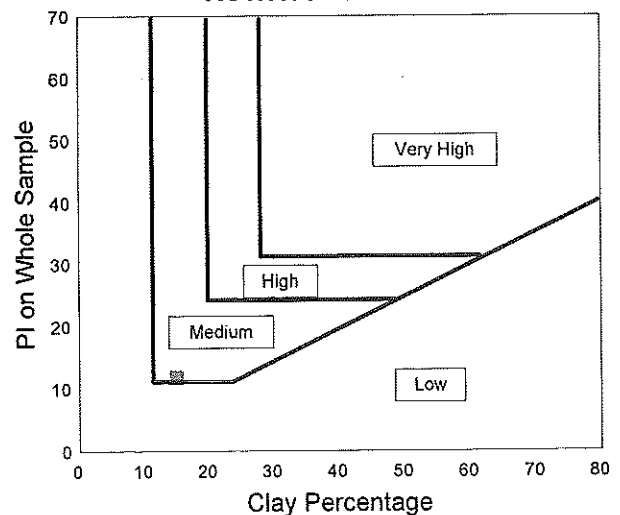
Liquid Limit	31
Plastic Limit	15
Plastic Index	16
Linear Shrinkage	7
Grading Modulus	0.74
Moisture Content	11.91
PI on Whole Sample	12

### ACTIVITY CHART

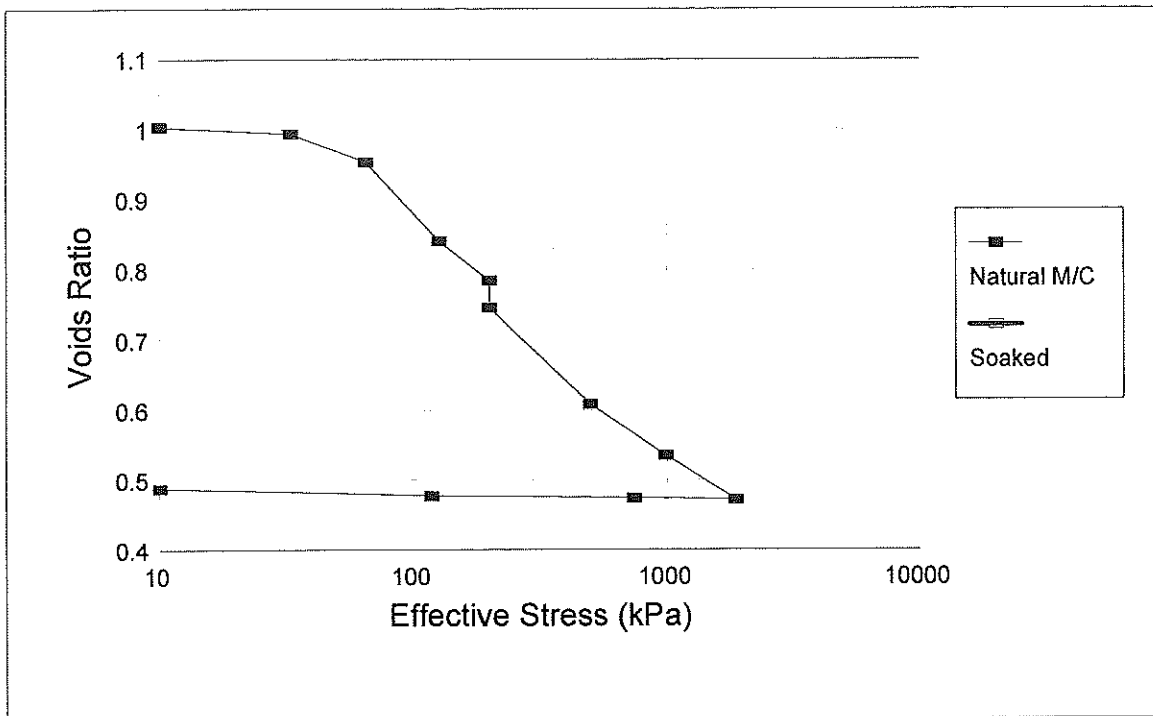
Test No: 365

**GEOPRACTICA**SOILS & MATERIALS TESTING  
P.O.BOX 227, MARAISBURG, 1700TEL: (011) 674 1325  
FAX: (011) 674 4513  
e mail: lab@geopractica.co.za**COLLAPSE POTENTIAL at 200 kPa**

### VOIDS RATIO v EFFECTIVE STRESS

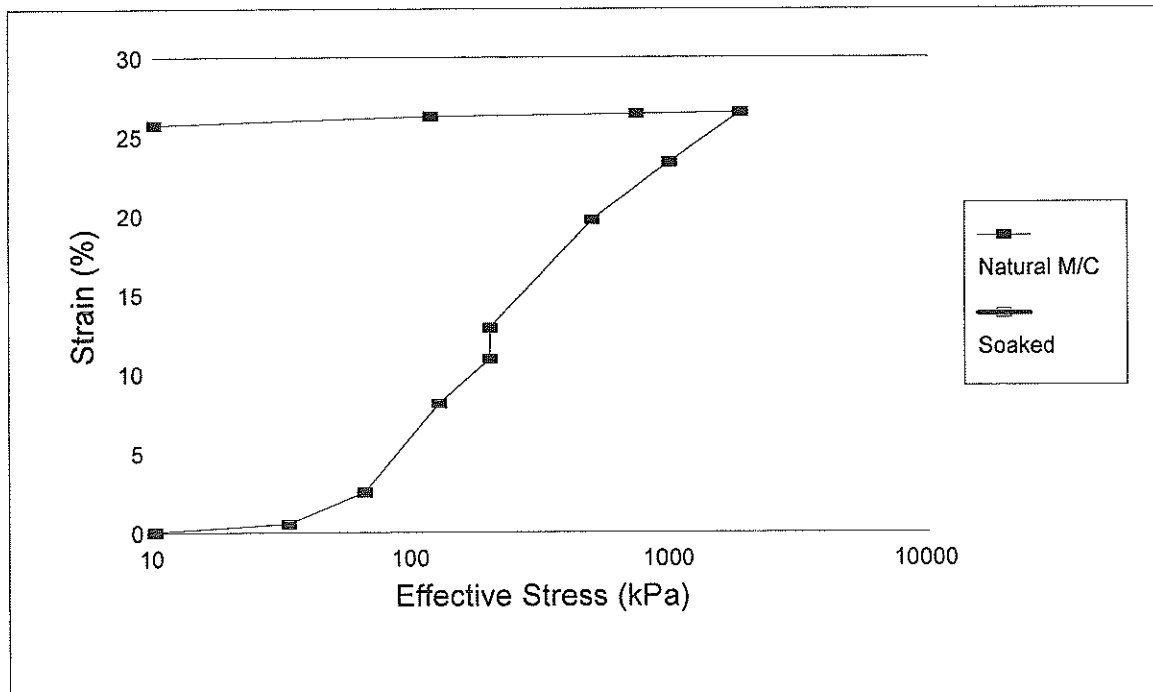
Test No: 365

### STRAIN v EFFECTIVE STRESS

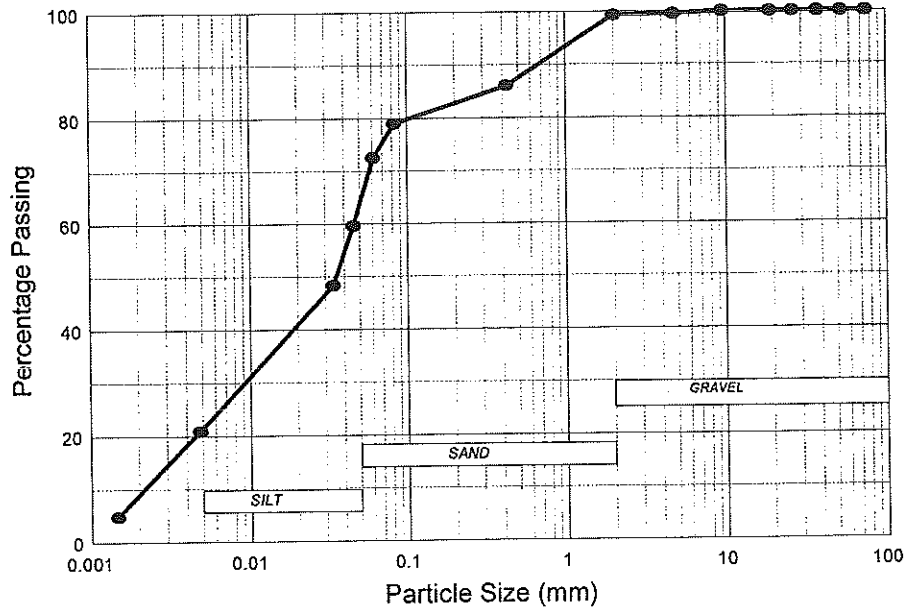
Sieve Size (mm)	Total Passing (%)
75.00	100.00
53.00	100.00
37.50	100.00
26.50	100.00
19.00	100.00
9.50	100.00
4.75	99.59
2.00	99.35
0.425	86.08

### GRADING ANALYSIS

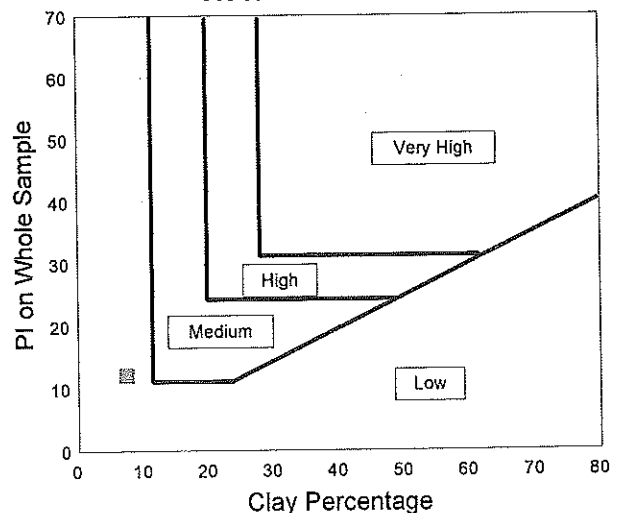
Liquid Limit	28
Plastic Limit	14
Plastic Index	14
Linear Shrinkage	7
Grading Modulus	0.36
Moisture Content	16.97
PI on Whole Sample	12

### ACTIVITY CHART
