**PROJECT No: M18/3762**

**FACTUAL REPORT ON GEOTECHNICAL AND DOLOMITE STABILITY INVESTIGATION CARRIED OUT FOR: PROPOSED ADDITIONS TO KAALFONTEIN HATCHERY ON: REMAINDER OF PORTION 7 OF THE FARM HARTEBEESTFONTEIN 17-IR, EKURHULENI METROPOLITAN MUNICIPALITY, GAUTENG PROVINCE**

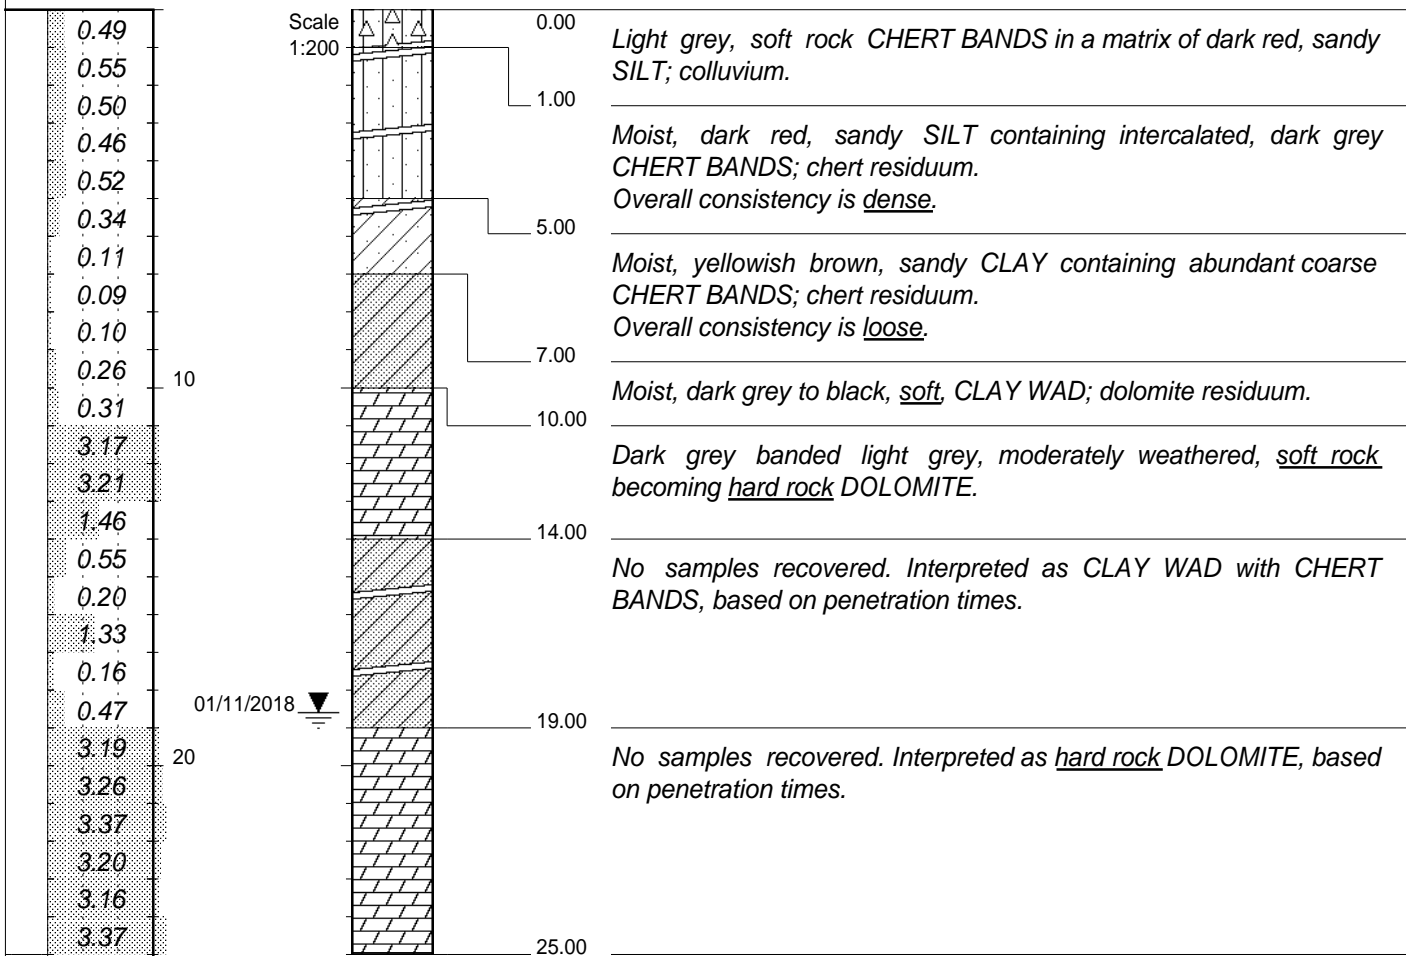
JOB NUMBER: **J13/3762**

- 1) Total air and material loss from below 14m.
- 2) No ground water seepage encountered.
- 3) Water table standing at 18,6m on 01/11/2018.

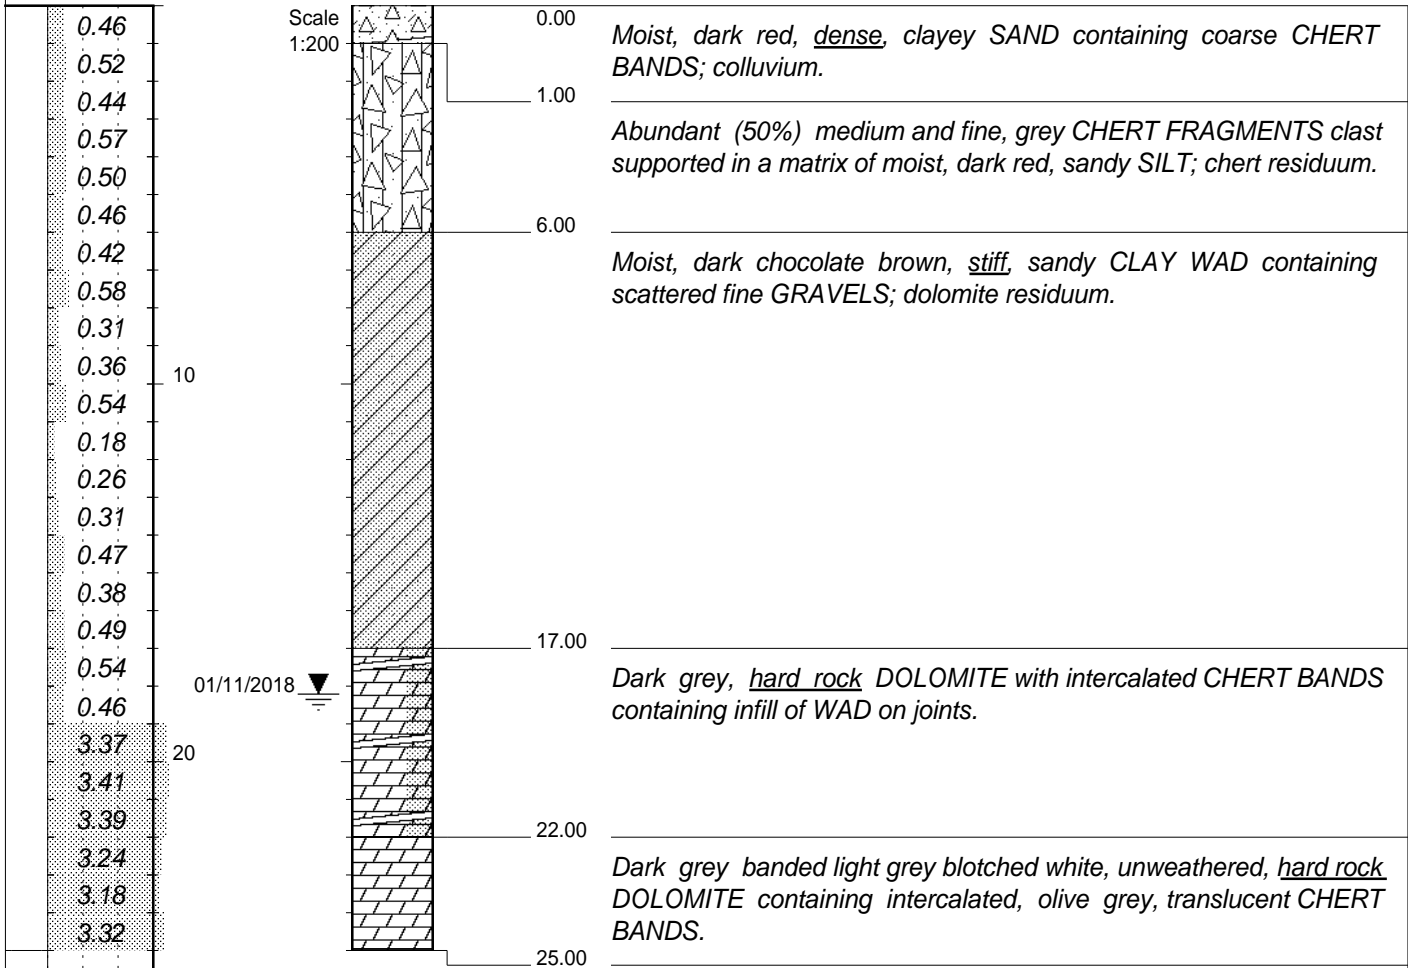
HOLE No: **KHB/2**  
 Sheet 1 of 1

- NOTES**
- 1) No ground water seepage encountered.
  - 2) No air or sample loss encountered.
  - 3) Water table standing at 18,2m on 01/11/2018.
