M&M TRANSPORT DIESEL DEPOT

Hydrogeological Evaluation, Portion 1 Erf 6154, Pietersburg
Extension 8, Polokwane Local Municipality, Limpopo

**HYDROGEOLOGICAL EVALUATION FOR THE PROPOSED M&M
TRANSPORT DIESEL DEPOT ON PORTION 1 ERF 6154,
PIETERSBURG EXTENSION 8, POLKWANE LOCAL MUNICIPALITY,
LIMPOPO PROVINCE**

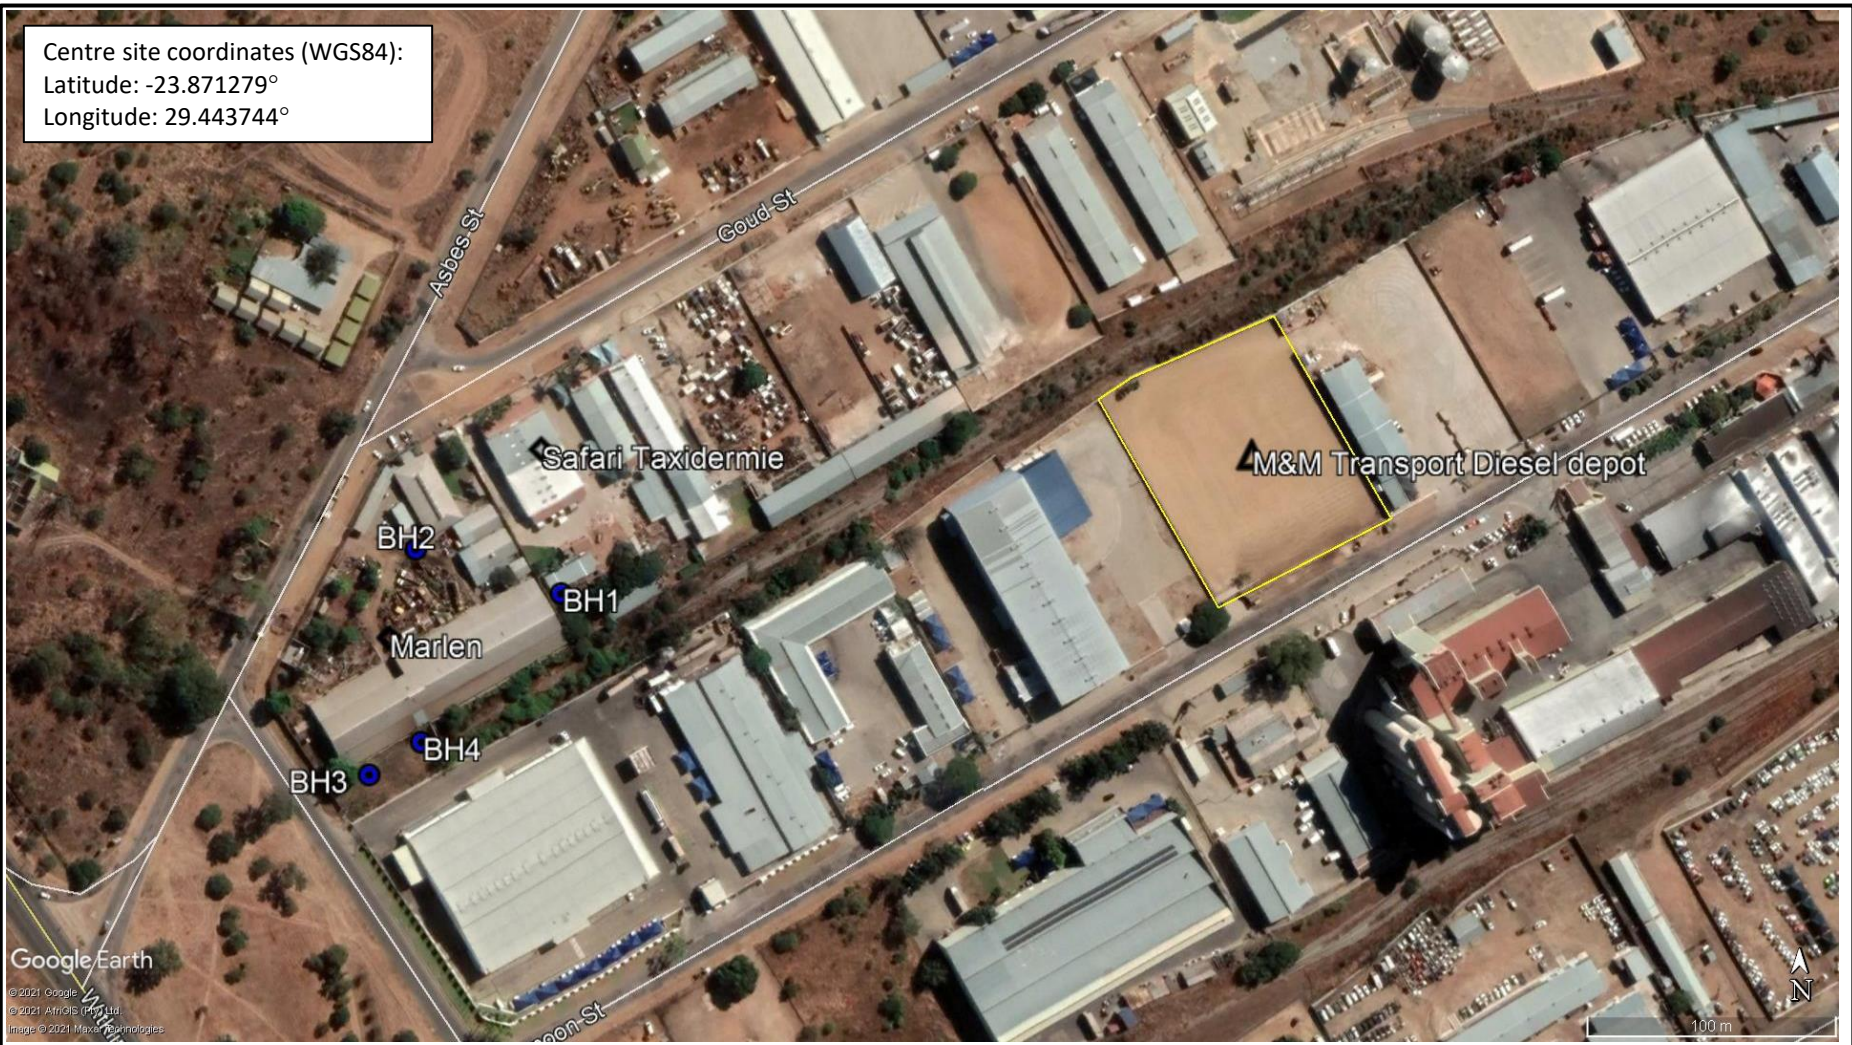
Project Description: M&M Transport Diesel depot
Investigation Type: Hydrogeological Investigation
Figure 8: Hydrocensus Map

No boreholes are located on the development property. Four boreholes were located on the neighbouring properties namely BH1, BH2, BH3 and BH4. Borehole BH1 was the nearest borehole located to the property and therefore sampled and tested for water quality analysis by a SANAS accredited laboratory. The locations of the boreholes are given in figure 8 and the borehole information is given in table 2.

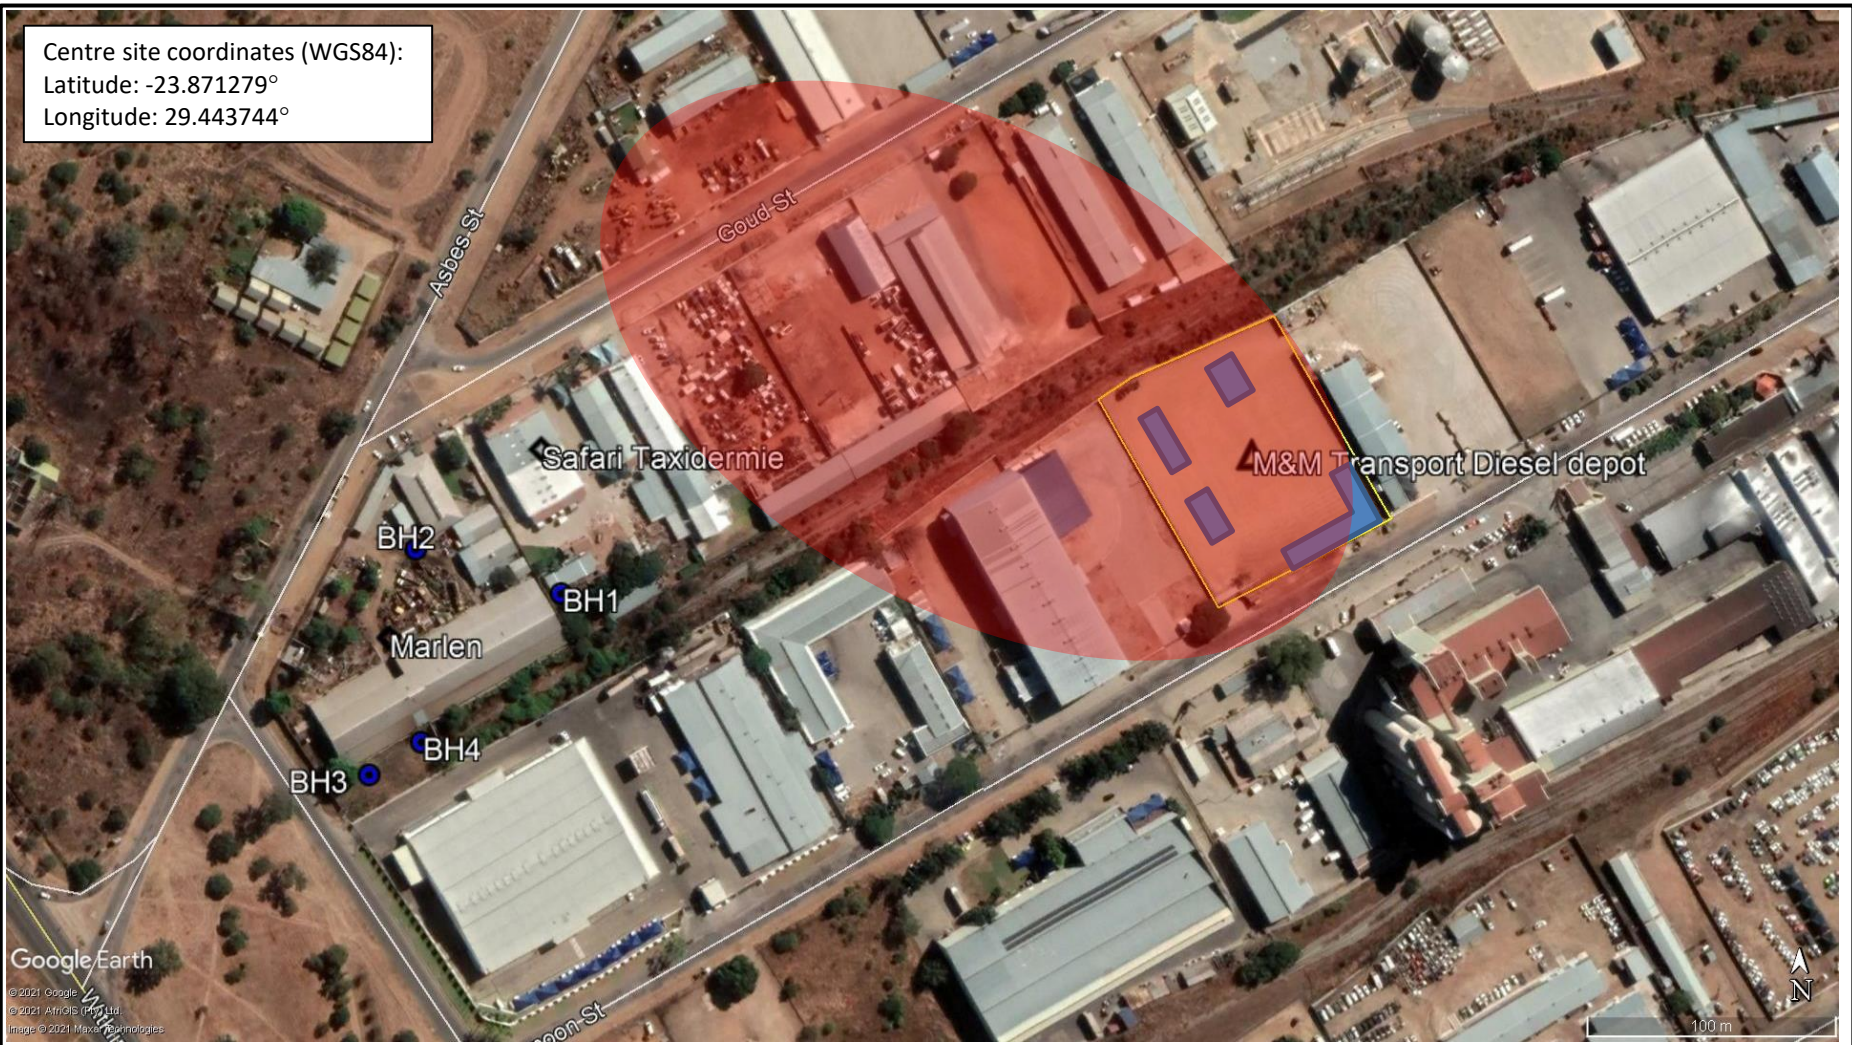
Project Description: M&M Transport Diesel depot
Investigation Type: Hydrogeological Investigation
Figure 10: Estimated maximum pollution plume emanating from a spill

The fate of any contamination emanating from the filling station is of concern as a potential source of groundwater contamination and seepage to surface water. The extent of any contaminant plume will depend on the volume of the spill and its duration, the rate at which natural attenuation takes place to degrade the spill by natural processes, and aquifer hydraulic properties. The estimated maximum pollution plume is given in Figure 10.
