MOTIVATION FOR APPLICATION BY JAGERSFONTEIN DEVELOPMENTS (PTY) LTD FOR A PERMIT IN TERMS OF SECTION 38(1) OF THE NATIONAL HERITAGE RESOURCES ACT, NO 25 OF 1999 ("NHRA") FOR THE PROPOSED BACKFILLING OF THE OLD JAGERSFONTEIN OPEN PIT LOCATED ON PORTION 15 OF THE FARM JAGERSFONTEIN 14 IS, SITUATED IN THE MAGISTERIAL DISTRICT OF XHARIEP, FREE STATE PROVINCE

1.1 Jagersfontein Developments (Pty) Ltd ("**JD**") proposes to backfill the old Jagersfontein open pit ("**Pit**") with fine tailings suspended in water ("**Paste**") and coarse tailings from its tailings processing operations ("**Tailings Operations**").

2 PHOTOGRAPHS OF PIT

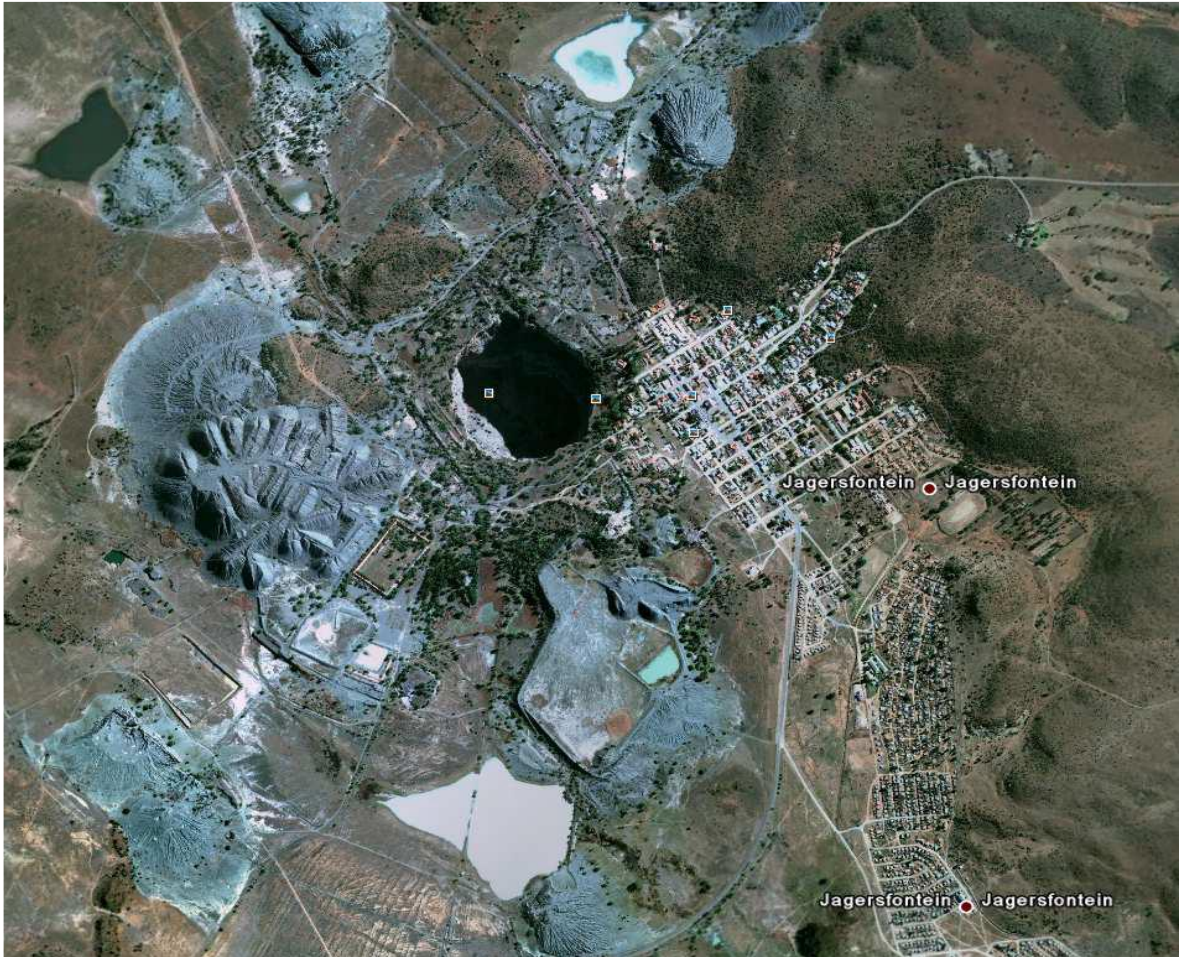
Figure 1: Aerial map of the pit and surrounds

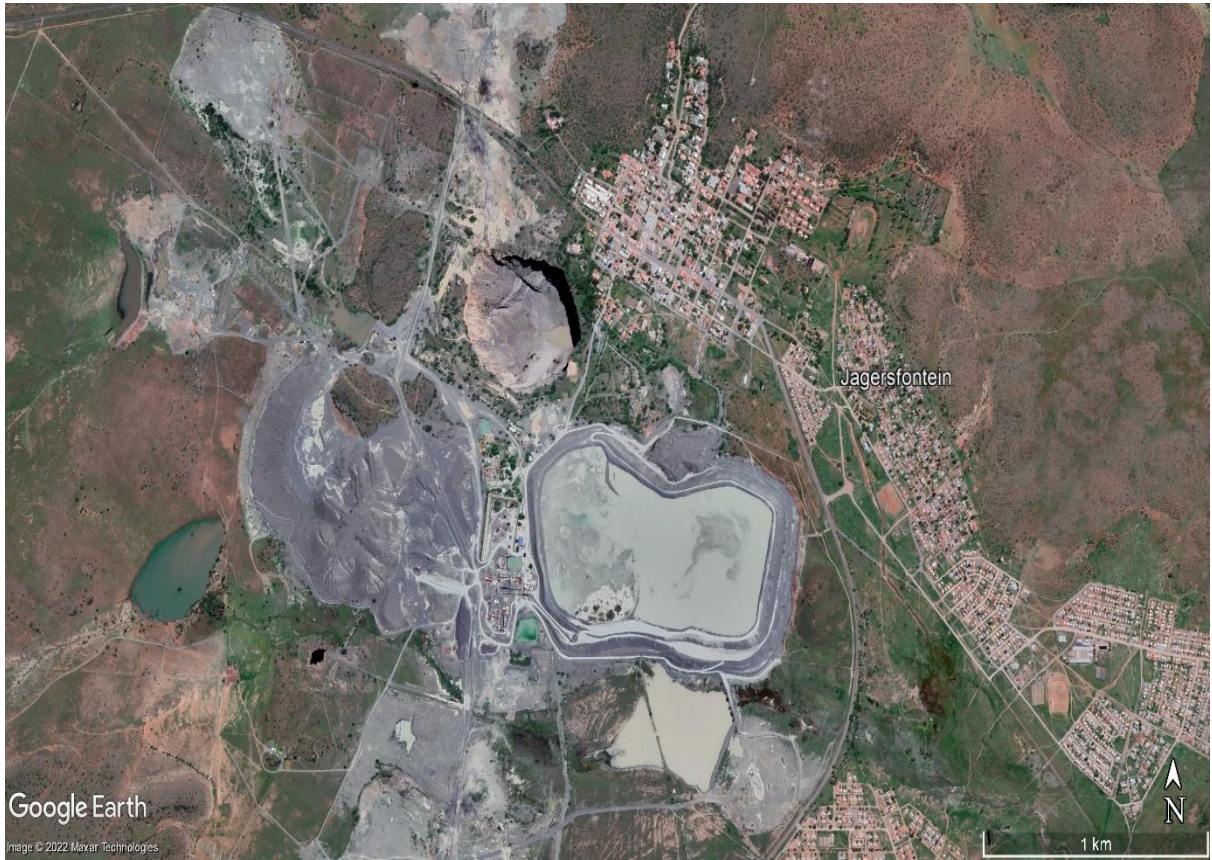
Figure 2: 2022 serial map of the Pit and surrounds

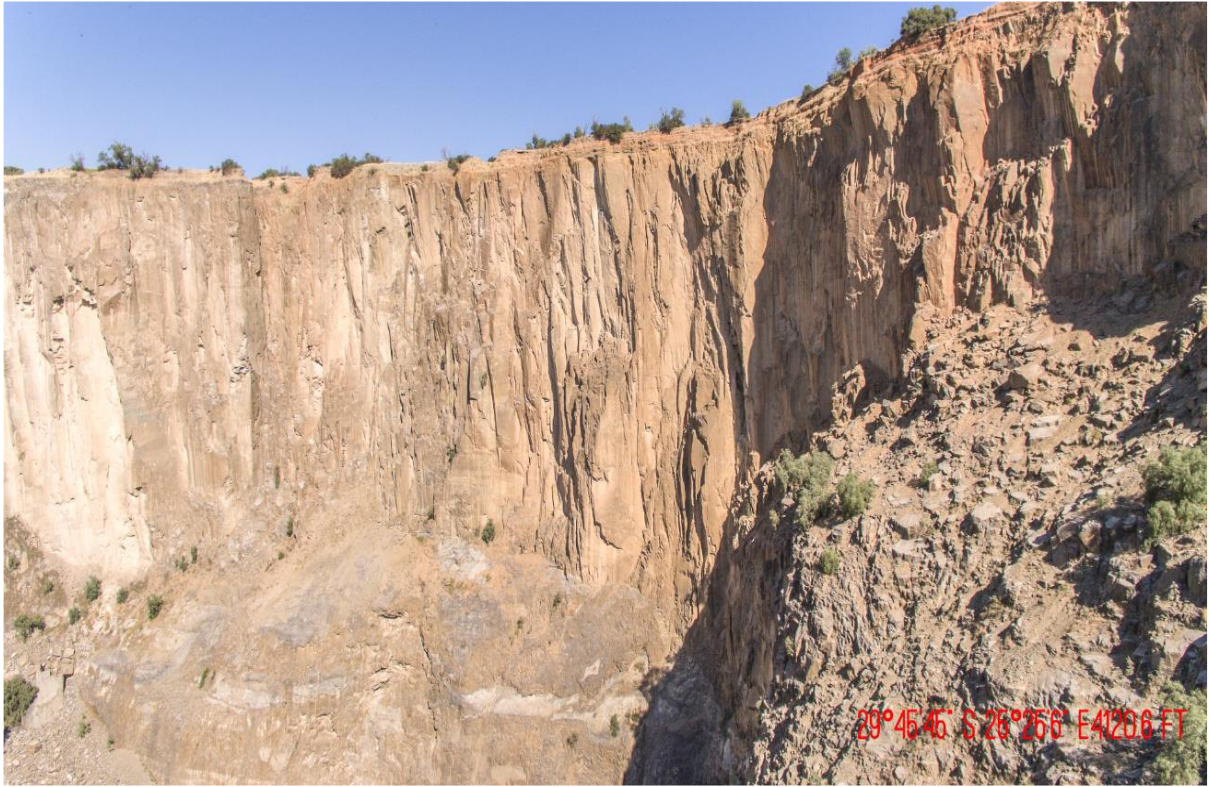
Figure 3: Clear indication of the pit mining itself, caving in

- 3.3.1 The Pit is currently in a serious state of degradation and very unstable, due to back-breaking of the sides / walls, which has and can result in associated vibrations in the area. The risks posed by the Pit, which are further detailed below, were previously assessed by Mr HAC Meintjies and Dr G Howell of SRK Consulting (South Africa) (Pty) Ltd ("**SRK**") in the report entitled "*Review of Jagersfontein Pit Stability and Backfilling Options*" (Report Number 445072/1, April 2012) ("**2012 Initial Geotechnical Report**").

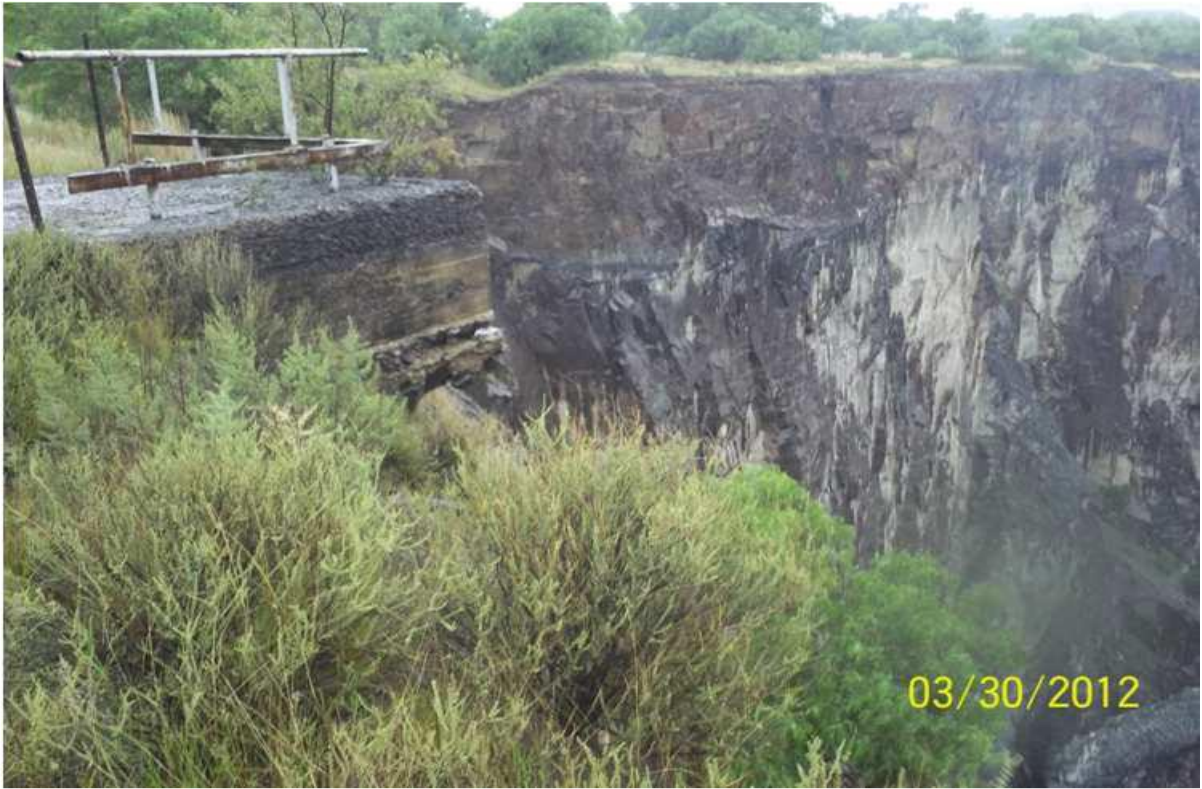
Figure 4: Condition of the outlook position.

- 5.1.1.1.11 An outlook was present on the Pit's northern side. The rock beneath the Pit has completely collapsed.⁵
- 5.1.1.2 The photographs on pages 17-20 of the 2012 Initial Geotechnical Report and clearly depict the Pit's instability. Drone photos also clearly reflect the collapse / caving in of the Pits walls are also included in the May 2017 Underground Pit Condition Inspection Report (pages 11 – 15).

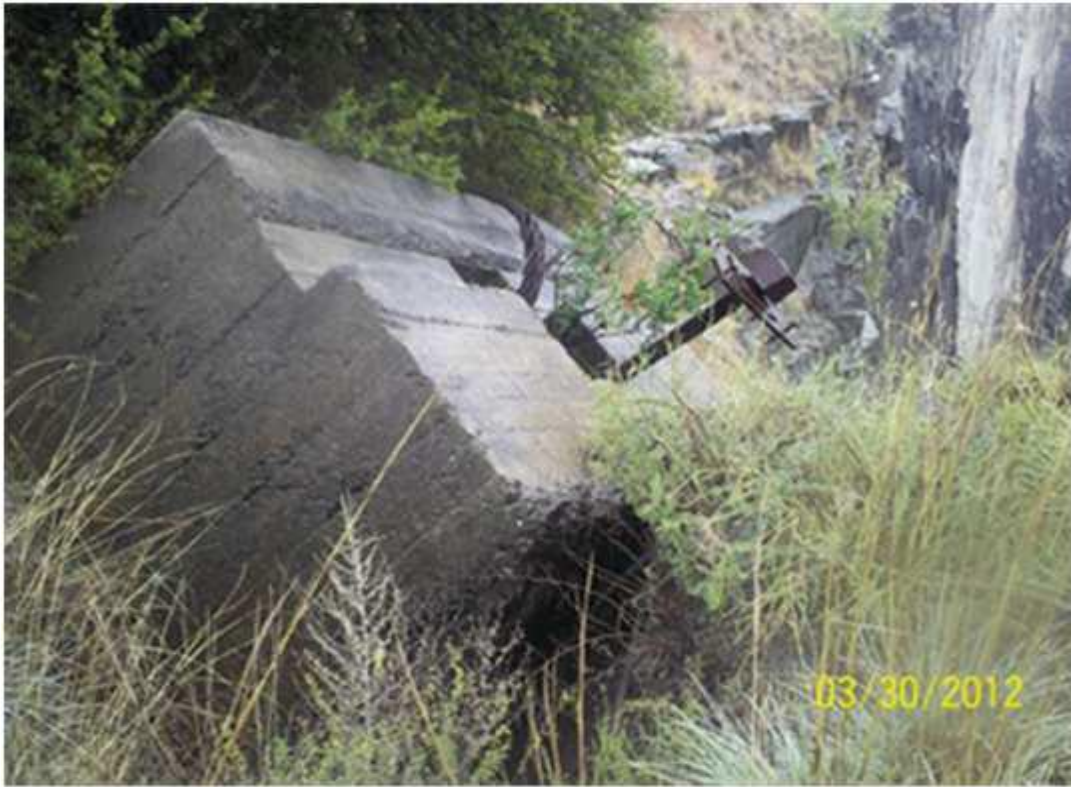
Figure 5: Old undermined installations.

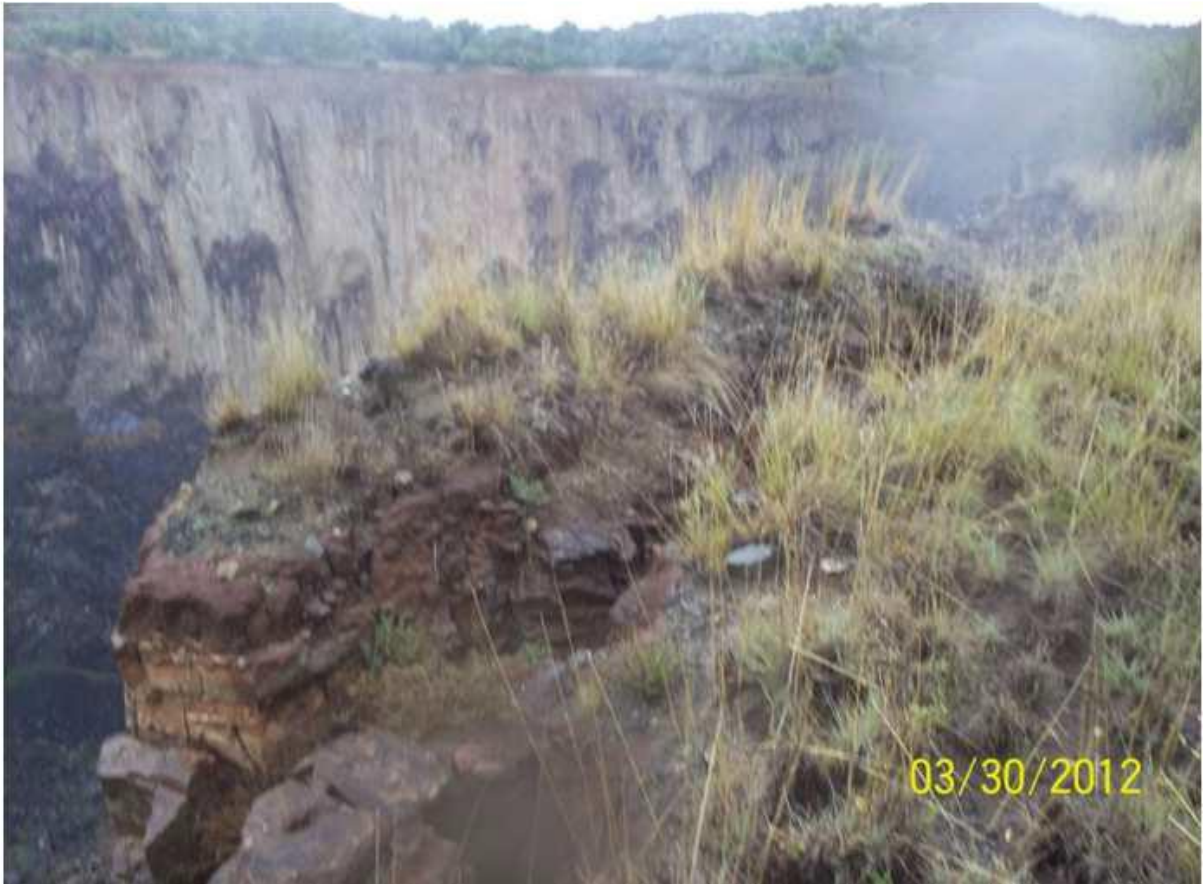
Figure 6: Block of material about to fall into the Pit.

5.1.1.1.3 At SRK's site visit to the Pit in 2012, abundant boulders were noted on the Pit's floor, which have fallen from the upper slopes, indicating the presence of an active geological process.³ (These boulders can still be observed).

5.1.1.1.10 During a Site visit, there were two occasions when noise was heard from the Pit's side slopes when large rock boulders broke loose and fell to the bottom of the Pit. This is ongoing evidence related to active geological processes attempting to flatten the Pit's side slopes in the longer term, by the slope's break back phenomenon.

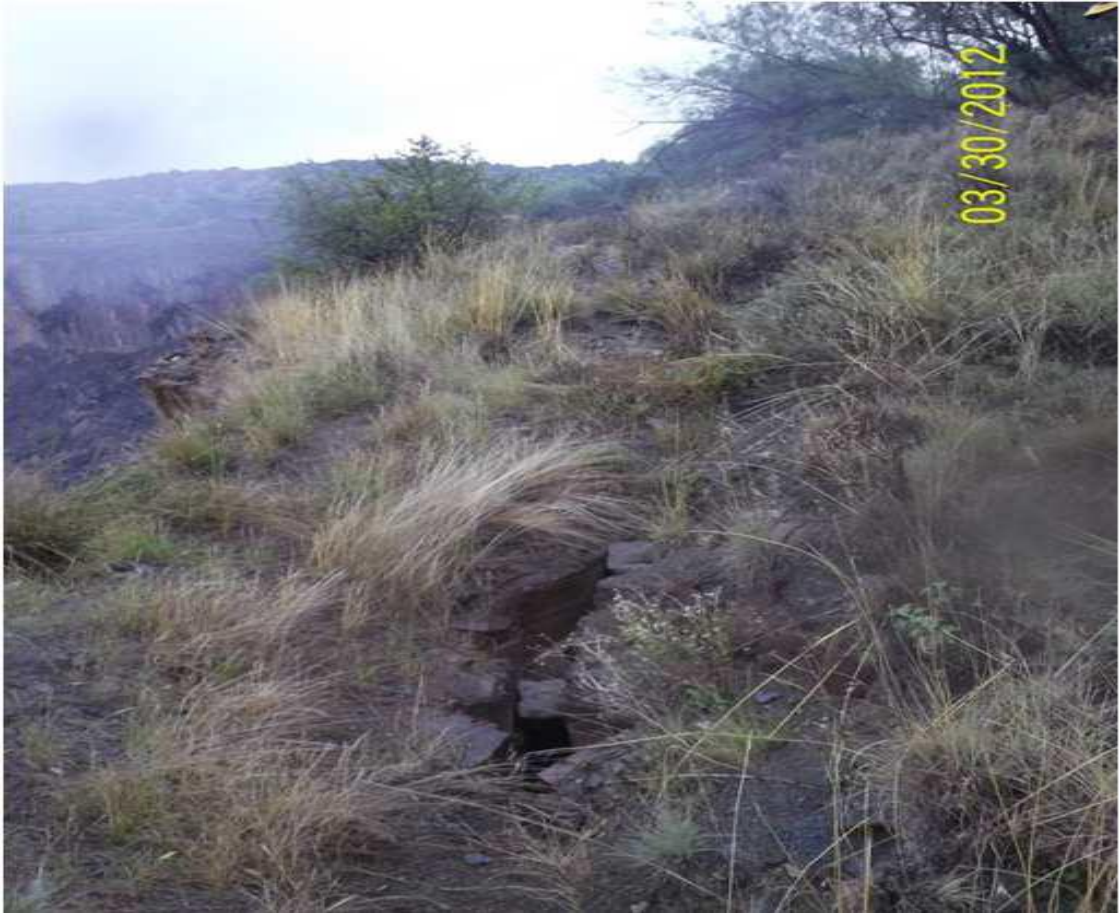
Figure 7: Numerous cracks at distance of 5m 10m from the edge of open Pit.

5.1.1.1.5 There are numerous places at the Pit where the joints are open, clearly due to movement which will influence the development of break back. On the northern side, open joints were observed, indicating further development of break back on this area.

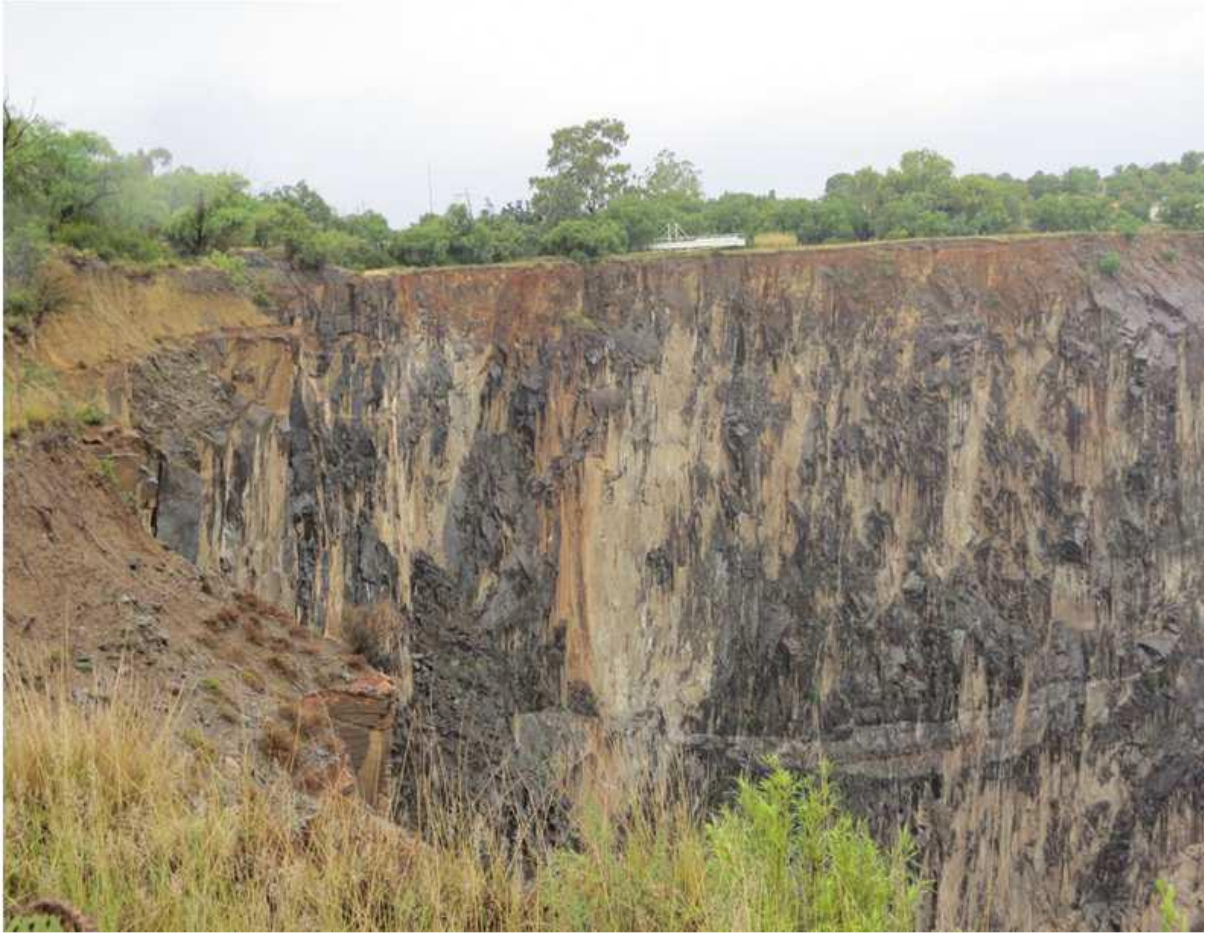
Figure 9: Very consistent high wall rock conditions close to the outlook location

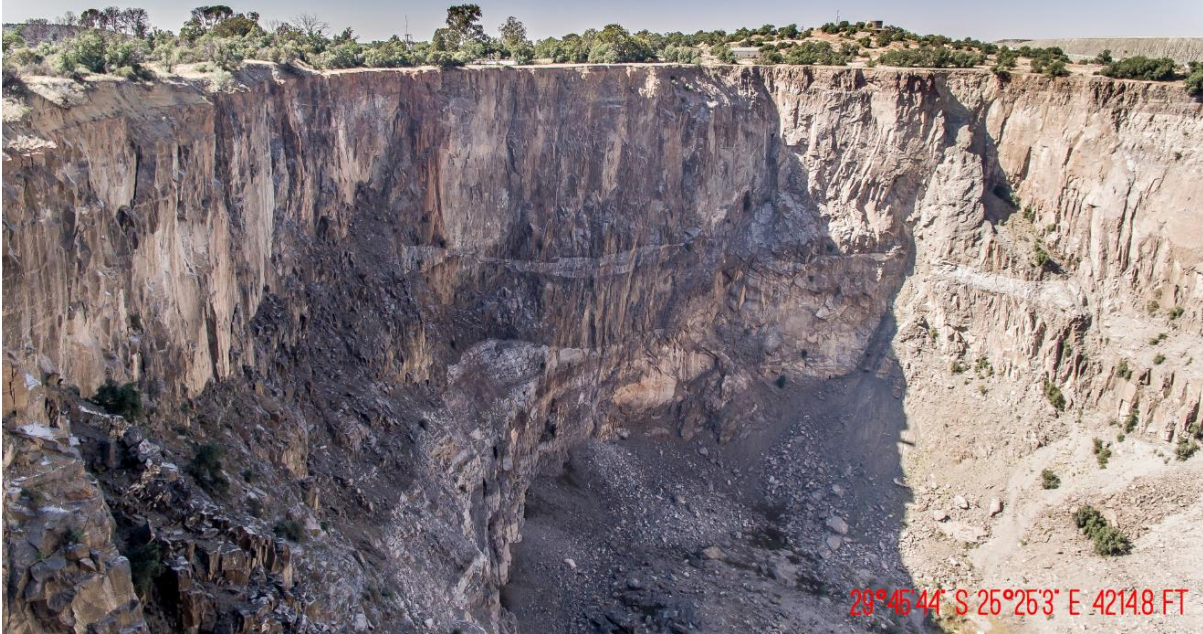
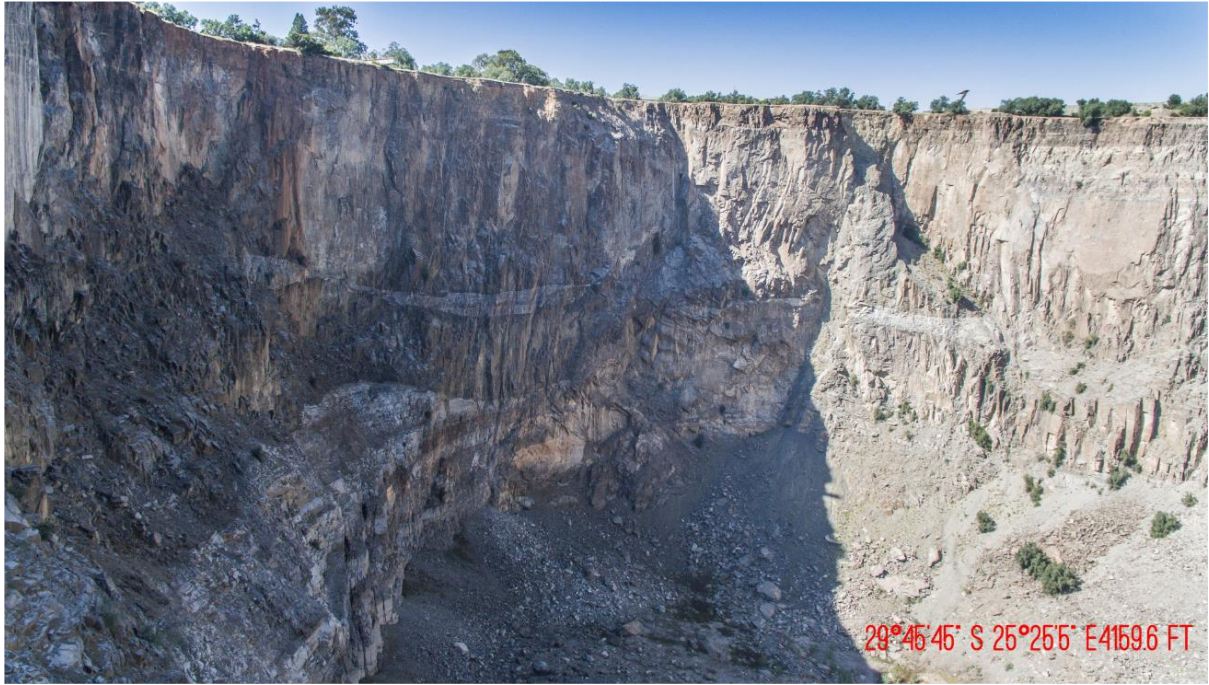
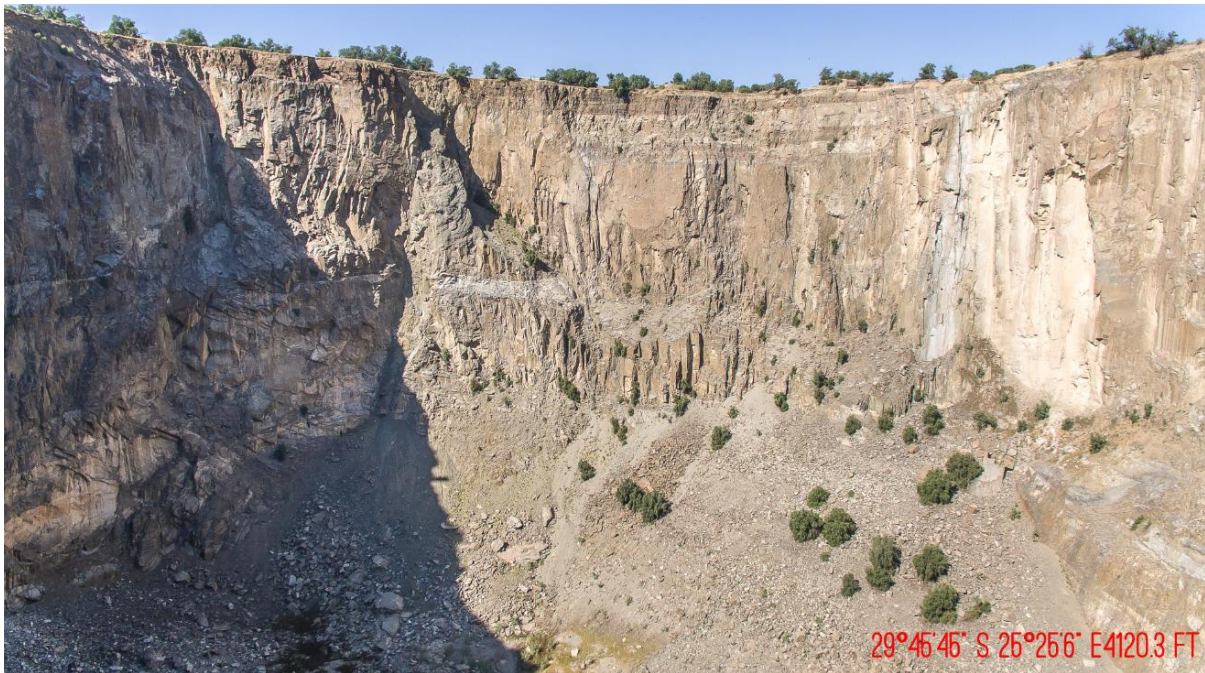
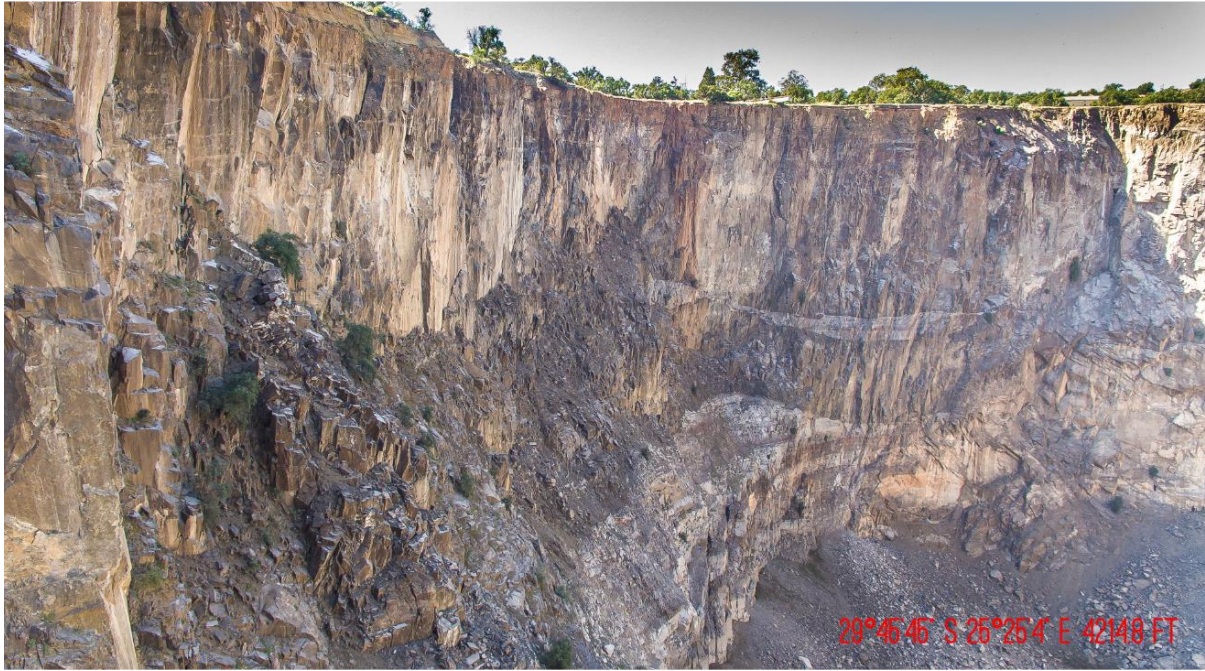
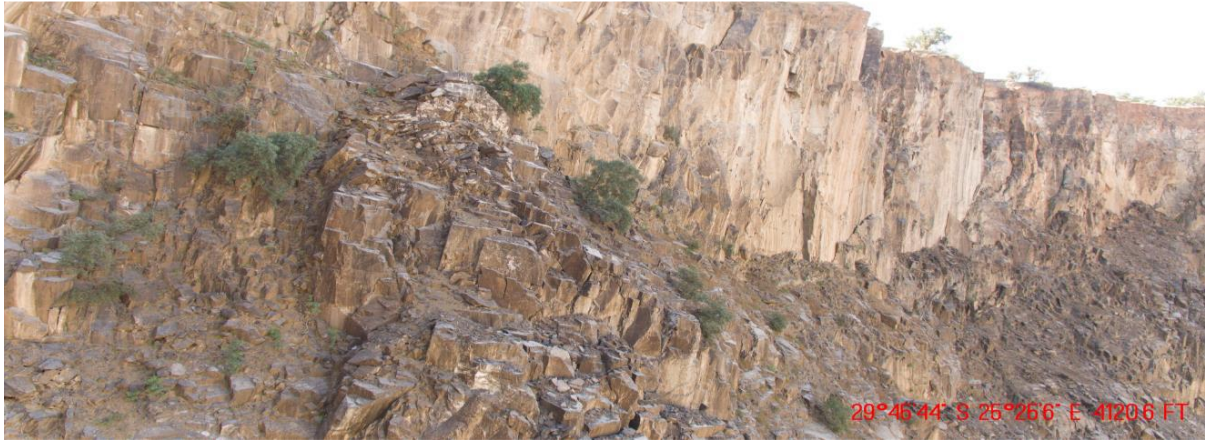
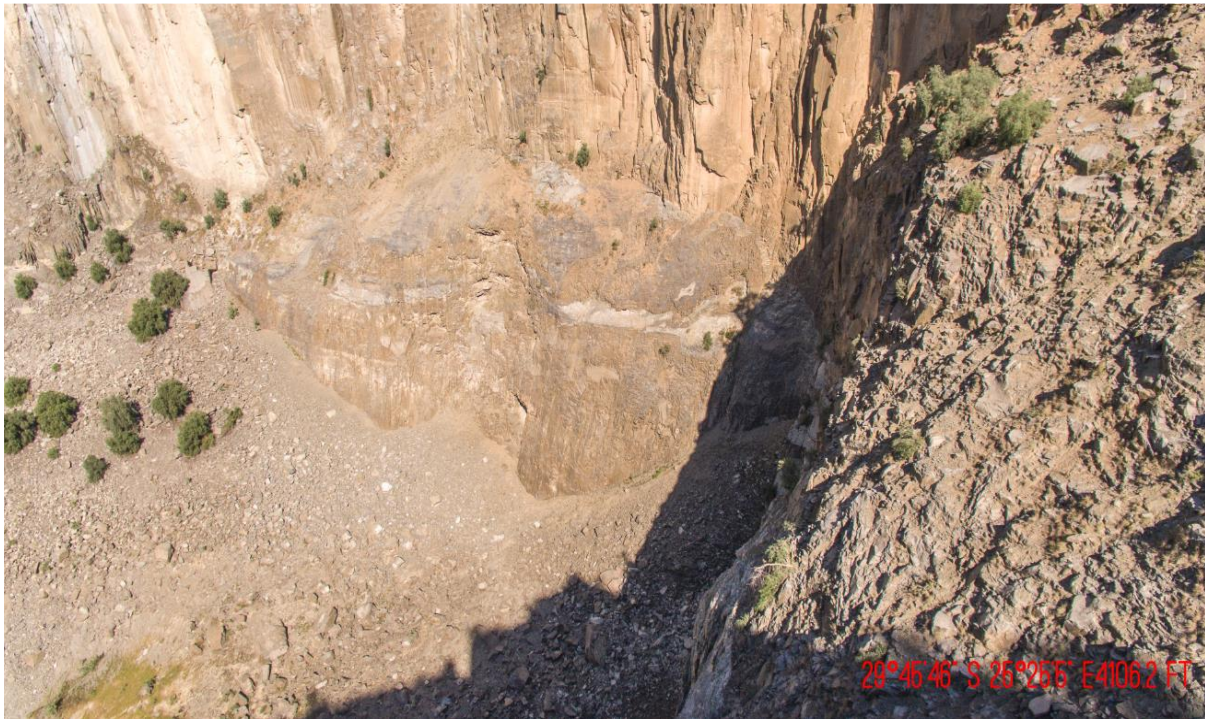
May 2017 Underground Pit Condition Inspection Report – Drone Photos

Clear indication of Pit caving in
