MOTIVATION FOR PROPOSED ALTERATIONS  
to  
GLEN DIRK HISTORIC CISTERN  
Erf 10373 Klaasens Road, Wynberg

Rod Gurzynski Architect

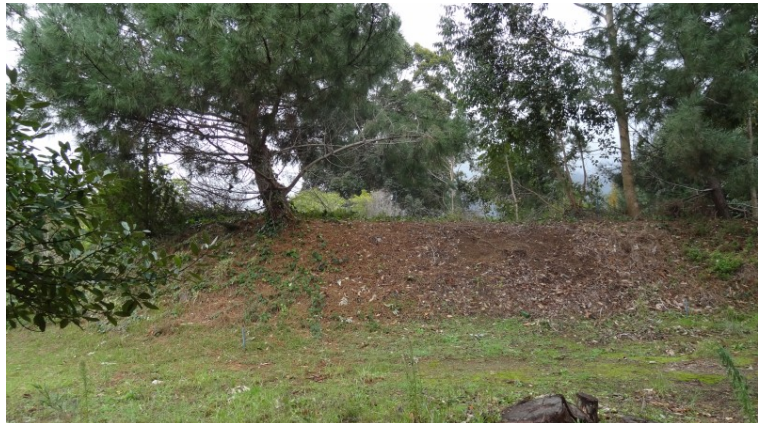
Cistern: view of north side

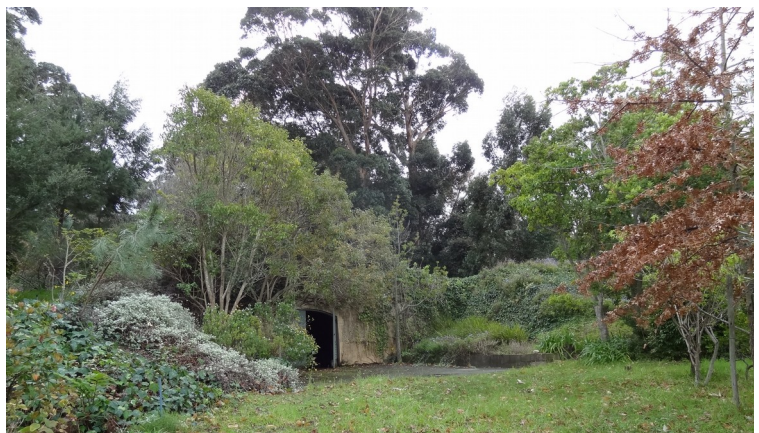
Cistern: view of south side with doorway

Measuring 20m x 17m at the base and covering 345m<sup>2</sup>, the cistern is partly sunken into the ground and partly contained by an earth embankment. On the lower, southern side there is a doorway, a later intervention made for access for storage. Apart from that, only a screeded vaulted brick roof is visible from the top of the embankment. The roof is supported by mass concrete arches which are visible internally as a consequence of the access door. Prior to that, the only access was by way of a service hatch.

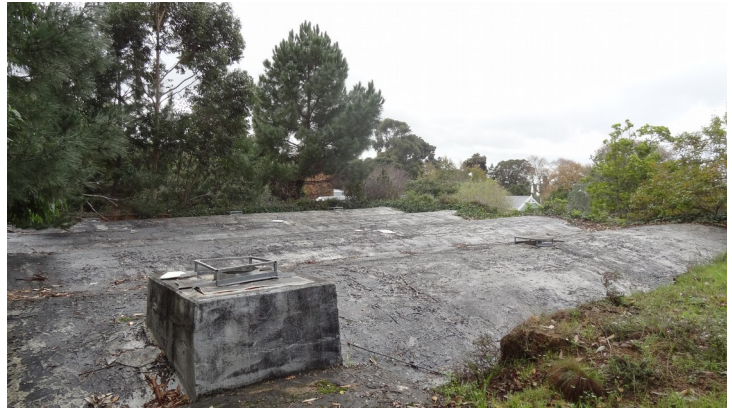
Cistern: view of roof

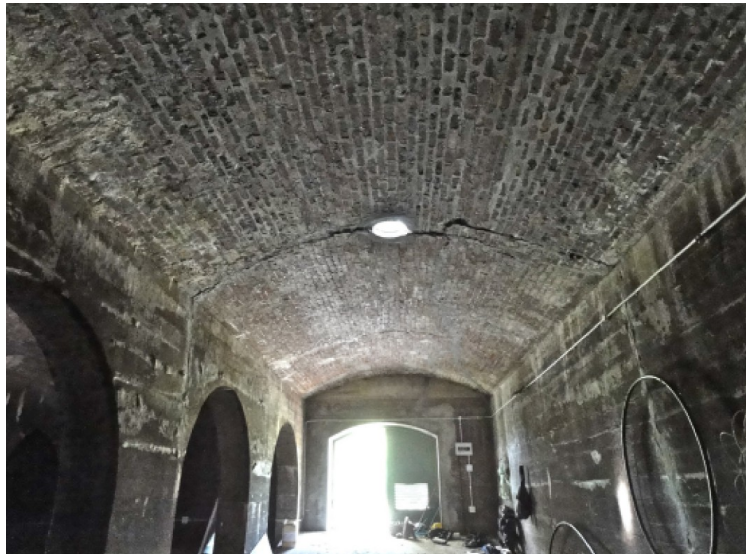
Cistern: view of interior.  
Note structural crack running through the vault at mid-span, through piers and perimeter wall.

The cistern is damaged due to ground settlement and cannot be safely used without major structural repair.<sup>4</sup> The structural crack is the result of movement of the foundations.

3. The proposed line of the cut corresponds with a structural crack that runs through the roof from west to east, through the concrete support arches and external wall. This intervention will include underpinning the foundations thus ensuring that the cistern is saved from collapse.

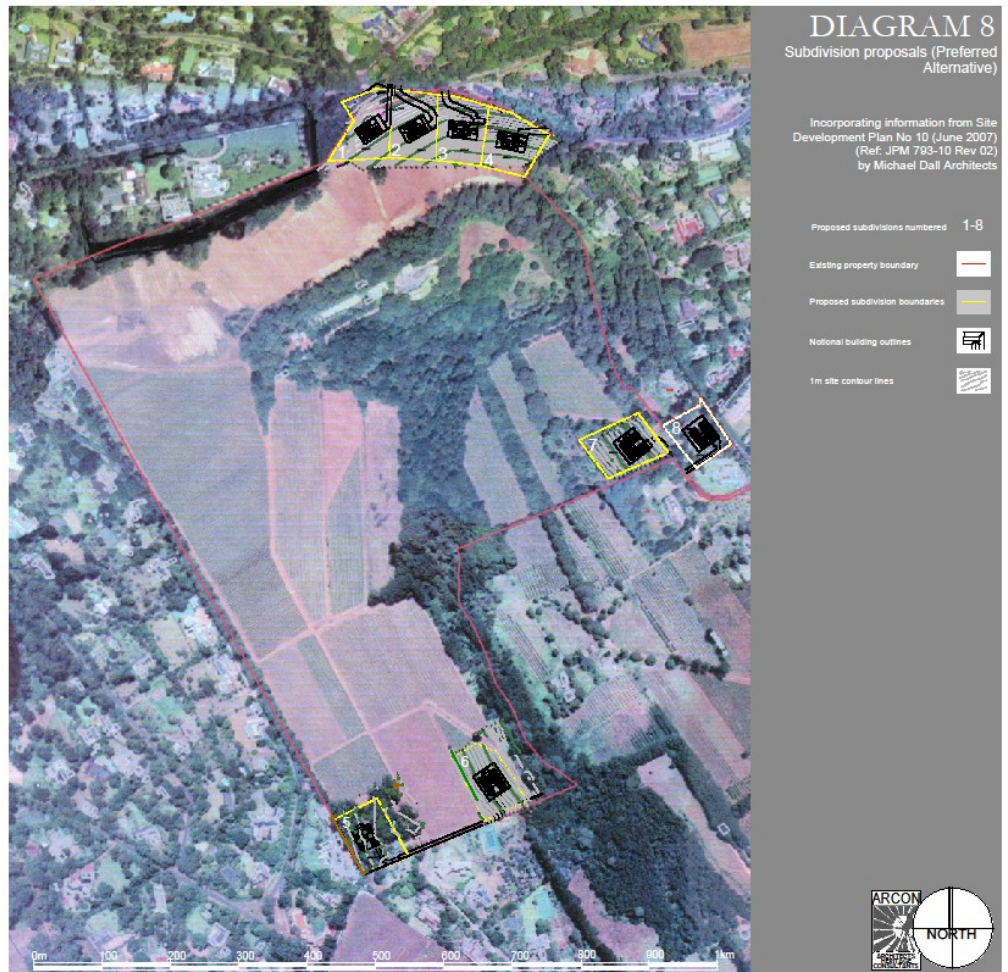
The portion is identified as no. 8 in the diagram below, which shows a notional building outline in the middle of the property.

Glen Dirk Farm HIA: subdivision proposals (preferred alternative), diagram 8<sup>3</sup>

This proposal is for a new residence and alterations to the cistern on an undivided portion of erf 10373, on the site of portion 8 on diagram 8 which has been identified and approved for use for a domestic residence.

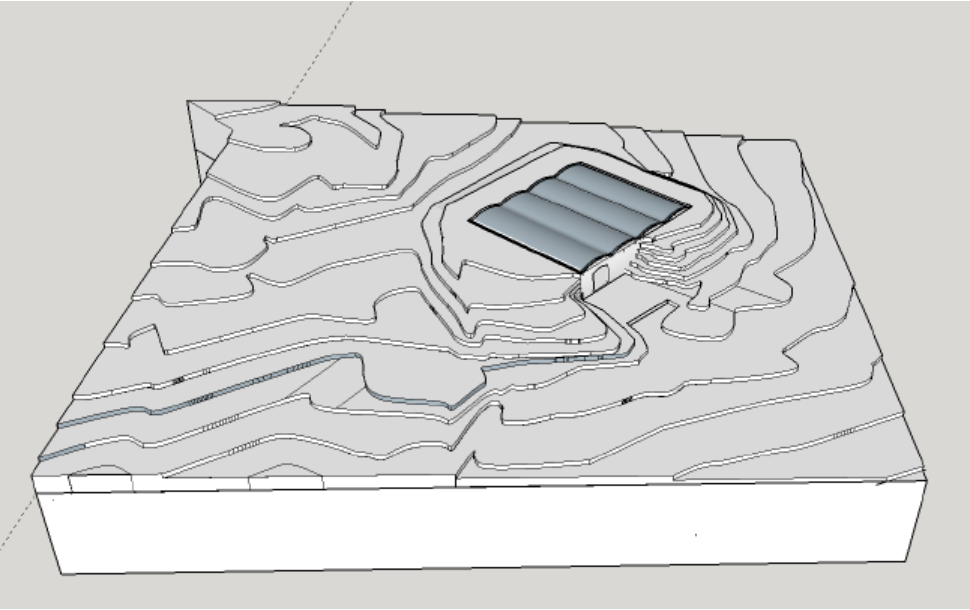
Site topographical view

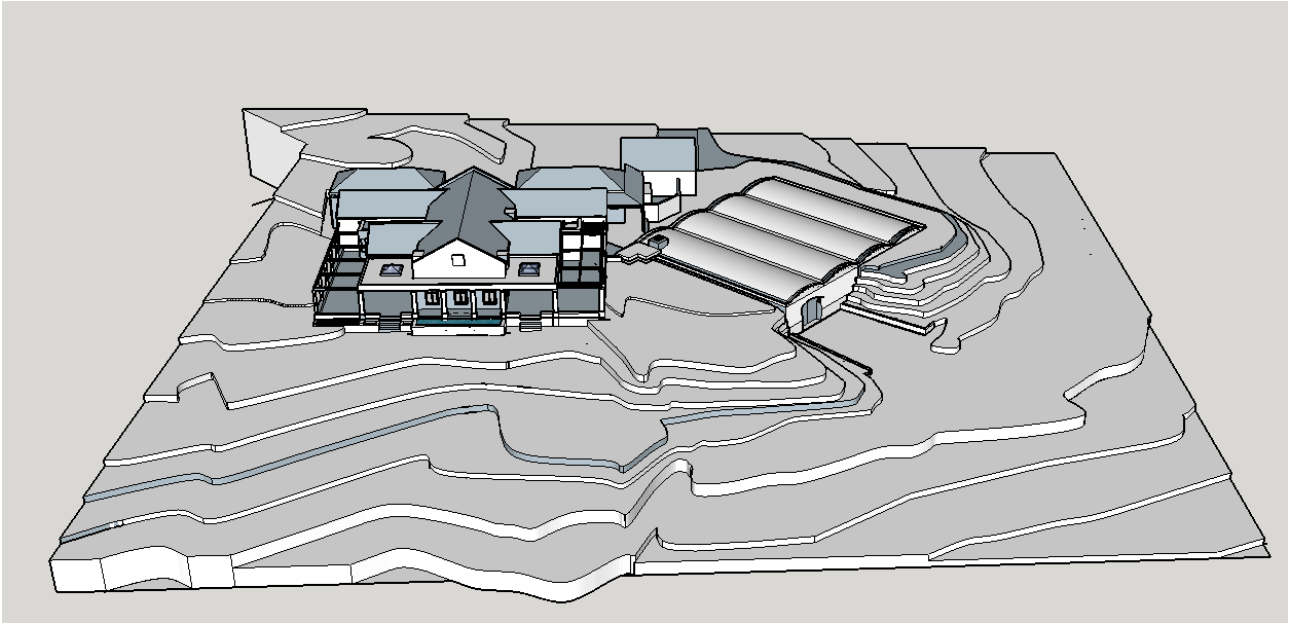
The views below show the house in relation to the cistern, with the cistern as-is and with part of the roof removed to create the sunken courtyard kitchen-garden.

Birds eye view of house and cistern without intervention

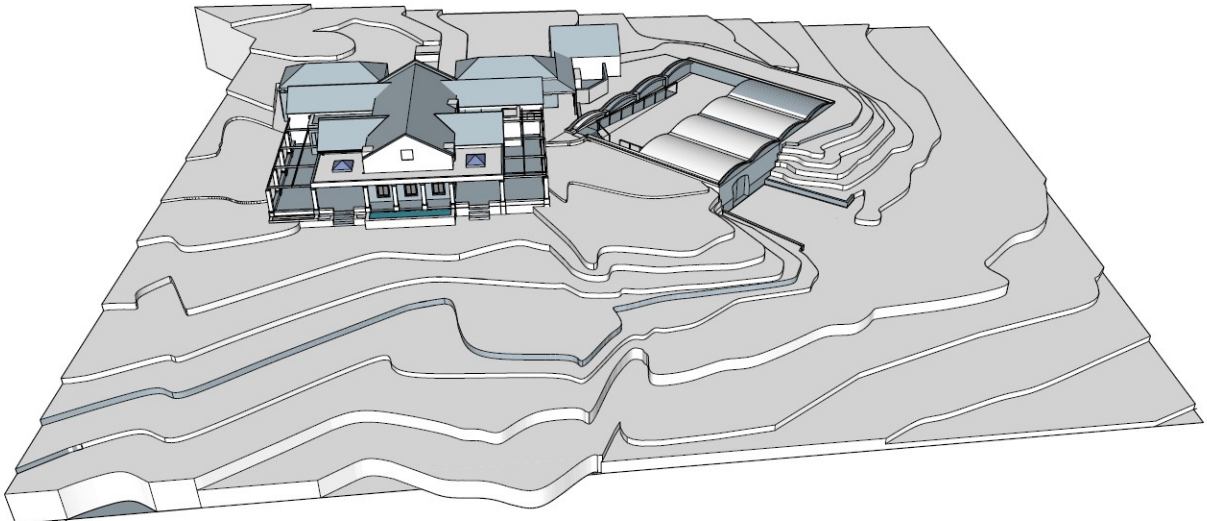
Birds eye view of house and cistern with sunken courtyard kitchen-garden

It is proposed therefore to create the sunken kitchen-garden by removing part of the cistern's vaulted roof, starting from the line of the structural crack mid-way through the length of the vaults and stopping short of the vaulted wall on the north side. The shape of the brick vaults would thereby be made visible in elevation, emphasized further by means of vaulted brick segments cantilevered over the walls on both sides of the courtyard by 300-400mm, as if in section. This is all as recommended in the Heritage Statement.<sup>5</sup>

A pre-cast concrete floor system would be inserted 1.2 metre down from the top of the cistern walls, with a brick ramp and some stairs leading down from the house patio. The ramp, stairs and the new wall along the cut line would be faced with brick from the demolished portion of the roof. The external walls of the cistern forming the internal walls of the sunken courtyard kitchen-garden would be retained as-is. The kitchen garden would be housed in hardwood timber boxes.

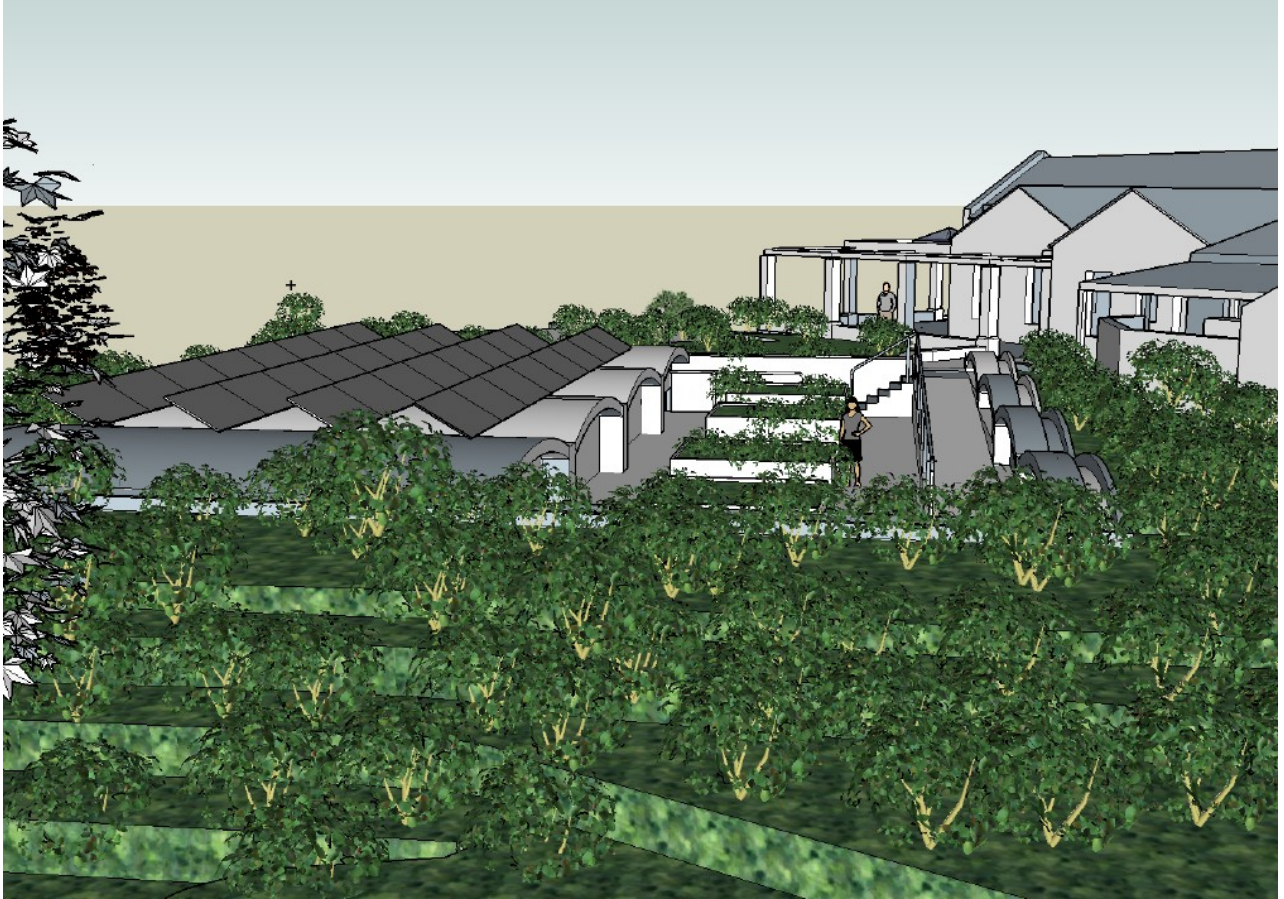
Birds eye view from east, with PV panels.

Secondly, with its barrel vaults aligned true north-south, the cistern is perfectly oriented for the location of photovoltaic panels. Half of the total roof area is required for this. Using the cistern roof in this way solves the problem of locating PV panels since the roofs of the house are not aligned to north (the plan of the house is aligned to the view). This also removes the problem of an aesthetic mis-match between the scale of the solar panels relative to the small scale of the house roofs.
