Department:
Public Works and Infrastructure
REPUBLIC OF SOUTH AFRICA

INTERNAL MEMORANDUM

Subject:	Parliamentary Precinct : Old Assembly building-fire damage : Temporary Roof and gable stabilisation
-----------------	--

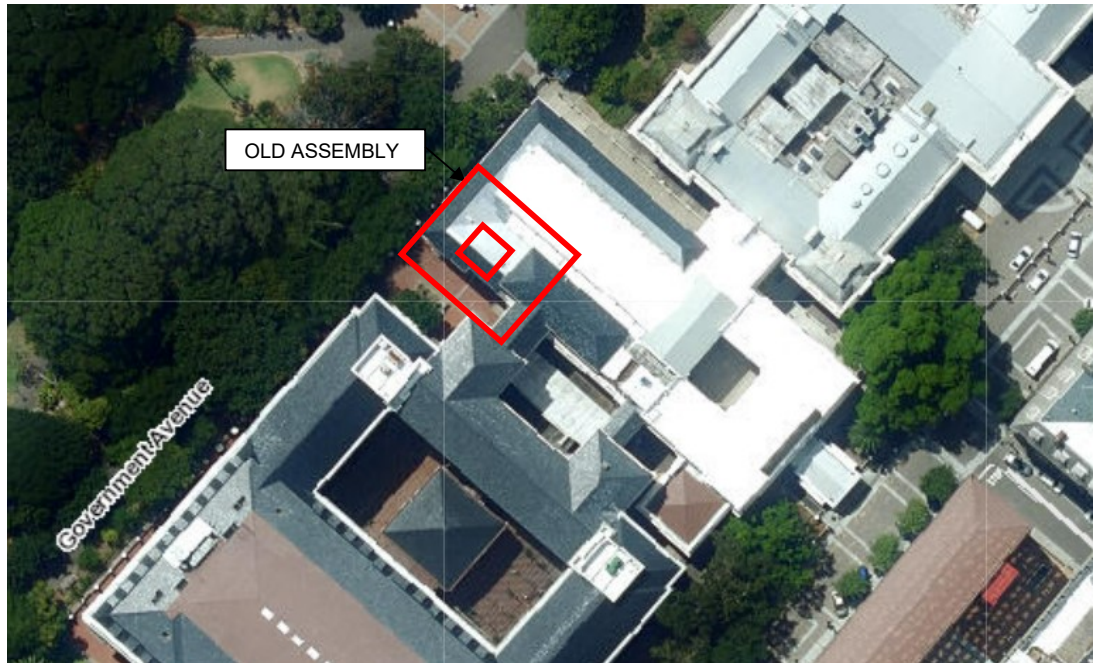
- 2.1. The building is located between Parliament Street & Government Avenue. The affected area is highlighted in red in the image below. Access to the building is restricted therefore access should be arranged prior to visiting the site. See Annexure B for a locality plan of the Precinct
