## **Rehabilitation Plan for alluvial diamond mining operations at Rooipoort on the farms Zandplaats 102/5, Vogelstruis Pan 101/0, Vogelstruis Pan 98/0, Bergplaats 100/0 and Klipfontein 99/0 near Schmidtsdrif, Northern Cape Province.**

August 2018

### **Darius van Rensburg**

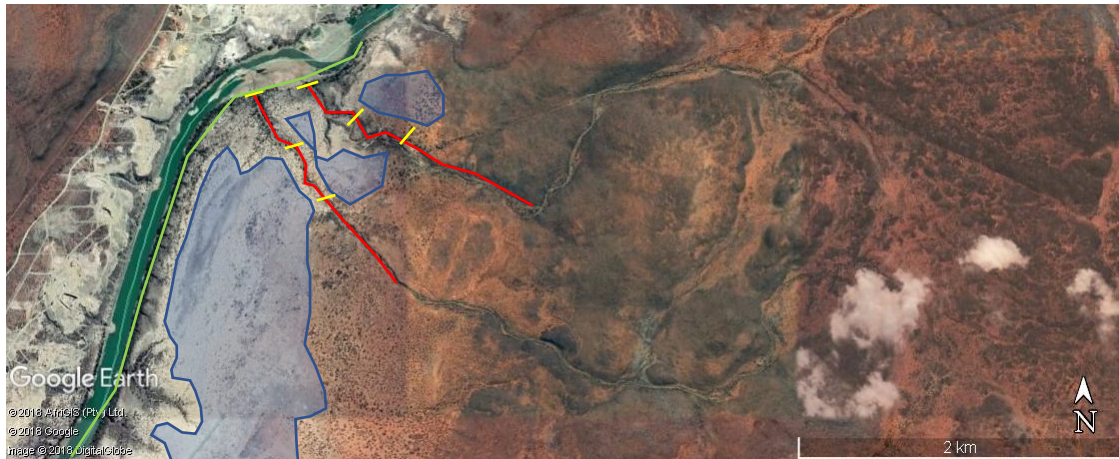
Figure 13: Illustration of the recommended of mining, i.e. first catchment, then watercourses, then the Vaal River (Google Earth 2018). Blue indicates catchment, red watercourses, yellow transverse berms and green the Vaal River.

The recommended mining order can be summarised as follows (Figure 13):

- Mine the catchment in the interior of the study area and rehabilitate (blue).
- Mine the smaller watercourses within the interior of the study area and rehabilitate (red).

- Mine the bed and banks of the Vaal River and associated alluvial fans and rehabilitate (green).

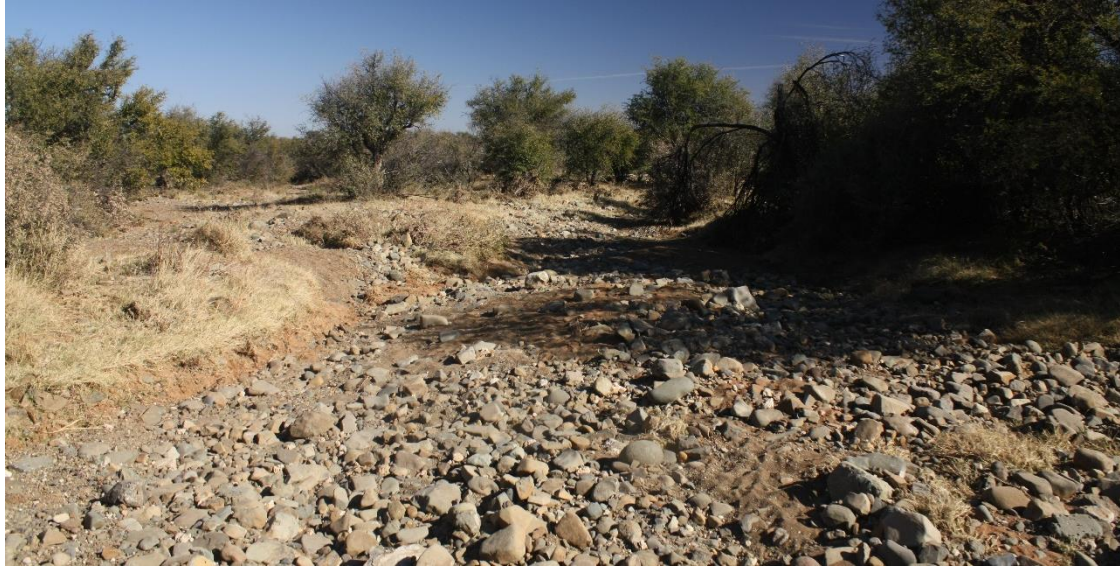
Figure 18: View of one of the watercourses in the study area with a bed dominated by round stream rocks. Such a bed will aid in decreasing erosion.

Where seasonal or ephemeral watercourses in the interior of the study area is affected additional erosion measures should also be implemented. A berm should be erected perpendicular to the direction of flow and across the main channel of the watercourse. This will retard water flow following mining and will stem gully erosion within the main channel. Many of the watercourses in the study area also contain a bed covered by round stream rocks (Figure 18). These also aid in retardation of flow and would decrease erosion. As a result, where erosion is problematic rocks can be placed in the main channel to aid with erosion prevention.

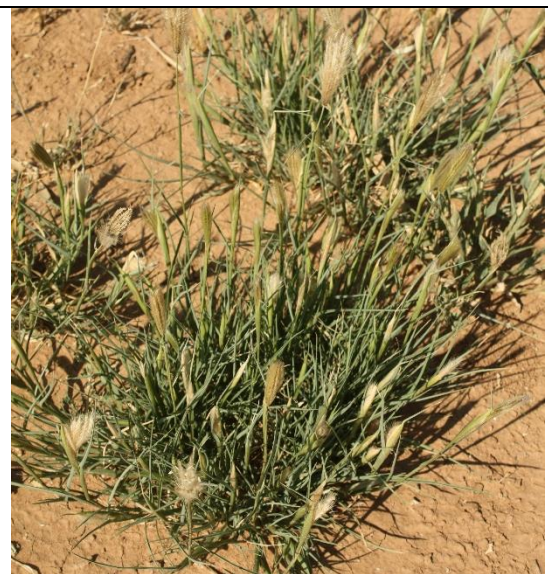
Figure 19: Grasses recommended to be seeded along watercourses affected by mining.

Seeding of rehabilitated areas is a sound basis for the establishment of a riparian vegetation layer. Hydro seeding mixes is commonly available but as the site in question consist of riparian vegetation these mixes are unlikely to successfully establish in an area which experiences periodic flooding. It is therefore recommended to source seeds of riparian species already present at these sites. Harvesting of seeds from the surrounding areas is anticipated to have mixed results as time of seeding varies and amount of seed harvested will be low. It is therefore considered an option to source commercially available seed.

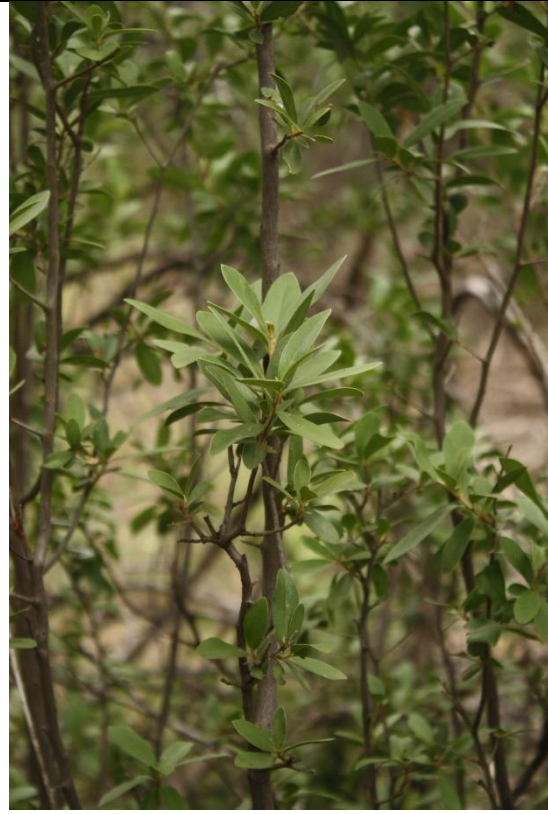
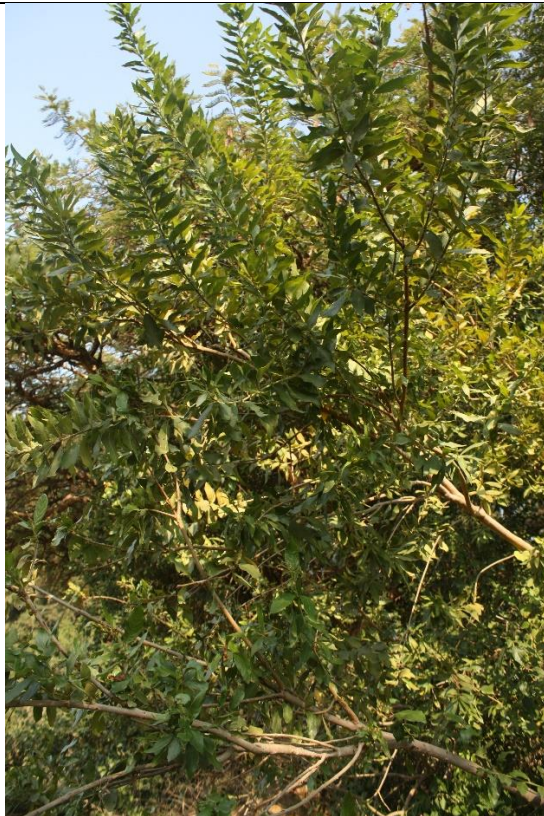
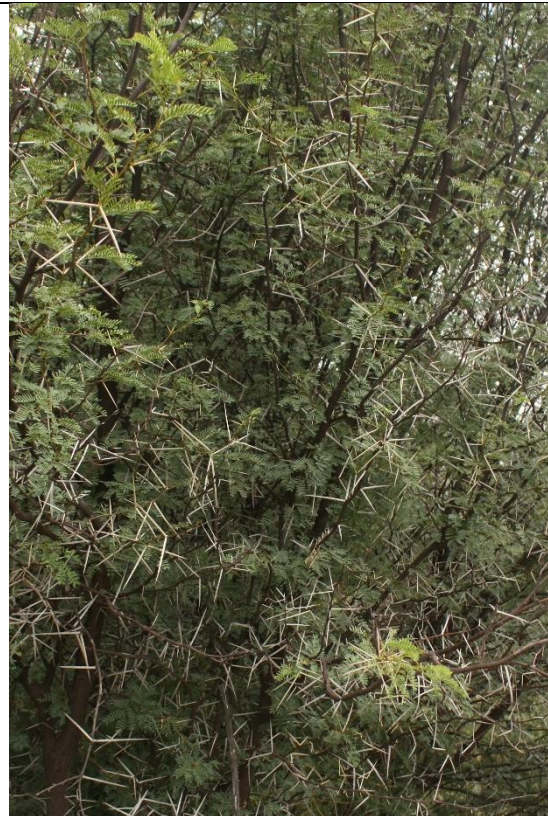
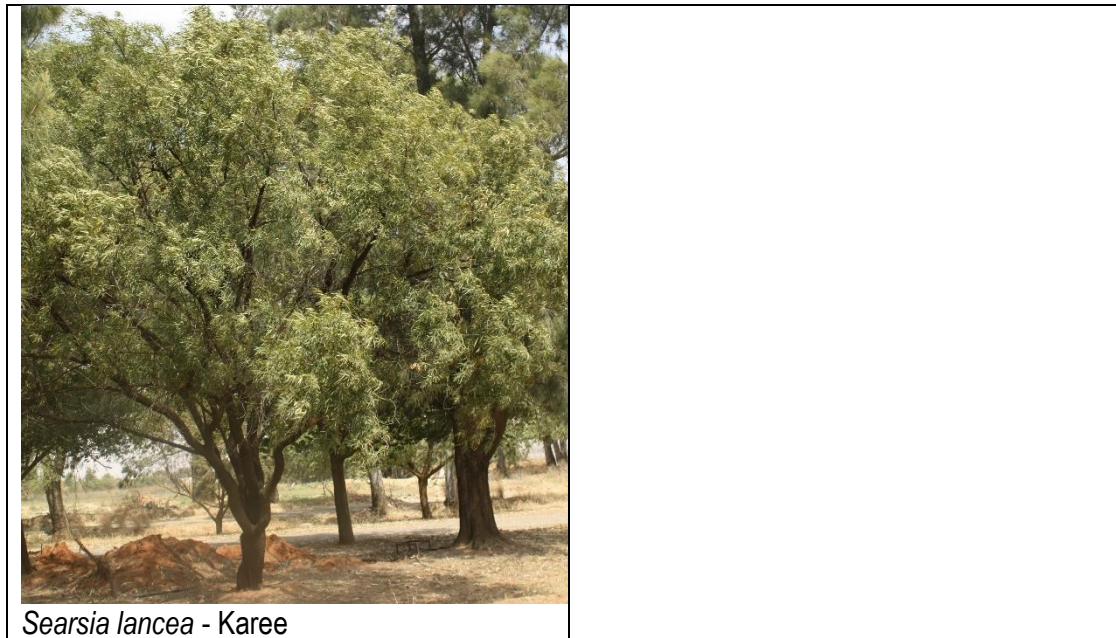
Figure 20: Trees to be established in the riparian layer along the banks of watercourses.

The vegetation structure along the banks of the watercourses contain a distinctive tree/shrub layer along the banks and also along the upper zone of the Vaal River bank (Refer to Section 3). Trees and shrubs are important binders of soil. It is recommended that tree and shrub saplings also be planted in the rehabilitated areas. The trees on these sites are all easily grown from seed and it is recommended that seeds be harvested on the site and used to replant rehabilitated areas. Seeds should be germinated in black plastic nursery bags which are commercially available and should be stored outside the mining area in a designated nursery area. Following rehabilitation the saplings can then be planted on the banks of watercourses. After planting they should receive a thorough drenching with water. Tree and shrubs species occurring along the banks and which can be utilised in rehabilitation include *Ziziphus mucronata*, *Diospyros lycioides*, *Combretum erythrophyllum*, *Vachellia karroo* and *Searsia lancea*.
