Scope of Works Document

Robben Island Museum
General Repairs & Renovations

Village School Property:

Compiled by:

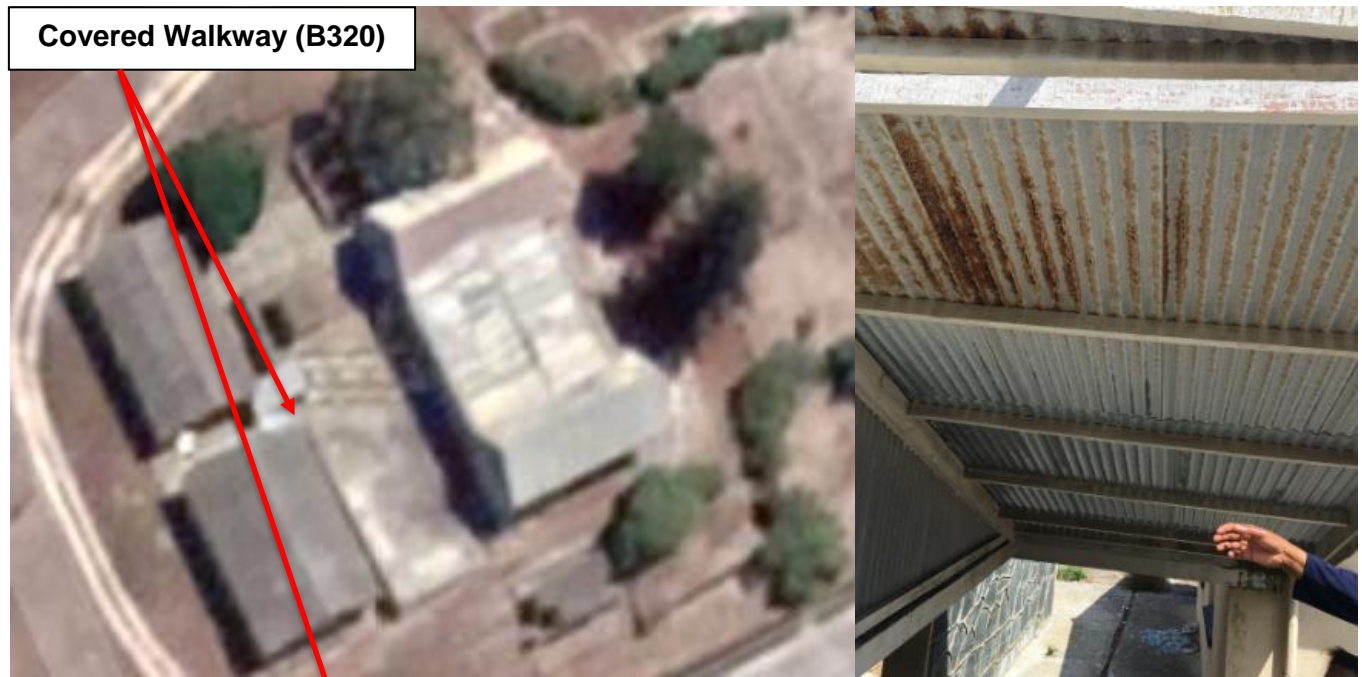
2. B320 - Covered Walkway (Total Floor Area = 40m²)

Covered Walkway (B320)

- All existing walkway profiled metal roof covering and side cladding is to be removed and replaced with similar approved metal roof covering.
- All existing timber roof structure is to be sanded down and painted.
- All existing fibre cement fascia/barge boards to be removed and replaced with new Nutec or similar approved fascia/barge boards.
