Skoenmakers River Maintenance

River rehabilitation

DRAFT REPORT Rev 1

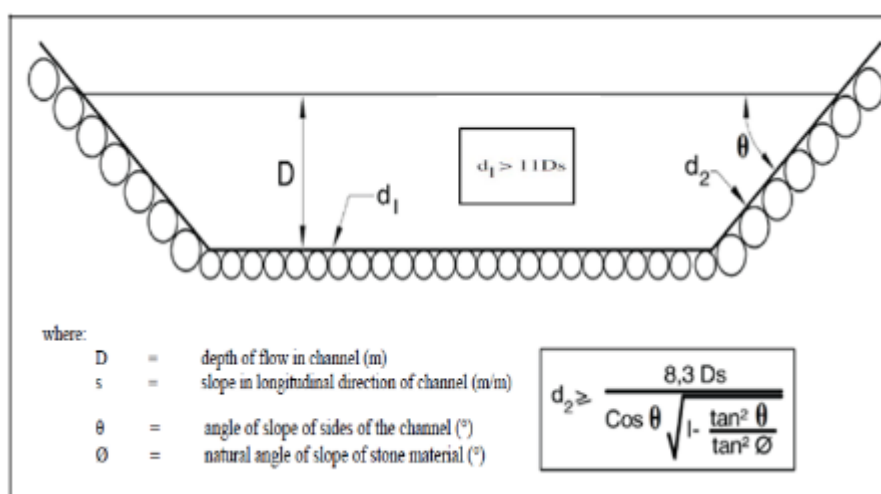
Figure 5.2-1 Required sizes of rock for erosion protection of loose bed channels (SANRAL, 2015)

The riprap size was designed in accordance with SANRAL (2015) guidelines. A sample of the guidelines is as illustrated in Figure 5.2-1. The riprap angle of repose was taken as 40 degrees and the angle of the sides slope of the channel as 1:2.5 (V: H). A steeper slope will increase the riprap diameter, and contractors found 1:2.5 to 1:3 more practical slopes to work with in the past. The 100 year ARI flood was used to design the riprap sizes.

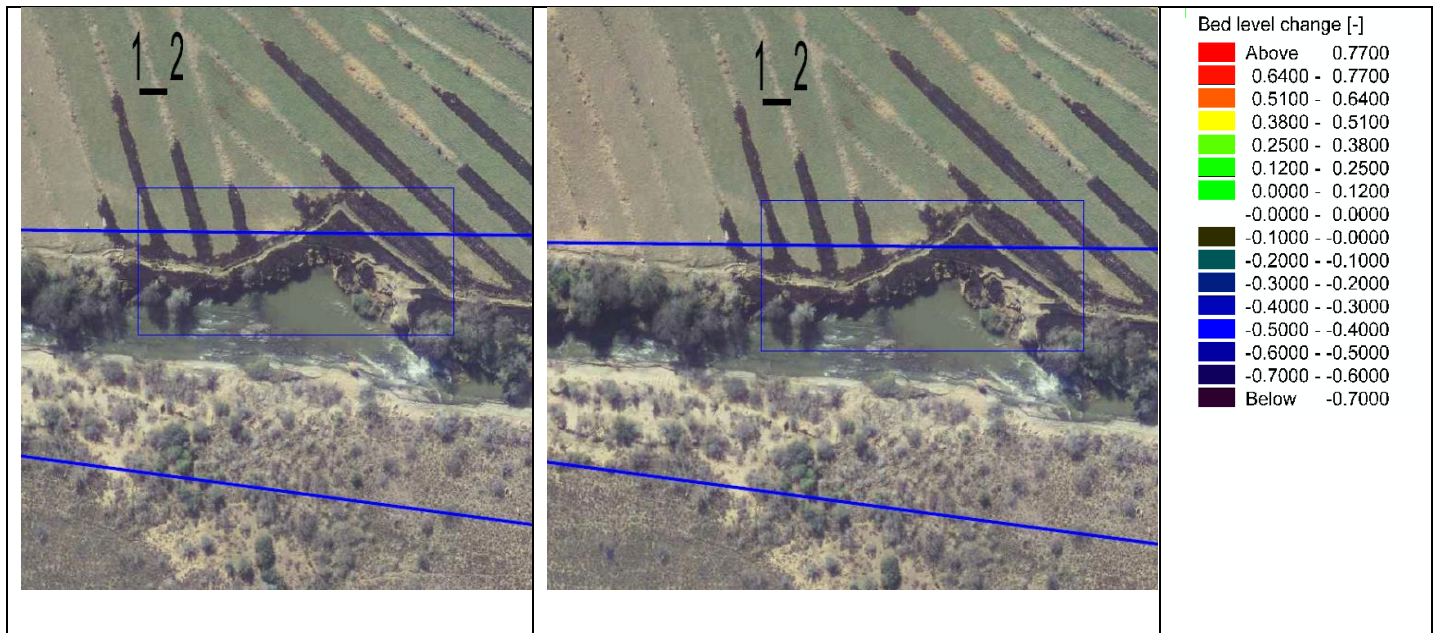
Appendix 3: Zone 1_2 Q10 flood peak scour pattern

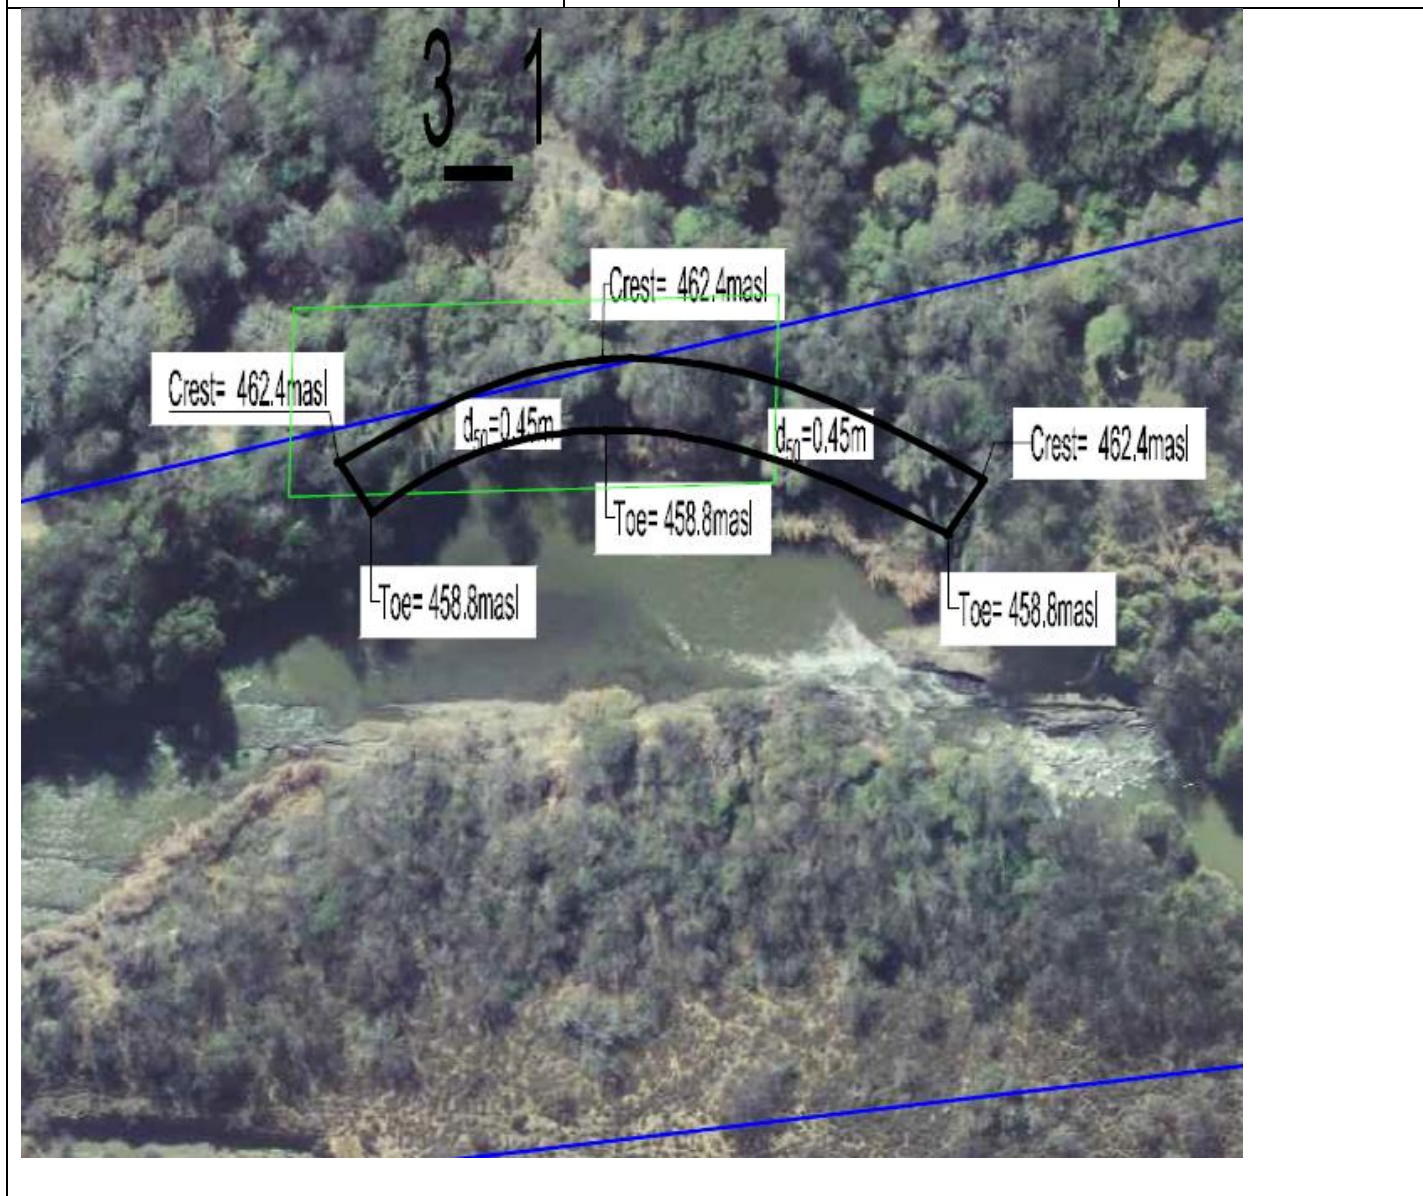
Appendix 20: Zone 3_1 Q10 flood peak scour pattern and proposed scour protection

The zone has unstable banks crossing the servitude. $d_{50} = 0.45$ m was found appropriate. This area is shown in Appendix 20.

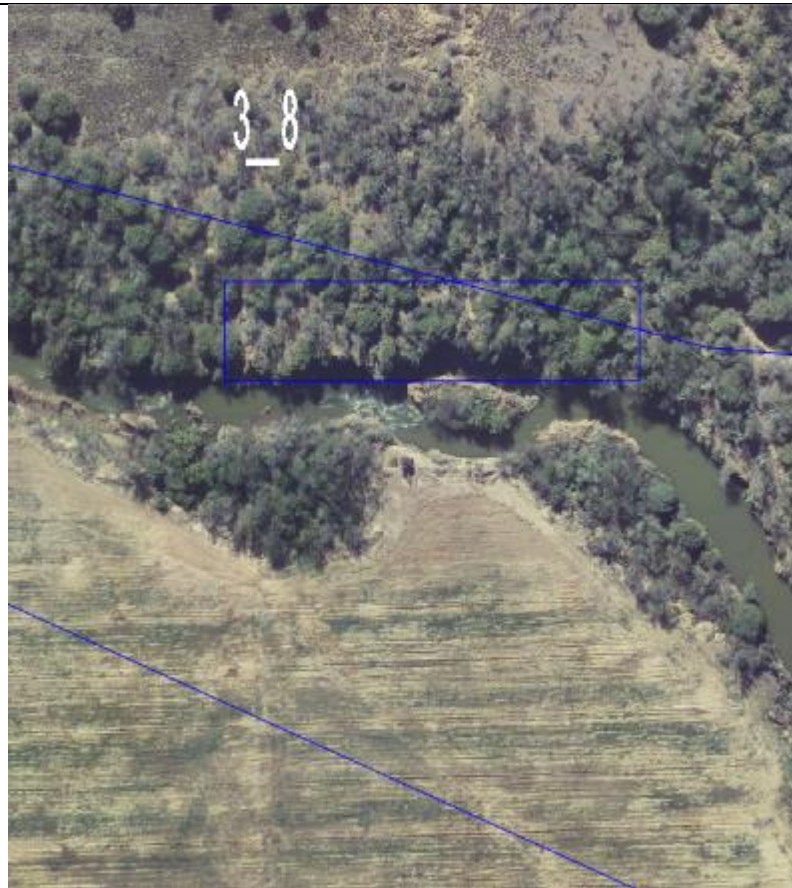
Appendix 25: Zone 3_8 Q10 flood peak scour pattern and proposed scour protection

The zone has unstable banks within the servitude. Protection was found not necessary. This area is shown in Appendix 25.

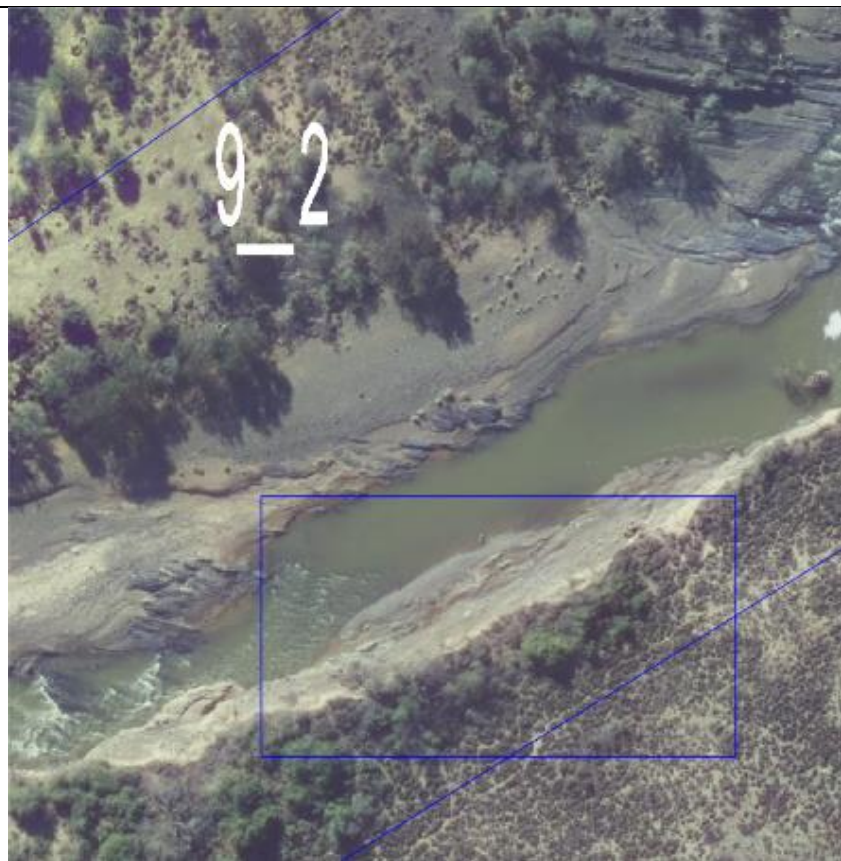
Appendix 59: Zone 9_2 Q10 flood peak scour pattern

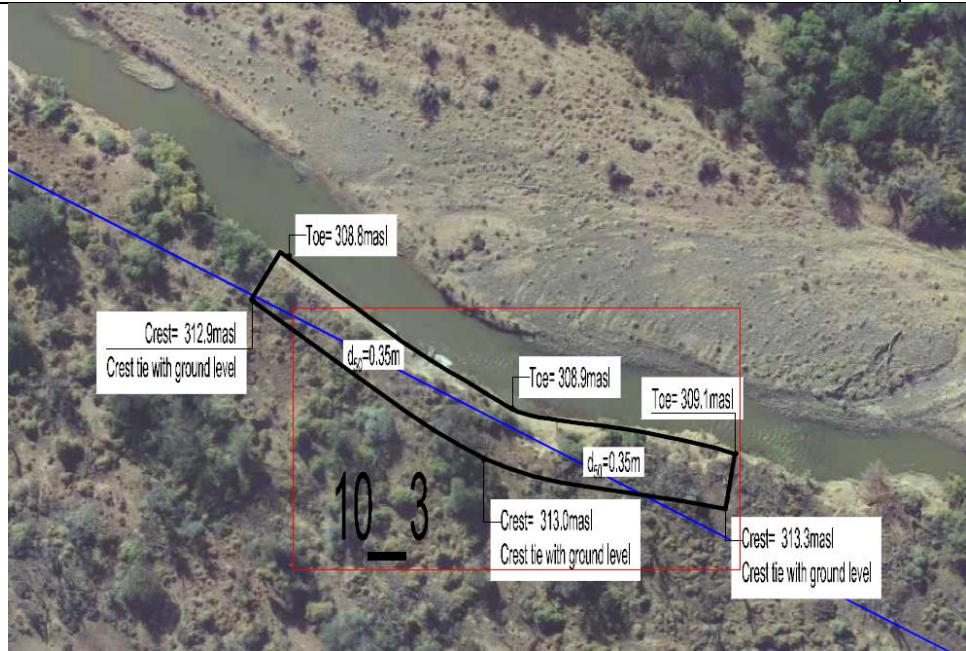
Appendix 63: Zone 10_2 and 10_3 Q10 flood peak scour pattern and proposed scour protection

The zone has banks crossing the servitude. $d_{50} = 0.35$ m was found appropriate. This area is shown in Appendix 63.

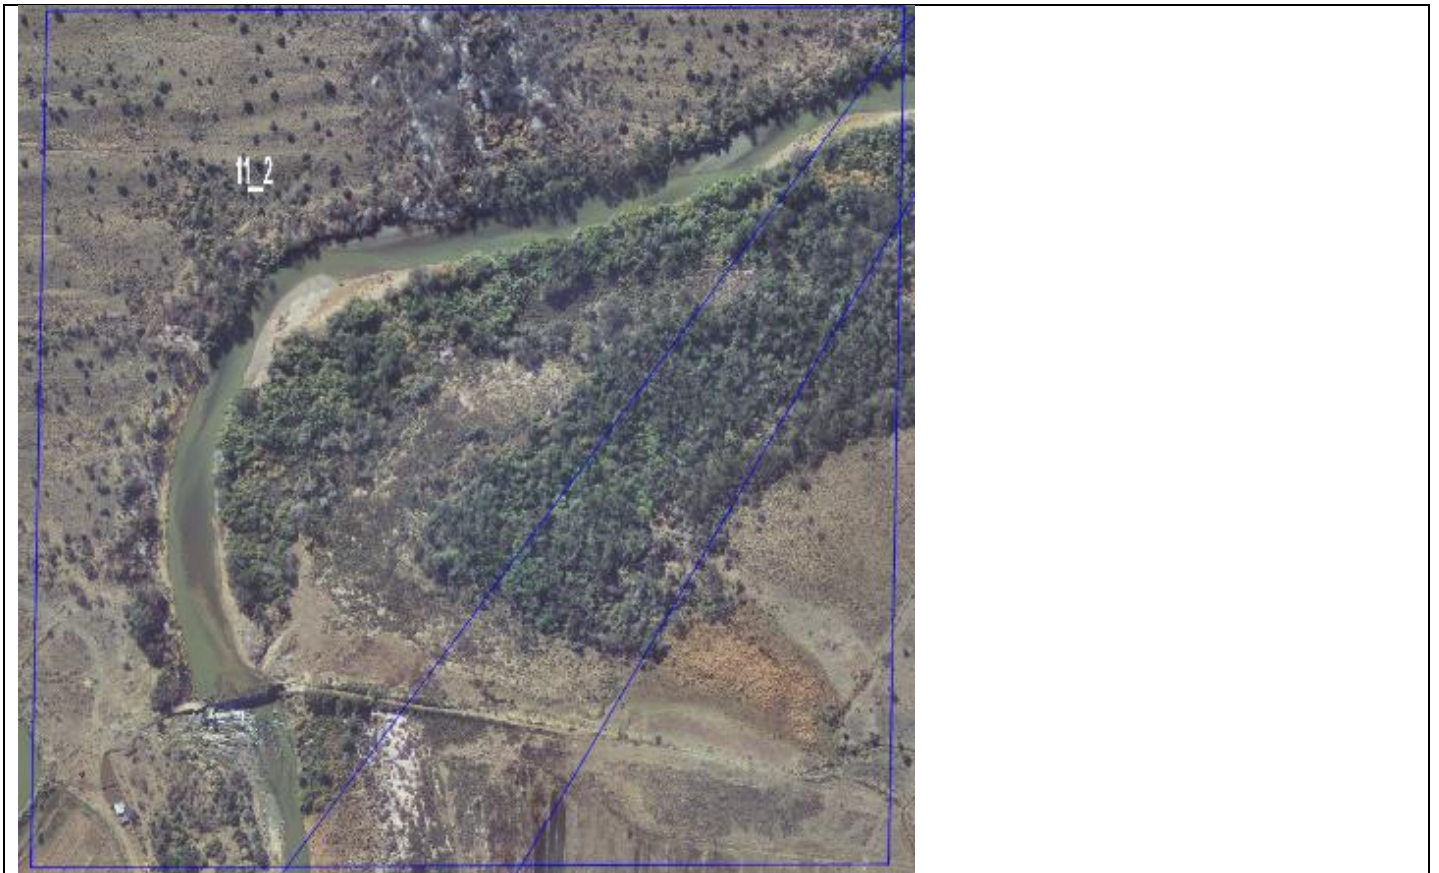
Appendix 67: Zone 11_2 Q10 flood peak scour pattern

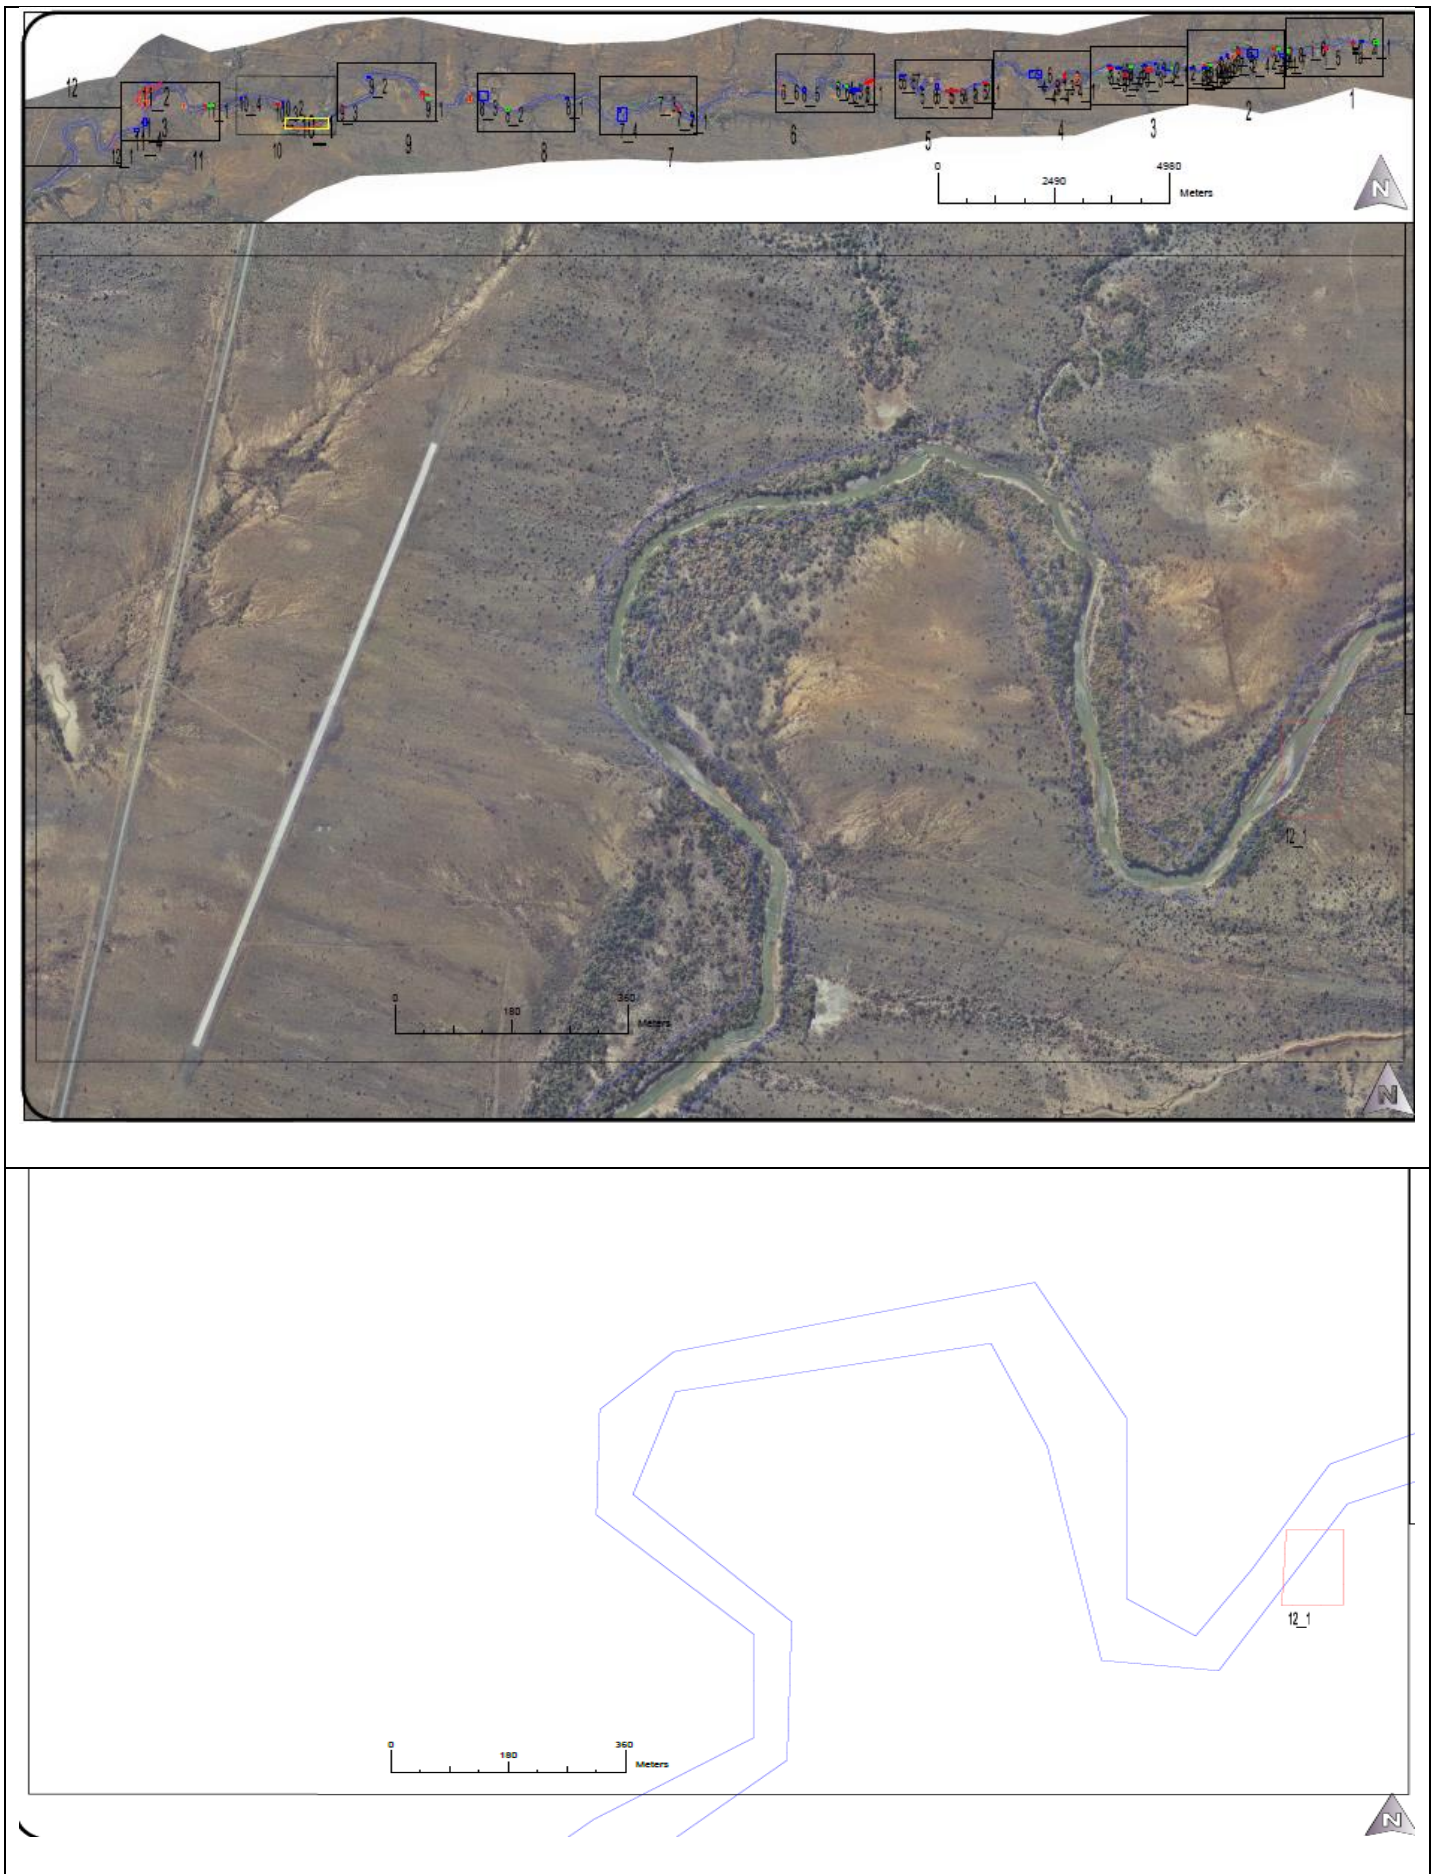
Appendix 70: Zone 12_1 Q10 flood peak scour pattern and proposed scour protection

The zone has unstable banks crossing the servitude. $d_{50} = 0.35$ m was found appropriate. This area is shown in Appendix 70.
