Hydrogeological Investigation Report for the Proposed Transnet Railway in Lephalale, Limpopo Province

Draft Report Prepared by

NALEDZI WATERWORKS (PTY) LTD
4/24/2019

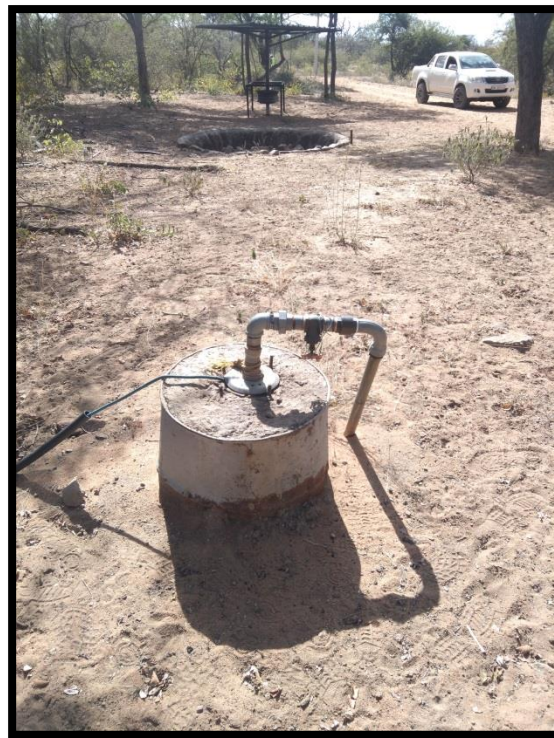
Figure 6: Existing Borehole and water trough

The results of the hydrocensus together with the previous hydrocensus by Golder (2018) were used to determine the baseline water use in the area. The groundwater in the project area is used for domestic and game watering purpose with several boreholes pumping water into the drinking troughs located in the bushes (Figure 6). The details of the visited sites are presented in **Appendix B** and their positions are shown in Figure 7.
