TEMPORARY EXPROPRIATION DIAGRAM
BORROW PIT 3 : THE DOWNS 308/1

A PHASE 1 ARCHAEOLOGICAL IMPACT ASSESSMENT (AIA) FOR THE PROPOSED UPGRADING OF THE N2 HIGHWAY BETWEEN COEGA AND COLCHESTER AS WELL AS THE CONSTRUCTION OF THE NEW SUNDAYS RIVER BRIDGE, AND FOUR BORROW PITS, NELSON MANDELA METROPOLITAN MUNICIPALITY, PORT ELIZABETH, EASTERN CAPE PROVINCE

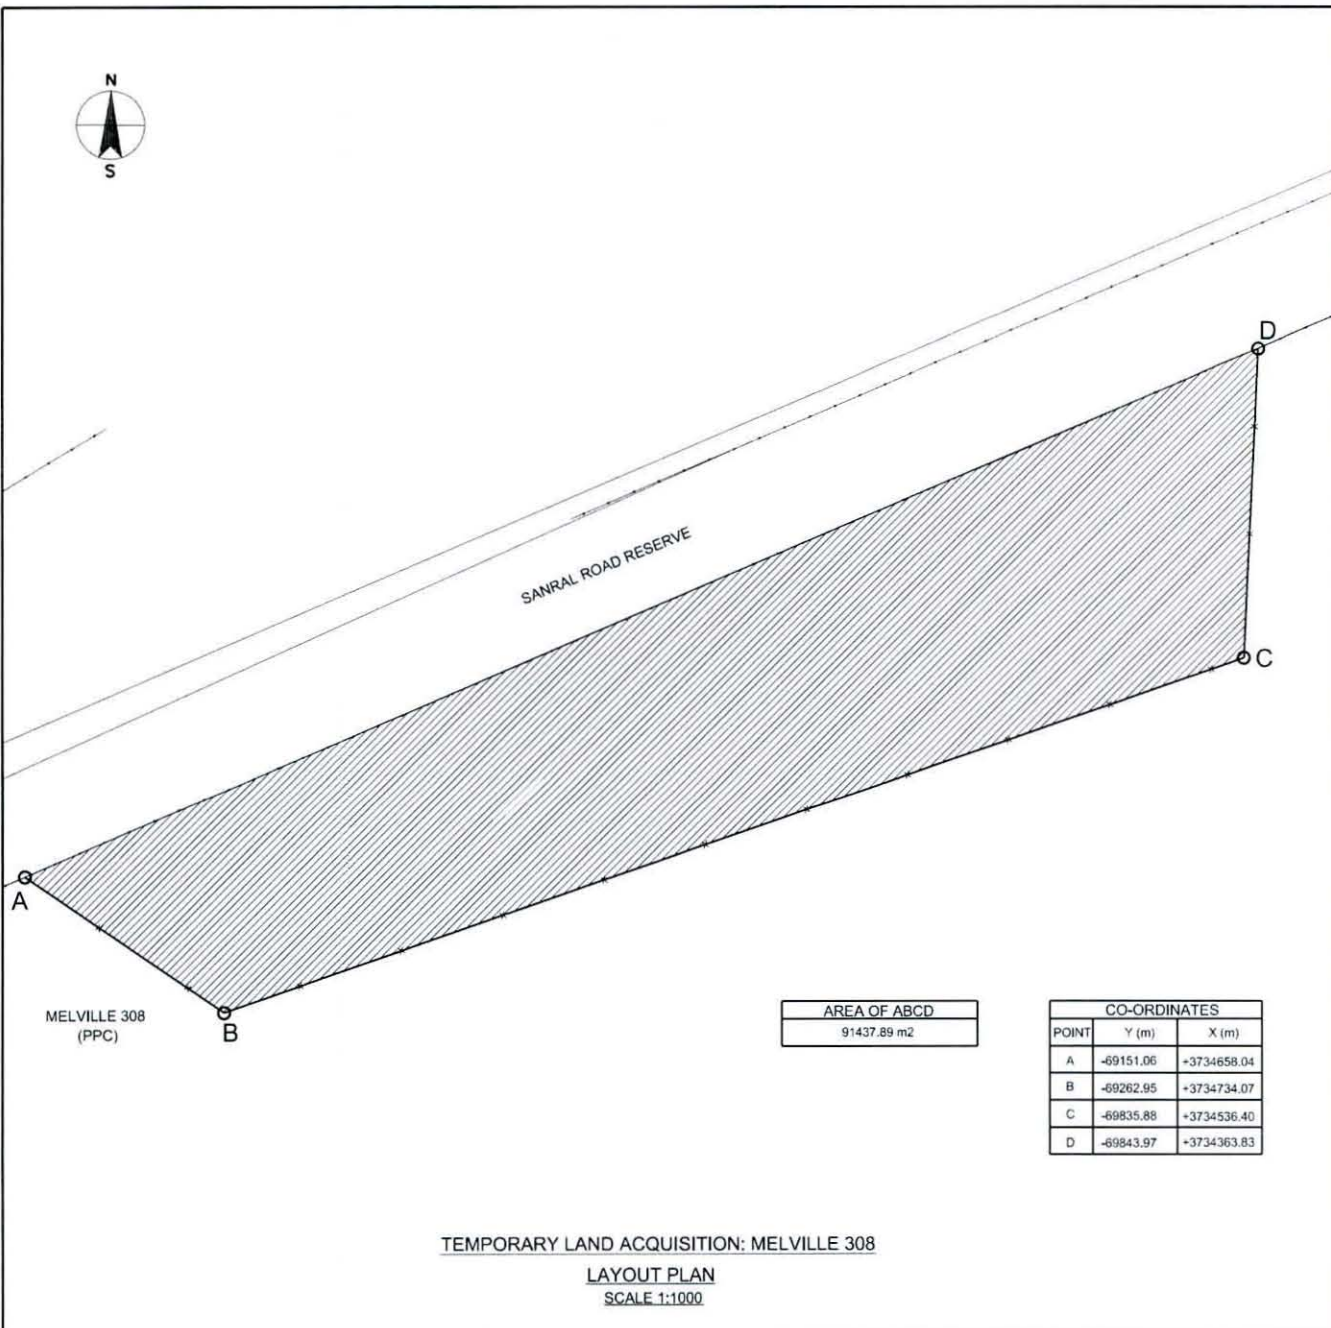
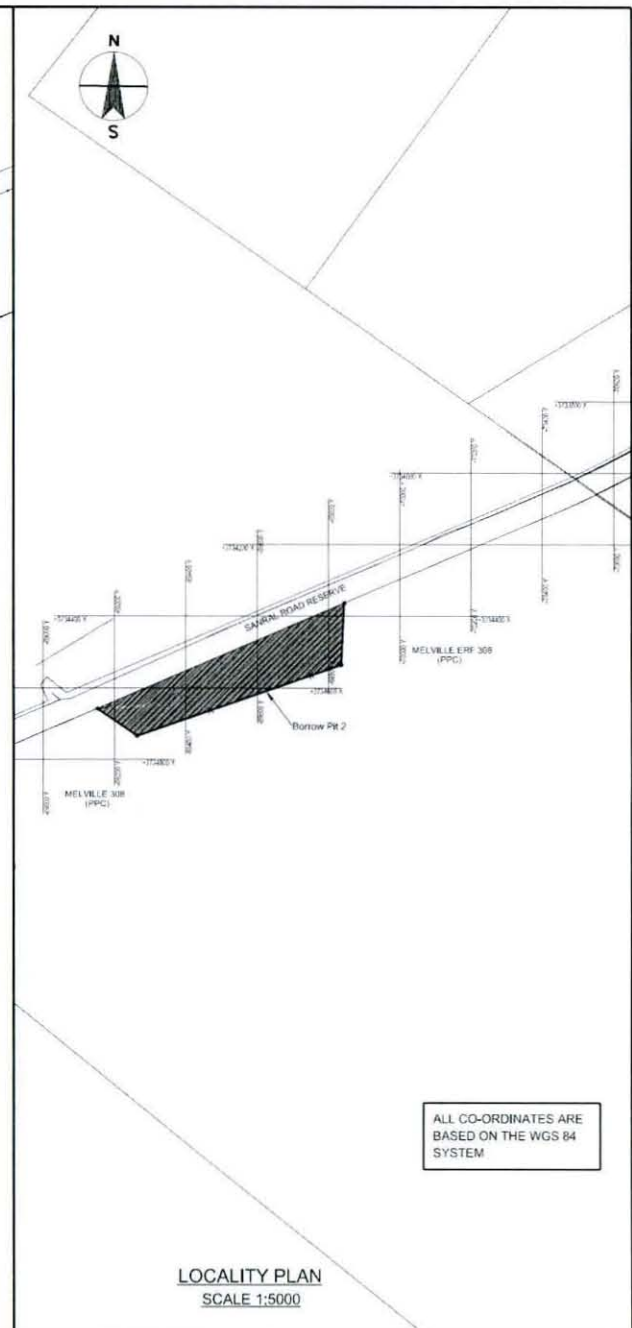
AREA OF ABCD	
91437.89 m ²

CO-ORDINATES		
POINT	Y (m)	X (m)
A	-69151.06	+3734658.04
B	-69262.95	+3734734.07
C	-69835.88	+3734536.40
D	-69843.97	+3734363.83

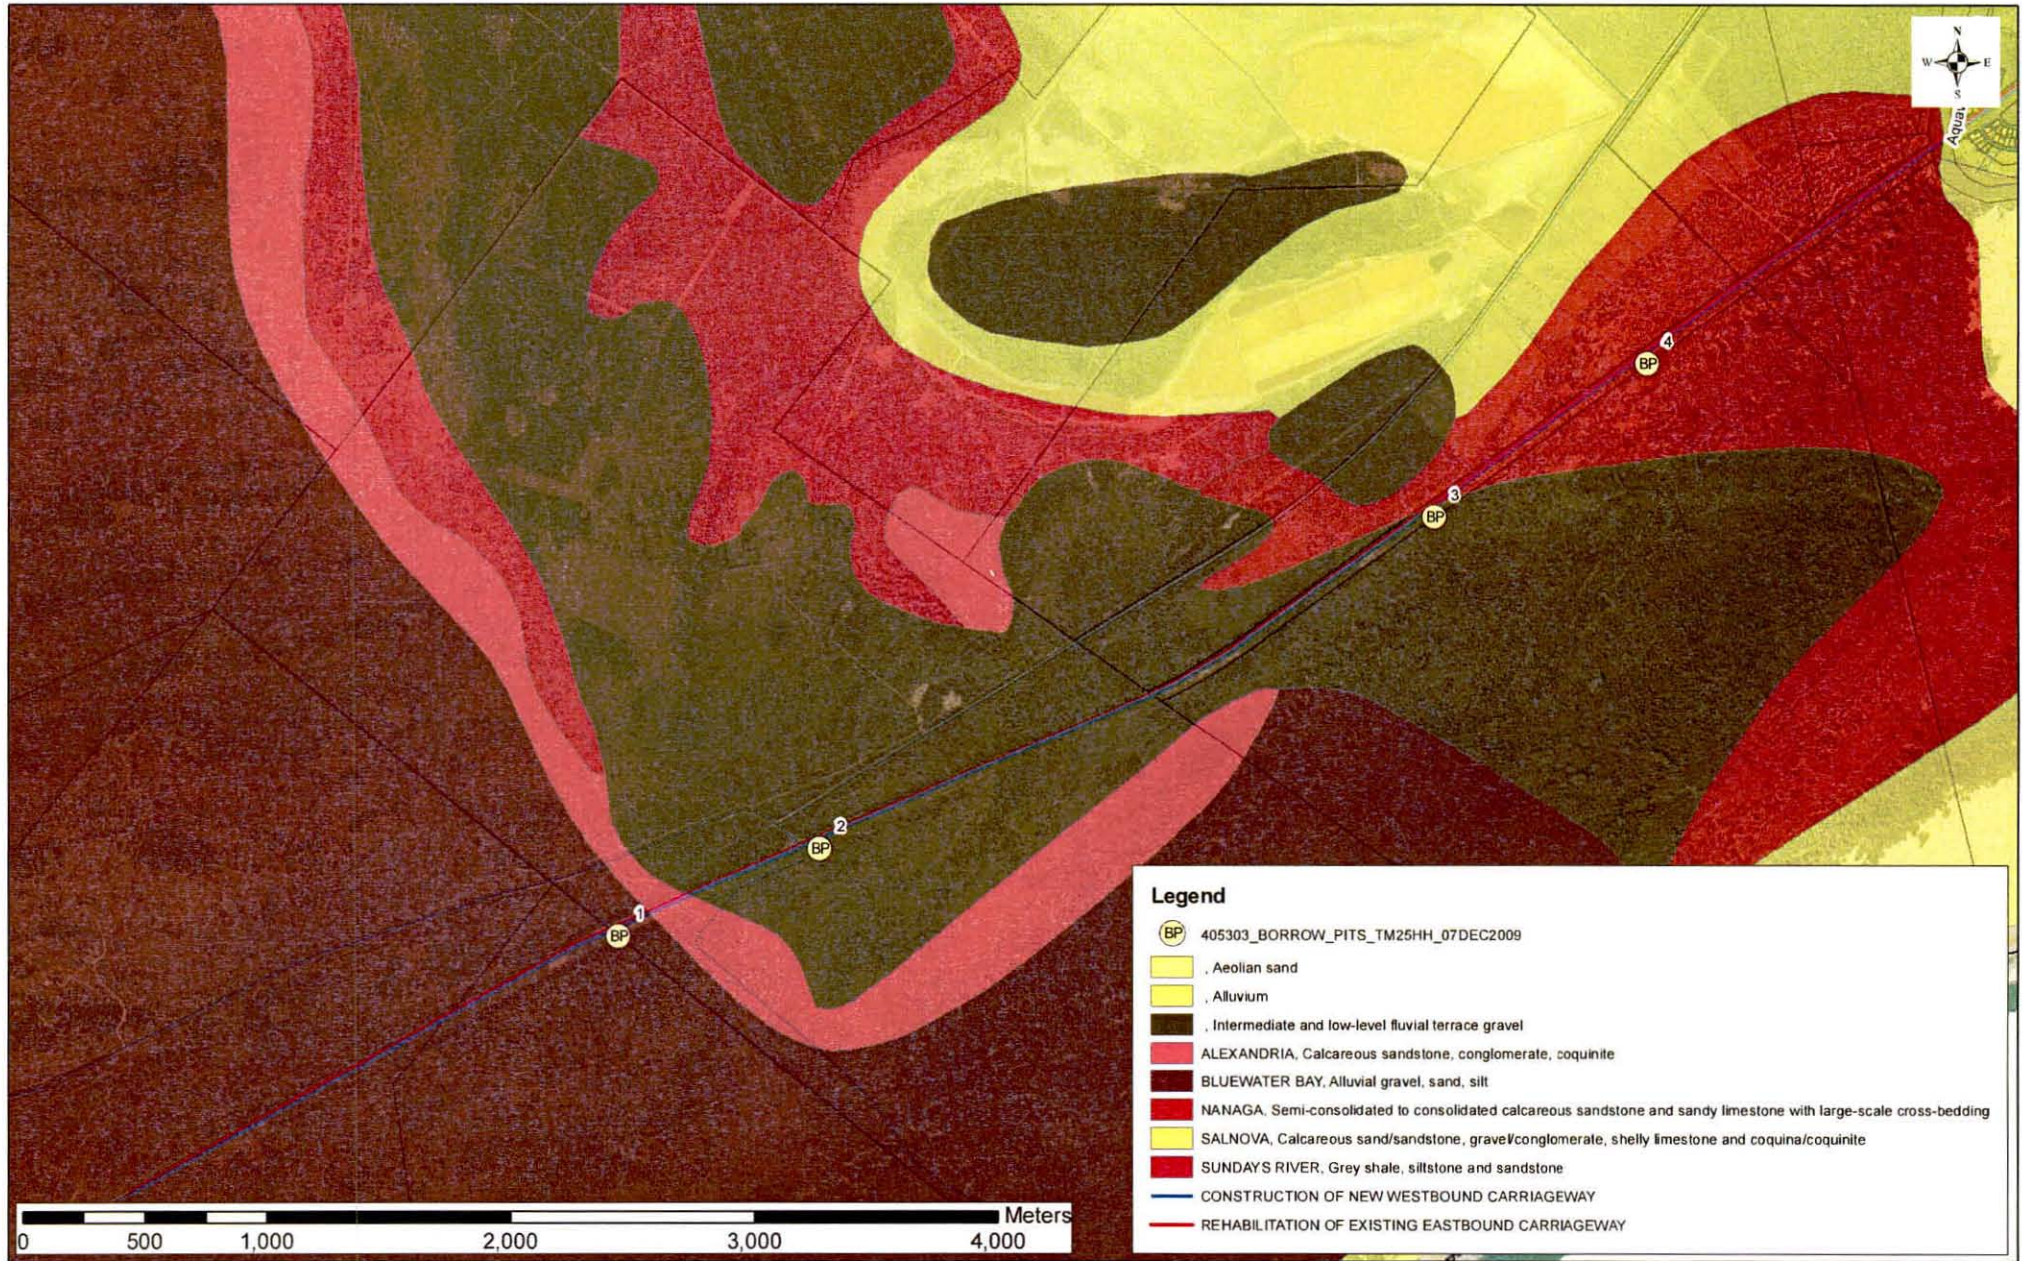
N2 COEGA TO COLCHESTER EIA
GEOLOGY

- BP 405303_BORROW_PITS_TM25HH_07DEC2009
- Aeolian sand
- Alluvium
- Intermediate and low-level fluvial terrace gravel
- ALEXANDRIA, Calcareous sandstone, conglomerate, coquinite
- BLUEWATER BAY, Alluvial gravel, sand, silt
- NANAGA, Semi-consolidated to consolidated calcareous sandstone and sandy limestone with large-scale cross-bedding
- SALNOVA, Calcareous sand/sandstone, gravel/conglomerate, shelly limestone and coquina/coquinite
- SUNDAYS RIVER, Grey shale, siltstone and sandstone
- CONSTRUCTION OF NEW WESTBOUND CARRIAGEWAY
- REHABILITATION OF EXISTING EASTBOUND CARRIAGEWAY

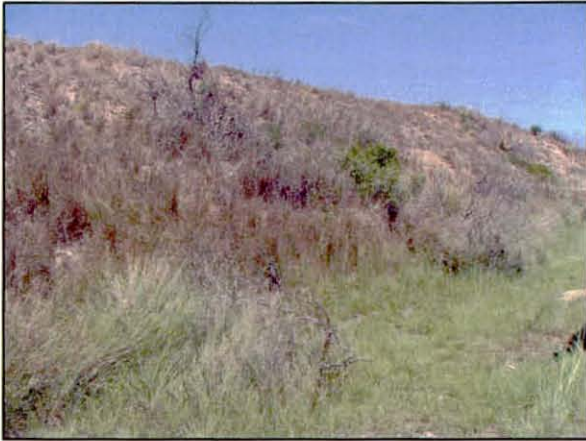
Figure C-1: Berm adjacent to the existing road at borrow pit 1

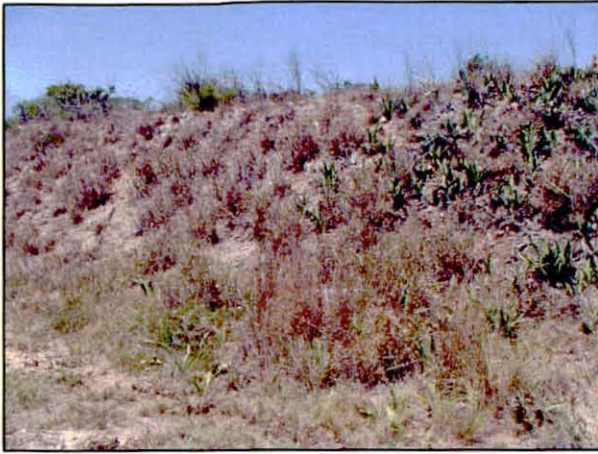
Figure C-7: Vegetated berm adjacent to the existing road at borrow pit 2

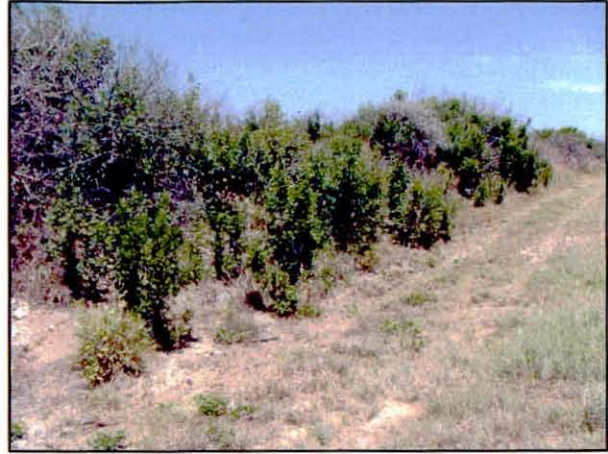
Figure C-8: Vegetated berm adjacent to the existing road at borrow pit 2

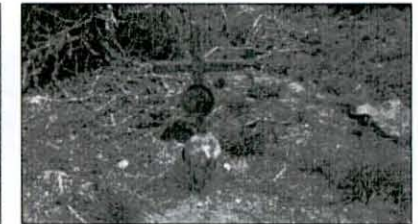
Fig. 6. The cross situated within the proposed BP 3 area.

accident prevention barricade and the construction of the existing N2 highway. A small cross was observed during the survey, situated next to the road within the area proposed for BP 3, most probably in memory of a person who may have been killed in an accident within the area. The dates 13.10.1982-30.12.2007 were inscribed on the cross, however, no name could be observed. It is unsure how regularly the 'cross' is visited; although some grave goods have previously been placed in front of the cross (Figs 5-6).

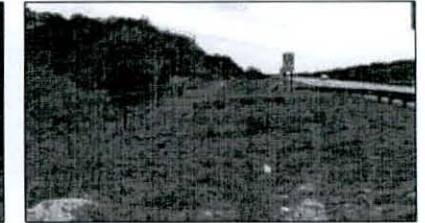
Fig. 14. Area disturbed by erection of the fence and construction of the barricade and road signs.

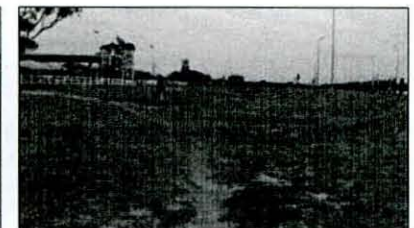
Fig. 23-24. View of the petrol station, lamp posts and chevron sign posts facing west.

The end of the contract for the proposed N2 road upgrade finishes at the Colchester Petrol Station. The area between the bus stop and the petrol station has been heavily disturbed by the construction of the petrol station and a shopping centre. Lamp poles and chevron sign poles have also been erected (Figs 23-24).

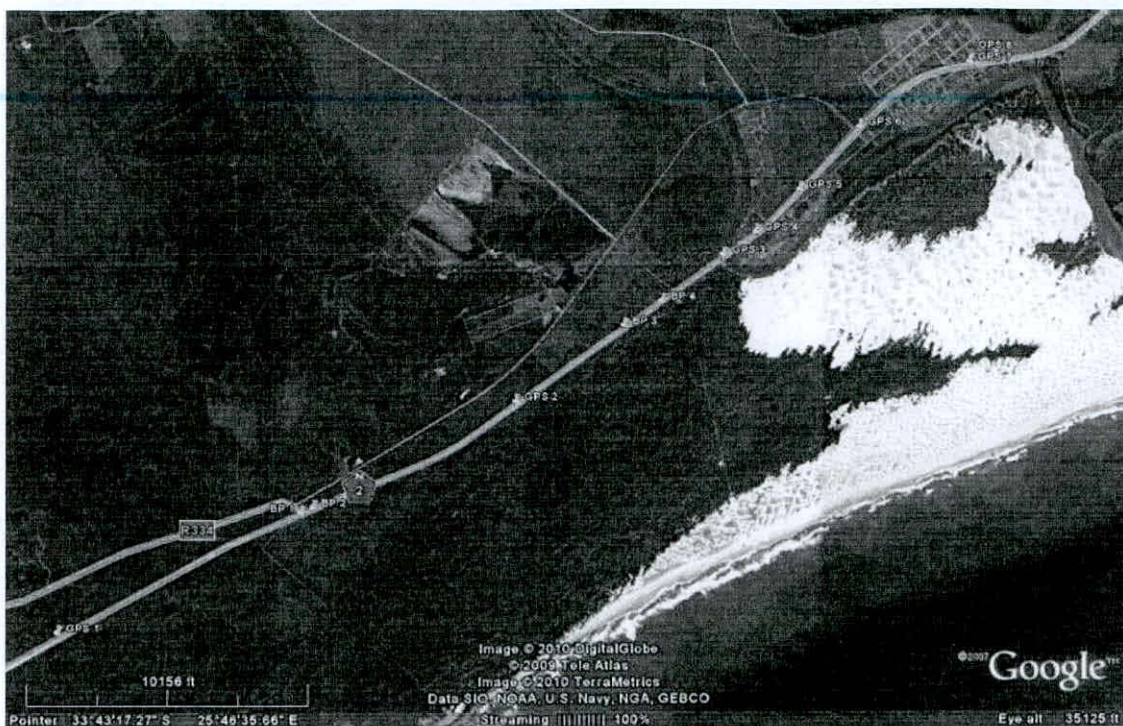
Map 2. Aerial view of the proposed area for the N2 road upgrade and the four proposed borrow pits, GPS plotted.

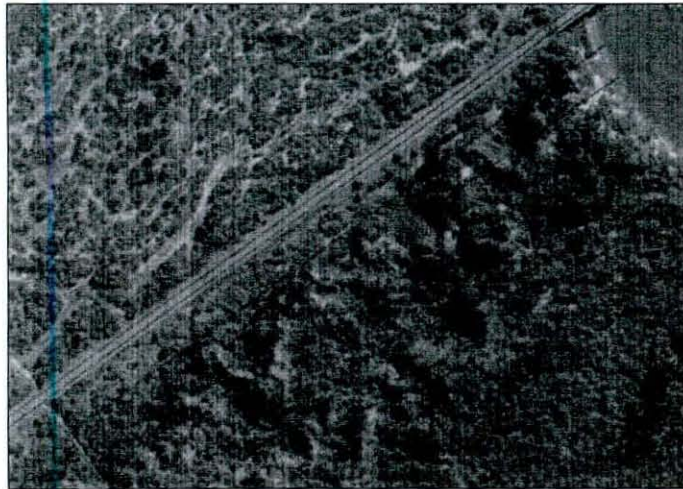
Figure 4.1: Aerial Photograph overlain with DEM, indicating sensitive vegetated dune field adjacent to Sundays River crossing. (A) indicates road servitude edge and (B) proposed areas where dune to be removed and replaced after construction of retaining wall.

The proposed widening of the west of the Sundays River will require the temporary removal of portion of a dune during road construction and a retaining wall (Figure 4.1 and Figure 4.2), followed by subsequent replacement of the sand, re-profiling of the dune and revegetation. Maps and photos of site in Appendix 1 and 2.

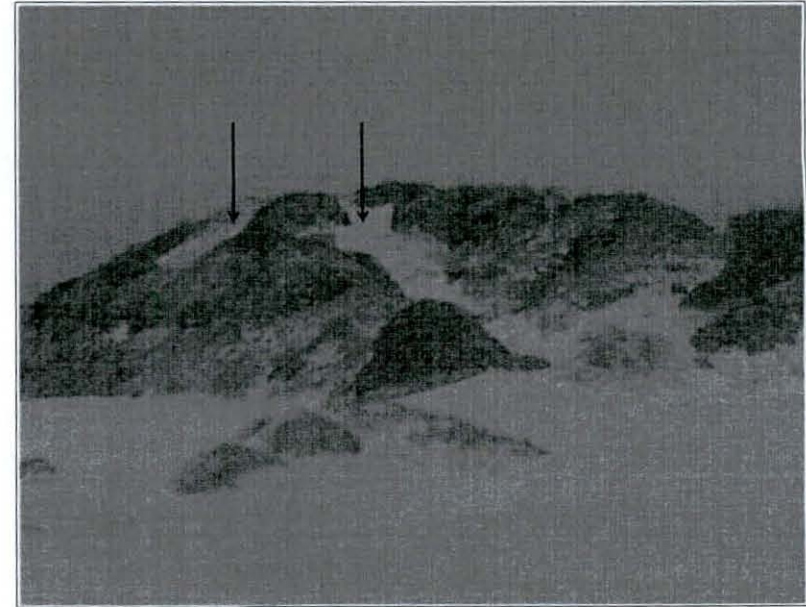
Figure 4.4: Example of a dune blowout. As the name implies such features are formed by wind scour rather than wave attack. The dune present adjacent to the Sundays River and road reserve will be susceptible to dune blowouts after roads construction has been completed.

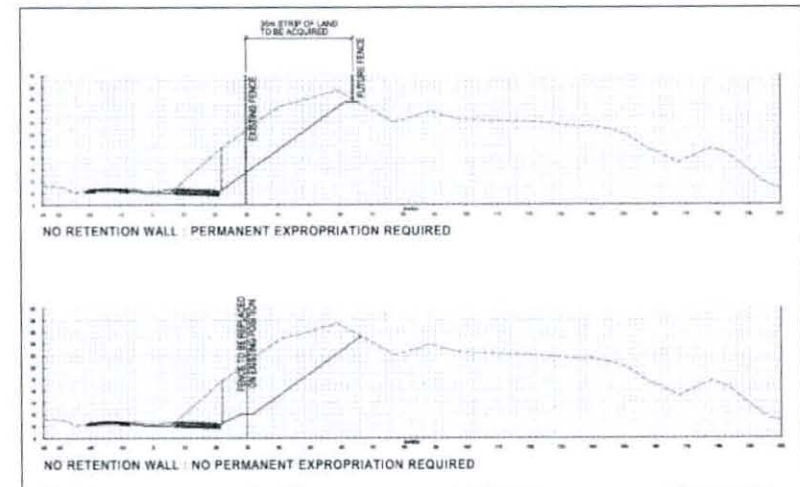
Figure 4.5: Alternative approaches without a retention wall.

- An alternative to the above procedure would be to apply a deeper fertile topsoil layer over the mobile sands, and grasses sown using a hydro-mulching technique together with the use of a biodegradable netting/matting (made from jute, sisal, coir or similar material) or a geofabric, geogrid or nylon fabric. The long-term persistence of this method is however uncertain as erosion of soil beneath the matting and potential drying out could result in failure of the technique in the long-term;

- Stabilisation of mobile dune sands can be difficult and long-term follow up may be necessary;
- The preferred procedure, using a retaining wall, could result in long-term issues resulting from a build-up of sand above the retaining wall and subsequent wind-borne sands spilling over the top of the wall and/or damage to the wall. The alternative, without using a retaining wall could result in a more effective solution as it would minimise the risk of wind-borne sand building up and spilling over the retaining wall and a 'hedge' shrubs/small trees could be planted adjacent to the road to trap wind-borne sand. Periodic removal of this accumulated sand may be required to prevent migration of the dune into the road reserve.

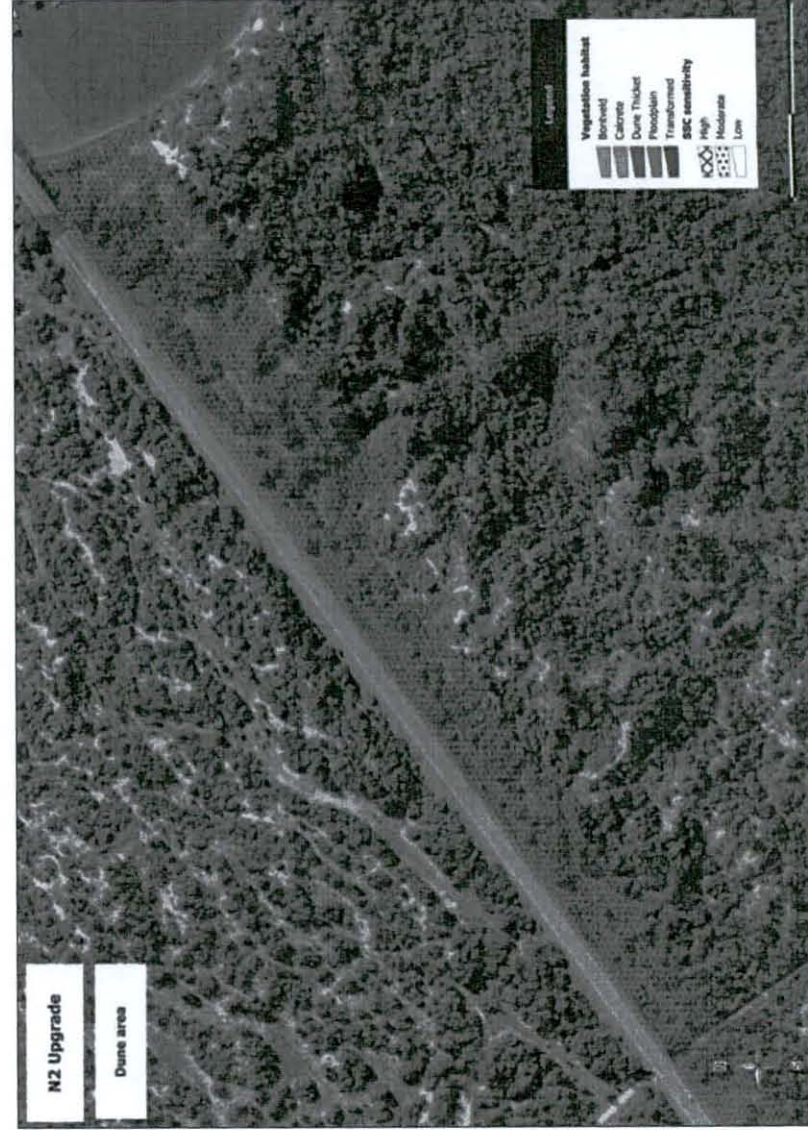
Map 4: Proposed widening adjacent to Sundays River into dune.

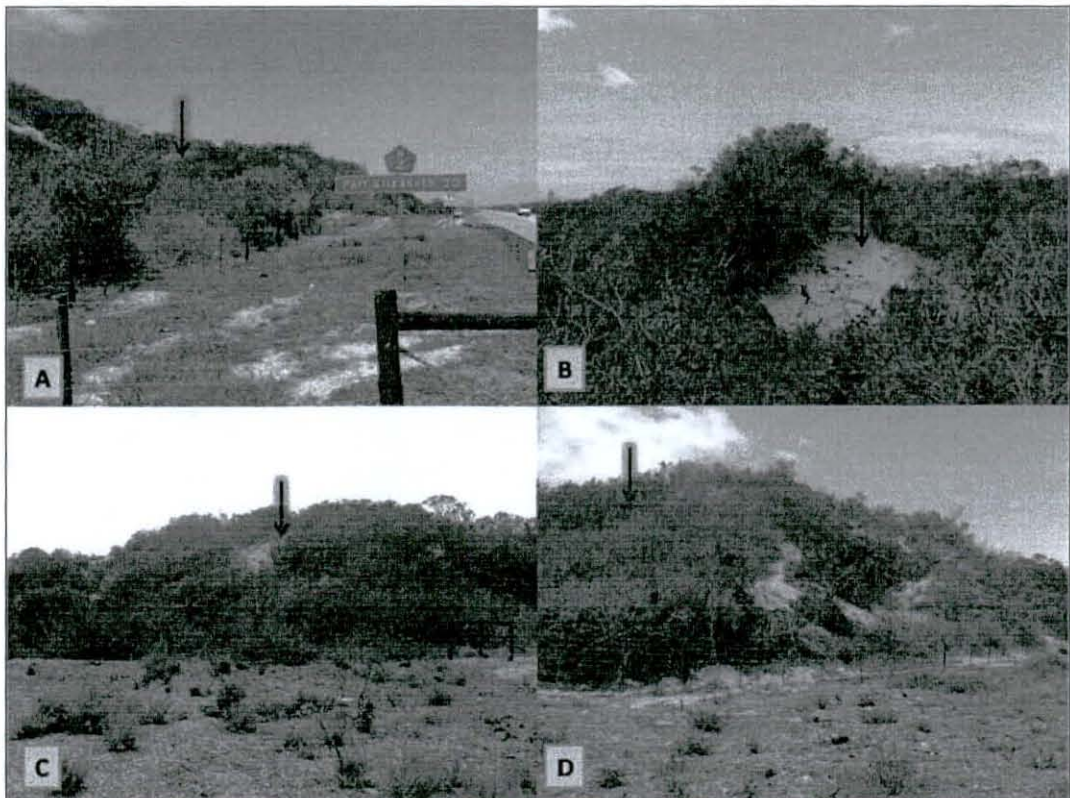
Photo 3: Dune area: (A-C) Sparsely vegetated dunes with exposed sands prone to erosion; (D) Shrub species key stabilisers.

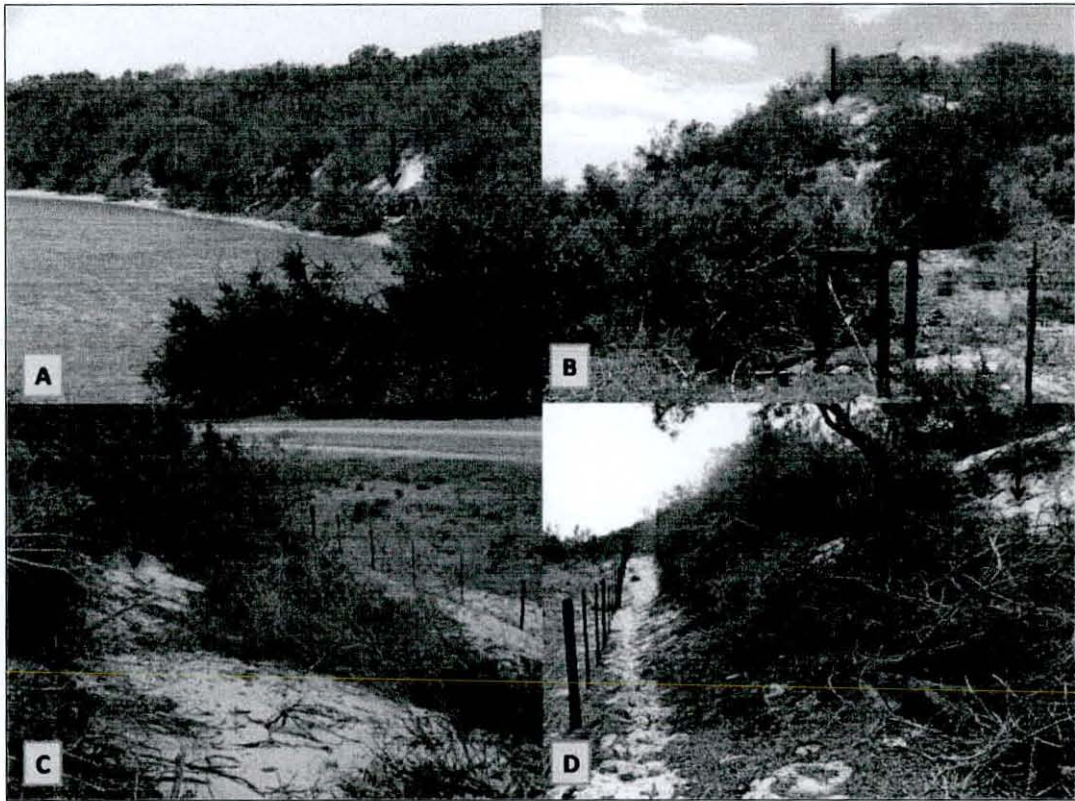
Photo 4: Dune area: (A) Erosion along river bank southwards of proposed activity; (B) Exposed dunes prone to slumping on eastern edge adjacent to rover; (C-D) Exposed base of dunes with inadequate topsoil and vegetation cover.
