## 2. NATURE AND EXTENT OF THE ENVIRONMENT AFFECTED BY ACTIVITY

To determine the suitability of the proposed site for the construction of the pond and wetland wastewater treatment works, a site investigation was conducted by JOHANN VD MERWE (Pty) Ltd. (Consulting Applied Earth and Environmental Scientists). The full geotechnical report by Mr. Johann van der Merwe, entitled Factual Report on Geotechnical Investigation carried out for the proposed: Delmas Abattoir Waste Water Treatment Works on: Portion 21 of the farm Geluk 234-IR, Delmas District, Mpumalanga Province, can be viewed under Appendix D. The following information has been extracted from the report.

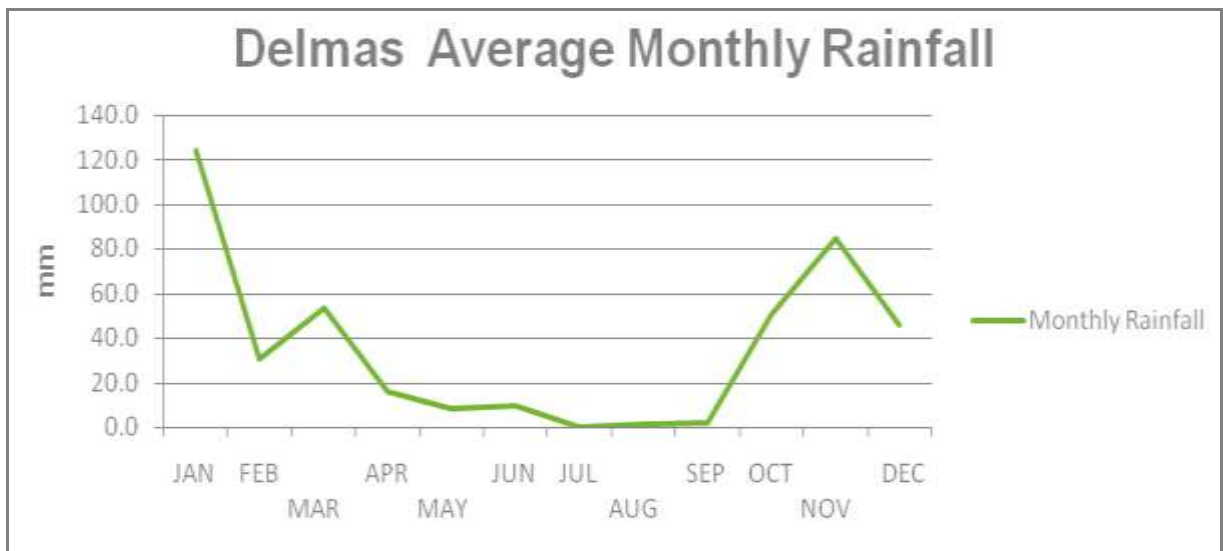
Figure 22: Delmas Average Monthly Rainfall.

The site occurs in a summer rainfall area receiving a mean average annual rainfall of 426.3 mm. The average precipitation (taken over a period of 5 years from 2005 to 2009) is 127 mm in January and 6mm in July. The relative humidity varies between 12 % as minimum and 93 % as maximum.

Figure 22 for the Average Monthly Rainfall of Delmas as provided by [www.weathersa.com](http://www.weathersa.com).
