**Letter from DEADP requiring EIA application dated 10.04.2012 &
Letter from DEADP confirming withdrawal of EIA application dated 10.02.2015**

Founders Garden
Foreshore
Cape Town

DESKTOP ARCHAEOLOGICAL ASSESSMENT OF THE PROPOSED FOUNDERS GARDEN DEVELOPMENT ON ERF 186 ROGGEBAAI, CAPE TOWN FORESHORE

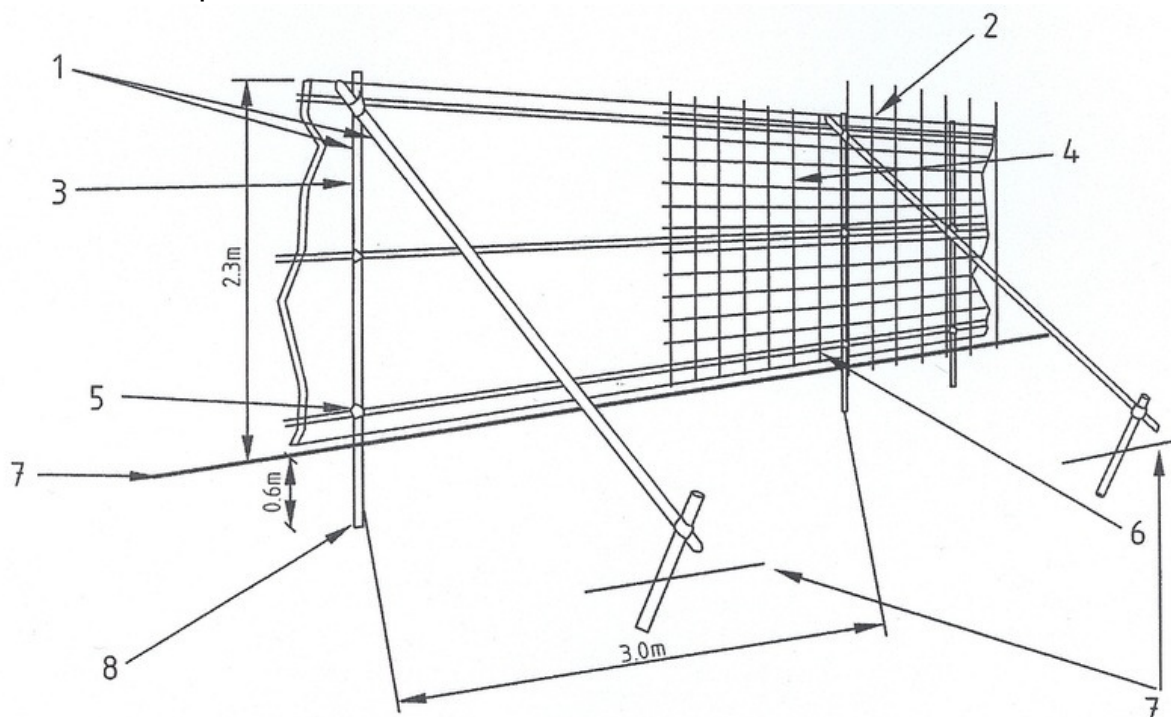
Please see example of barrier below:

- 1 Standard scaffold poles
- 2 Uprights to be driven into the ground
- 3 Panels secured to uprights with wire ties and, where necessary, standard scaffold clamps
- 4 Weldmesh wired to the uprights and horizontals

- 5 Standard clamps
- 6 Wire twisted and secured on inside face of fencing to avoid easy dismantling
- 7 Ground level
- 8 Approx. 0.6m driven into the ground

The RPA should be clearly marked, cordoned off with fencing and marked as an absolutely NO GO area for anyone or anything.

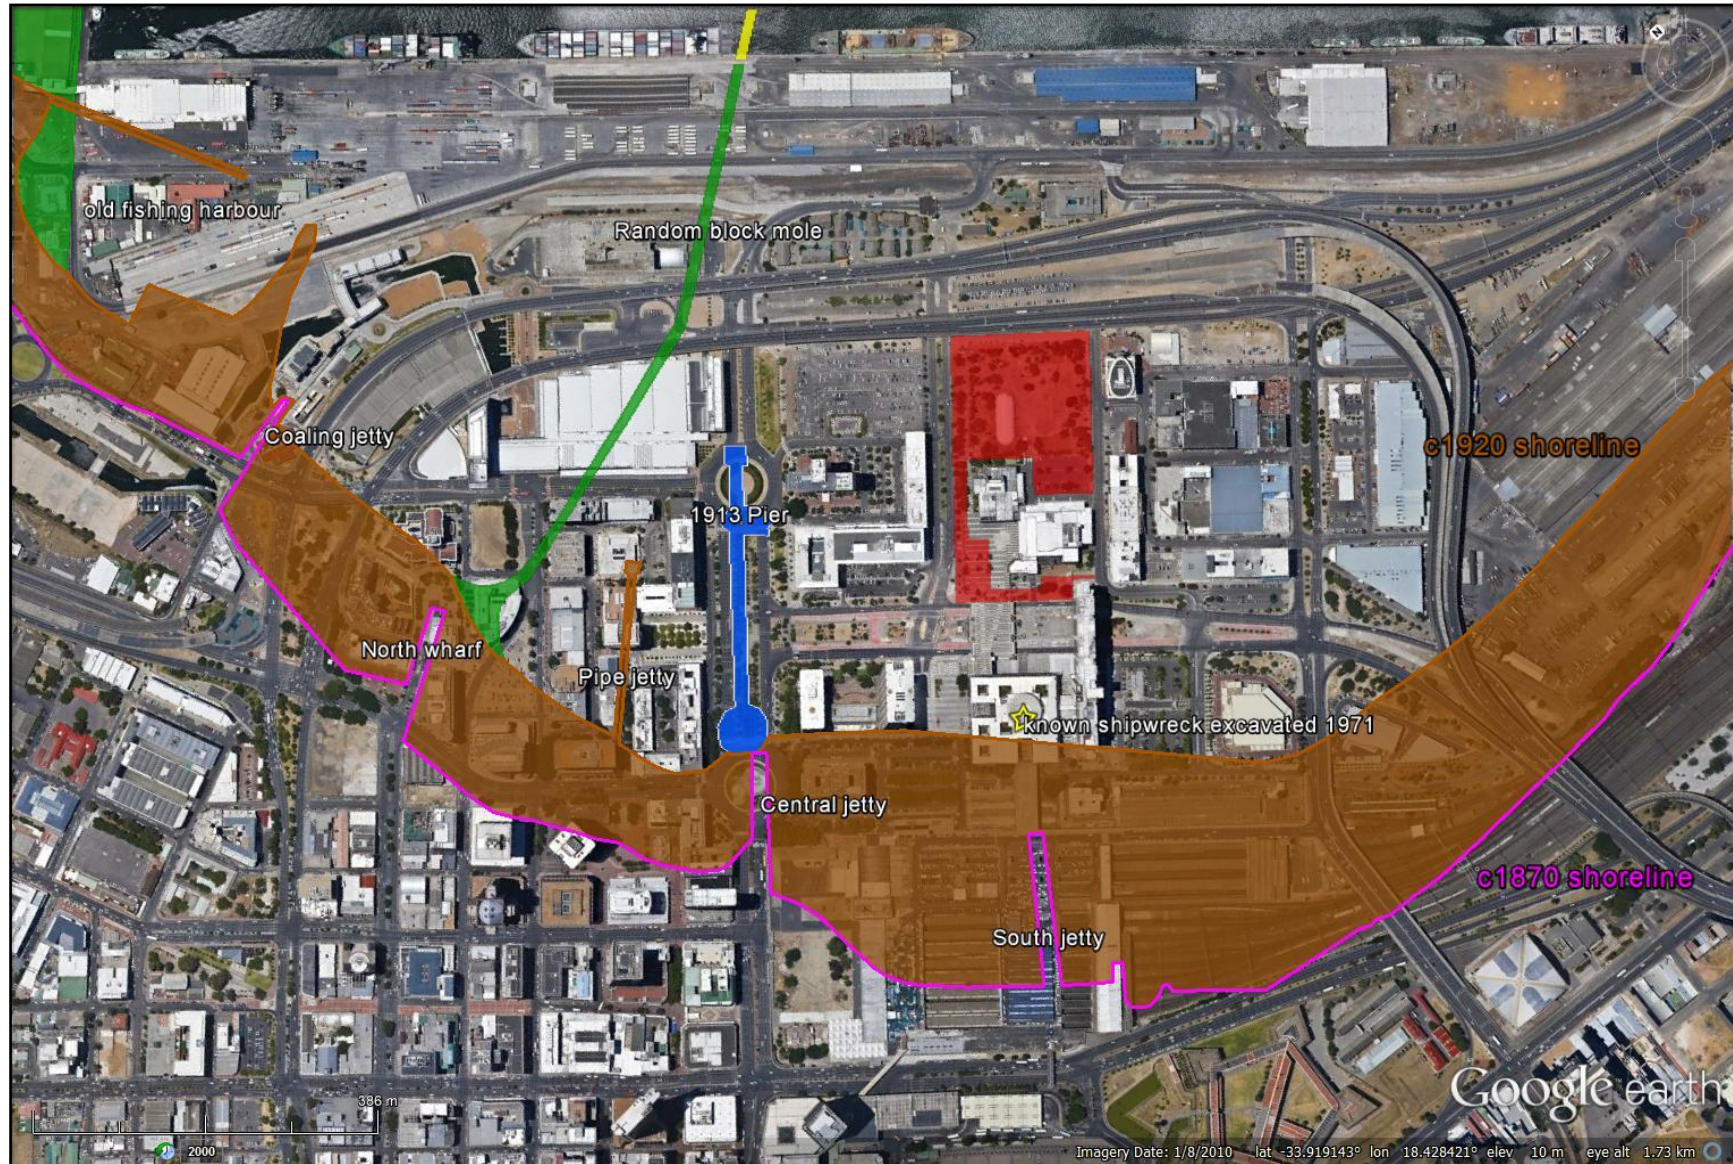
Figure 2: Table Bay harbour - historical development 1870-1985 (based on: South African Transport Services Drawing TBH 106 (1985): A-374). Proposed development site shown in red. The area between the 1920 shoreline and the existing harbour was reclaimed between 1938 and 1943. Comparison with the 1926 aerial photo in Figure 7 shows that the information with regards to the 1920 shoreline omits certain features such as the Rogge Bay fishing “harbour”.

The tipping of gravel for the breakwater marked the beginning of the large civil works programs to improve mooring and harbour facilities in an attempt to cut the loss of ships during the winter storms. Over the years a number of jetties had been constructed at strategic places along the shoreline to provide loading and offloading facilities for visiting ships. A number of those are shown and identified on Figure 2.

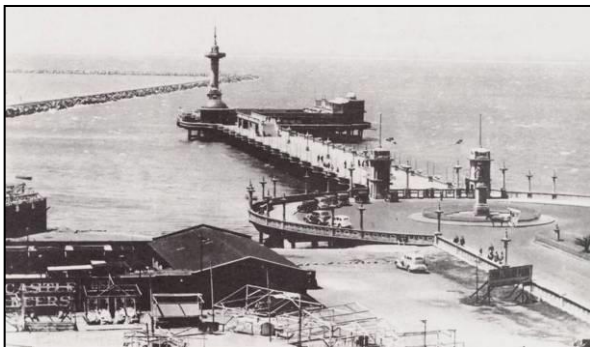
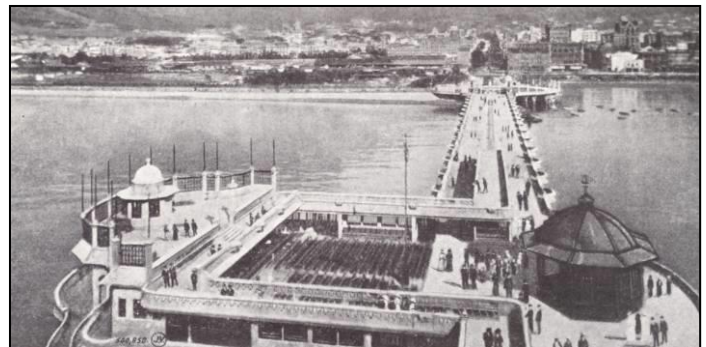
Plates 7 & 8: The 1913 Municipal Pier at the foot of Adderley Street. The random block mole can be seen at left (both in Newal 1993, SA Library and Newal's collection)

In 1913, the Cape Town Municipality built a public pier (Plates 7 - 10) at the foot of Adderley Street at the western end of the promenade. This may in part have been motivated by the desire to replace the old Central Wharf⁶ (Plate 11) which was by now almost completely buried by reclamation. Part of this old wharf and the associated earthworks is likely to have been what was excavated by archaeologists during the recent upgrade of facilities adjacent to Adderley Street at the Cape Town Station (Halkett 2010).

The Pier extended some 300 meters out into the bay and incorporated a tower, concert pavilion, restaurant, and swimming and boating facilities. It brought the townspeople to the sea and was a very popular outing for many Capetonians. It was however never a financial success despite its popularity and the demands of harbour expansion saw the last concert held on the Pier on 27 March 1938, after which it was demolished to just above the high-water mark and the remains were buried in the fill (de Kock 1999, Sharfman 2003:21).

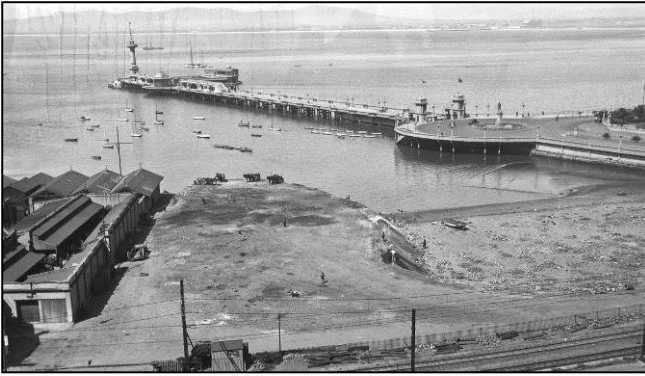
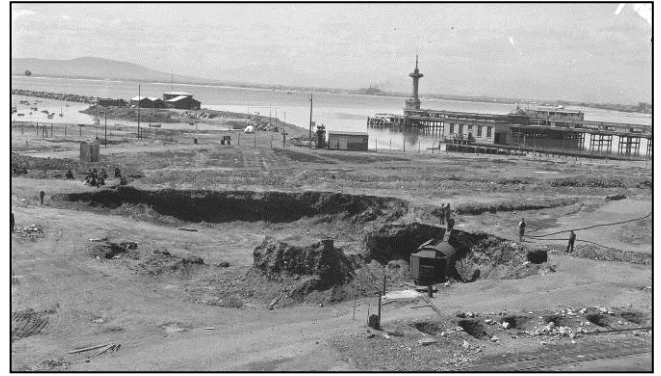
Plates 9 and 10: The 1913 Municipal Pier seen alongside the Roggebaai fishing harbour which was still in use at this time. Of interest is the horse drawn carts in the photograph at left apparently dumping material at the end of the berm (City of Cape Town: Heritage Branch CCb120_f17_i01, CCb119_f17_i01).

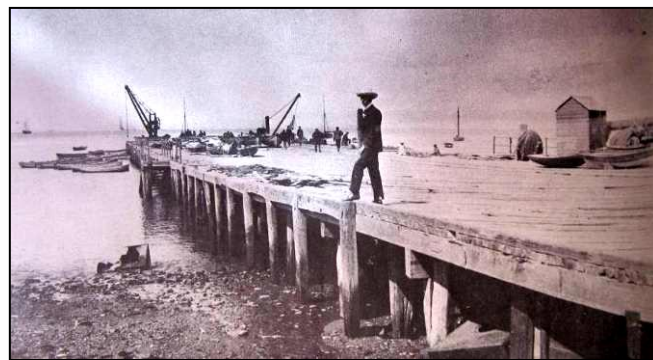
Plate 11: Photograph of the wooden jetty (Central jetty) at the end of Adderley Street c1902 (Picard 1969:118). The central jetty was constructed in the 1850's and became the central hub of harbour activities. In 1907 the jetty was extended to create a central pier and promenade. The pier was demolished in 1938 to make way for the Foreshore Reclamation Scheme (Patrick et al 2010).

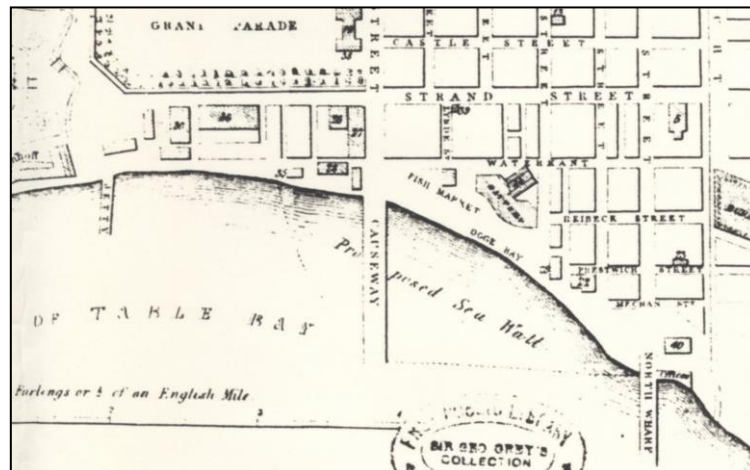
Figure 4: Map of Cape Town c1859 (provenance unknown), showing the proposed causeway and north wharf. The proposed sea wall extends from a (central) causeway to the base of the north wharf. In actual fact it appears from later maps to have been less formal than depicted here, and a small boat harbour was created in front of the fish market at Roggebaai (see Figure 7 this document).

Since this was mostly too shallow to allow for the passage of larger shipping, it was considered sensible to reclaim the area and use it for the expansion of the growing city² as well as placing harbour facilities closer to deeper water. Ever since the earliest harbour construction, rocks from local quarries, and sand dredged from the harbour works were used in the land fill³. During the 1870's, an embankment was built on the south-eastern shore of Table Bay to prevent wave erosion of the beach and by 1875, 16,500 cubic yards of excavated material had been brought from the new graving dock site and dumped between the Central Wharf and the Castle (Figures 4,5 & 6). In the process, the

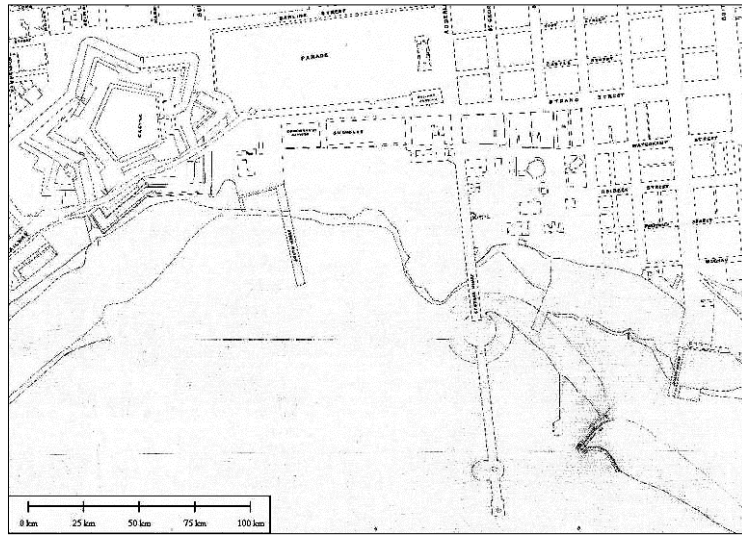
Figure 5: Detailed overlay showing c1862 and 1938 shorelines showing the proposed location of the new pier at the end of Adderley street, and the location of the old Central jetty. The earlier landfill between the Castle and Central Wharf is prominent and the later fill and sea wall (promenade) show as a faint line. (ACO map collection).

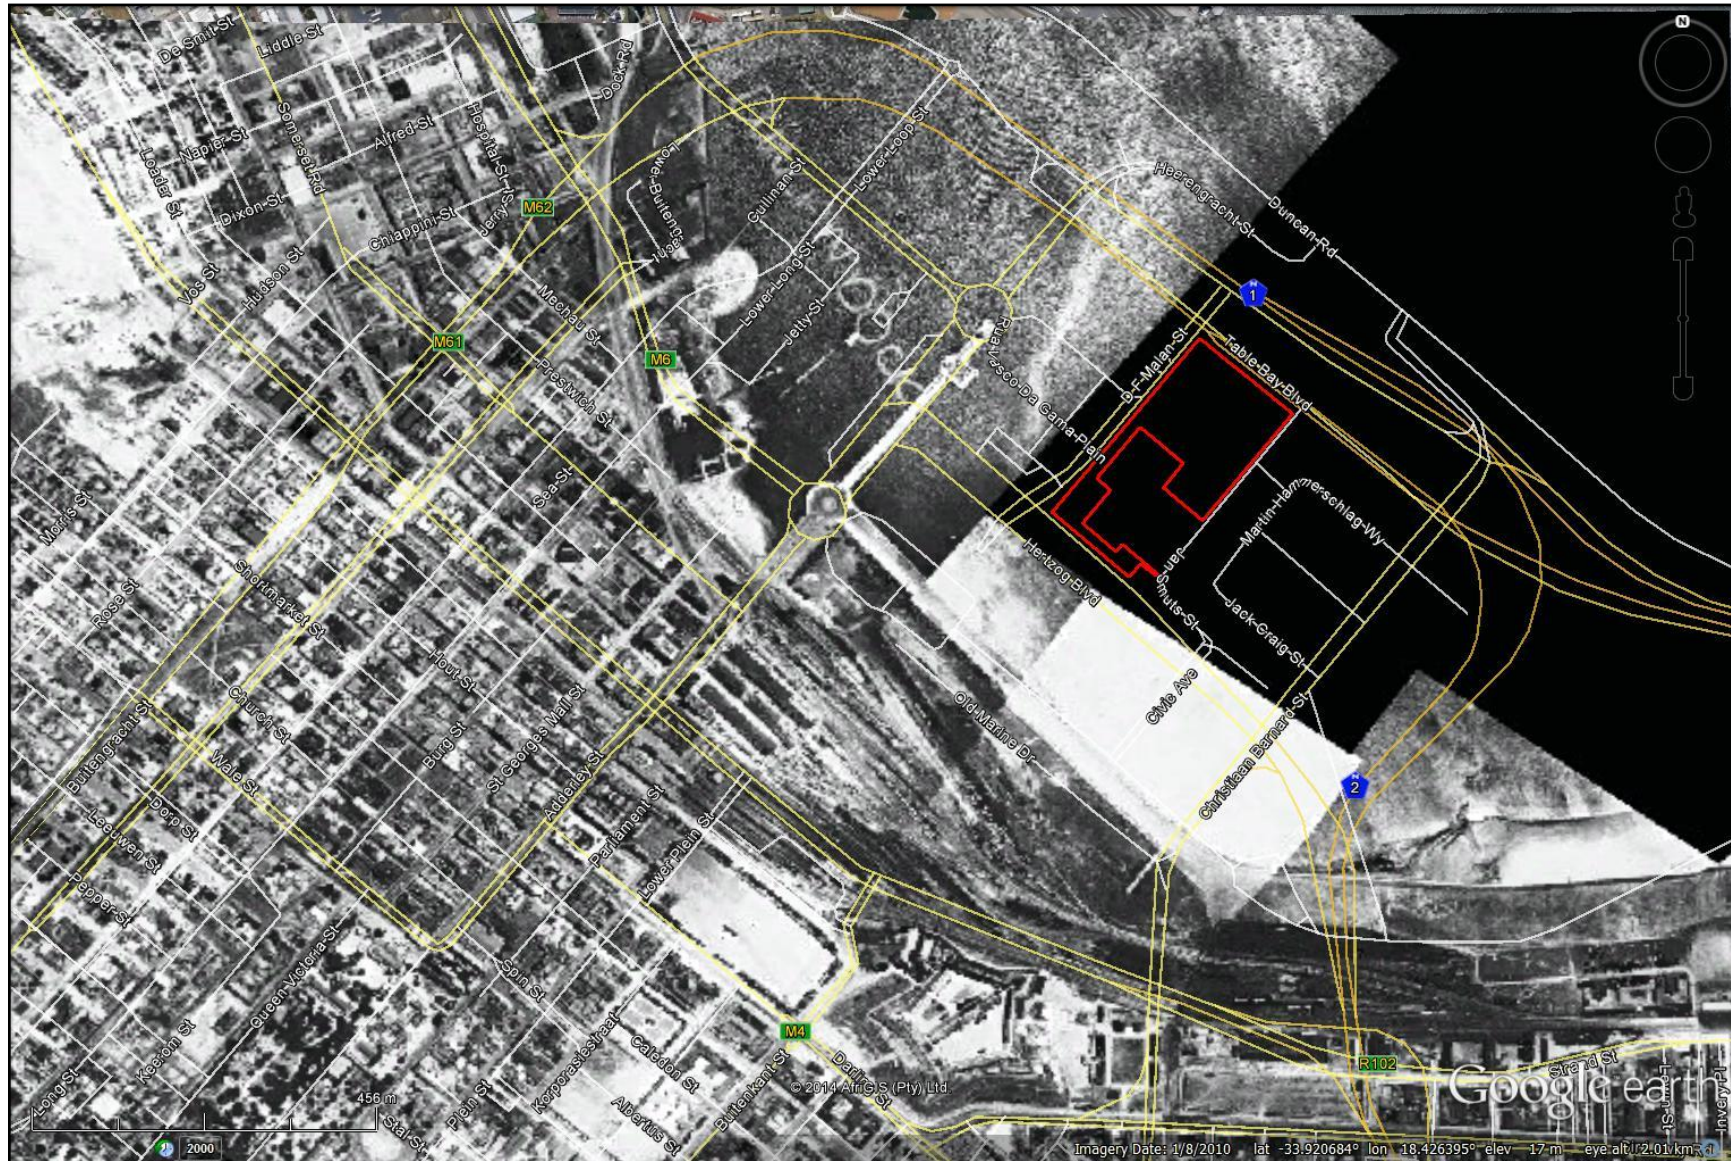
Figure 7: An extract from the 1926 aerial photo of Cape Town showing the 1913 pier (source: Jordan 2003) with current street map superimposed via Google Earth. The old Roggebaai fishing boat harbour and beach clearly visible at center. The old promenade running south east from the base of the new pier at the foot of Adderley Street. The position of Erf 186 offshore at that time is indicated by the red polygon.

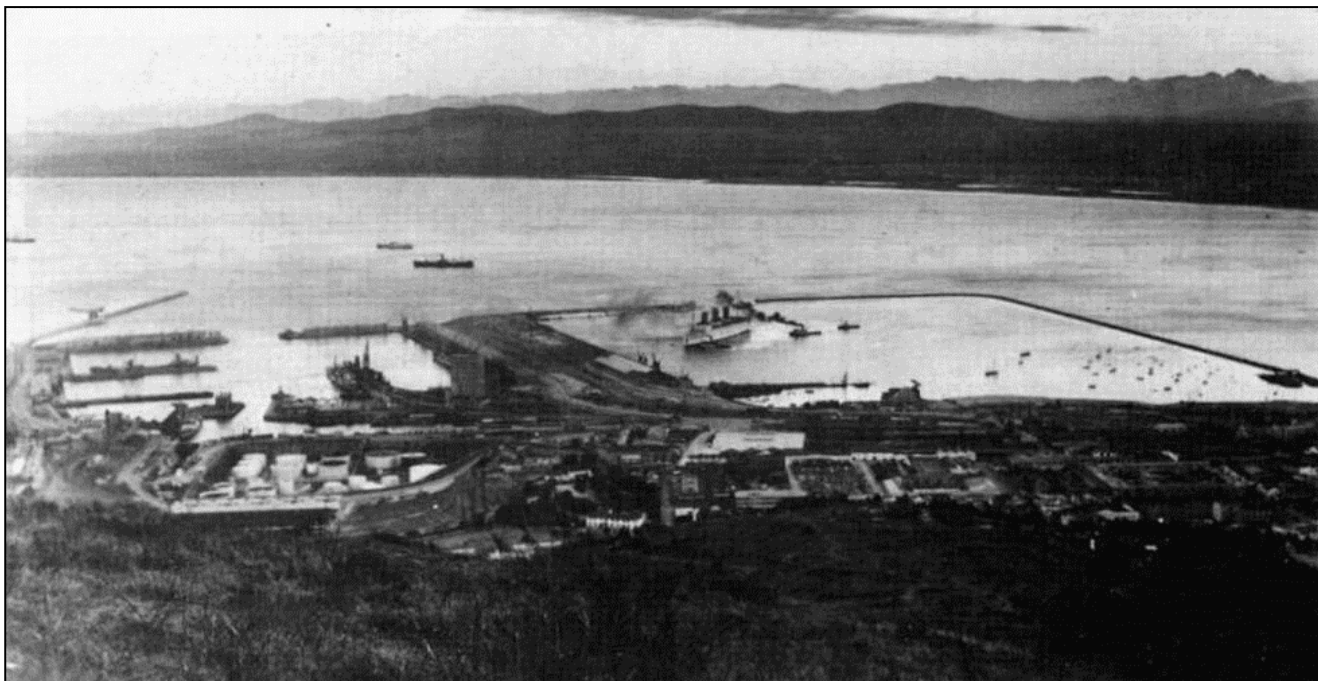
Plate 12: The new southern basin in 1934 with the random block mole at right (in Newall 1993)

From 1926 to 1932, as a result of the need for docking space for more and larger ships, a mole (the so-called “random block mole”) was constructed just northwest of the municipal pier to form a large sheltered basin. It extended in a north-easterly direction before angling to the north-west towards the end of the Victoria Basin (Spies & Du Plessis 1976, quoted in Durden 1992. See Plate 12 & 13 and Figure 2).

The mole was originally built by first dumping rubble on the seabed and then placing large six-ton concrete “wave-breakers” on top. When dismantled, the wave-breakers were removed by a crane equipped with a grab-claw and were subsequently stacked ashore (although some were found during the construction of the CTICC 1). The Municipal Pier was demolished to just above the high-water mark and the remains were buried in the fill (de Kock 1999).

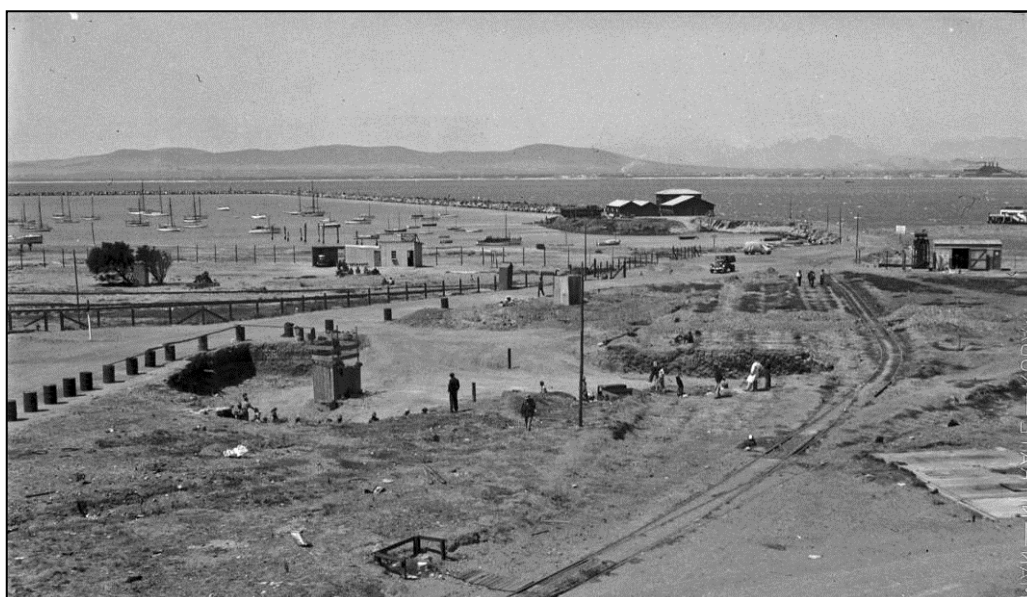
Plate 13: The Random Block Mole shown beyond an area of landfill (City of Cape Town: Heritage Branch CCb119_f45_i01)

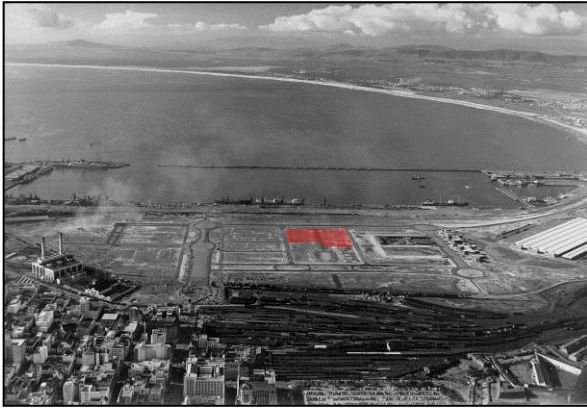
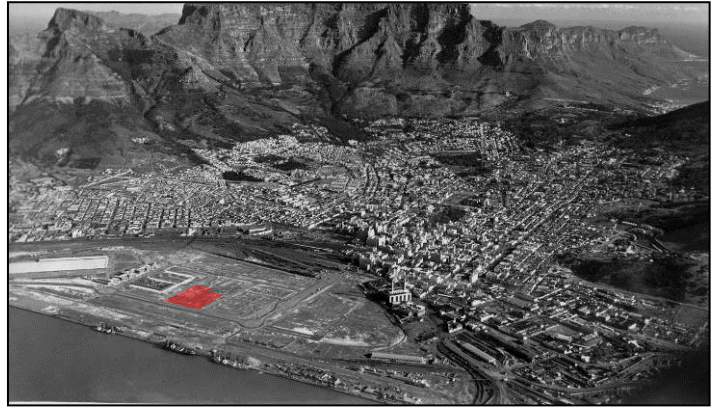
Plates 15 and 16: Two aerial views of the reclaimed land on the foreshore with proposed development sites shown in red. Probably late 1940's. (Photographs supplied by S. Lukey & Assoc but original source unknown)

A number of views of the newly reclaimed land are shown in Plates 15 -18 with the proposed development sites marked in red on some. A panoramic view of the area from the old Power Station is shown in Plate 19.

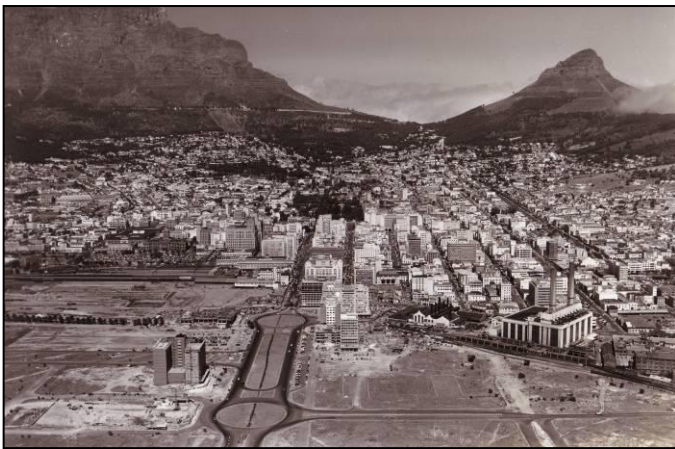
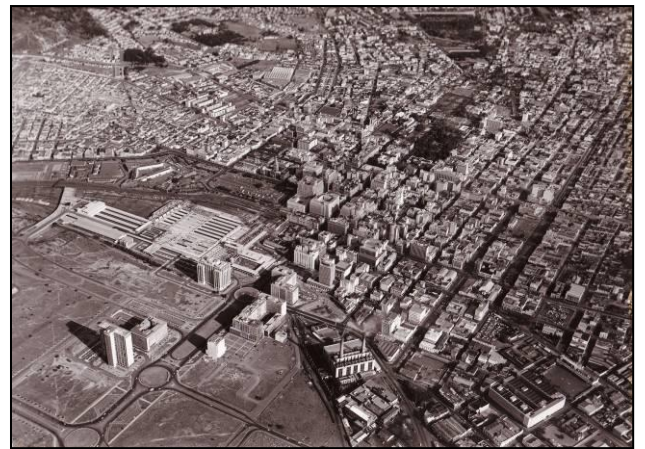
Plate 17: Aerial photographs of the lower city with new construction taking place on the reclaimed land. Photo at left predates the new station and probably dates to the late 1950's. The old promenade is marked by the line of trees on the mid left of the photo. **Plate 18:** The Sanlam building and new station can be seen in the right hand photo which would date it to the 1960's. The old promenade has almost been obliterated by this time though some trees can still be seen (Photographs supplied by S. Lukey & Assoc but original source unknown).

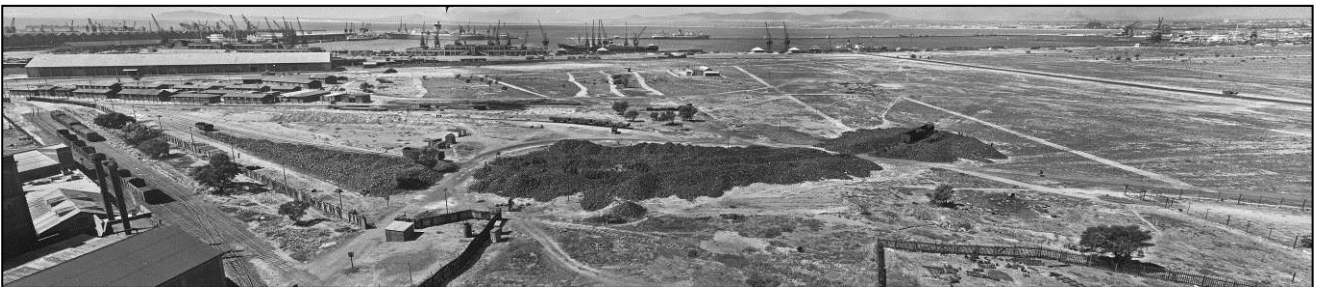
Plate 19: Broad panorama over the landfill area (City of Cape Town: Heritage Branch)

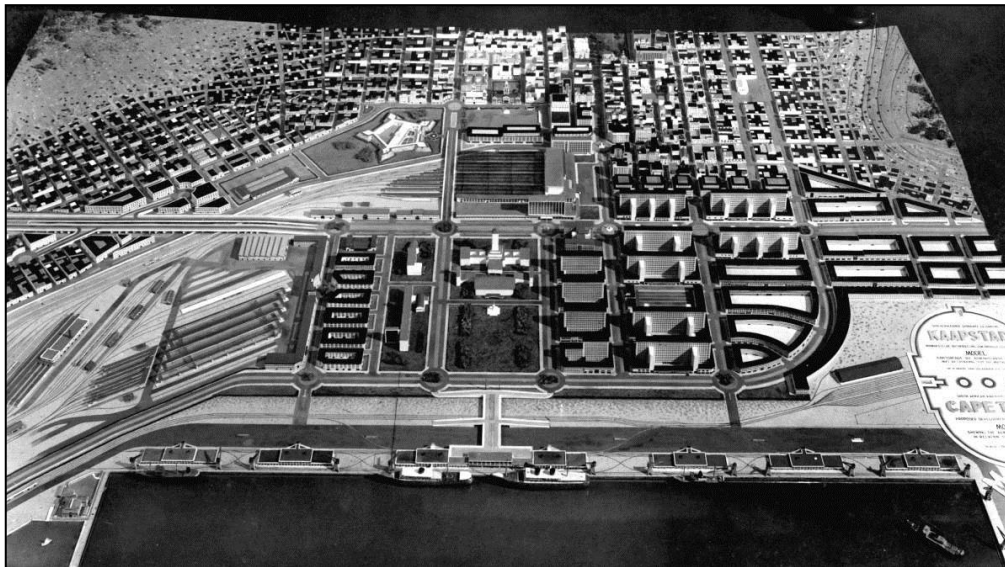
Plate 20: A photograph of the model of the proposed layout of the foreshore (source unknown - included with a number of loose photographs in a second hand copy of the 1940 Foreshore Scheme report in ACO possession)

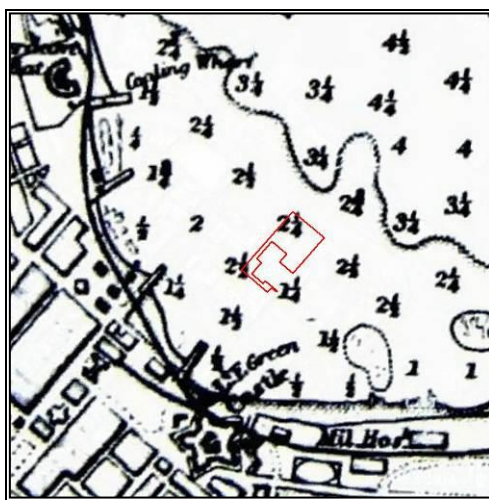
Figure 8: An extract from a plan showing the bathymetry of Table Bay in 1858, as surveyed by F. Skead R.N (see also Figure 2). Although the date on the chart suggests that it was prepared in 1858, some of the landmarks that have been included indicate that the map is probably from sometime after 1860. Depths in fathoms (1 fathom = 1.8288 meters). Sceptre Reef appears in front of the old Military Hospital at Woodstock.

Figure 3: The bathymetry of Table Bay in 1858, as surveyed by F. Skead R.N. The area defined by the hatched polygon is shown in Figure 8 with relevance to the proposed development site

The analysis of available historical information has indicated that the proposed development lies on reclaimed land above a part of the bay that would have been between approximately 600 meters from the old shoreline (in about 1870). The approximate position of the development site is indicated in red on the depth chart below and suggests that sea depth in the area of Erf 186 would have been in the order of 4.1 – 4.5 meters (2.25 - 2.5 Fathoms). It is worth bearing in mind when the parking basement/foundation depth is discussed as it will be in that range where material may be found on the old seabed during bulk excavations.

The almost complete lack of major reefs or rocky shoreline along the eastern and southern shores of the bay (except for the so-called Sceptre Reef see Figure 8 (and also Hart 1998:21), meant that vessels grounded on the beach could sometimes be successfully refloated. Many however could not and were instead salvaged. Both the ships timbers and fittings and the cargoes were valuable and were removed for resale. Frequent auctions of the grounded vessels and salvaged items were advertised in the local press (Figure 11). The significance of these auctions for the likelihood of finding wrecks below landfill lies in the fact that shoreline wrecks were mostly salvaged! If fragments were left behind for whatever reason, they are only likely to represent fragments of the original vessel and its cargo. Material that remained would probably have been inaccessible due to having been quickly buried by beach deposits (see Lightley 1976). Even to this day, fragments of vessels are exposed from time to time on Milnerton Beach.

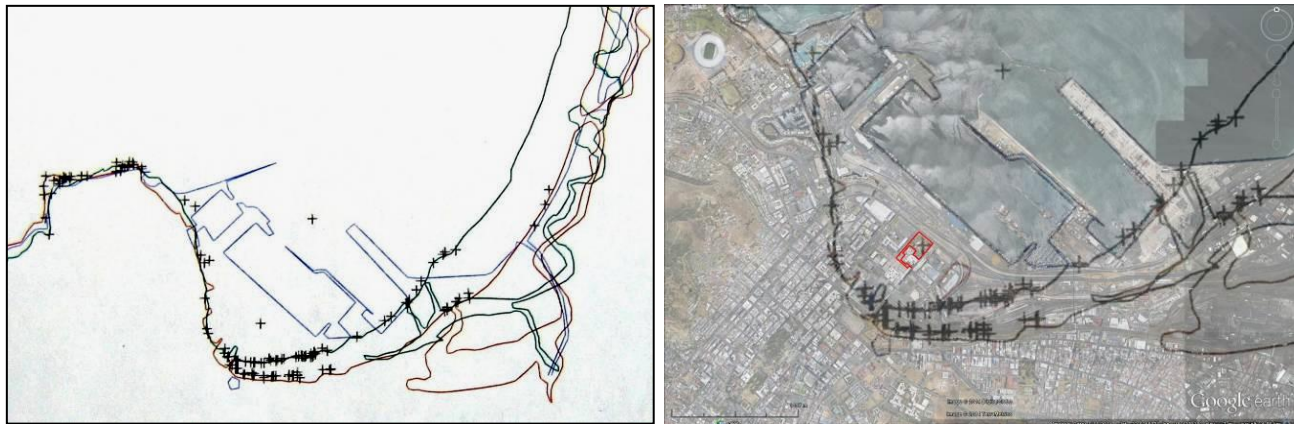
Figure 9: Map overlay of Table Bay showing approximate locations of 19th century shipwrecks (Durden 1992).
Figure 10: Overlay of Durden's shipwreck data on a current aerial photograph of a portion of Cape Town. The proposed development site shown in red. The "x" within the development site is believed to be incorrectly placed. It should be over the Civic Centre as it most likely represents the Dutch vessel "Nieuwe Rhoon" described by Lightley (1976).

In order to illustrate the statistics more graphically, Durden (1992) presented shipwreck positions plotted in relation to the old shorelines (Figure 9, 10). One could look at his data and assume from it that he has used co-ordinates to achieve the distribution. Rather he has made an attempt to convert rough landmark data into positions to facilitate the use of GIS technology. Turner (1988) has presented Latitude and Longitude co-ordinates for a number of wrecks but similarly, these can also be no more than rough guesses.

Despite the fact that Durden's plots are to be viewed with a degree of circumspection, his map of the shoreline nevertheless gives some idea of the distribution of wrecks as described. The map also shows the changes in shoreline that occurred over time. By overlaying a portion of the Durden wreck distribution over a current aerial photograph of Cape Town (using the Google Earth software) (Figure 10, we achieve a very graphic demonstration of the most likely areas where wrecks will be found.

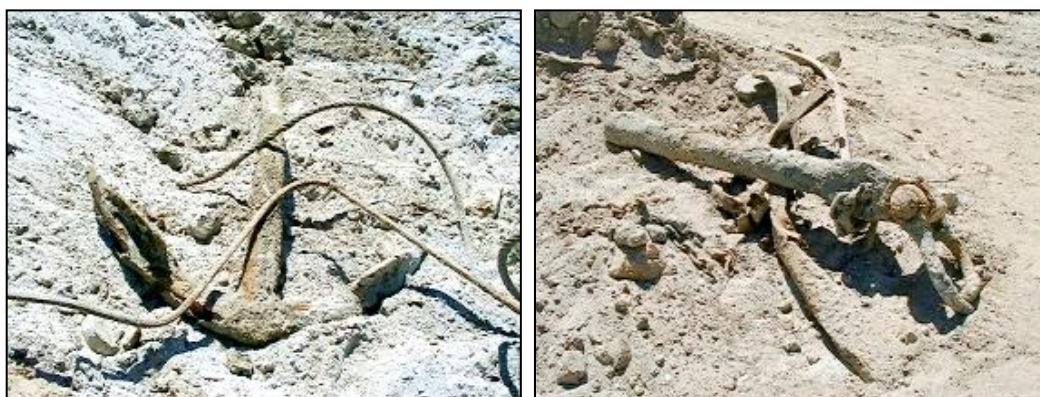
Plates 21 & 22: Two anchors were recovered from the lower rubble fill during bulk earthworks at the CTICC 1 site. The admiralty pattern anchor shown at left is made from wrought iron and has curved arms tipped with flukes. These were used throughout the 19th century. The anchor at right had lost its arms although the mechanism at the top of the shank was well preserved. Neither anchor had a stock (an “L” shaped iron bar that passed through the shank just below the chain ring at right angles to the arms. This device prevented the anchor from lying flat on the seabed and ensured it dug into the sandy bottom).

It is difficult to determine what may be found on the old seabed. Anchors, cargo and fragments of vessels are probably most likely (anchors were found previously on the *Arabella Hotel* (now the *Westin*) site during bulk excavations (Halkett 2002, and at the *Silo 1* site at the *Waterfront Schietecatte* in prep). Significance would be determined on a case by case basis. The recovery of such items is unlikely to result in significant delays. We believe it to be highly unlikely (although they cannot be ruled out) that individual human remains will be found on the old seabed.

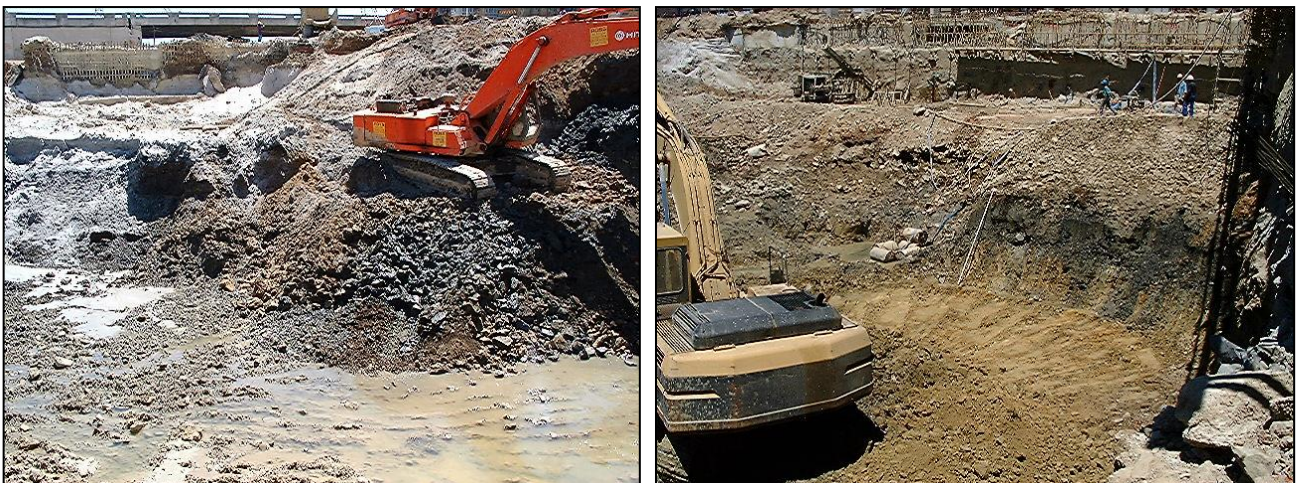
Plates 23 & 24: At left two types of fill consisting of the lower rock rich deposits (from the base of Duncan Dock?) and sea/dune sand above. A thick dark layer in the photograph at right, was interpreted as the old seabed, upon which was a build up of organic debris and coal residue (Photographs: ACO Associates archive).

Despite the size of the earthmoving area, the sequence of deposits remained more or less the same across the whole site (Halkett 2002:2). In contrast to official records of the landfill, we recognised five stratigraphic land fill units that can be described as follows (see also Plates 23 & 24):

- Upper rubble: this is a landfill made up largely of building debris and from the smell in places, also industrial waste;
- Dredged sand: landfill consisting of dredged seabed material, white in colour and rich in water rounded marine shell. Clearly of marine origin, this cannot be the dune sand reported to have been brought from near the airport and it must have been used elsewhere (see Cox 2000 and Sharfman & Mavradinov 2000);
- Lower rubble: earlier landfill containing much rocky material and other debris. This appears to have been submerged or waterlogged and had a strong sulfurous aroma;
- Old seabed: this was marked by a relatively thin deposit (on average 80cm thick) of black/grey clay also having a strong sulfurous aroma;
- Bedrock: Malmsbury Shale.

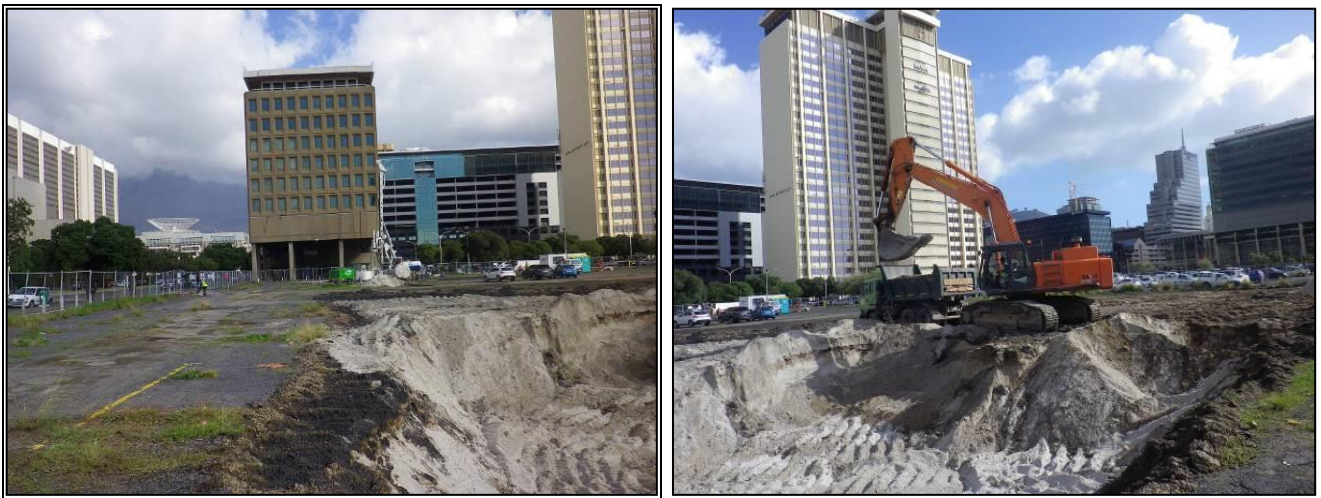
Plates 25 and 26: Bulk earthworks at Erf 247 in progress. A number of key buildings provide reference points. The uniform nature of the sub-surface deposits is clearly visible

According to Seeman (2013a,b,c) the reclamation material consisted predominantly of marine sediments throughout, with a single brown organic and rubbish layer encountered at approximately 1.5 meters below surface separating two episodes of marine sand filling. The white marine sediment covered the entire site to a depth of approximately 3.5 meters below surface (Plates 25 and 26). This material is consistent with the material that was interpreted as dredged marine sediment at the CTICC1 site (Halkett 2002). Grey gravelly sand with numerous white mussel shell fragments was found in the deeper lift shaft excavation that progressed to a depth of approximately 6 meters below surface.

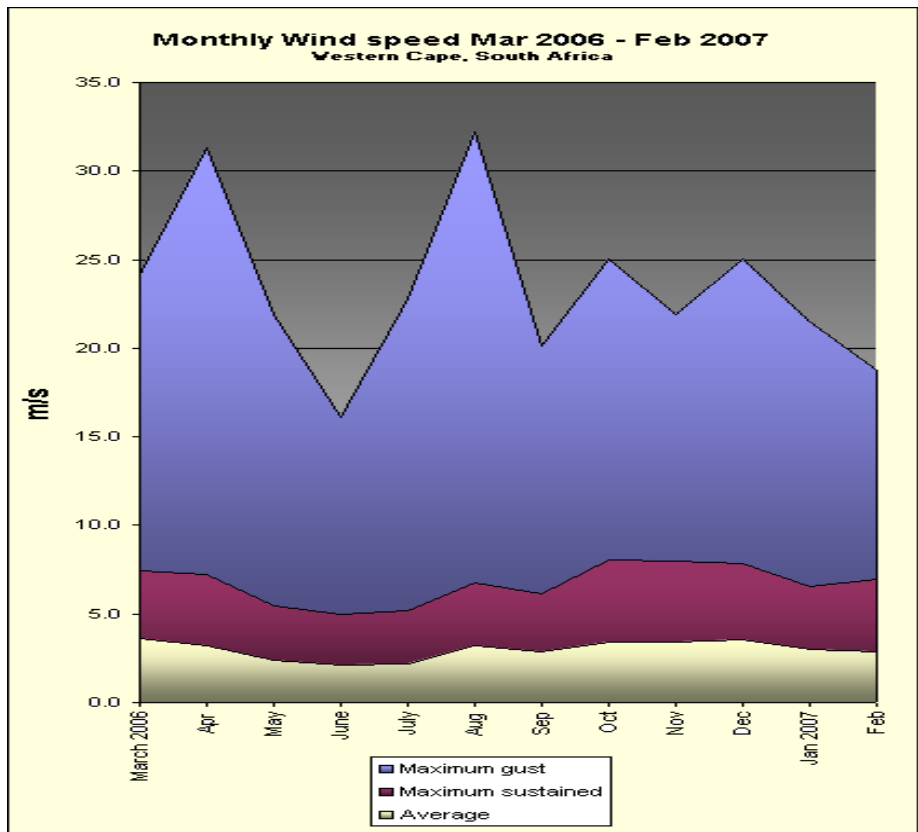
The graph above shows a wind profile for March 2006 to February 2007. Note that the maximum gust speed exceeds the average speed by up to 5.5 times.

- a. The wind in the area of the development is generally from the South / South East in summer and from the North West in winter.

- b. We have located the nearest recording weather station to the proposed site. The maximum wind speed recorded over the past three years is 62 km/h with a gust velocity of 96 km/h. This corresponds to wind speeds of 17 m/sec and 26 m/sec, wind being from the South / South East.

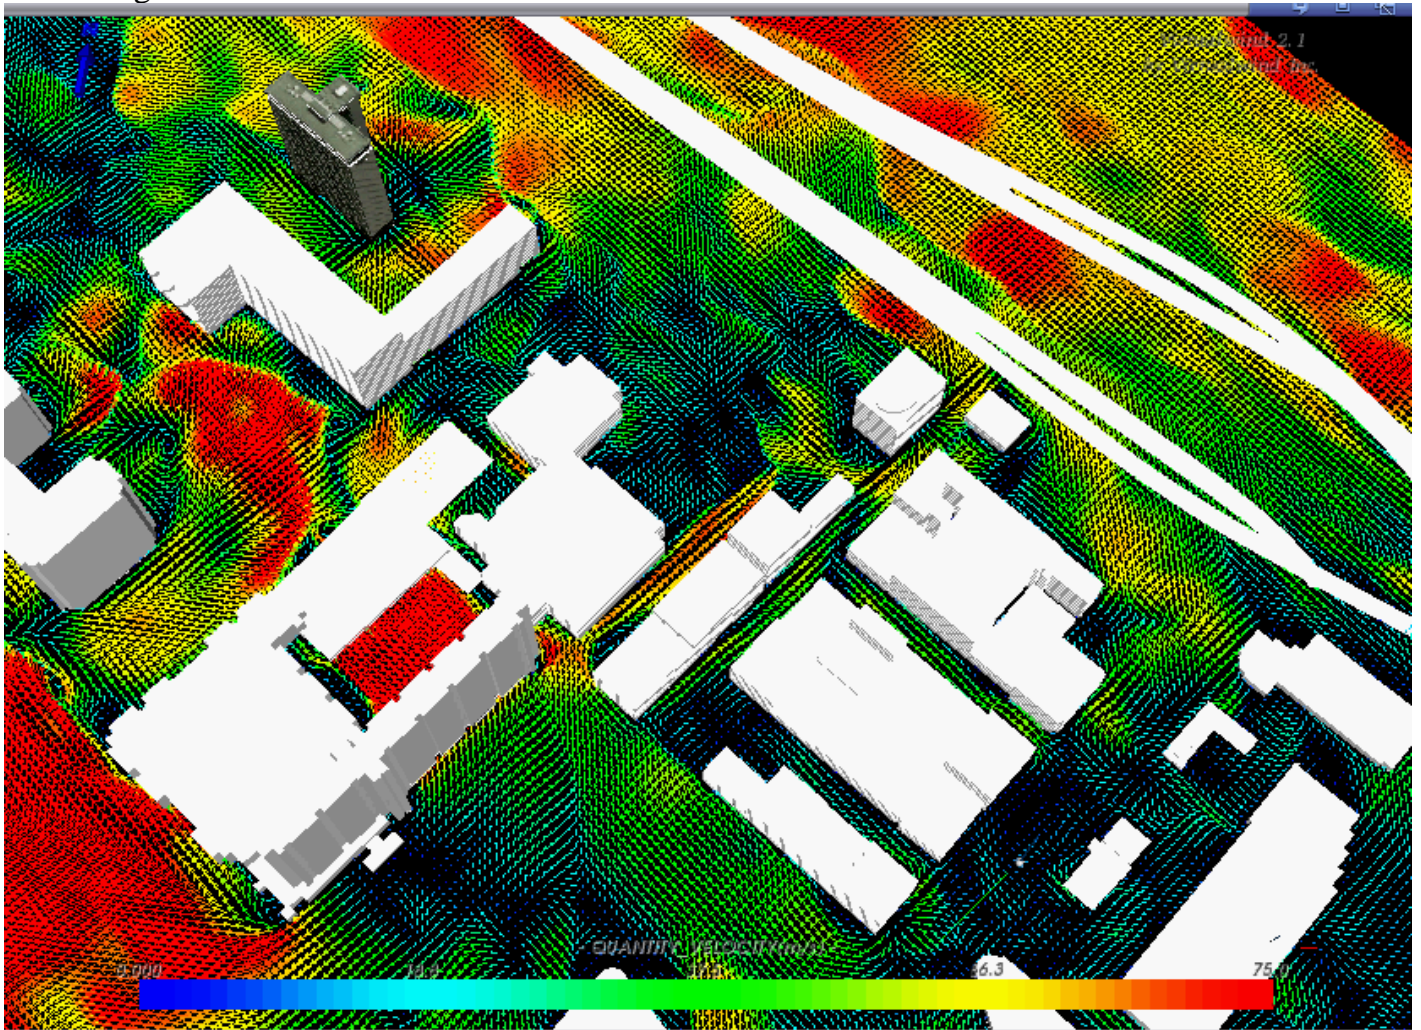
Page I

Page I: Wind from the SSE at 15 m/s at ground level: wind distribution without Founders Garden development or Netcare or 156 Roggebaai. This is the worst condition / highest velocity of ground level wind distribution with Founders Garden development excluded from the wind map. Note the strong East going vortex from the Mediterranean Shipping Company Building under the freeway, the very high winds under the Municipal offices and the East going vortex from the Caltex Building. The two vortices dissipate under the freeways.

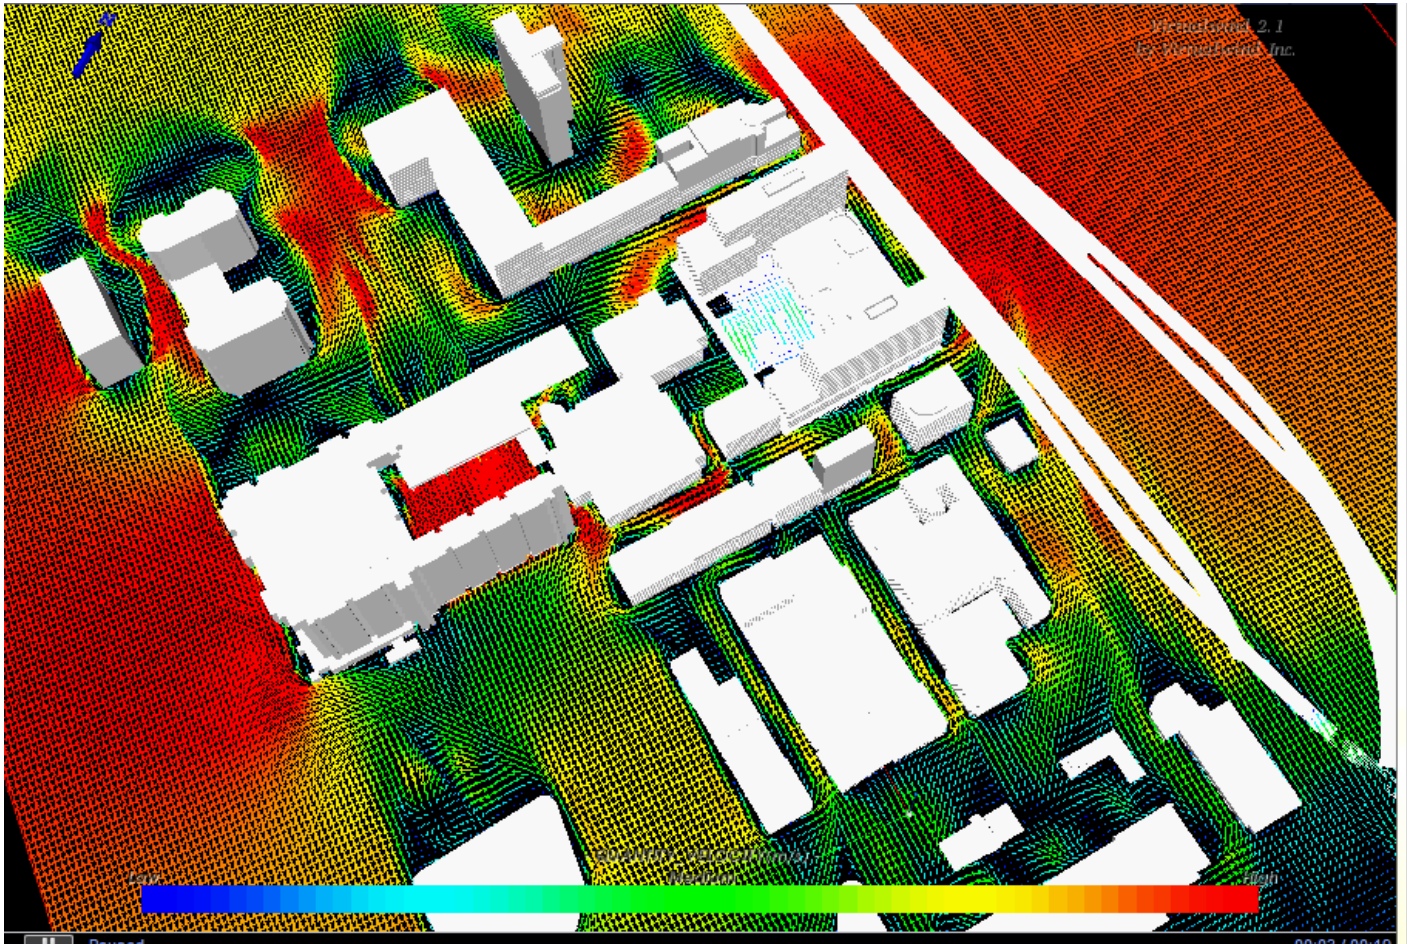
Page II

Page II: Wind from the SSE at 15 m/s at ground level: wind distribution with Founders Garden development and Netcare Building included in the model. This is the worst condition / highest velocity of wind at ground level

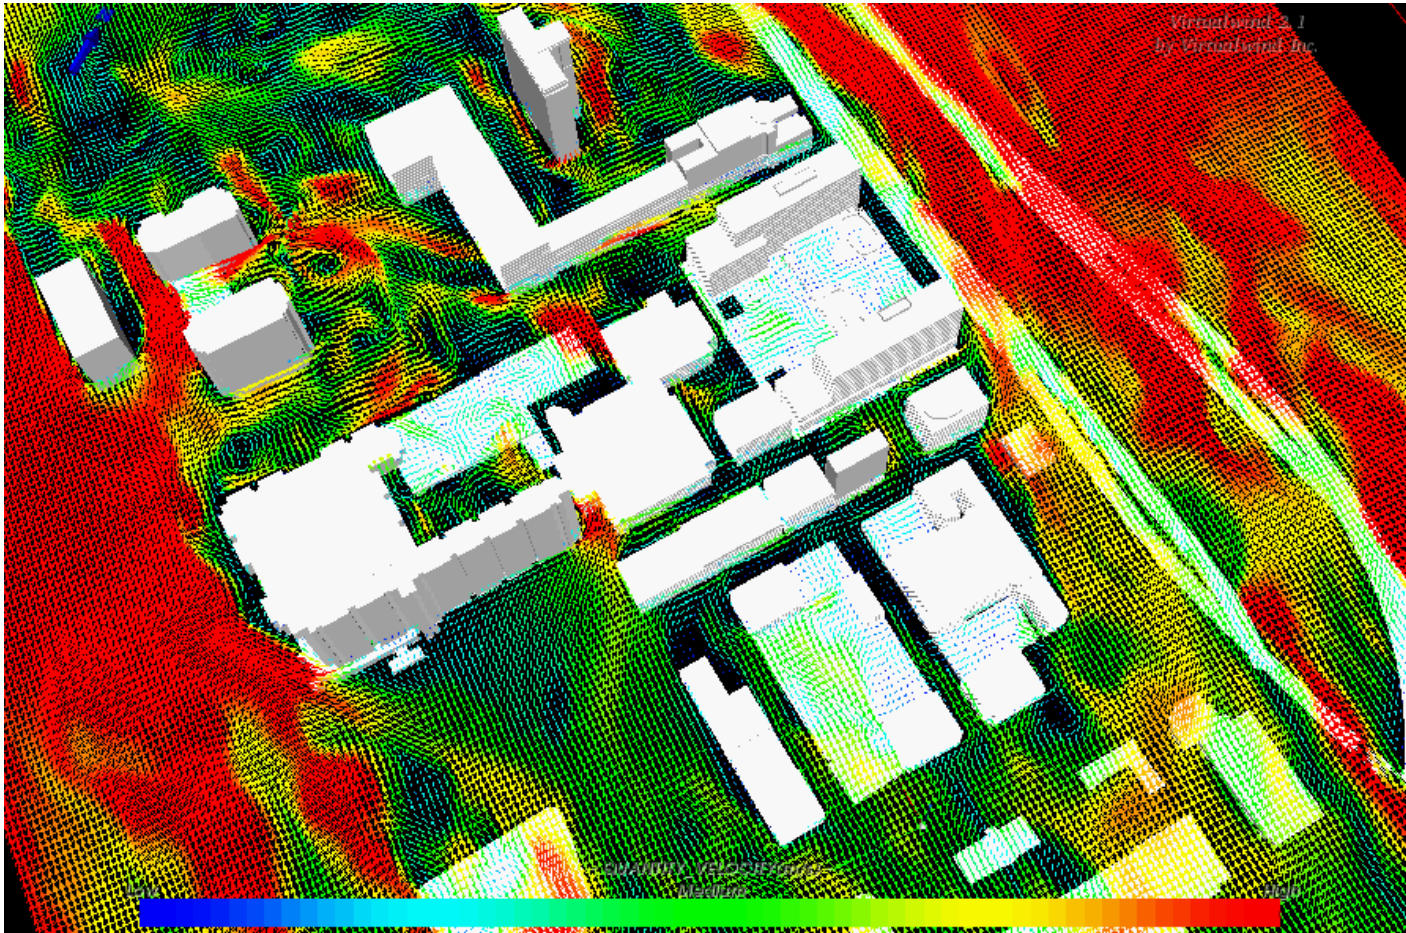
Page III

Page III: Wind from the SSE at 15 m/s at 20 m above ground level (i.e. 2 m above the Freeway) : wind distribution with Founders Garden development and including Netcare building. This is the worst condition / highest velocity of wind at 20m above ground.
