**Letter from DEADP requiring EIA application dated 10.04.2012 &
Letter from DEADP confirming withdrawal of EIA application dated 10.02.2015**

Founders Garden
Foreshore
Cape Town

DESKTOP ARCHAEOLOGICAL ASSESSMENT OF THE PROPOSED FOUNDERS GARDEN DEVELOPMENT ON ERF 186 ROGGEBAAI, CAPE TOWN FORESHORE

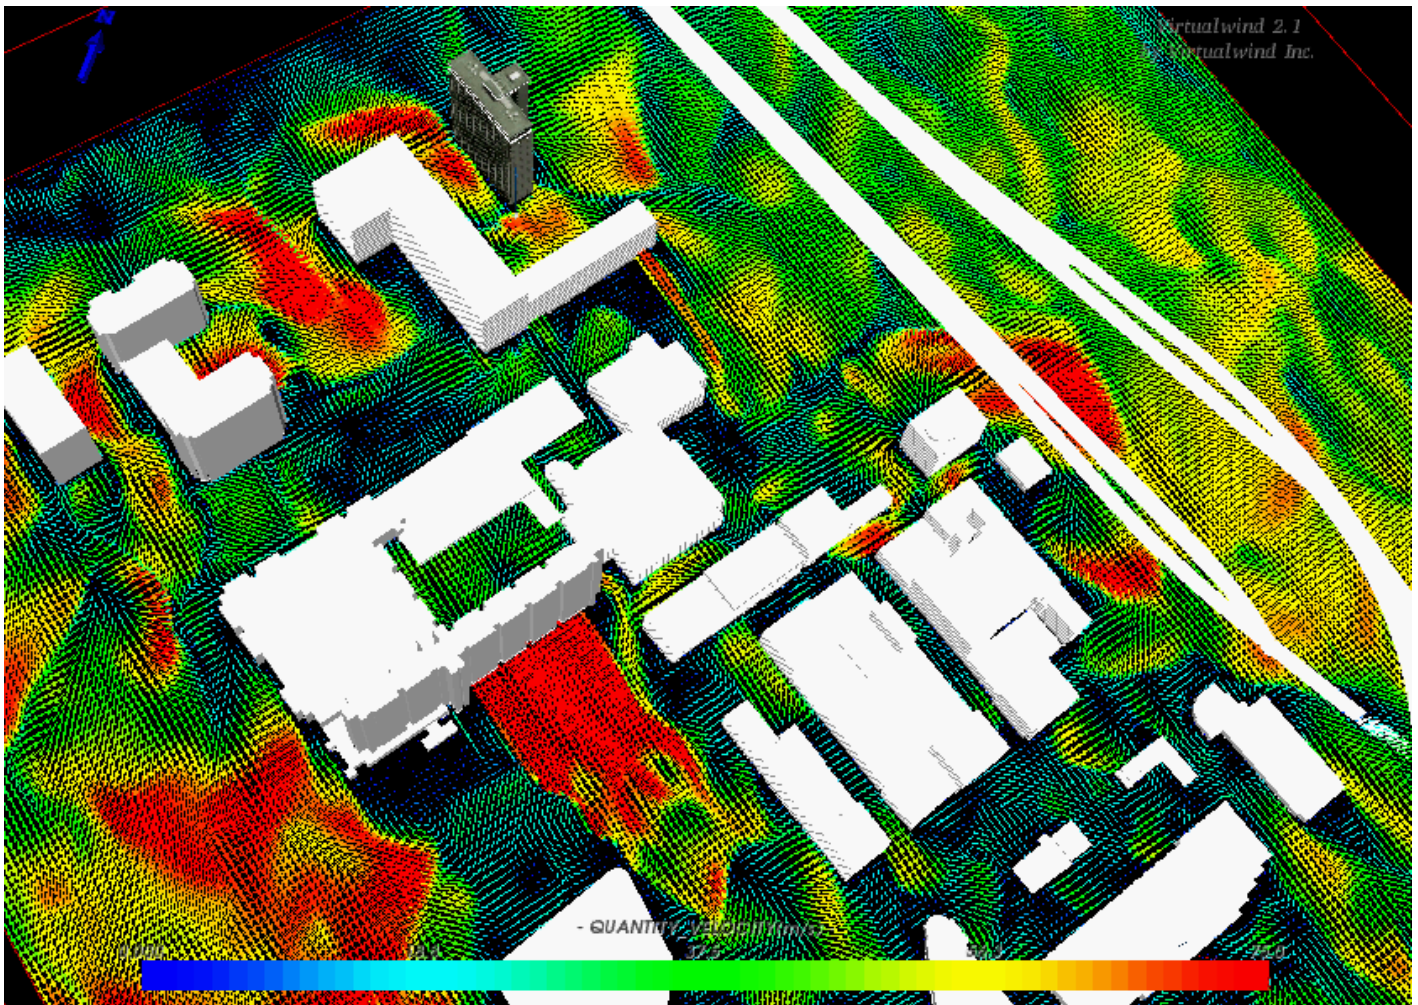
Page IV

Page IV: Wind from the NW at 15 m/s at ground level: wind distribution without Founders Garden development or Netcare or 156 Roggebaai. This is the worst condition / highest velocity of ground level wind distribution with Founders Garden development excluded from the wind map. Note the strong East going vortex from the Mediterranean Shipping Company Building under the freeway and the very high winds under the Municipality Building. The two vortices dissipate under the freeways.

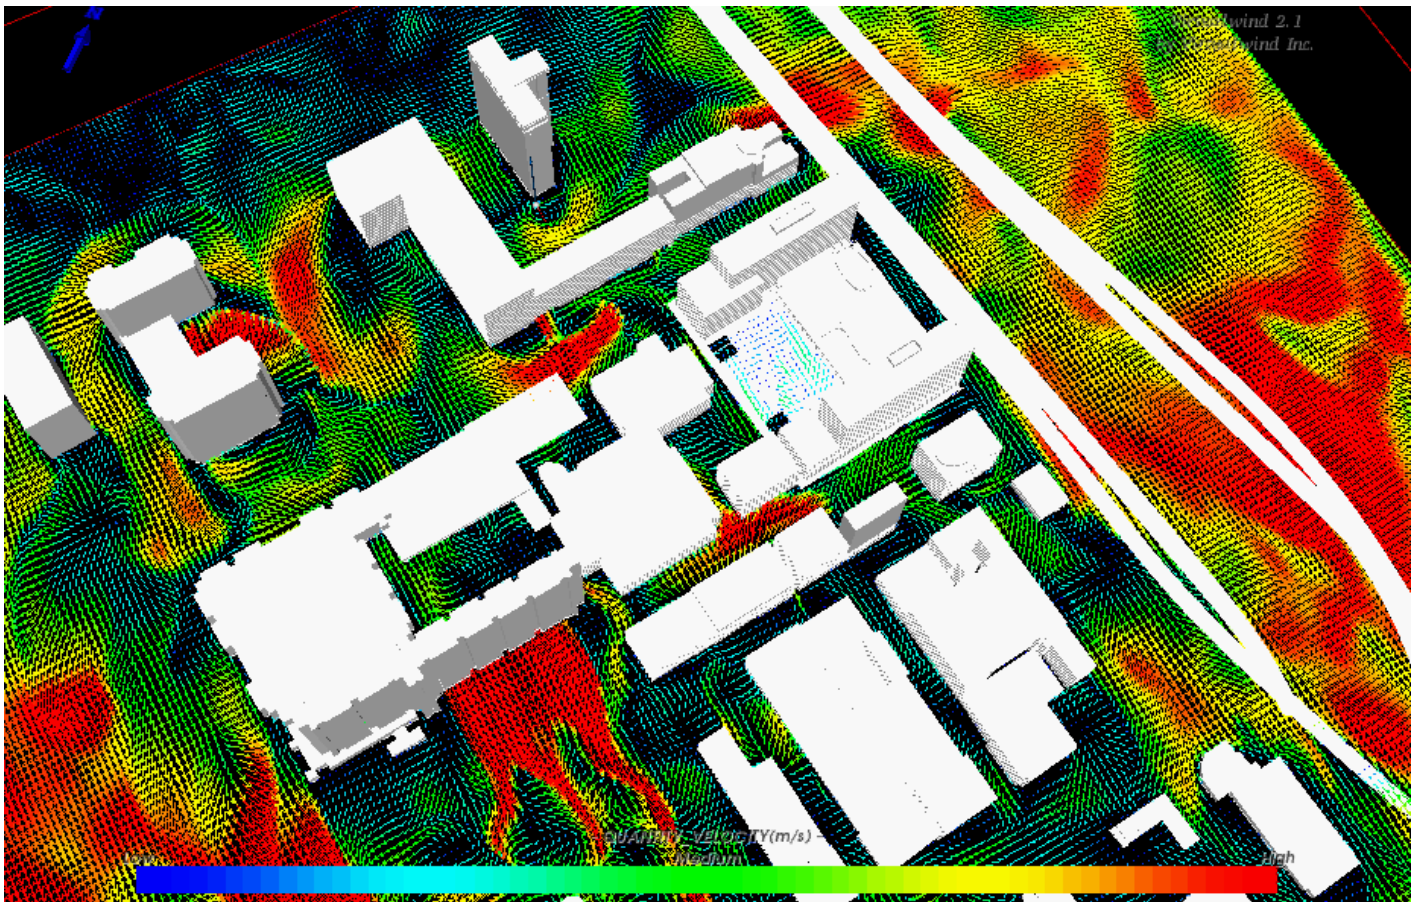
Page V

Page V: Wind from the NW at 15 m/s at ground level: wind distribution with Founders Garden development and Netcare development included. This is the worst condition / highest velocity of ground level wind distribution.

- a. The effect of the increase in building massing is to deflect much of the wind South South East (SSE) under the freeways. Since the deflected wind meets the incident wind from the NW the wind velocity increases (maximum as above) and then dissipates to a large degree.
- b. High winds flow under the Municipality building.
- c. Extremely turbulent conditions SE of Caltex house and between the Standard Bank towers.

- 6.1 The wind from the South/South East is the prevailing wind for this area of the City of Cape Town during summer and North West in winter.
- 6.2 The cumulative effect of the Founders Garden development and the Netcare development is to block wind paths from both the SSE and the NW. The result will be that the area +/- 2m above ground level to the NE of the Freeways will always be windy with high gust occurrence, regardless of wind direction. High winds will flow under the Municipality building.

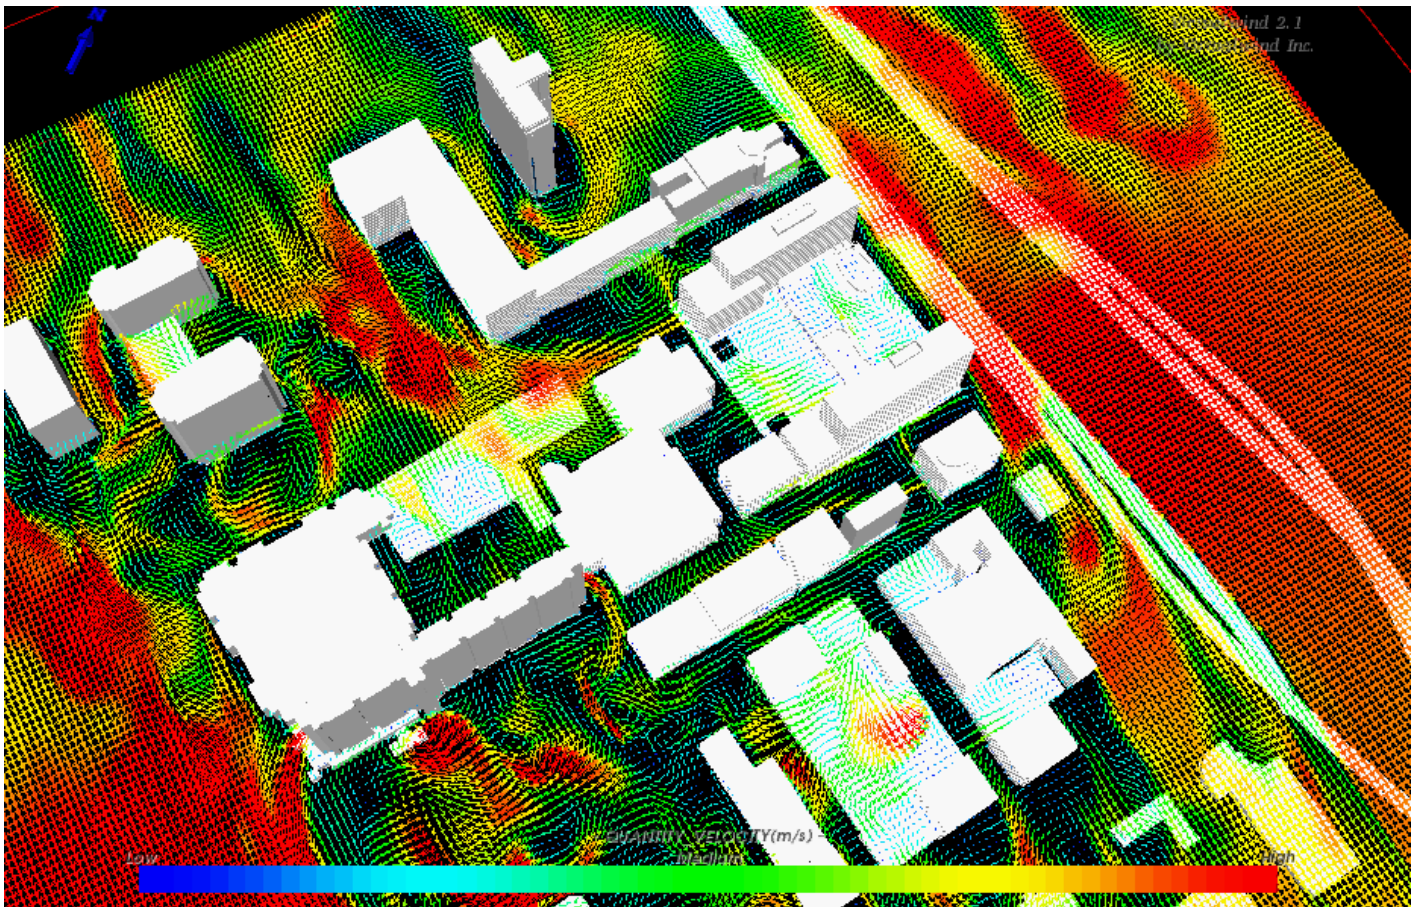
Page VI

Page VI: Wind from the NW at 15 m/s at 20 m above ground level (i.e 2m above Freeway level): wind distribution with Founders Garden development and Netcare development included. This is the worst condition / highest velocity of ground level wind distribution.

- a. The effect of the increase in building massing is to deflect much of the wind South East (SE) over the freeways. Since the deflected wind meets the incident wind from the NW the wind velocity increases (maximum as above) and then dissipates to a minor degree. The outgoing freeway lanes will be turbulent with high gusts and will affect two wheeled traffic.
- b. There is an oscillating vortex incident on incoming freeway lanes. This is caused by the Founders Garden building. The vortices are strong and intermittent

- 6.3 The cumulative effect of the Founders Garden development and the Netcare development is to block wind paths from both the SSE and the NW. The result will be that the area 20 m above ground level (+/- 2m above Freeway level) will always be windy with high gust occurrence, regardless of wind direction. The outgoing freeway lanes will be turbulent with high gusts and will affect two wheeled traffic. The wind shear that will arise over the N1/N2 outgoing freeway as above has the potential to cause vehicle loss of control and the consequences thereof.
