**HERITAGE IMPACT ASSESSMENT FOR PROPOSED
REMEDIAL WORKS TO THE SEWEWEEKSPOORT PASS,
LAINGSBURG AND LADISMITH MAGISTERIAL DISTRICTS,
WESTERN CAPE**

Required under Section 38 (8) of the National Heritage Resources Act (No. 25 of 1999).

1st draft: 04 February 2017

Final report: 12 October 2017

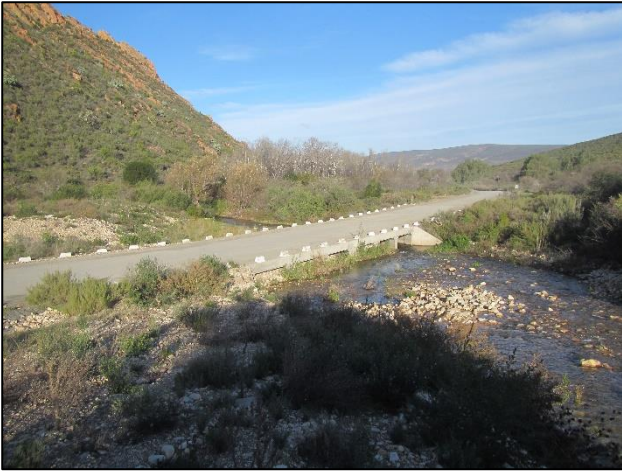
Figure 2: Current river crossing at km 57.1. Note siltation and grass growth under culvert.

54.40	33°26'3.00"S 21°24'24.34"E	Road way gets flooded by river and washes material away completely during floods	350m Long Wall
57.10	33°27'14.40"S 21°25'15.08"E	57m causeway with 6x2.4m openings, 500mm slab, aprons and wing walls, 4 openings blocked with rocks only 2 openings clear	Drop inlet on existing structure

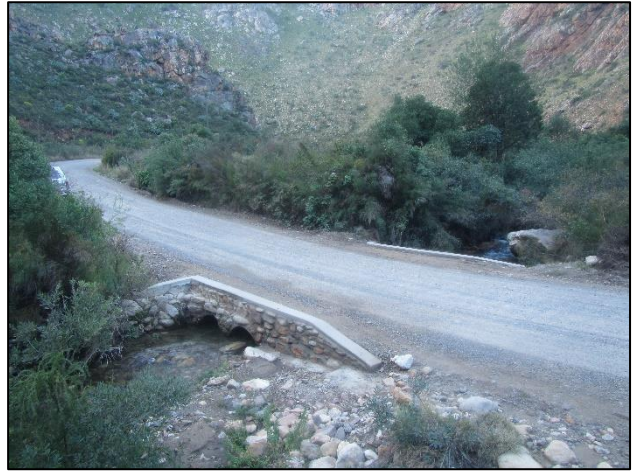
Figure 3: Current river crossing at km 54.1. Note small pipes for river.

54.10	33°25'56.48"S 21°24'26.57"E	2x900mm pipes with stone head wall up and down stream, mostly damaged, large boulders in river	4m Wide Cell causeway
54.30	33°26'0.20"S 21°24'24.55"E	2x900mm pipes with stone head wall up and down stream, mostly damaged, large boulders in river bed, siltation high	4m Wide Cell causeway

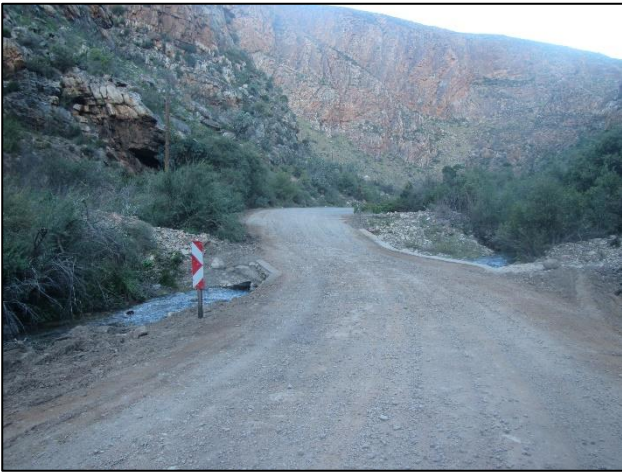
Figure 4: Current river crossing at km 53.4. Note small culvert and exposure of road to river.

53.20	33°25'35.88"S 21°24'16.53"E	2x900mm pipes with concrete protection works up and down stream, scouring severe	4m Wide Cell causeway
53.40	33°25'39.94"S 21°24'20.83"E	2x600mm pipes with stone head walls at inlet and outlet, mostly buried, nearly completely destroyed	4m Wide Cell causeway

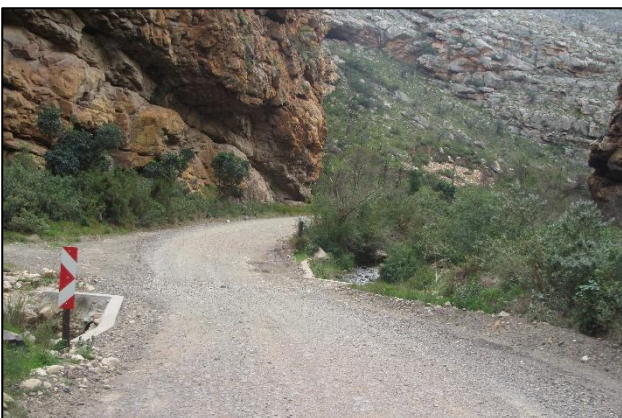
Figure 6: Current river crossing at km 50.8.

50.30	33°24'46.14"S 21°24'29.91"E	2x900mm pipes with stone head and return wall downstream, severely damaged and siltation issue	4m Wide Cell causeway
50.80	33°24'56.08"S 21°24'14.54"E	3x600mm pipes with stone head and return walls up and down stream, severely damaged and siltation prevalent	4m Wide Cell causeway

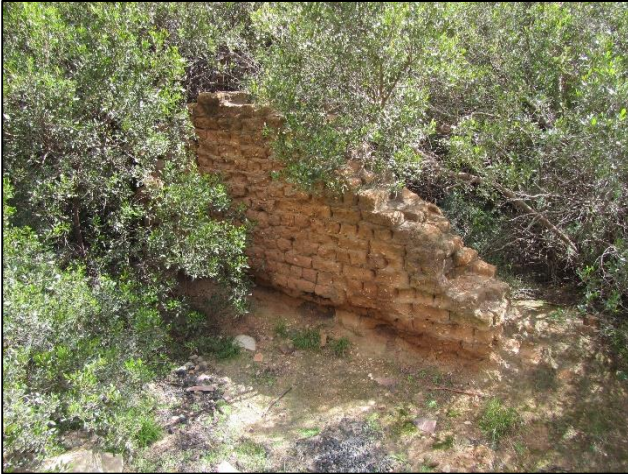
Figure 18: Ruined structure at waypoint 261. It has mud brick walls on a stone foundation.

Clearly a more important building, the structure at waypoint 261 was built from sun-dried mud-bricks atop a stone foundation (Figure 18). The stone section was quite high so as to raise the floor level of the structure far higher than any of the other ruins in the poort. The bricks contain fragments of sandstone and were very likely manufactured in the poort by the same convicts who worked on the road. The ruin was apparently the house of the supervisor of the road construction and is known locally as “The White House”. It stands almost exactly halfway through the poort when measured from the toll house (10.6 km along the road north of waypoint 261) to the R62 road in the south (10.3 km along the road south of waypoint 261). A smaller structure stood behind this house at waypoint 262. It was again built of stone and is said to have housed the servants of the road construction supervisor.

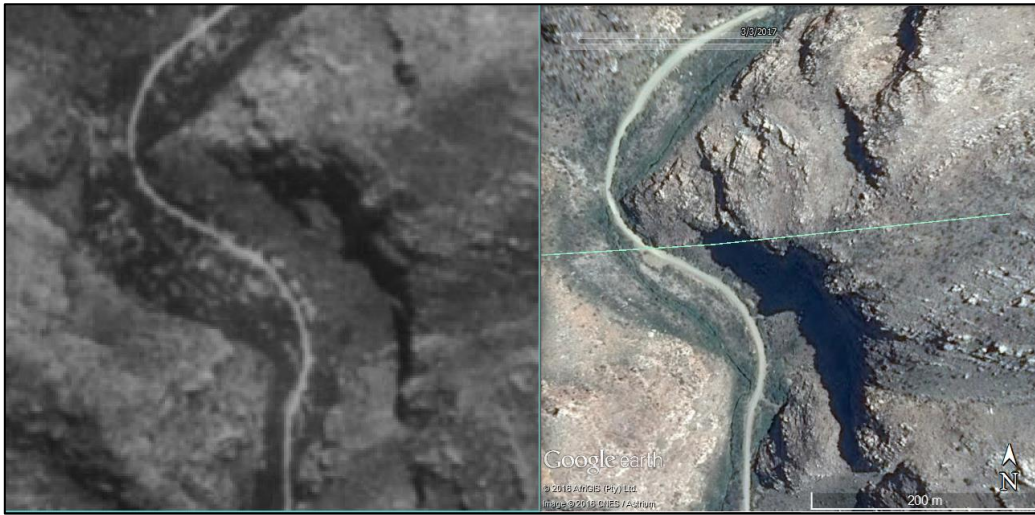
Figure 28: Comparative historical (1944; J Job 53, strip 8, photograph 2743) and modern aerial views of a section of the pass right in the middle of the Poort. The small borrow pits are more clearly evident in the earlier view as light patches.

The last archaeological features of note are the very large number of small excavations situated alongside the road throughout the length of the pass (Figures 26 & 27). These were material sources dating to the original construction of the road. They were excavated into the colluvial deposits at the foot of the slopes in order to obtain rocks and gravel. Comparison of a section of the pass on 1944 and modern aerial photographs shows these features clearly – they were less overgrown in 1944 (Figure 28).

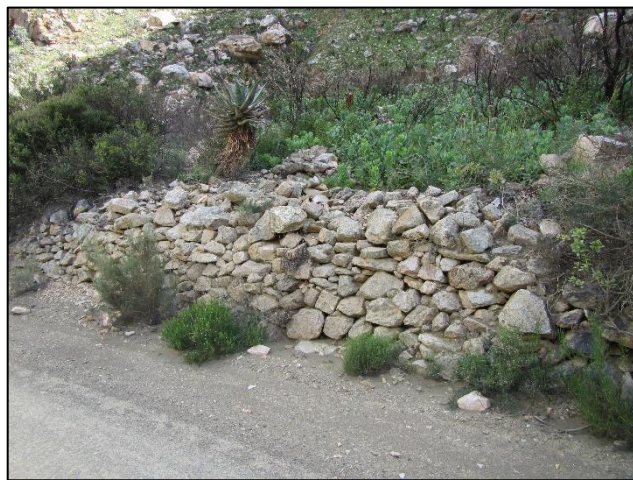
Figure 34: View of the stone retaining wall located along the road at waypoints 674-675.

Other heritage resources considered under built environment are sections of walling that were built as part of the road and retain their original functionality. Such retaining walls were observed in two locations, one above the road (waypoint 674-675; Figure 34) and one below the road where the latter passes very close to the river (waypoint 217). While no works are planned in the vicinity of

the second one, the first one does have a tributary stream crossing that requires attention immediately at its north-eastern end. This section on the end does look slightly different to the rest and may have been reconstructed after flood damage at some point in the past.

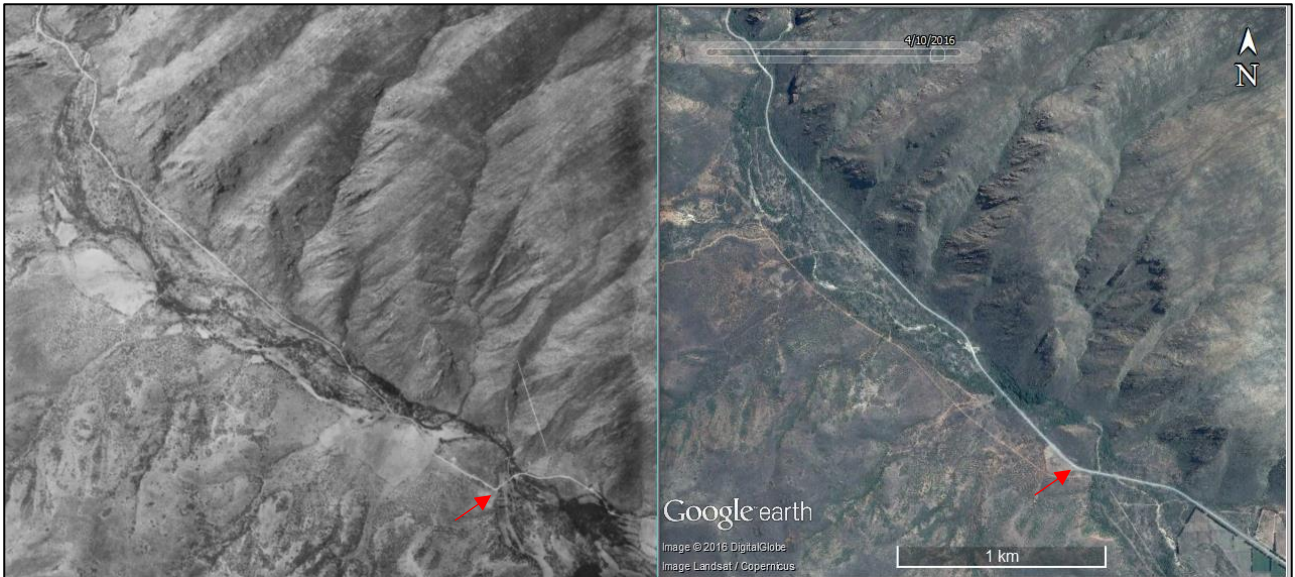
Figure 35: Aerial views dating to 1944 (Job 53, strip 10, photograph 3652) and 2016 (Google Earth). The two views cover an identical area and it is evident in the northwest and southeast that the road alignments have been straightened in recent times. “Daadshoogte” is indicated by the red arrows.

For the majority of its length within the steep-sided valley it follows the most logical route as chosen for its original mid-19th century construction. In the south-east, however, it has been substantially altered. To the southeast of about km 55 we see from the 1944 aerial photography that the road has been straightened considerably (Figure 35). The long straight section known as “Langbaan”, however, was always straight. It is interesting to note that the place known as “Daadshoogte” used to be a very sharp turn and it was no doubt at this point that accidents used to happen prior to the straightening of the road. The 1966 1:50 000 topographic map appears to show the straightened roadway, as does the 1968 aerial photograph (Job 586, strip 8, photograph 1369) which means that the changes were made between 51 and 73 years ago.

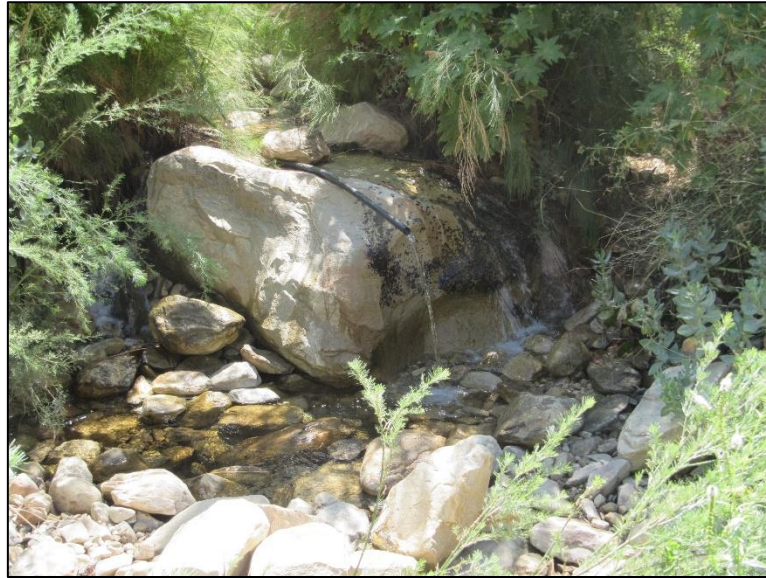
Figure 36: The important water point known as “Sterkwater” or “Drinkwater” (waypoint 269). Note the plastic pipe inserted to make water collection easier.

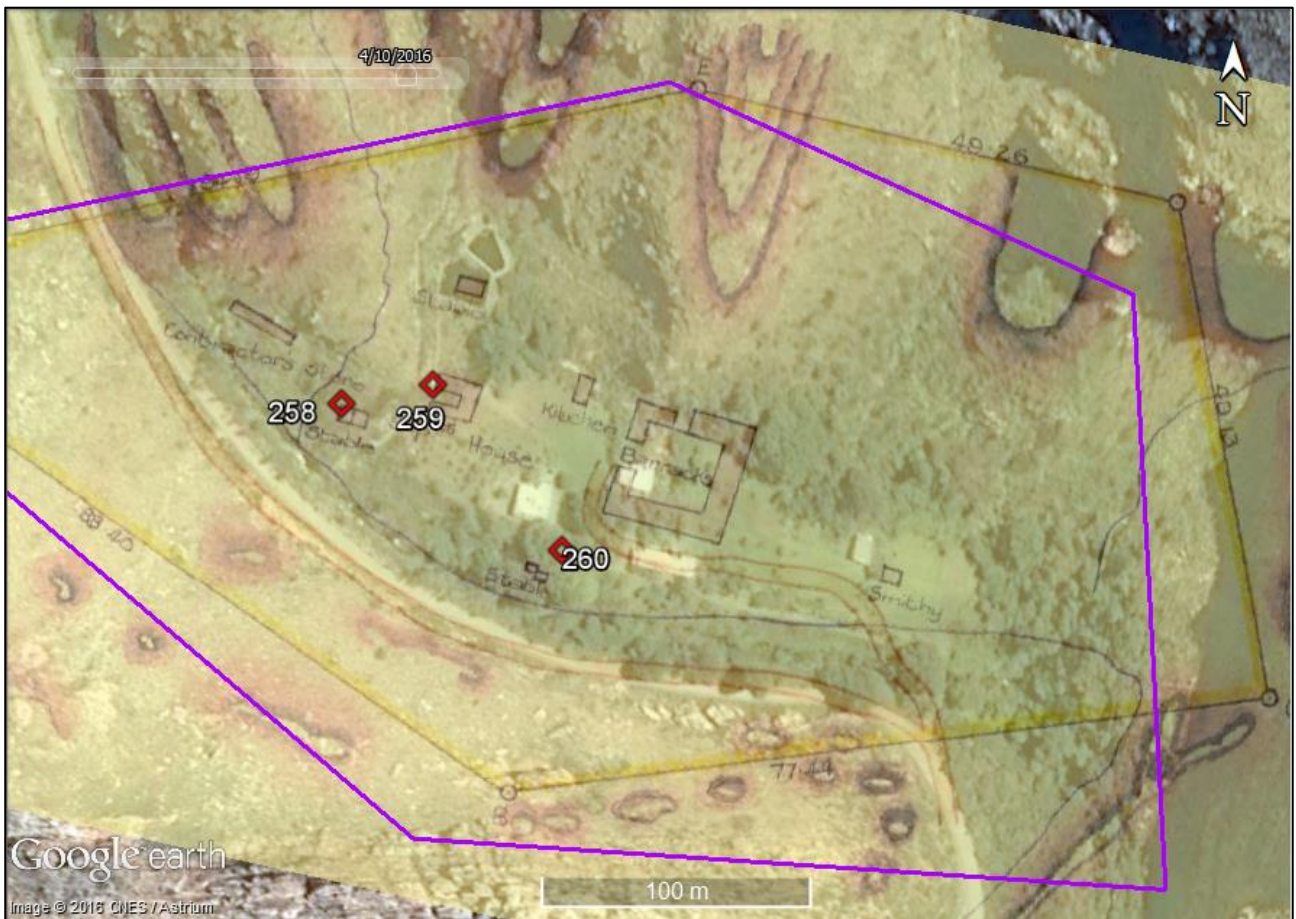
Figure 40: Composite image created by superimposing Survey Diagram 667/1872 onto the modern aerial view. The purple polygon is, according to Cape Farm Mapper, the correct farm boundary. The superimposition is based mostly on the position of the road.

Further south another small piece of land was also surveyed off in 1872. This might indicate that the land became a private farm in 1872. Survey Diagram 667/1872 indicates that it was “Copied from a working plan by Mr. A.G. de Schmidt” which suggests that this was likely the main construction camp set up during the construction period. The diagram indicates a barracks, a superintendent’s house, a kitchen, a smithy, three stables and a contractors store (Figure 39). It was very difficult to determine whether any of the original structures still remain. The image in Figure 40 was created by first superimposing the farm boundary (obtained from Cape Farm Mapper) onto Google earth and then tracing it (purple polygon in Figure 40), and then attempting to reconcile the 1872 survey diagram with the modern aerial image. It appears, despite the inaccuracies, that the original structures have been largely (if not completely) removed and replaced by newer farm buildings. It seems likely that the original structures were built with drystone walling and the subsequent structures may have reused the rocks but with cement. Two notable features are that the river has been realigned since the earliest days of the settlement (see stone walling at Waypoint 259 in Figure 40) and the position of the current graveyard seems to have been occupied by a stable building before.

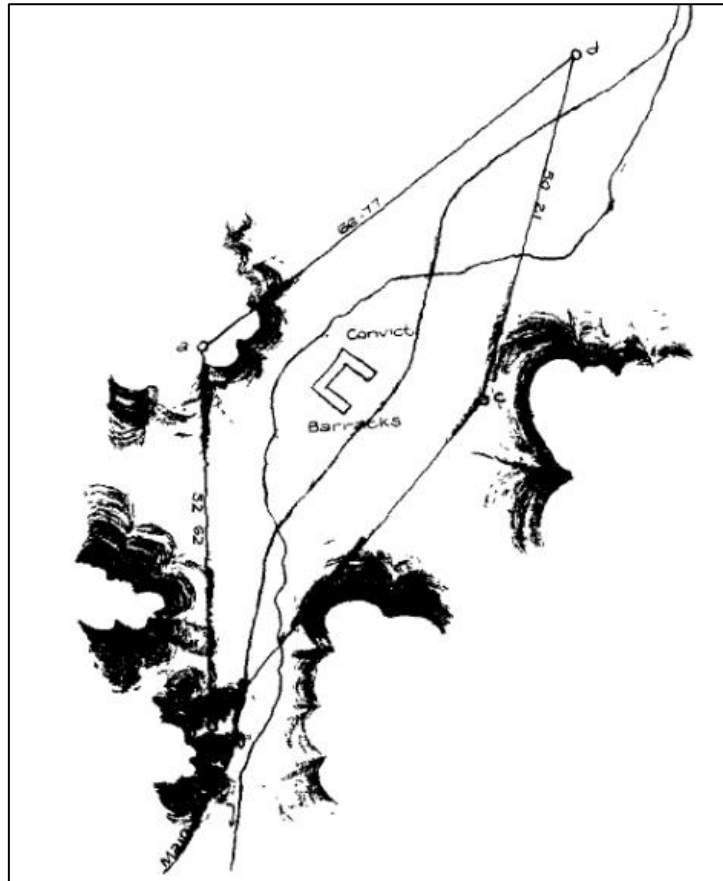
Figure 40: Extract from Survey Diagram 665/1872 showing the U-shaped ‘convict barracks’ with the river to its northwest and the road to its southeast.

Further south again, Survey Diagram 665/1872 is once more indicating a small farm. This one has a 'convict barracks' indicated on it and is the now-ruined structure located at Waypoints 215 and 216.

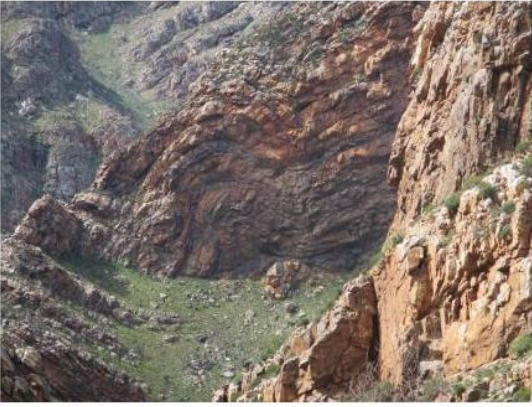
I also wanted to ask was about the folding. The poort is a great example of a section through the Cape Fold Belt so I think it is worth listing as a geological heritage site from that point of view. Do you agree? There is one especially spectacular view of folds as below.

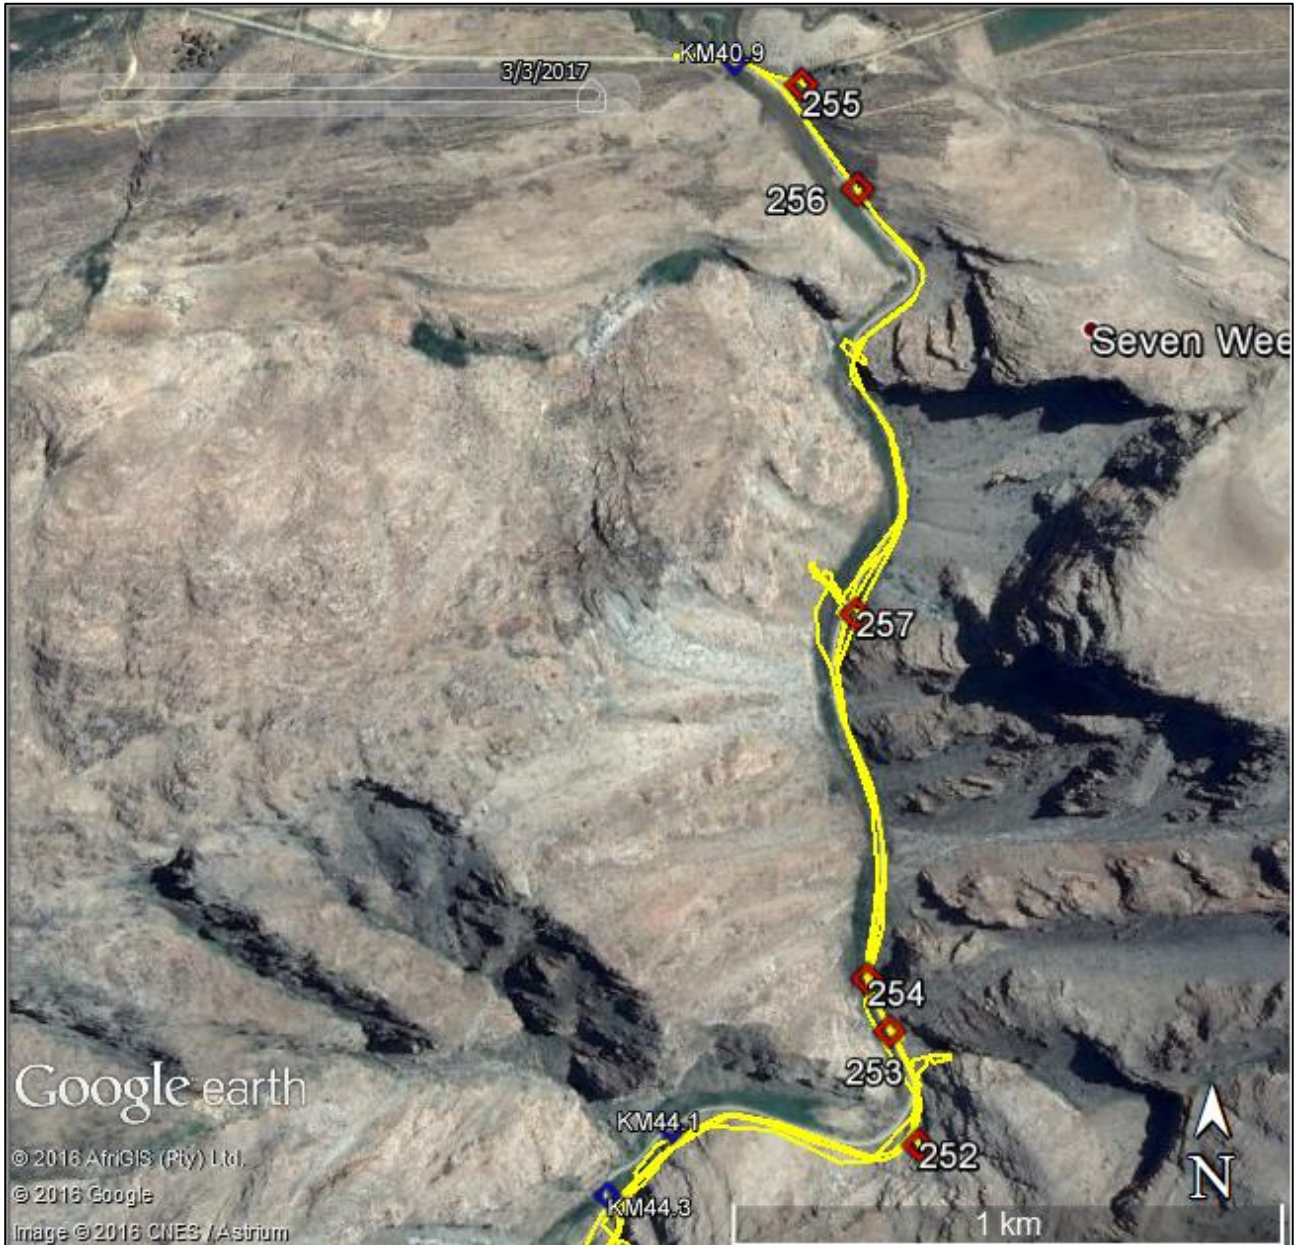
Figure A4.1: Map 1 showing the river crossings and other sites requiring work (blue symbols numbered with their km marker), all heritage sites and places of local significance (numbered red symbols), and the drive- and walk-paths recorded during the survey (yellow lines).

Note that the aerial photography and GPS co-ordinates do not always match up due to both the way in which the aerial photographs have been loaded on Google Earth and the fact that the steep mountains on either side of the Poort has reduced the accuracy of the GPS readings.

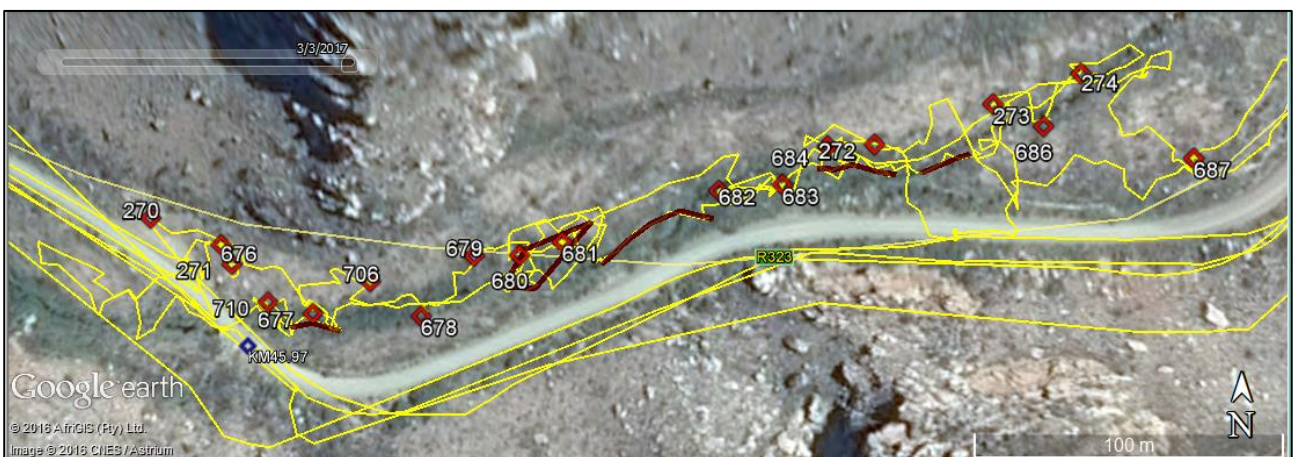
Figure A4.3: Map 2A (see Figure 13 caption). The dark red lines indicate piled stone berms.
