EXCAVATIONS IN DISTRICT SIX: A RESIDENTIAL PROPERTY AT THE CORNER OF STUCKERIS AND ROGER STREETS

January 1996

Archaeology Contracts Office

University of Cape Town

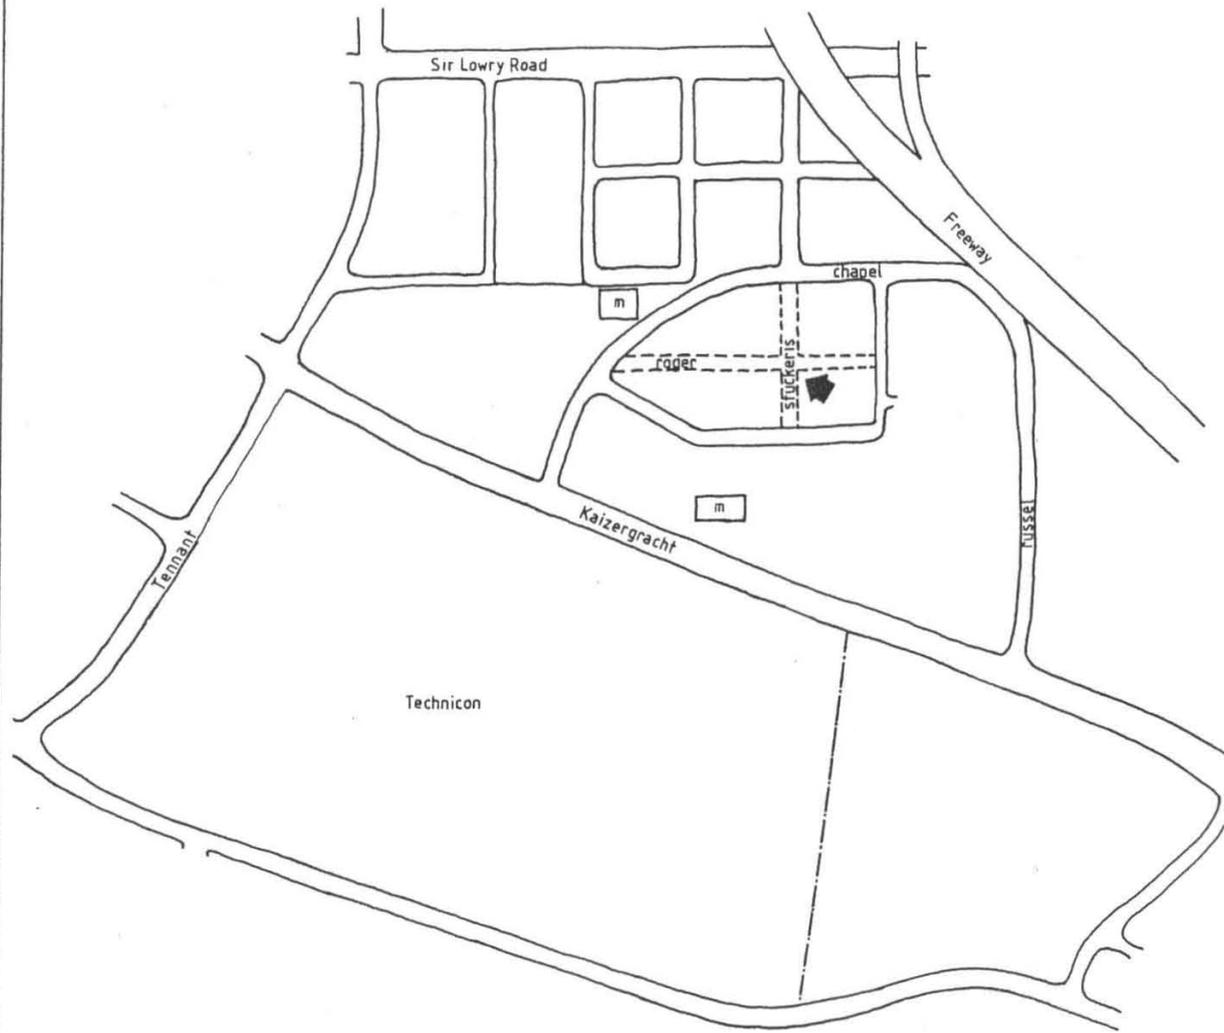
Of the eighteen targets that had been identified on the Snow survey, only three were left after all criteria were met. One of these is the building that will form the basis of this report². The location of the excavation is shown on Figure 1. The map of the area is as it

appears today. Plates 1 and 2 show views of the excavation showing Stuckeris and Roger streets. Excerpts from various historic survey diagrams are presented in Appendix 1.

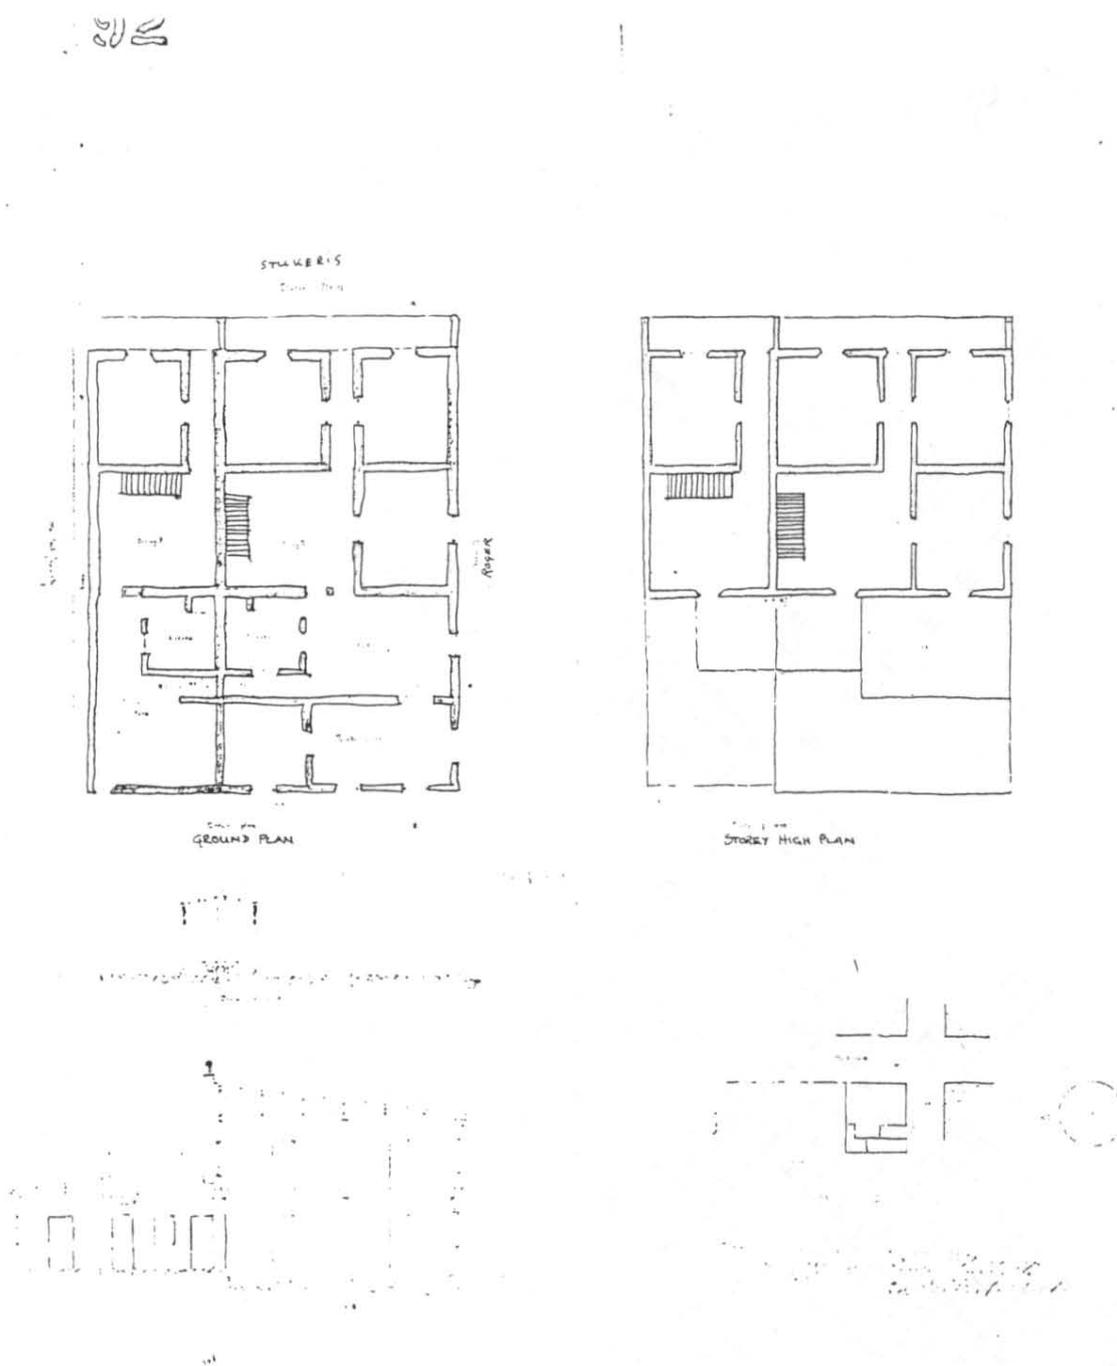
Early plan of the house at the corner of Stuckeris and Roger streets. (Lines have been inked in as original is faded and does not copy well.)

² The floor plan seems to indicate that the building was semi-detached. The adjoining building is reproduced on the same plan and shows a smaller building only one room and passage wide but otherwise duplicating the layout. The front room of this house was also excavated.

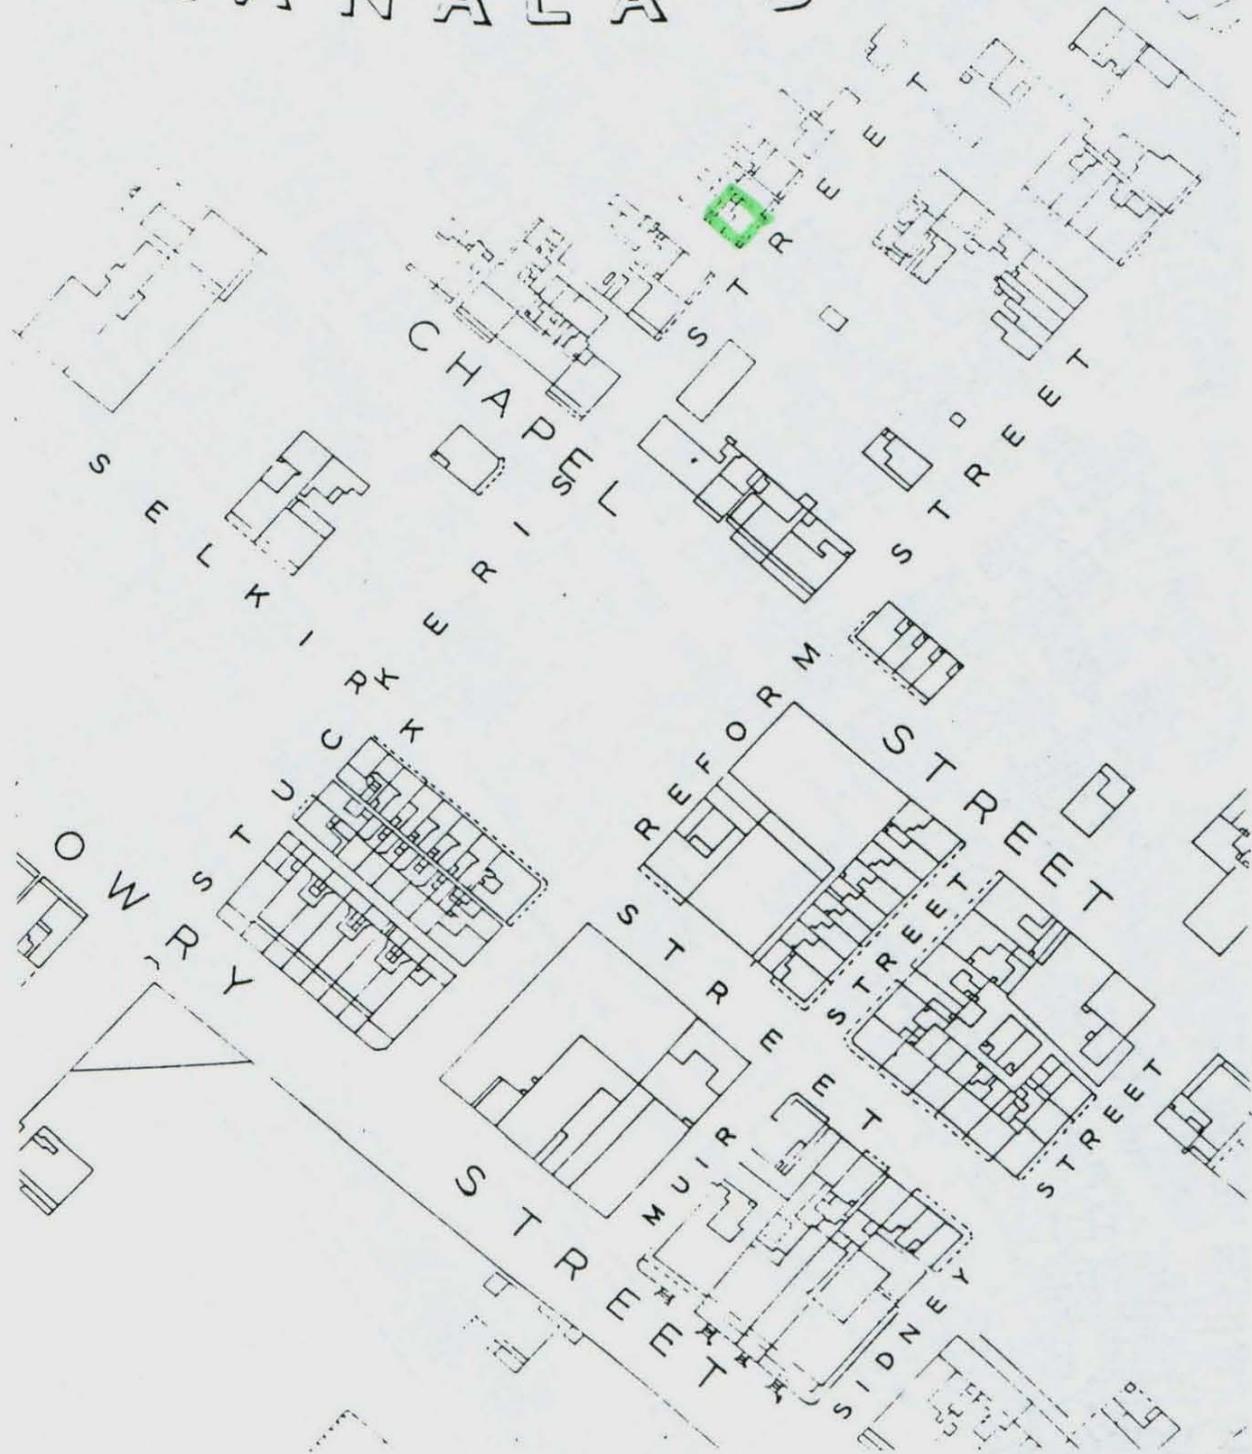
Extract from the Snow municipal survey c1862 (City Planners Dept)

Our initial objective was to identify buildings which were in existence by the middle of the 19th century. The Snow Municipal Survey of 1862 proved most useful in this regard and enabled a number of potential sites to be identified. Before establishing if there was any documentary material available for the various targets, it had to be established which of the targets were potentially excavatable. Various transparent overlays were produced which enabled portions of the Snow survey to be superimposed on a municipal survey dating to 1957¹. An additional factor to be considered was the fact that not only buildings were demolished during the sixties but much of the street system was abandoned at the same time. New roads were added often on different alignments and redevelopment of some areas obliterated any trace of roads and buildings alike. It was therefore necessary to overlay the combined Snow and 1957 survey information onto the present landscape to finally identify feasible targets. Between 1862 and the 1960's, some targets were lost as residential buildings were turned into commercial premises, in some cases requiring the old buildings to be demolished. It was for this reason that the 1957 information was important as this showed which of the sites had changed substantially.

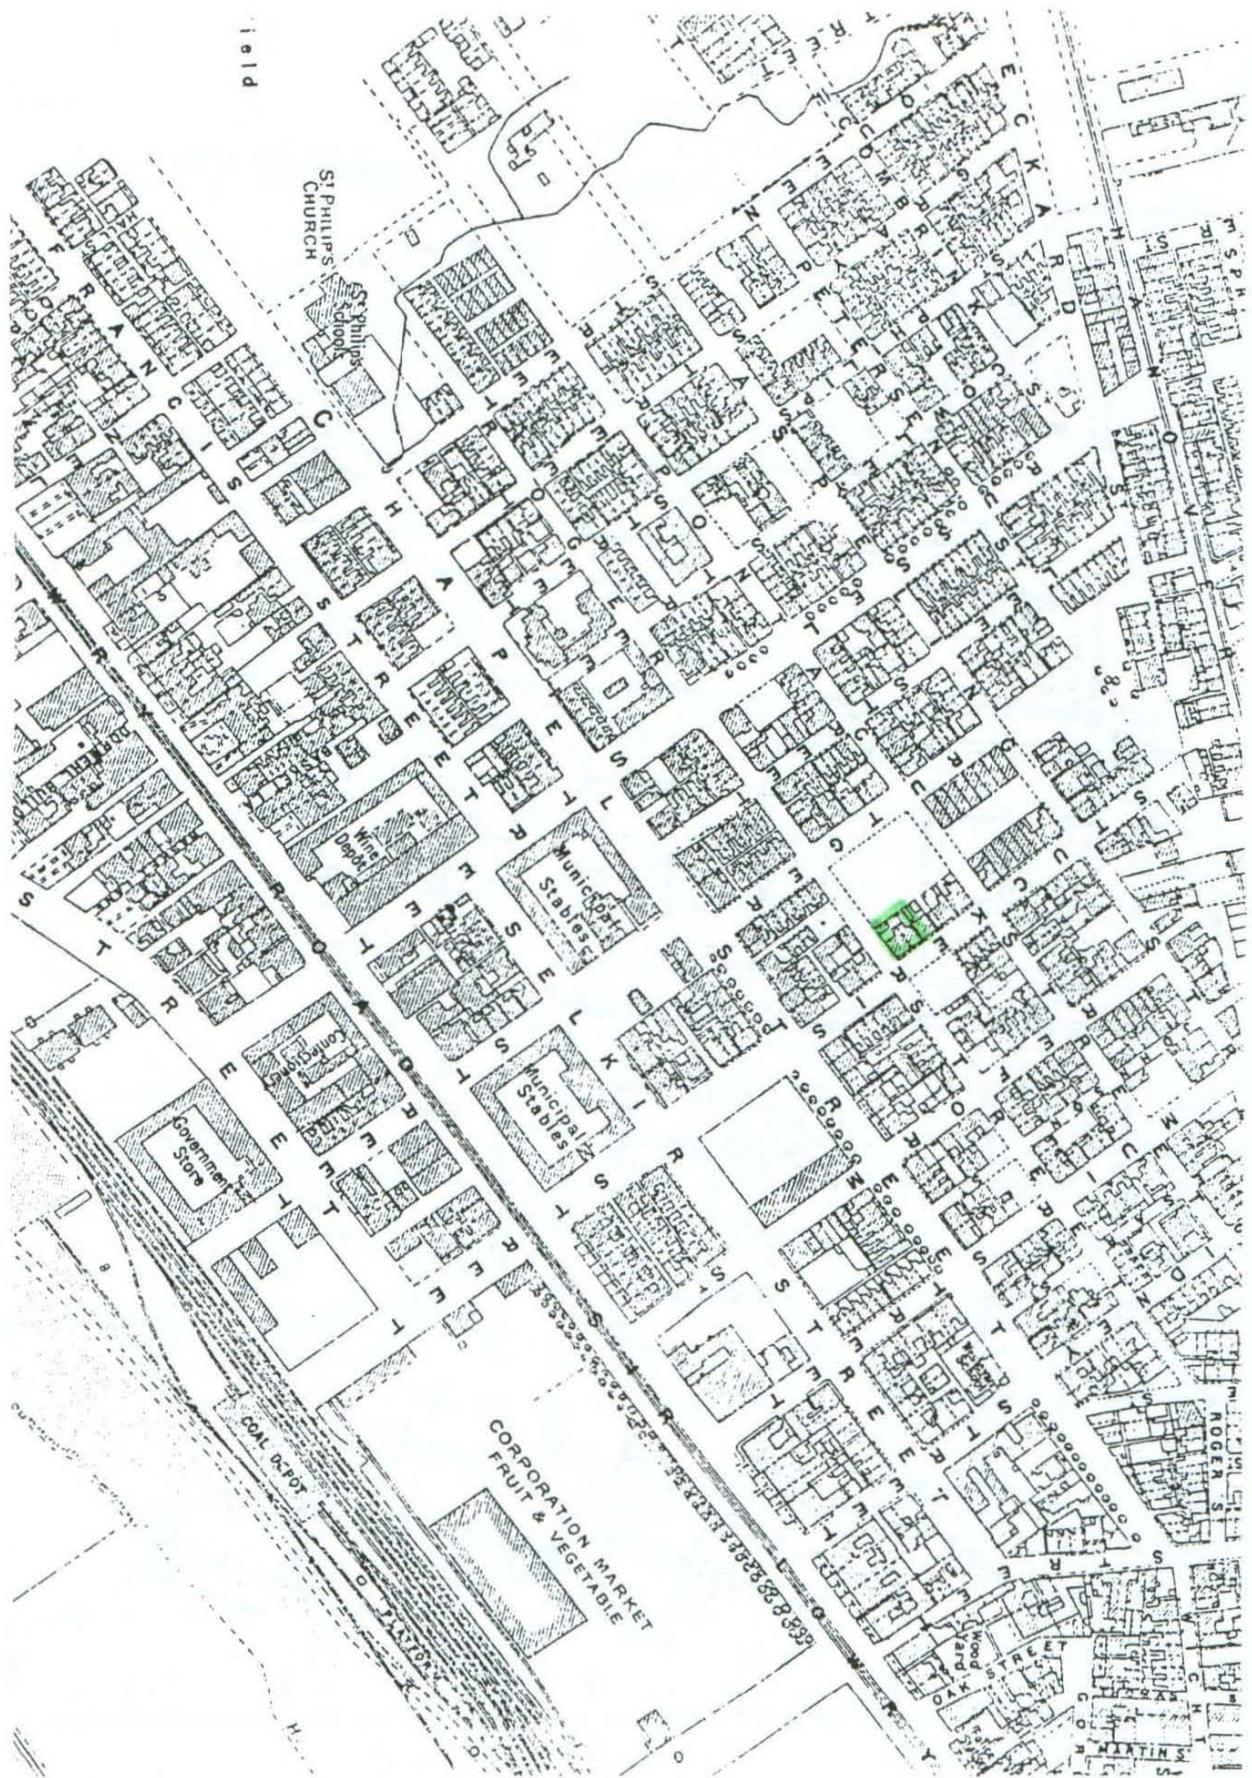
Extract from the Thom municipal survey c1900 (City Planners Dept)

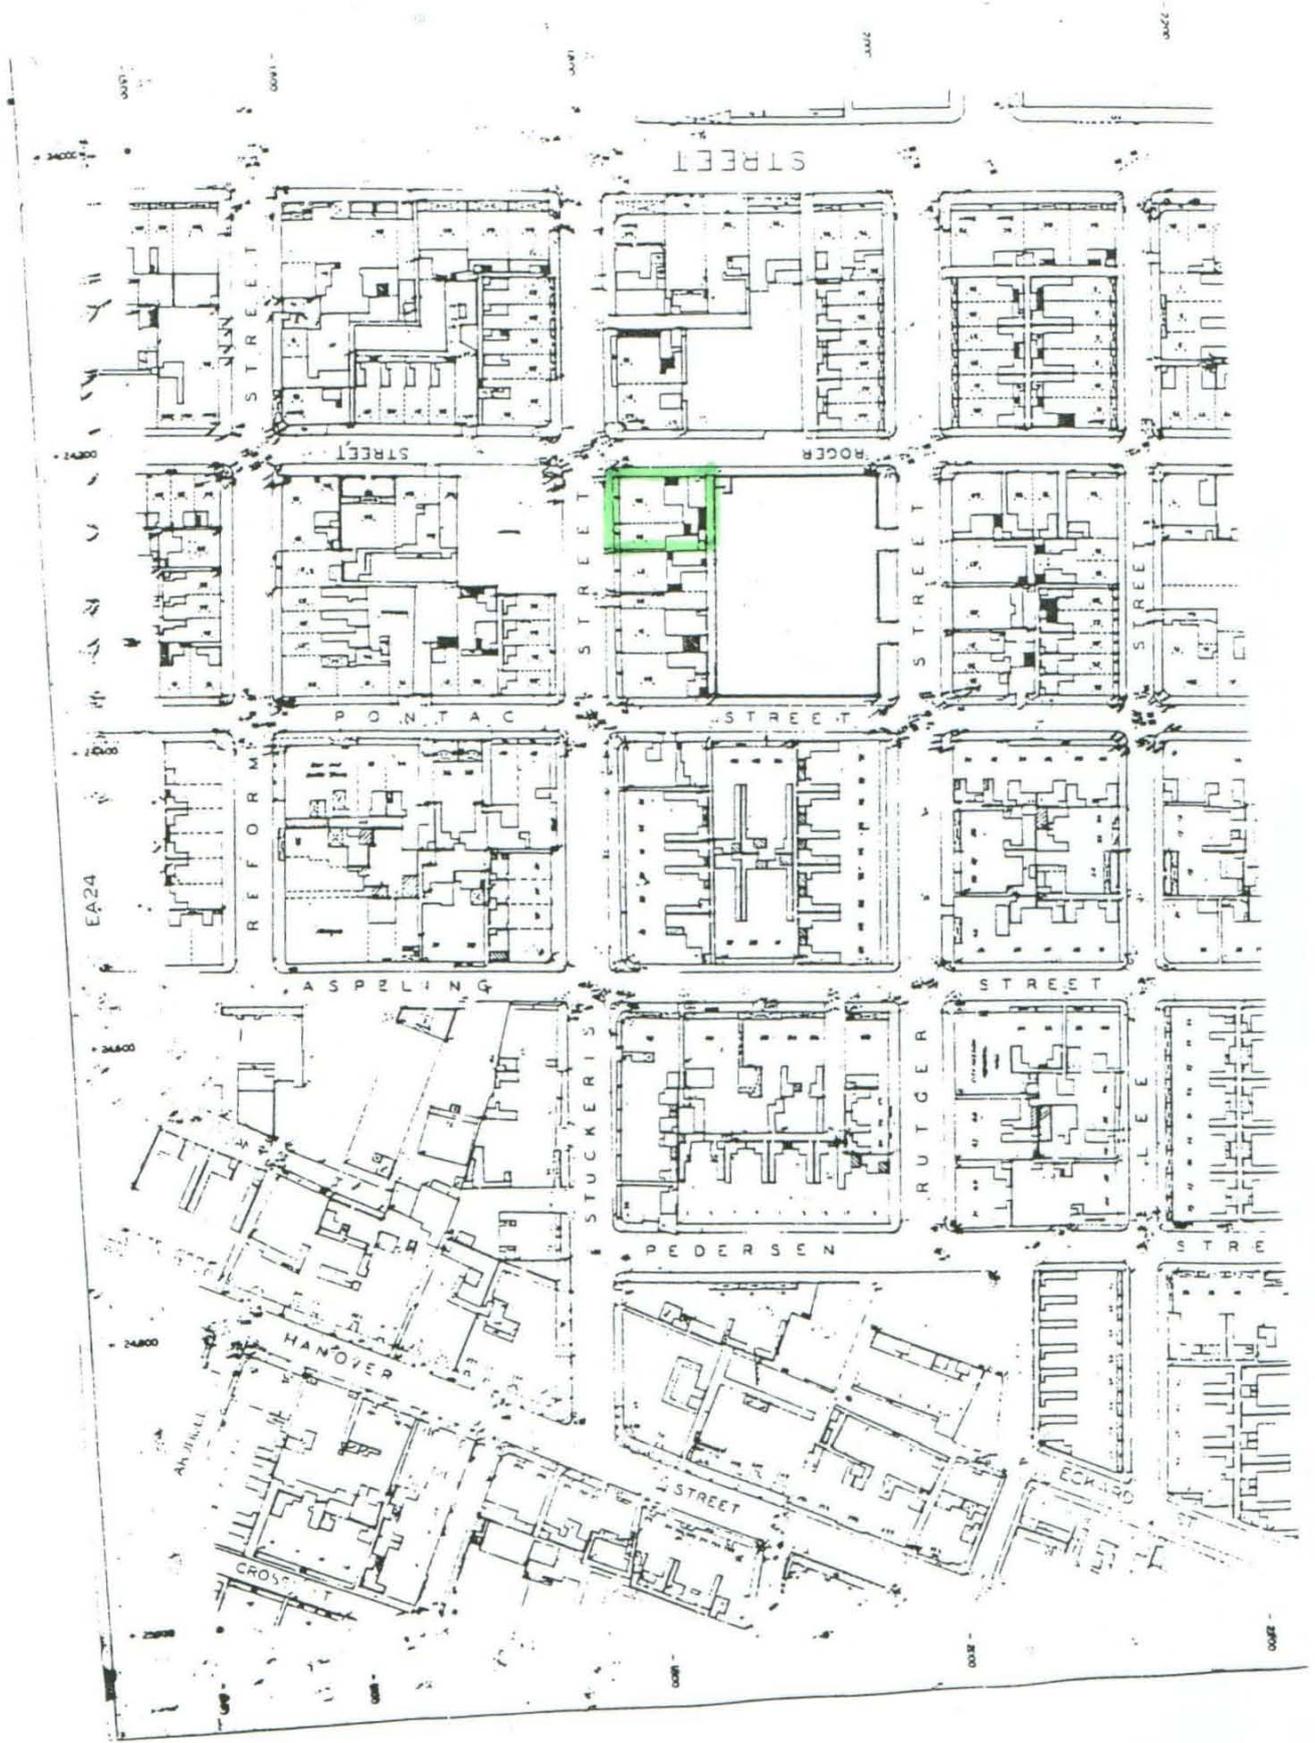
Extract from municipal survey c1957 (City Planners Dept)
