AN ARCHAEOLOGICAL ASSESSMENT OF THREE PROPOSED FARM DAM LOCATIONS IN THE CITRUSDAL DISTRICT

Ninham Shand (Pty) Ltd

June 2004

Archaeology Contracts Office

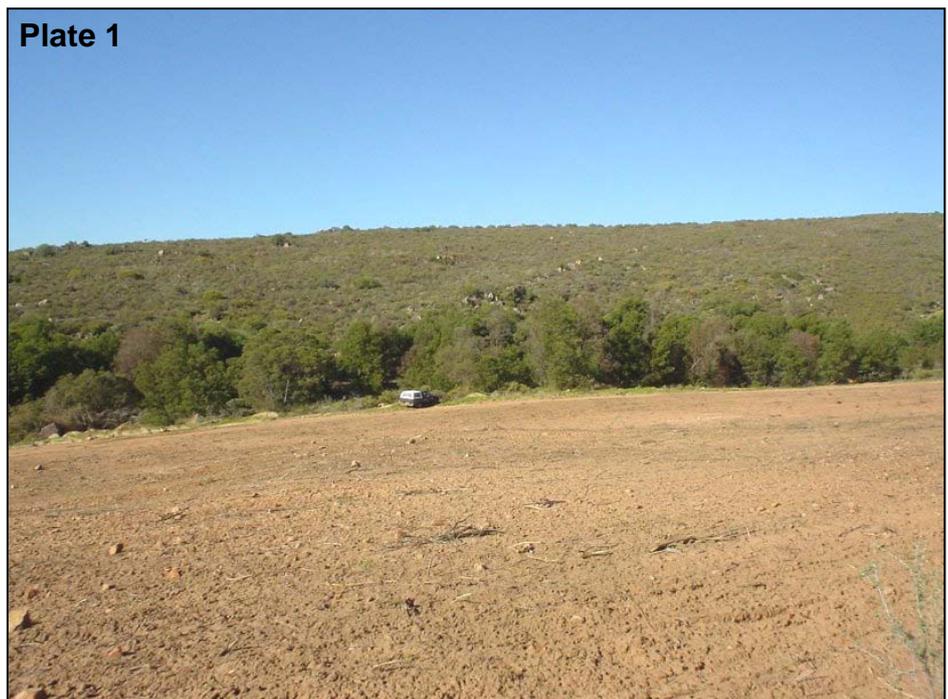
The site of the wall is shown in Plate 1. The north west side of the kloof at the site of the wall consists of cleared land. No vegetation was present at the time of the survey and thus visibility was very good. Most loose rock has been removed from the field and piles of it were found on a flat area in the river bed.

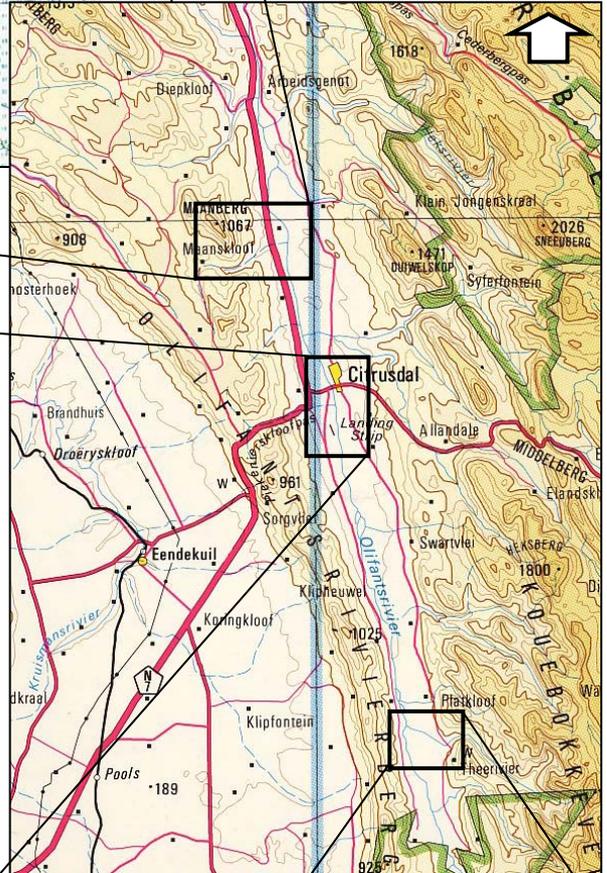
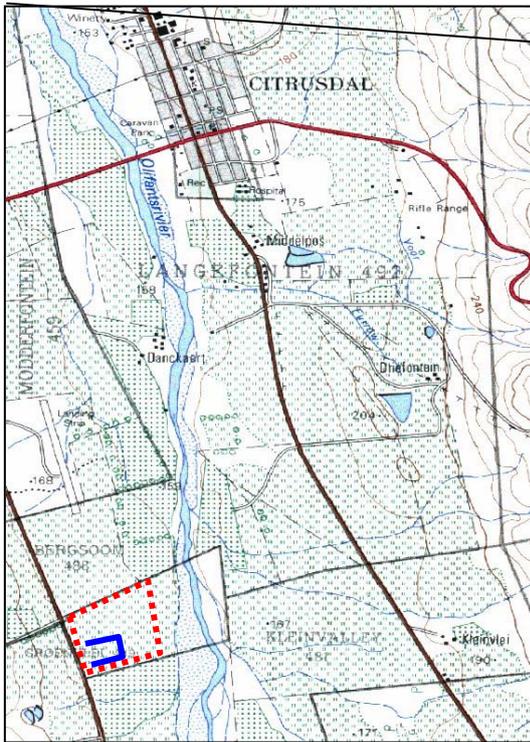
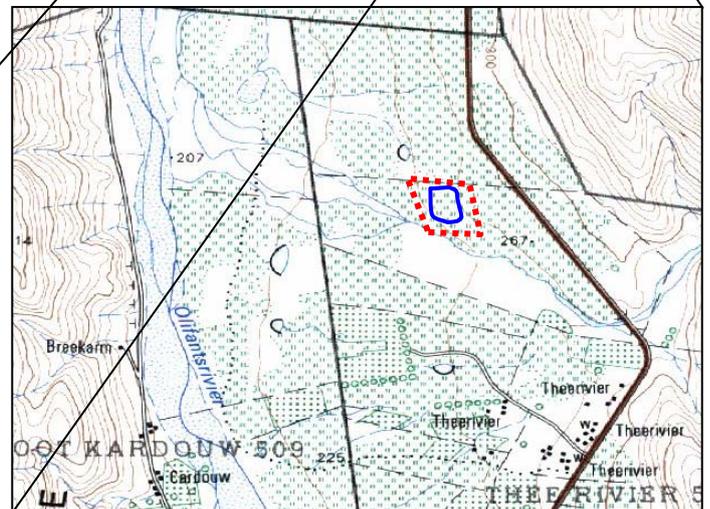
1

Maanbergskloof Dam

Groenvlei Dam

Tienrivieren Dam

Map extracts from:

- 3218DB Eendekuil
- 3219CA Citrusdal
- 3219CC Keerom

The Archaeology Contracts Office was asked to assess the impacts on archaeological material of three farm dams in the Citrusdal area. We met with the landowner who accompanied us to the three sites and pointed out the locations of the dams. Since there were slight discrepancies between the supplied mapping information and that pointed out by the landowner, the survey was broadened to encompass both the locations indicated on maps, and those indicated by the landowner. As the footprints of the dams are relatively small, extending the survey did not provide any problems. The locations of the three sites known as Maanbergskloof, Tienrivieren, and Groenvlei, are shown in Figure 1, relative to the town of Citrusdal.

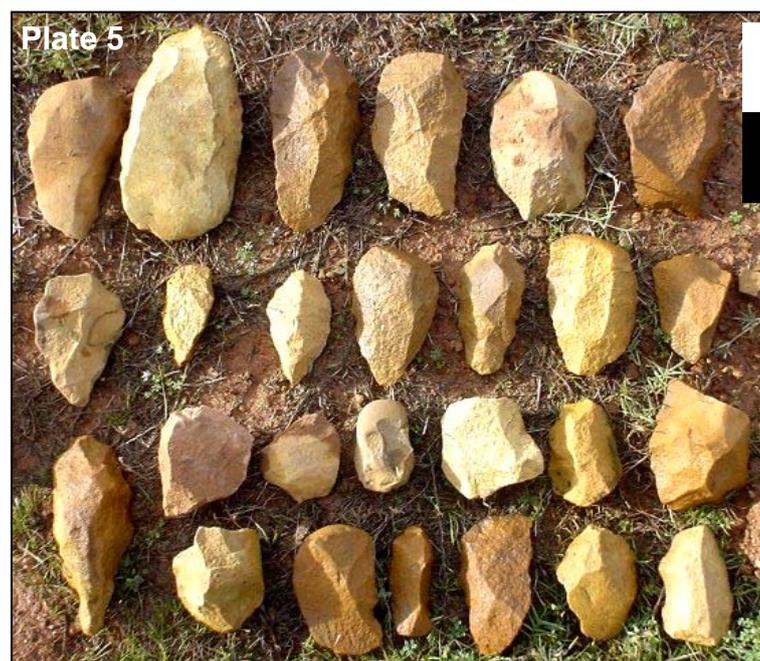
Scale: 20 cm

The rocky outcrop in the vegetated area was also a source of raw material for Early Stone Age (ESA)¹ people who left behind many artefacts which are today scattered around the area of the quarry. We noticed that artefacts were particularly prevalent on the south and south west edges of the quarry. A selection of artefacts was photographed at the site (but not collected) and is shown in Plate 5.

The material consists of formal and informal artefacts on sandstone. Handaxes (classic large and small types) are numerous, as are cores and flakes. Cleavers are also found. Cortex present on some items indicate the use of river cobbles as a source of raw material.

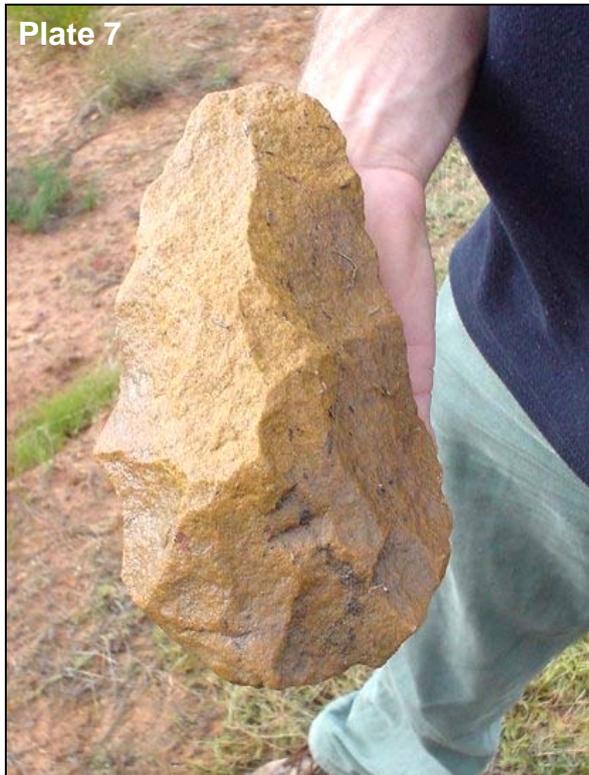
Handaxes are produced on both large flakes and on cobbles. The presence of a number of small hand axes such as those shown in Plate 6, may suggest that the collection dates from the later part of the Acheulian.² One of the classic, large handaxe specimens is shown in Figure 7.
