# SCHREUDERHUIS, STELLENBOSCH

AN OVERVIEW OF ITS EVOLUTION,  
HISTORY AND ARCHAEOLOGY  
WITH PARTICULAR EMPHASIS ON  
A KITCHEN, ROOM E  
NOVEMBER 2001

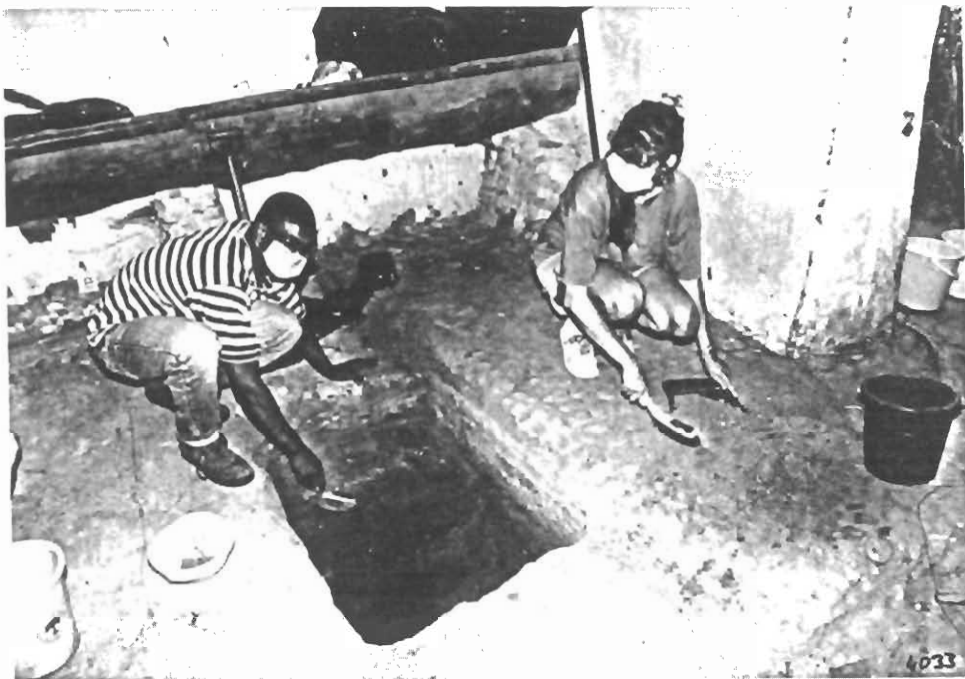
2. Room E was only partially excavated on top in 1981 and left as such, being closed to the public since 1988. In 1994 the one excavated test section was reopened by museological students (i.a. Michael Jonas). Fine dust was a constant problem during all excavations. Note the remainder of the 1975 cobbling and the built-up posts for the wooden crib at the back.

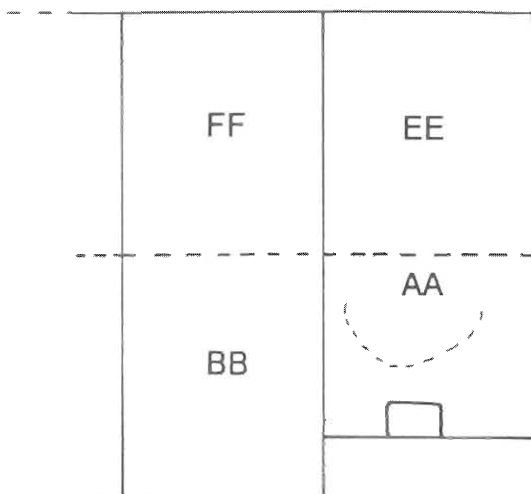
FIG.3 By early January 1710 the house and plots were for sale. Apparently the backyard (or more) was a local quarry for clays (Vos 2001).

Schreuder was granted this plot on 10 December 1709 (Van der Bÿl 1963:13; 1964:1)(ADD.D). According to the practice of the day, he may have "acquired" the property a year earlier, after resigning from his post as Messenger of the Court on 31.12.1708 (Kotze 1979:411). During the remaining summer months (1708/9) he could have built a house and was granted the plot officially late in 1709. By 13 January 1710 he desired to sell the house and its two house plots for f1100, a large sum, indicating a rather substantial house (Ibid.:412)(FIG.3).

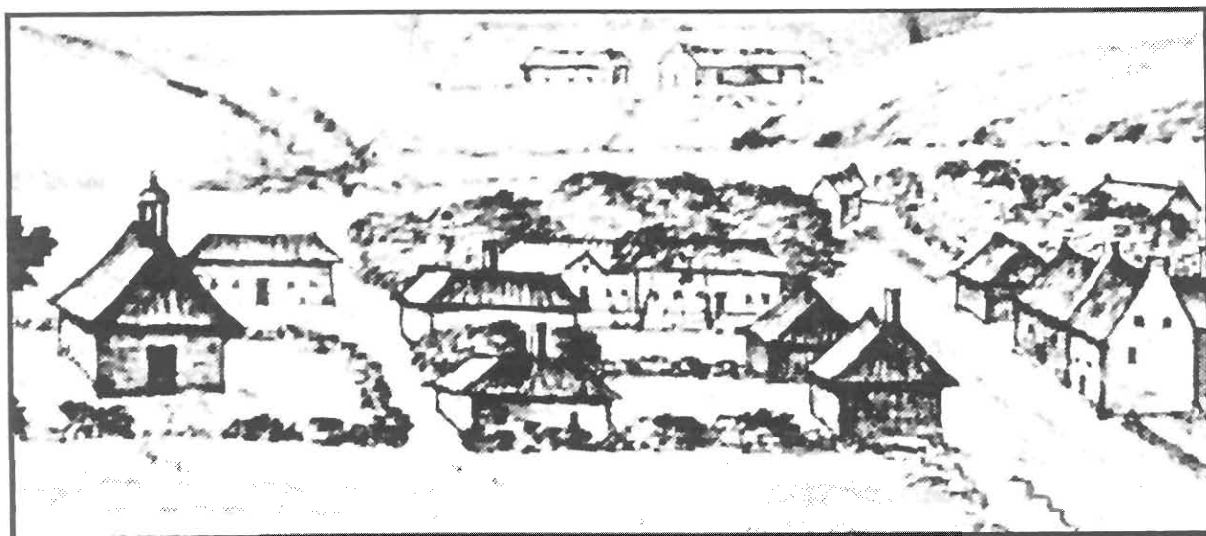
FIG.4 In mid-February 1710 Schreuderhuis is depicted with a "symmetrical" fenestration, low eaves and hipped ends. Note the absence of a chimney (Van Stade, CA).

On 4<sup>th</sup> January 1710 he was reappointed as *Geregsbode* and he received permission to stay in a *Colonieshuis* (Ryneveld Street), on condition not to start a "tappery" or "drinkgelagplek" (Ibid.:412). He was still a bachelor, but engaged to the widow Sara Wijnsandt, whom he married on 9 March 1710 (Ibid.:412). Did they live in the *Colonieshuis* or in Schreuderhuis (which he may have let)? One of the most important documents of the early house is its depiction on the Van Stade drawing (FIG.4) of 15<sup>th</sup> February 1710.

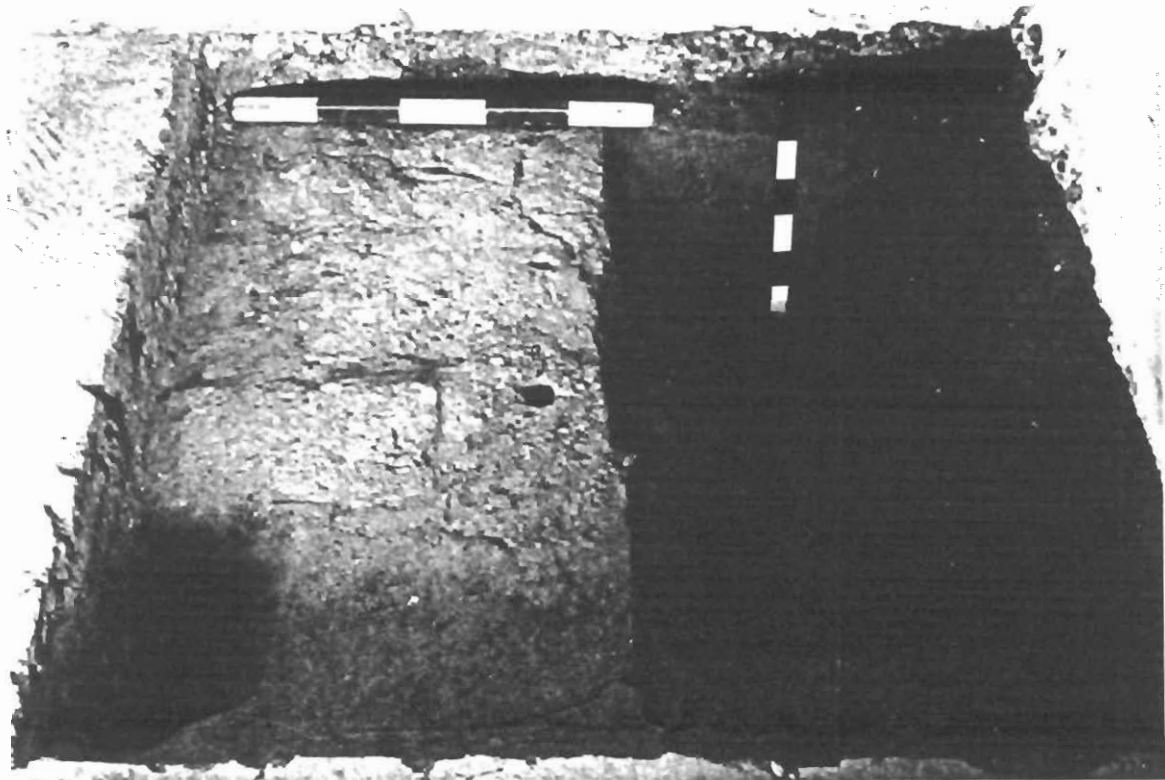
2.1 In Room B the original clay floor was excavated with a small posthole visible. Below the floor the clay was sterile, with roots from a tree visible (1981).

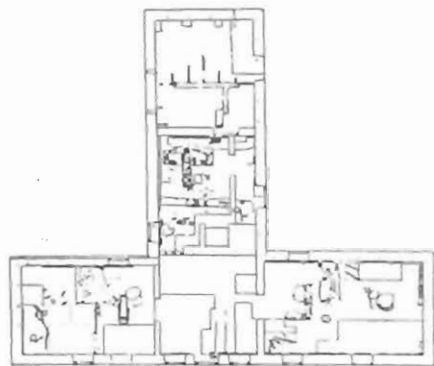
FIG.5 In relation to the existing structure, only a few original features could be ascertained. It is of the same size and position as the next two figures (Vos 2001).

1975 restoration and reconstructions? Thorough architectural and archaeological investigations have led to the conclusion that only five features can be established with a degree of certainty to be original (**FIG.5**):

1. The clay footing of the dividing wall in Room B.
2. The semi-circular floor-hearth in Room C.
3. The low clay wall footing of the lean-to in Room DD.
4. The grey clay floors in Rooms AA/A, BB/B, CC/C and DD.
5. Remains of the foundations of walls A4 and B4, and possibly others.

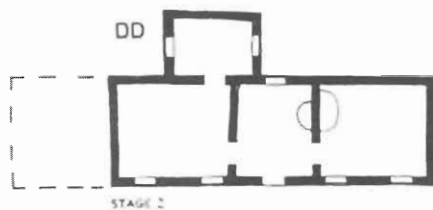
FIG.6b A speculative reconstruction of the lean-to, which was already added by 1712 (Fitchett 1996:514).

Fitchett too, questions the layout of the house and reinterprets the archaeological excavations to ingeniously arrive at a 2-roomed 1709 dwelling, and a 4-roomed 1712 dwelling (Fitchett 1996:514, Figures 217 & 218 on p.994)(**FIG.6a**, **FIG.6b**). Although this is the type of house one would expect to find, it is unfortunately based on imaginative speculation, not considering the facts.

4. In both of Fitchett's examples (see FIG.6), he ignores Room AA, postulating that the remains of an interior dividing wall AA/A, represented an exterior foundation. This "wall" was actually built on top of a thin grey clay floor, but without any foundations, except for two large, centrally positioned, river stones and a narrow line of broken orange brickwork of the late 18th century (V&B 1989a:7-8). The two large and two small river stones in the middle of this wall (>1770) supported a thresh-hold of a centrally positioned door. It is out of the question that this narrow wall (25 cm wide) represented an exterior wall. This wall may be correlated to the one demolished in 1974, which was built on top of an existing floor around 1800 (Le Roux 1975:9, plan A).

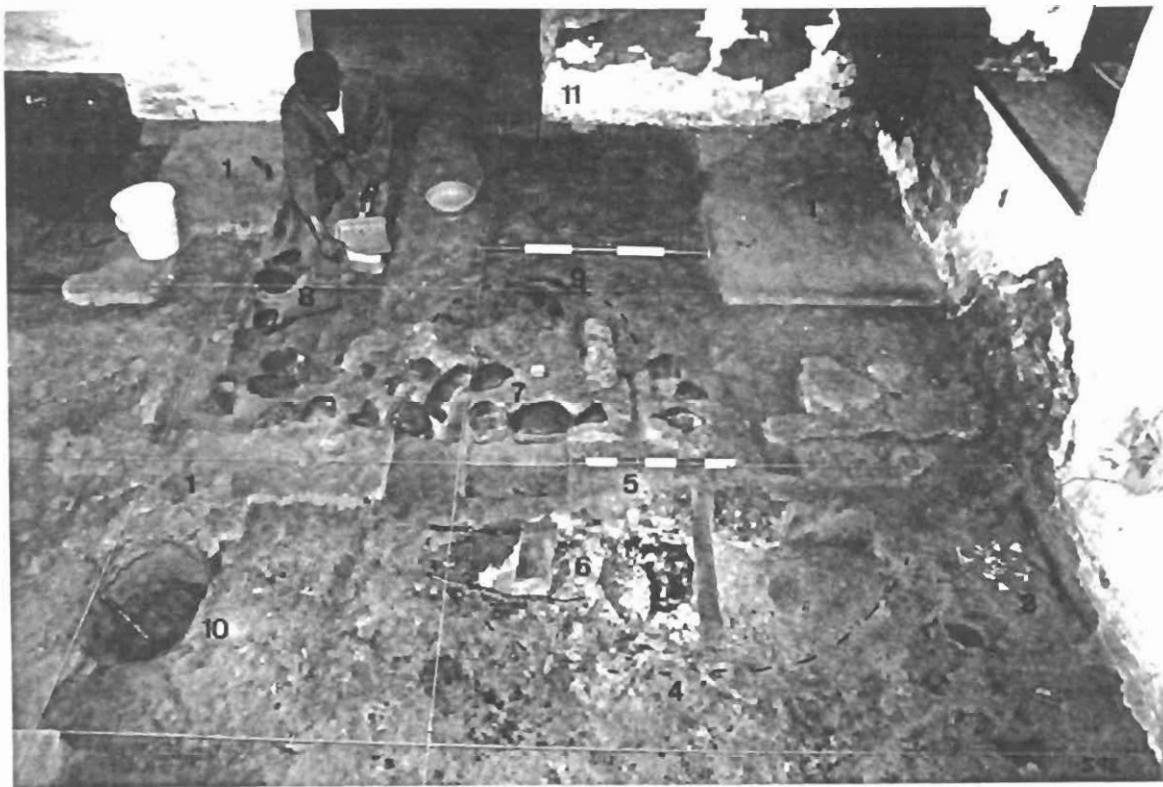
3. Some startling finds were made in Rooms CC/C in 1988. The yellowish clays (1) date to 1975, while the darker brown ones (2) date to early 1700. All the upper layers and floors (>1750-1972) were destroyed. Chinese porcelain of the 18<sup>th</sup> century lay against the wall (3), and the large semi-circular hearth A (4) abut some powdery brickwork (5). Ash and artefacts fill the centre (6). About 35 cm north of it are river stone foundations (7), which continue to about the centre of the room and appear to turn 90° (8). Hearth B (9) is much smaller and about directly against the foundation. Post-holes and scattered refuse were also encountered (10). Wall CC1 (at the back)(11) has no foundations and is built on top of a few floor layers.

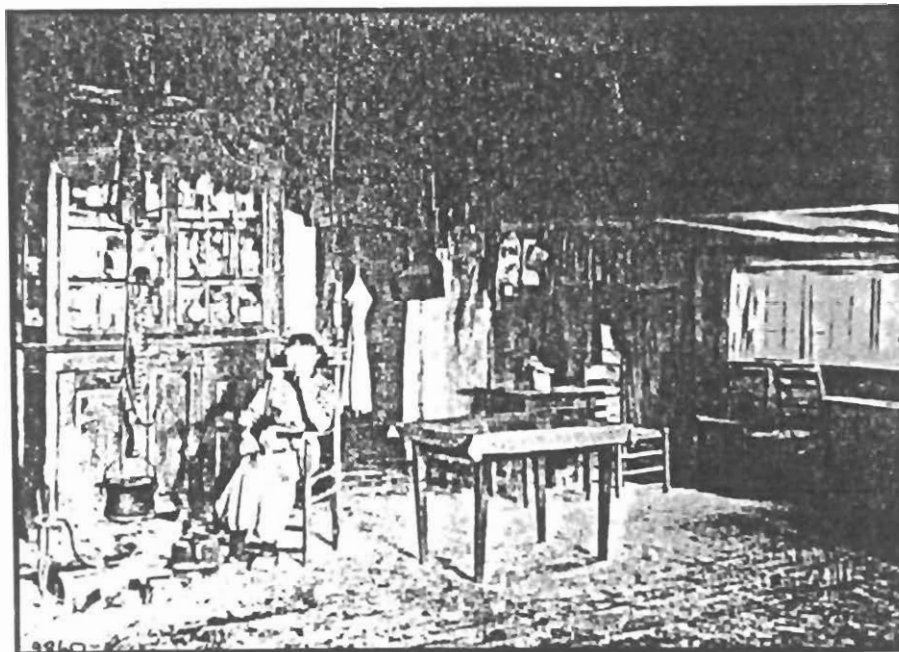
FIG.7 This open-plan kitchen and dining room has beams without a ceiling. The bricklined floor has an open floor hearth with kettle suspended from an adjustable hearth chain. This example is from Cloppenburg, Germany, dated 1930 (Bijdragen & Mededelingen van het Rijksmuseum voor Volkskunde 1983 vol.46:15).

Though there was no explanation in the thesis (Vos 1993a), there was a full description, plans and photographs in the earlier report (V&B 1989a:15-26). The large hearth A showed no signs of being against any foundation and was not positioned in the middle, but towards the side of the room. Floor-hearths were common in NW Europe for the last two millennia, and were still extant even up to the 20th century in Germanic houses (FIG.7).

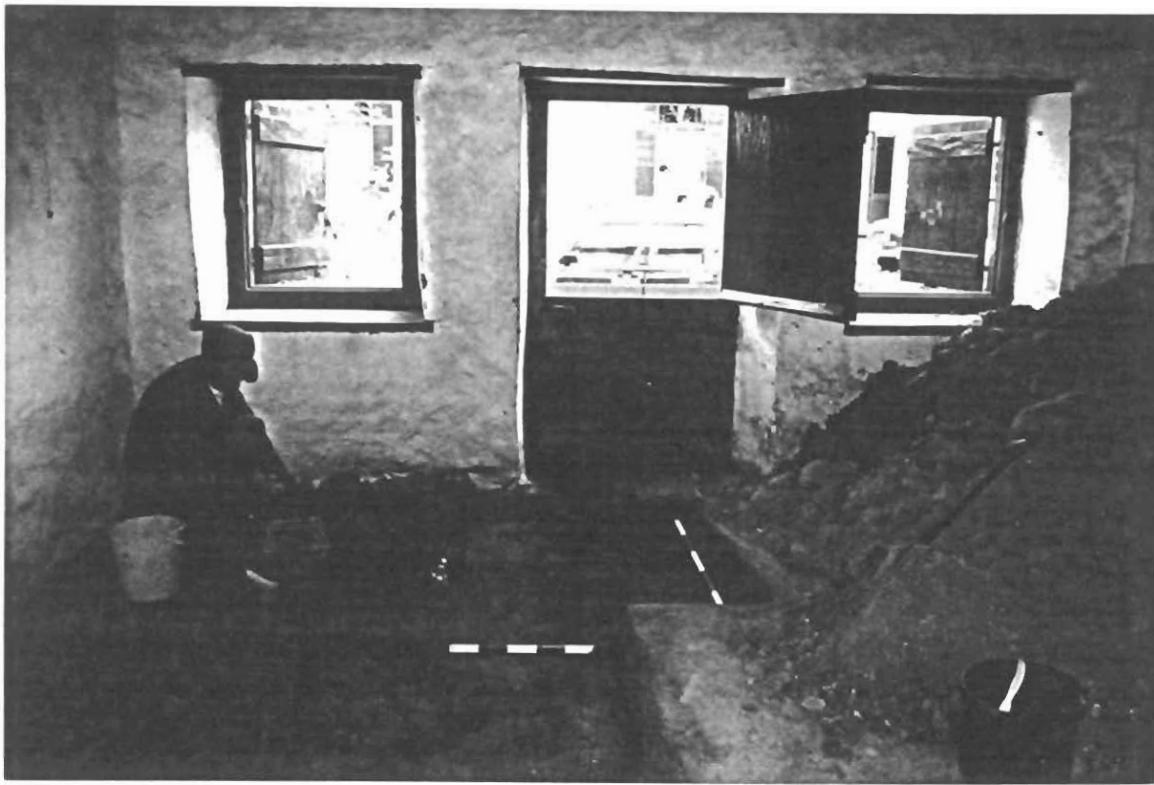
3.1 View of Room BB, looking westwards towards the front. Freddie Groenewald assisted with the excavations in 1988. The two windows (conjectural, Fagan & Fagan 1975:38), were afterwards blocked up. Note the remnant clay wall (1709) in the centre (50 cm scale), but disappears after some distance.

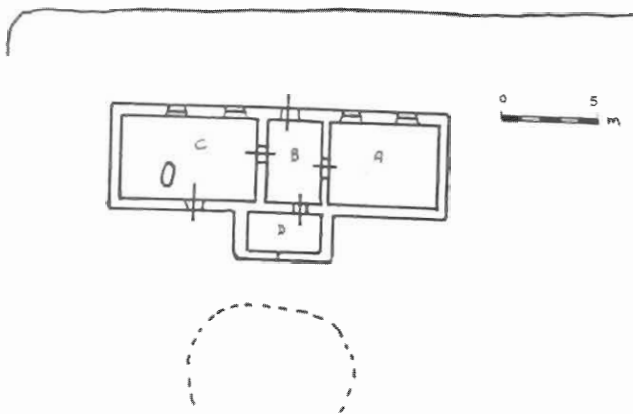
FIG.8 Possible reconstruction of the c.1710 dwelling, though sufficient evidence lacks. It could have represented a 3-roomed house, with a lean-to as an integral part. The "symmetrical" fenestration was probably irregularly spaced. It is possible that the entire dwelling was set obliquely to the *Groote Kerkstraat* (now Ryneveld St). The whole house could have been built in clayed up courses, with clay flooring and low indigenous beams but without a ceiling, thatched in rye-straw. Notice the southern Room C is depicted shorter than at present (Vos 2001).

With little evidence to the contrary, it is assumed that the structural footprint of the front was somewhat similar to the present foundations. The house could have been erected during the summer months (January-March 1709), when the clays dug in the backyard were stacked in layers and dried in the sun (FIG.8, FIG.9).

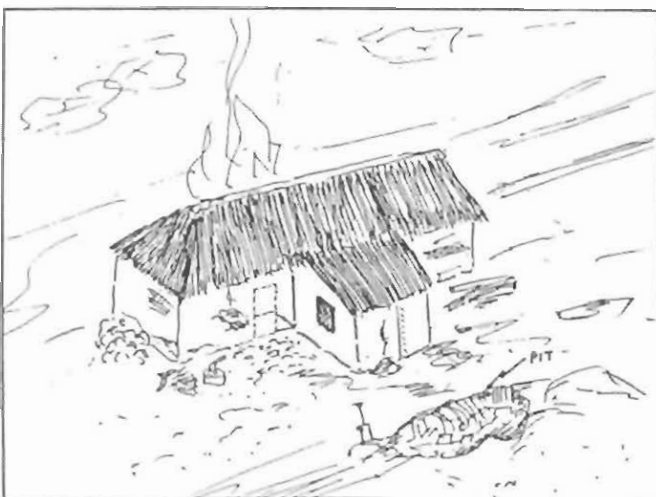
FIG.9 An interpretation of c.1720 according to the archaeological (>1988), architectural (1975), pictorial (1710) and inventorial (1712) documentation (Vos 2001).

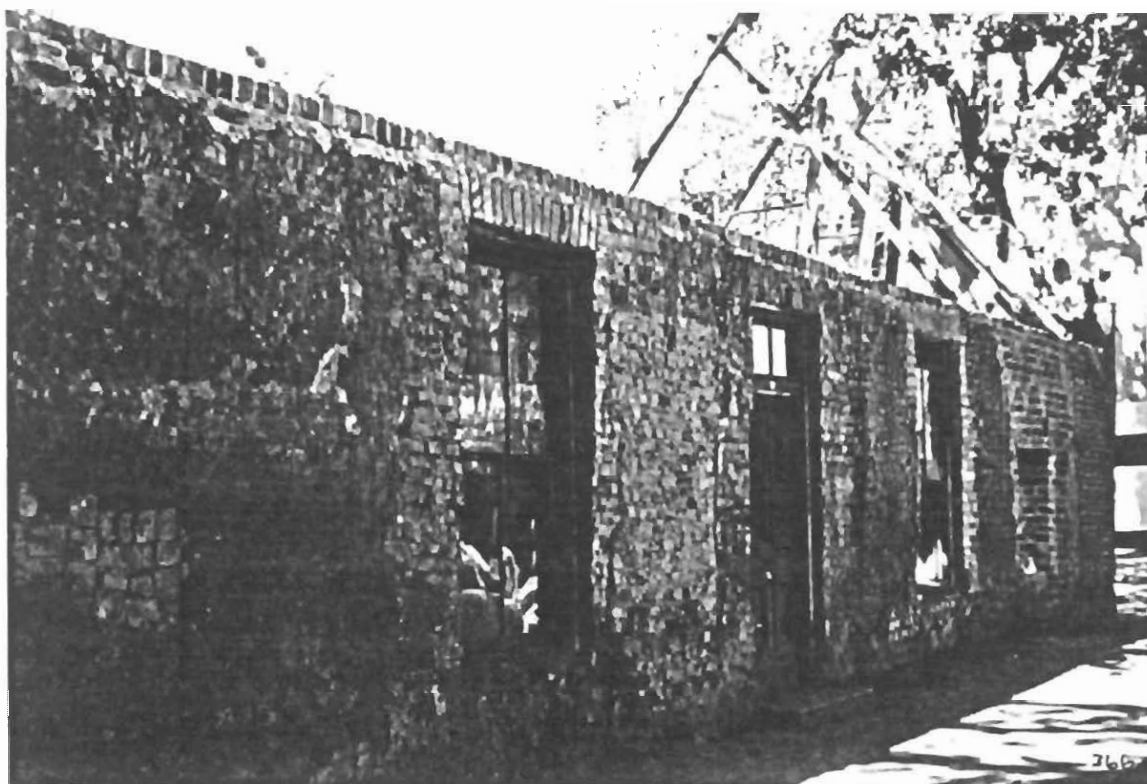
4. View of the façade, prior to most of the 1975 alterations. Note how little is even left of the >1730 raw brick walls. Much patching in 19<sup>th</sup> century brick is obvious (Le Roux 1974).

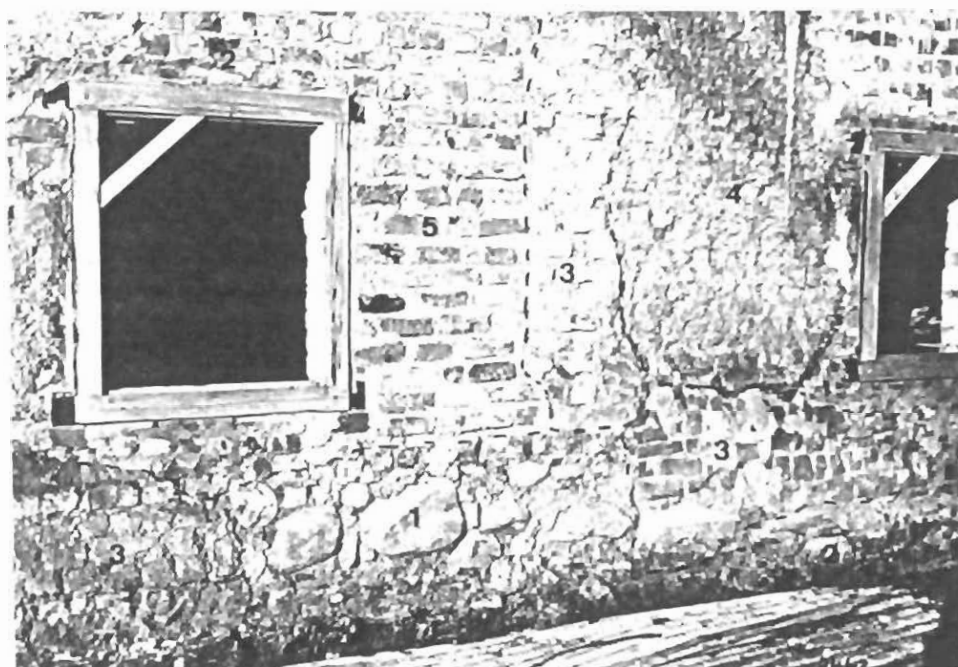
5. Close-up of the right portion of the façade wall between window 1 and window 2 (Rooms CC/C). Note the old foundation of river stones (c.1800?)(1), granite (c.1740)(2), brickwork (19<sup>th</sup> century)(3), the c.1740 raw brick (4) and 1975 fill-in brickwork and windows (5) (Le Roux 1974)

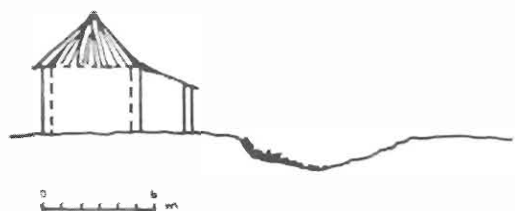
FIG.10a Conjectural interpretation of the clay pit and the initial (>1710) rubbish fill.

The floor-hearth A was "built-up" in layers over a number of years, as indicated by the evidence from the archaeological excavations. In addition, a surface hearth against the outside of the back wall of the lean-to D2, was also in use. Much ash, debris and peach pits were trampled into the surfaces. Was this an area used by labourers or slaves? The refuse from the hearth in Room C continued to be dumped at the back into the clay pit, slowly filling it up (FIG.10a, FIG.10b).

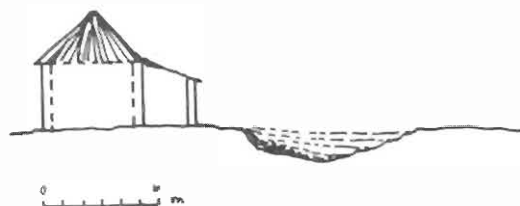
FIG.10b By 1730 the pit was nearly levelled with building rubble (raw brick/clay) and artefacts.

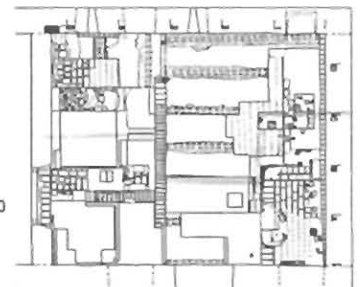
- 1 COBBLING in clays 1975
- 2-4 BROWN SOIL & FILL 20<sup>th</sup> c.
- 5 JOISTS FOR BOARDED FLOOR, with fill around c.1870
- 6 CLAY LAYER (FLOOR?) >1860
- 7 CRUSHED BRICK FLOOR, as fill in front of Hearth IIB c.1850

- 14 SIMILAR, with more charcoal & ecofacts
- 15 THICK CLAY LAYER (raw brick rubble?)
- 16 FINE LOOSE SANDY SOIL, few artefacts
- 17 SIMILAR GREY SANDY SOILS

- 20 SIMILAR SANDY SOILS, sterile
- 21 IN SITU GRAVELS OF TERRACE
- 22 EXTREMELY HARD CLAY LAYER, yellowish with white specs; indications of being burnt by fire

- 1 COBBLING & LAYERS OF FILL
- 2 YELLOW CLAYS & PLASTER 19<sup>th</sup> c.
- 3 GREY SOILS, FILL & RUBBLE
- 4.1 COBBLES BURNT BLACK ON TOP c.1740, IN FINE ASH-SAND
- 4.2 ORANGE COLOURED ASH LAYER c.1735
- 5.1 FINE GREY ASH LAYER
- 5.2 FINE BROWN SAND
- 6 BROWN SANDY SOILS CONTINUE

FIG.12 Composite drawing of archaeological sections B, C and f. The layering for each section differs as they were dug separately and individually (Vos 2001).

This period of rubbish deposition produced a variety of domestic articles, reflecting in particular the refuse from a kitchen, and was found stratified in 140-190 cm deep soils. Note that Room E was divided into three **units**, A, B and C, representing three smaller rooms of circa 1870 (FIG.11). In each of these units corresponding archaeological **sections** A, B and C were excavated down to a yellowish "base" clay layer. Surprisingly, in section C a test hole into the "last" layer (18), revealed at least three more layers, with layer 20 yielding Chinese porcelain of the early 18th century! A description, dating and interpretation of the layers is presented in the composite section FIG.12.

In the corner of Room E1/2, just above the hearth, traces of an old oven opening cut into the stacked clays, were discovered in 1974 (FIG.23). This old *bakoond* is lined with orange brickwork set in grey mortars (1750s), with an iron band strengthening the supporting arch. It has all the trappings of a *bakoond*, but with an interior hearth about 2.6 m wide. Here we have for the first time evidence of the transition of a floor-hearth to the well-known raised hearth with a small oven, which only continued about 40 c within the old 50 cm clayed up wall. There are no signs that the oven penetrated the exterior wall to form a *buitebakoond* (see photo 13 and FIG.12).

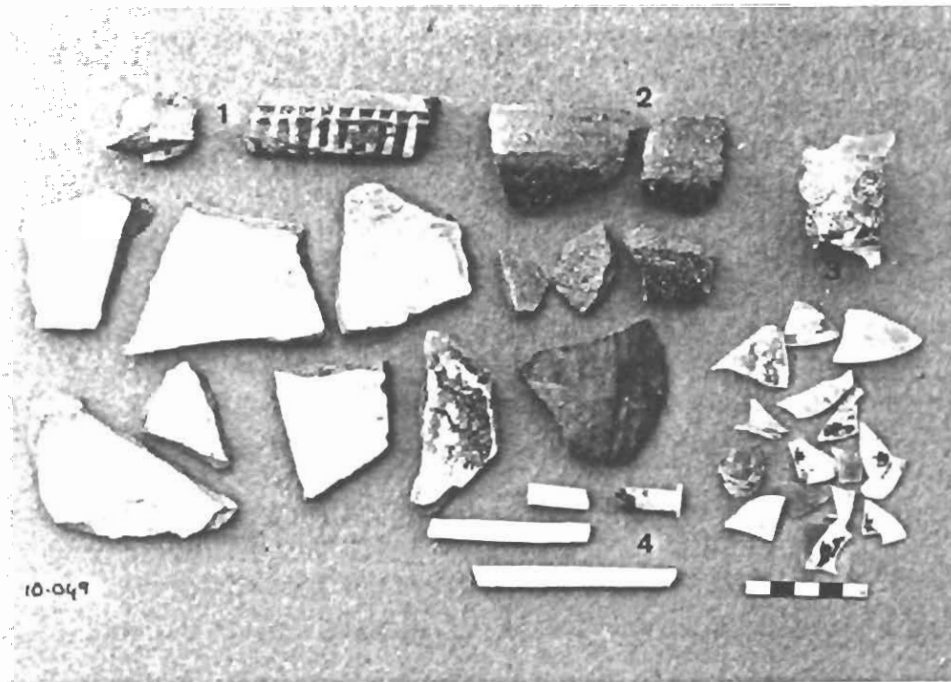
7. Artefacts from the deepest level (layer 23) in section B (unit B)(c.1710-1720)(scale 5cm).

- .1 Imported Dutch basin with yellow slipware (red earthenware).
- .2 Coarse earthenware, glazed on interior.
- .3 Roemer drinking glass with prunts and fragments.
- .4 Decorated pipe stems.

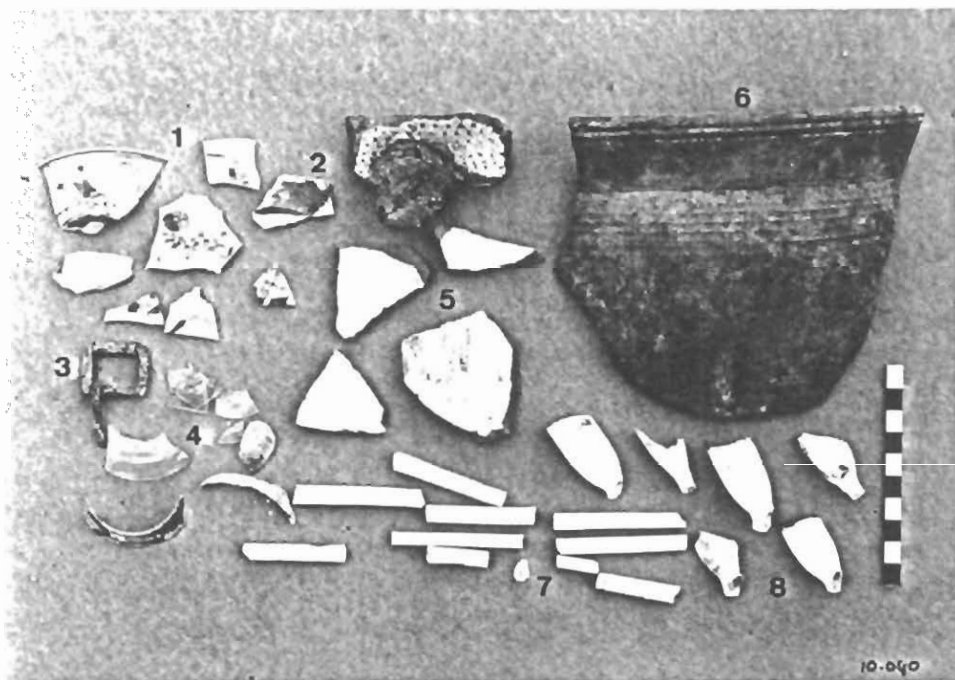
8. Artefacts from layer 23, section B (scale 10cm)..

- .1 Chinese porcelain, Kangxi.
- .2 Chinese porcelain piece with finely chipped edges ('reused').
- .3 Brass buckle.
- .4 Roemer glass fragments.
- .5 Earthenware basin.
- .6 Largest shard in excavation of an earthen cooking pot.
- .7 Pipe stems, many decorated.
- .8 Various pipe bowls.

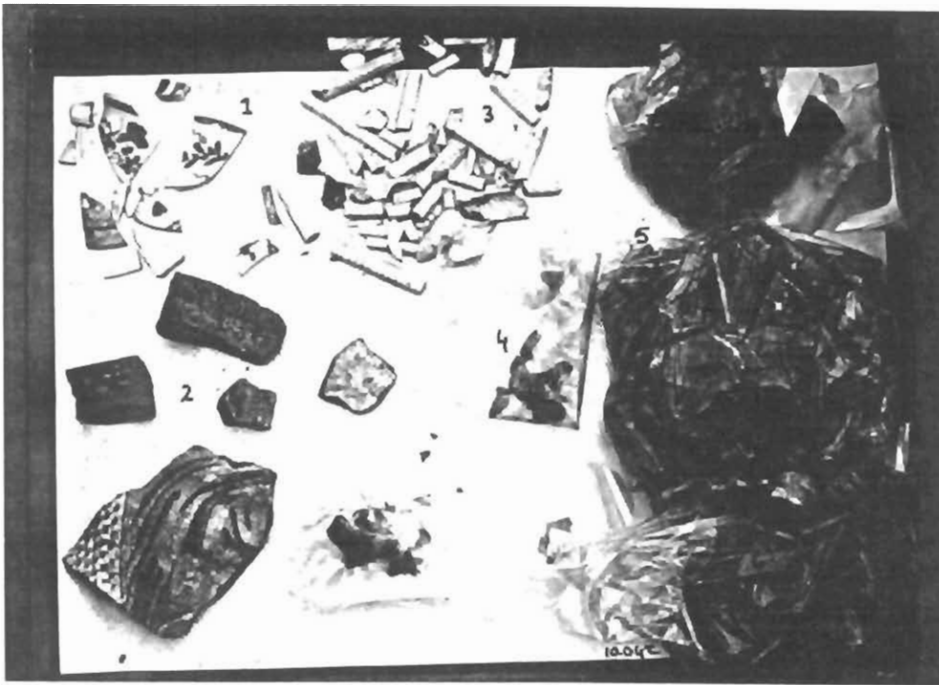
9. Artefacts from section A (deepest layer 23)(c. 1710-1720).
- .1 Chinese porcelain.
  - .2 Earthenware.
  - .3 Smoking pipes.
  - .4 Roemer glass.
  - .5 Bone.
  - .6 Brick rubble.

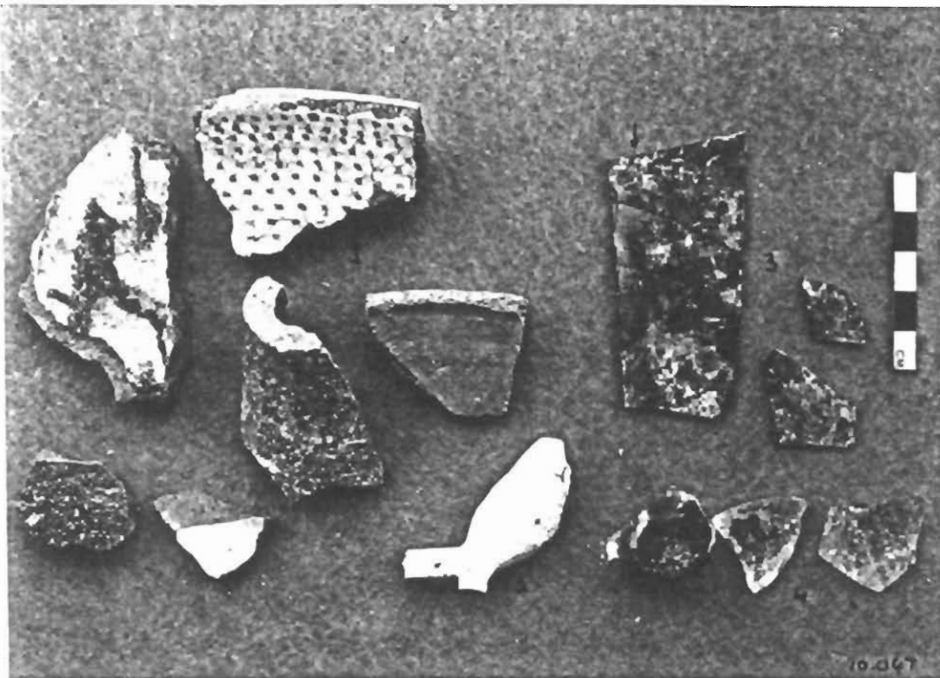
- 10.1 Earthenware (Dutch).
- .2 Smoking pipe (mark SVS, >1720)
  - .3 Window glass (came mark on left)
  - .4 Roemer fragments.

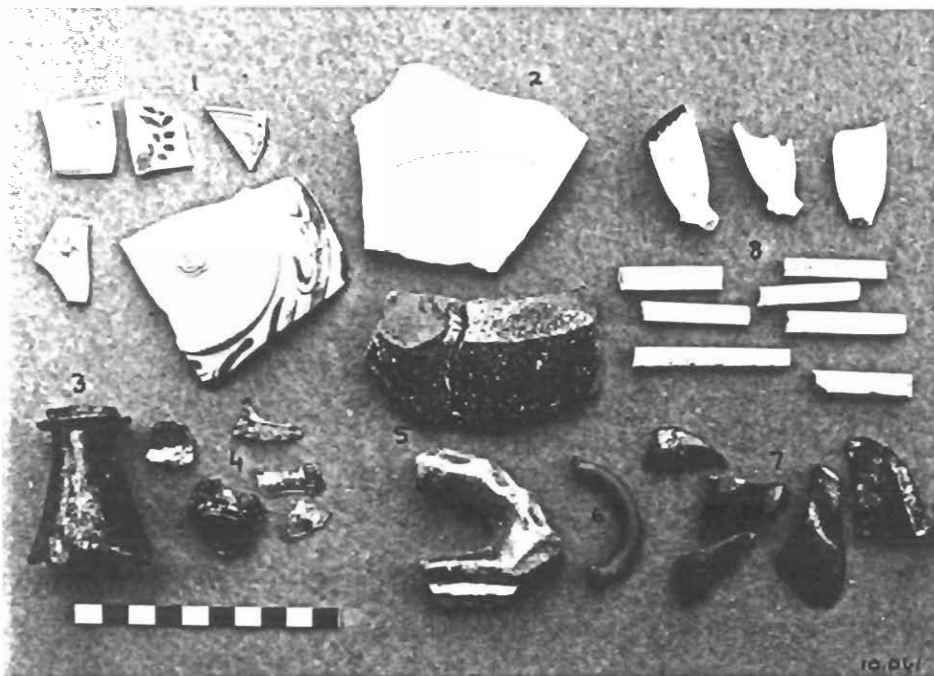
- 11.1 Chinese porcelain plates, bowl.
- .2 Unusual Asian incised plate.
  - .3 Bottle top.
  - .4 Roemer glass fragments.
  - .5 Earthenware fragments.
  - .6 Teapot handle (Yixing).
  - .7 Case bottle fragments.
  - .8 Smoking pipes.

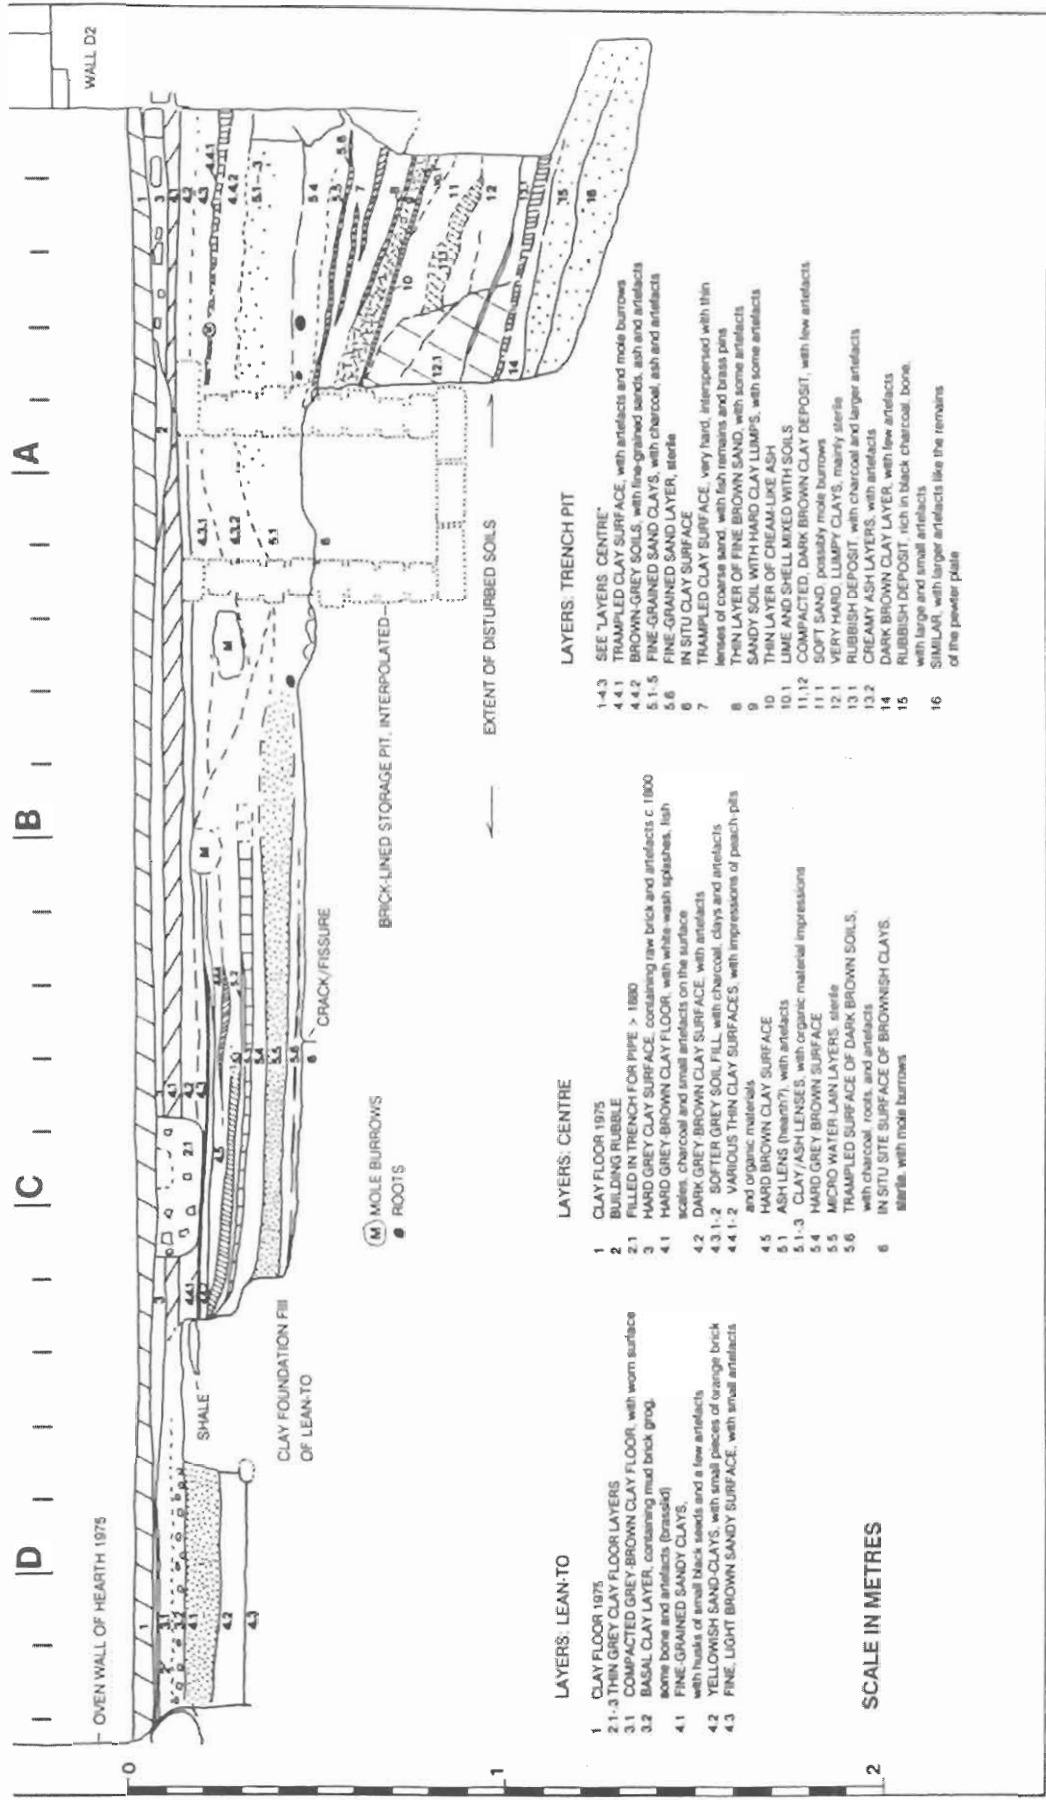
FIG.13 Composite section of the layers in Room D, as excavated in 1988 (V&B 1989a:28) (see also FIG.12).

CROSS-SECTION A-E 1/2

SCHREUDERHUIS ROOM D

LOOKING NORTH

- LAYERS: LEAN-TO**
- 1 CLAY FLOOR 1975
  - 2.1-3 THIN GREY CLAY FLOOR LAYERS
  - 3.1 COMPACTED GREY-BROWN CLAY FLOOR, with worn surface
  - 3.2 BASAL CLAY LAYER, containing mud brick frag.

- 4.1 FINE-GRAINED SANDY CLAYS, with husks of small black seeds and a few artefacts
  - 4.2 YELLOWISH SAND-CLAYS, with small pieces of orange brick
  - 4.3 FINE, LIGHT BROWN SANDY SURFACE, with small artefacts

In Room E, in unit B, a clay layer (no 15) of about 12-22 cm thickness, probably represents the trampled surface when the tail was erected. It corresponds roughly to layers 5.6/6 in Room D (area BC)(FIG.13). At this stage there was no dividing wall E4 and the tail functioned as one long room, possibly as some kind of workshop/dwelling.

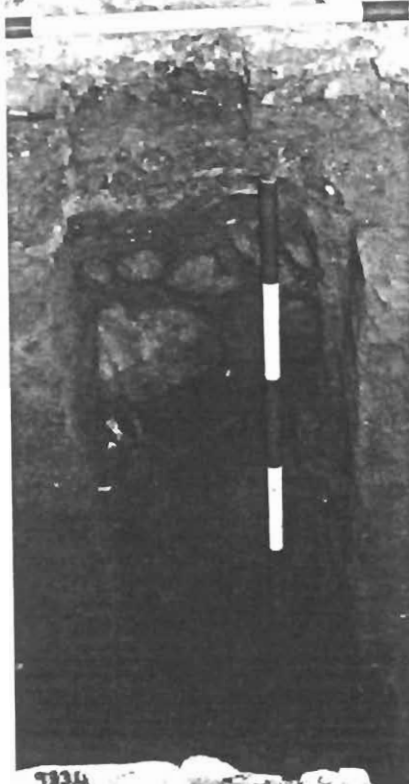
12. Room E, unit A, section A, shows river stones as foundation of wall E3 (looking S)(scale 1m).

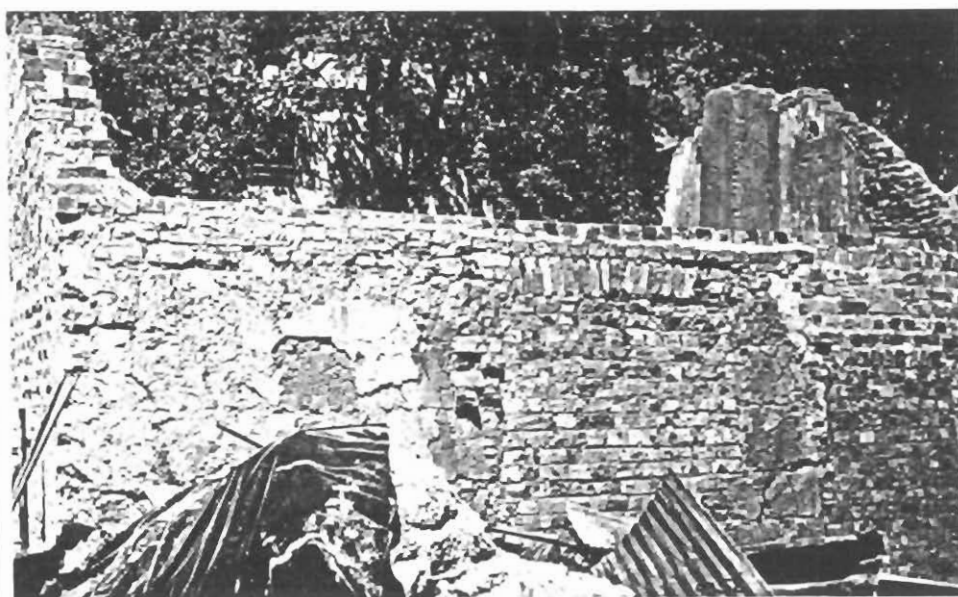
13. Tail end, exterior (E1) with clayed-up walls on left (looking S) (Le Roux 1975).

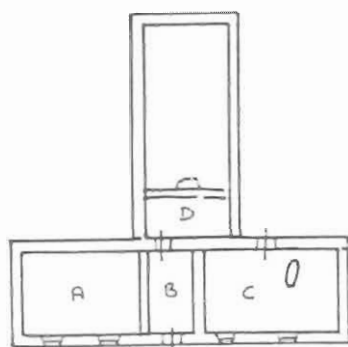
FIG.14 A possible layout of the footprint of Schreuderhuis in c.1730. It still follows the c.1710-30 layout with the diminished Room C. Its façade still has panes set in leaded cames.

In Room D the layers (4.3 - 5.6) against the lean-to wall, may be indicative of a period after the tail was erected. In Room E, unit B, the rough layers 12a-14 may correspond to these layers. If this was the case, then the back wall of the lean-to was only partially demolished and some kind of hearth (layer 5.1) may have existed here for a few years. A few thin layers directly above contained fish scales, charcoal and artefacts, and may represent uneven, trampled floors (FIG.14).

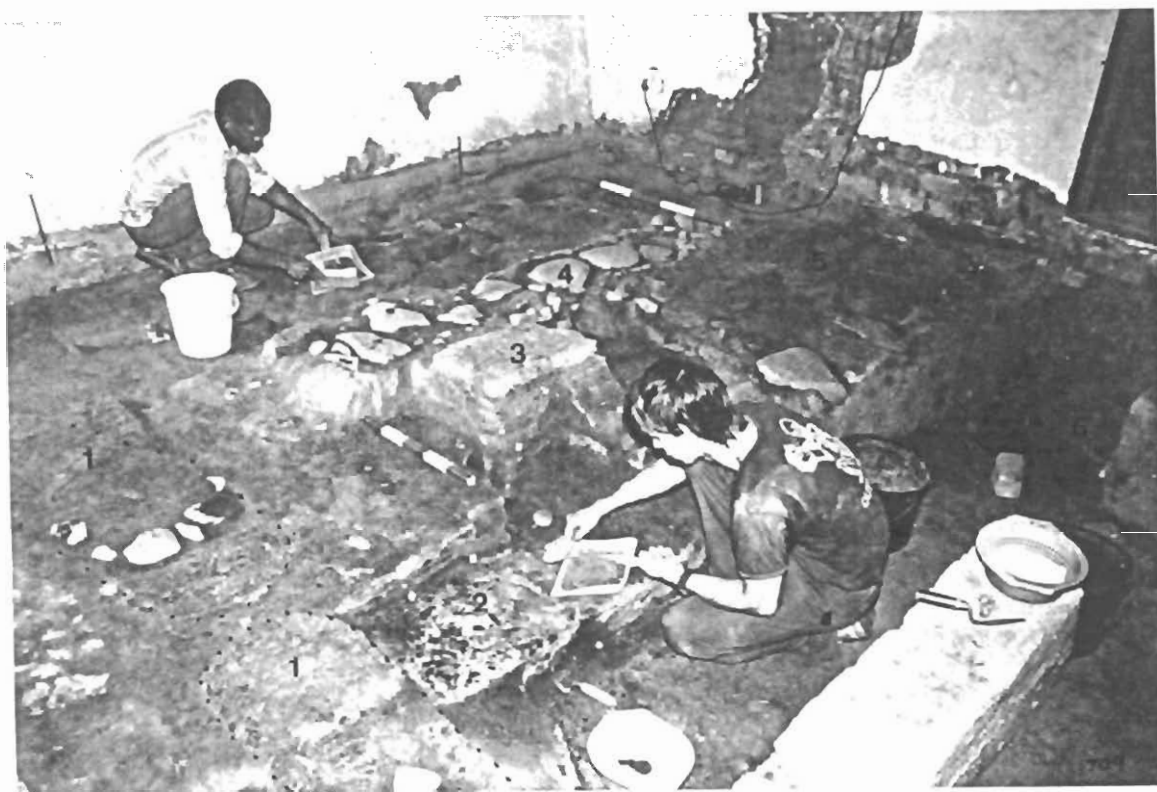
14. View of Room D, looking NE, during excavations in 1988. Note:

- .1 Lean-to with opening in between (1710).
- .2 Ash-hearth against lean-to (>1710-1715).
- .3 Yellow clay layer (dung smeared)(1975).
- .4 Shallow stone foundation (>1770).
- .5 Clay floor over filled-in cellaret (>1770).
- .6 Beginning of pit continuing into Room E (>1700).

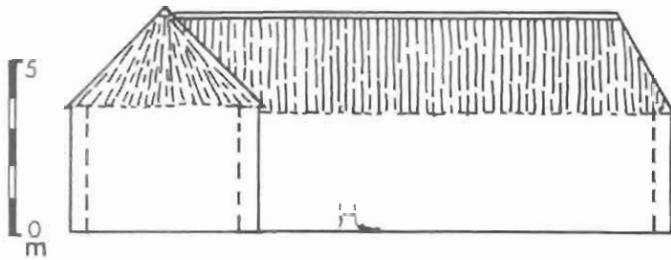
FIG.15a Cross section of Schreuderhuis with its pitched roof and newly erected tail in c.1730. A floor hearth may initially have been in use against the back of the clay wall of the lean-to.

In summary, by about 1730, the lean-to must have become either too dilapidated and/or inadequate and was demolished to make way for a larger, sturdier pitched-roof construction (FIG.15a).

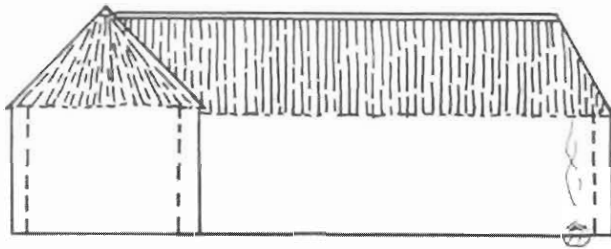
FIG.15b A new floor hearth was installed against the end wall E2 (>1730).

Indications are that after some time a rough floor-hearth was made against the end-wall E2 (unit C2), still contemporary with the clay floor (layer 15). What is surprising about this hearth, is the depth of its fine ash fill (layers 5.1-5.2). The brown sands below this contained a large case bottle fragment, indicating fill brought from outside. The hearth was at one time surfaced with brick (rubble), which turned completely into fine ash-dust, bordered by blackened stones on the same level towards the foundations at the back (FIG.15b).

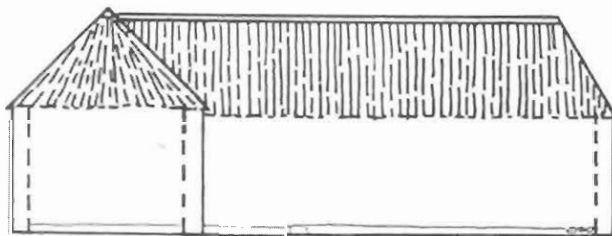
FIG.15c A layer of stones were afterwards added on top of the old floor hearth (c.1735).

Afterwards, slightly above this early hearth was laid a second surface, in this instance of cobbled stones on a level horizon. These medium-sized river stones were also all blackened on top (FIG.15c, FIG.15d). It appears to be contemporaneous with the hard, greyish clay floor 11, which was well worn in many places and must have lasted for a number of years. Rooms DE (of the tail) may have served as working quarters (for slaves), as so much refuse overlay the area.

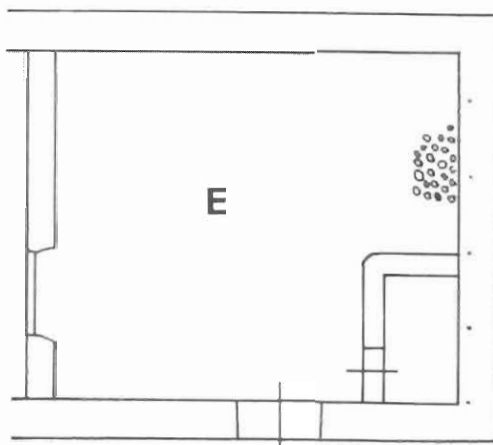
FIG.15d View of the c.1735 floor hearth with its surface of stones.

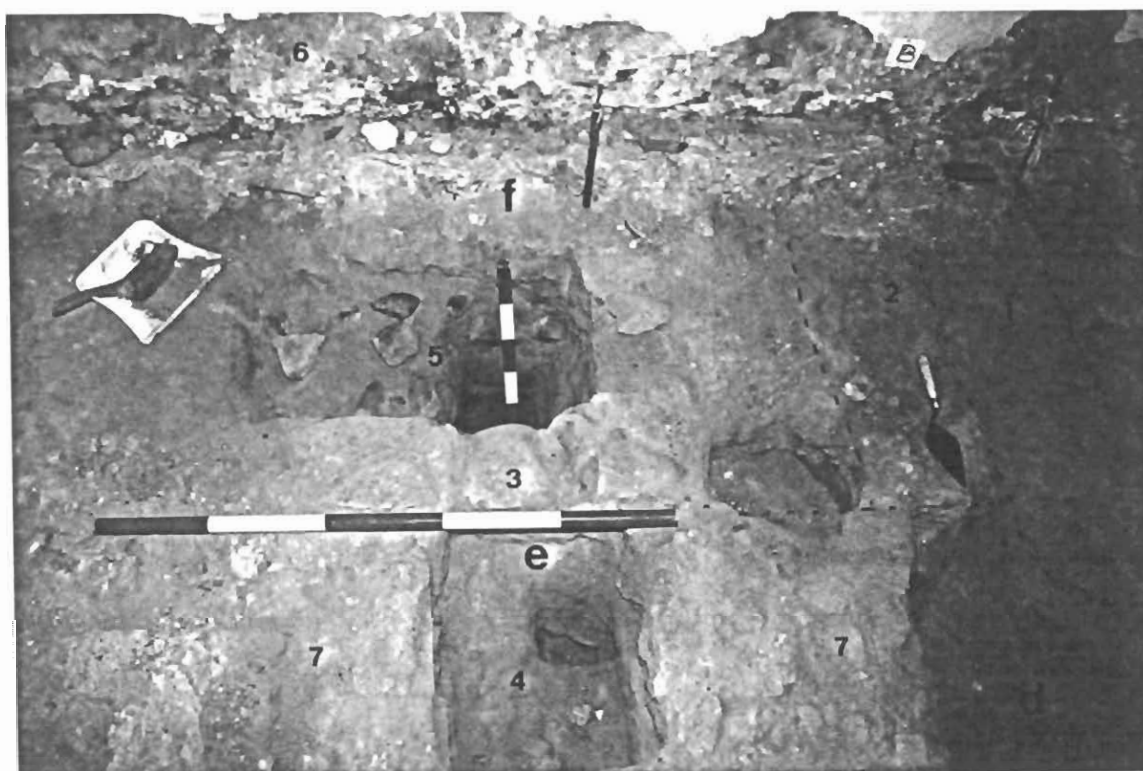
15. Room E, unit C, sections b1, e & f (looking E)(scales 50cm & 1m).

Note the following:

- .1 Section b1: demolished raw brick wall of pantry (c.1740).
- .2 Demolished wall of raised hearth.
- .3 Front stones of raised hearth wall
- .4 Section e with stones (unidentified purpose)(18<sup>th</sup> century).
- .5 Section f with lower levels of brick dust (early floor hearth) and later blackened stones on top (c.1735).
- .6 Rebuilt wall of 1975.
- .7 Brick floor of c.1830.

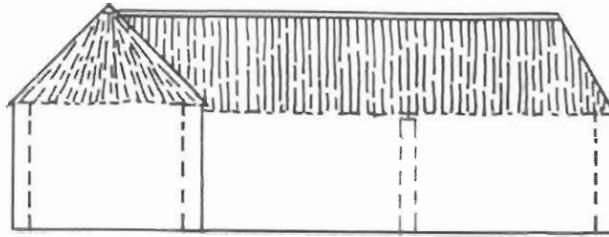
FIG.16 An interior wall was built on shale foundations, followed by some hardfired bricks and drawn up to ceiling height in raw bricks by about 1735.

During this period (if not earlier) some alterations were made. The interior dividing wall D2/E4 was constructed some time later and possibly only up to ceiling height (FIG.16). There were clear signs that it was dug neatly through layer 11 (section B) and therefore post-dates it. Its foundation consisted of roughly packed shale blocks, to a depth of 40 cm below floor 11. From floor level 11 upwards it consisted of about four courses of soft-fired, orange brick as water-proofing, the remainder being drawn up in raw brick with a height of 4-5 cm each, pointing to a period of c.1735 (FIG.16.1).

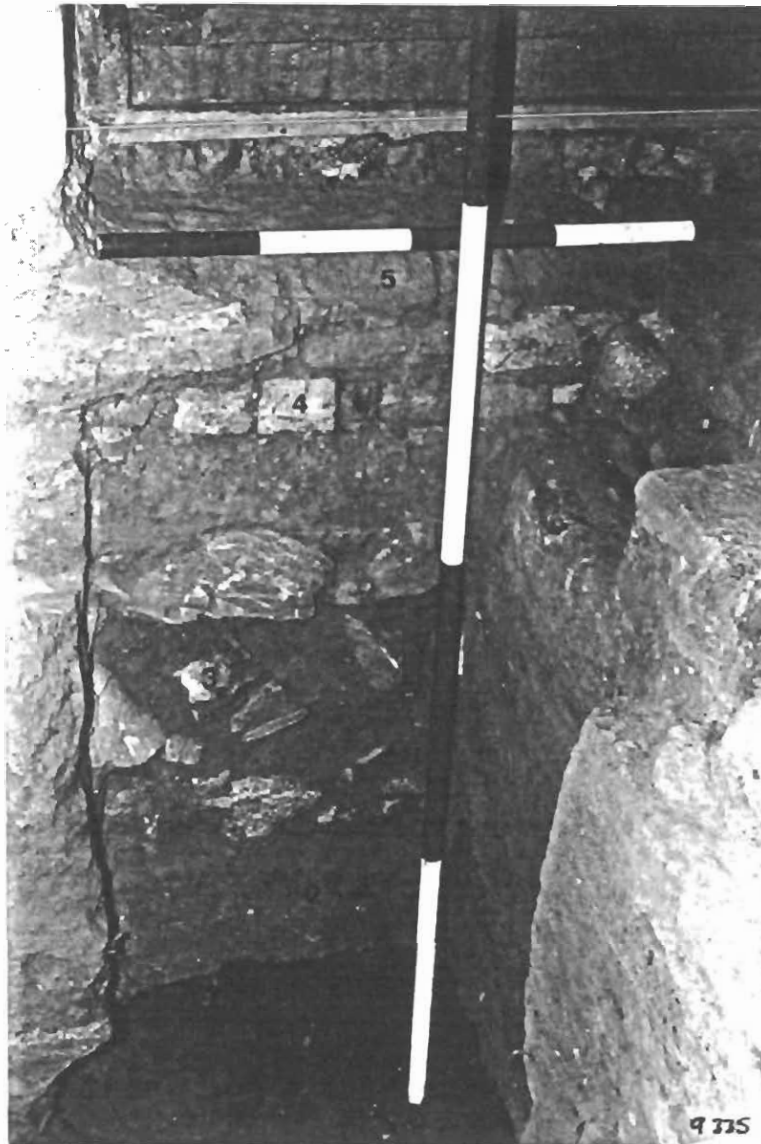
16. View of Room E, unit A, section A, looking W (scales 1m, 2m).  
Note the following:
- .1 Sterile base (layer 24) on which dump rests.
  - .2 Layers of rubbish fill (>1710).
  - .3 Shale foundations (in loose soils) of wall E4 (>1735)
  - .4 Hard-fired bricks (2 courses) on top of shale.
  - .5 Soft-fired brickwork (19<sup>th</sup> century) below door to Room D.
