# SCHREUDERHUIS, STELLENBOSCH

AN OVERVIEW OF ITS EVOLUTION,  
HISTORY AND ARCHAEOLOGY  
WITH PARTICULAR EMPHASIS ON  
A KITCHEN, ROOM E  
NOVEMBER 2001

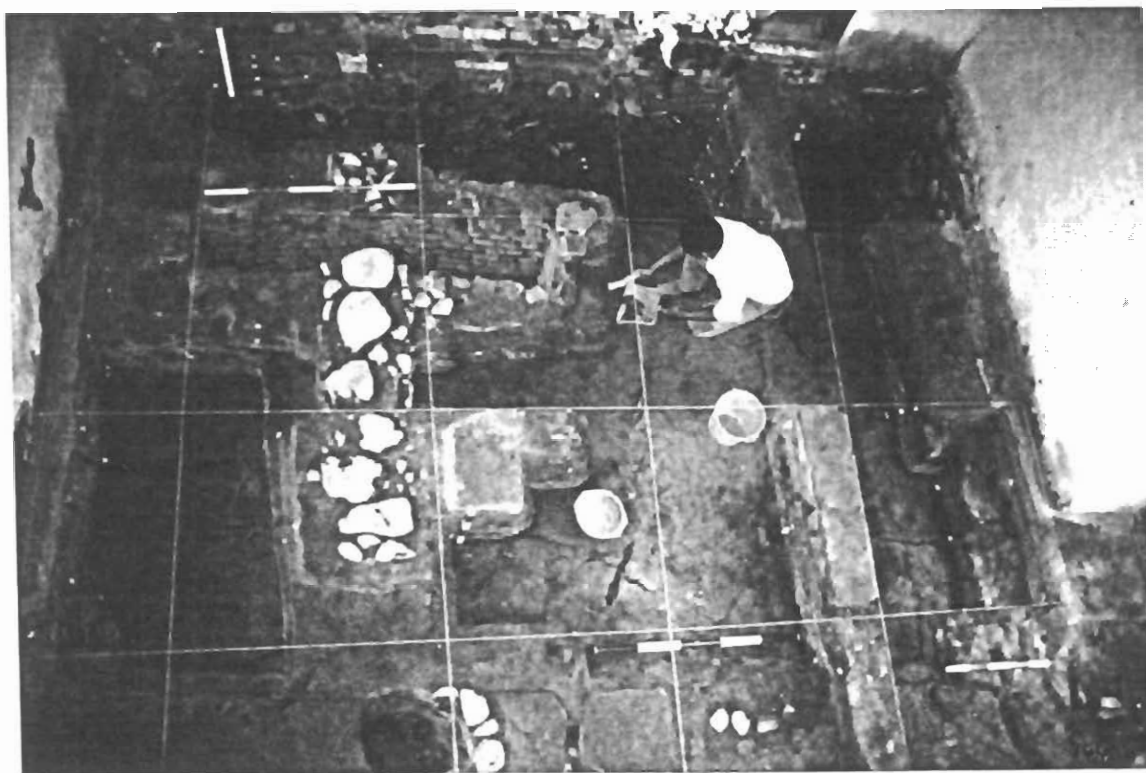
17. Birds-eye view of Room D, showing the brick-lined cellaret and the extent of the pit all along wall D2 (1988)(looking E).

In Room D a very interesting and unique feature was constructed in the floor, consisting of neatly built orange brick (as waterproofing) to a depth of 66 cm and shaped in a peculiar way, somewhat like a bow-tie. It may have been lined with wood. Why it was built in this odd shape is not known, but it probably served as a cellaret, for keeping things cold. Dairy products like milk, butter and foods that can easily spoil, as well as the odd bottle of wine, may have been stored here.

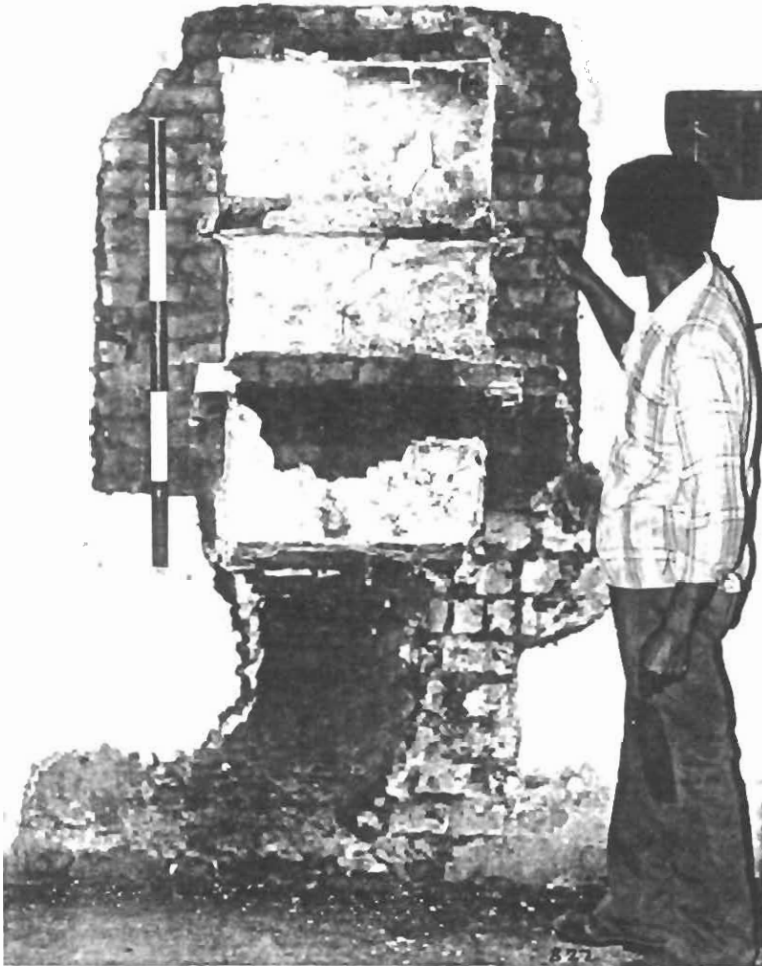
18. A small cupboard was cut into wall D2 and the filled-in brick was carefully removed to reveal its construction (>1740).

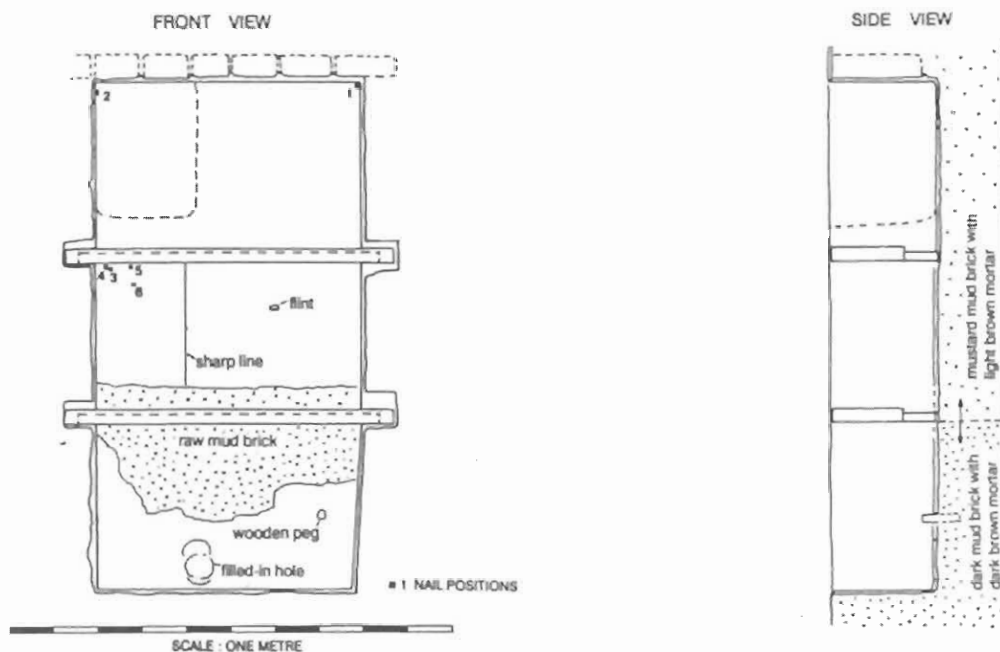
#### SHREUDERHUIS ROOM D

##### ELEVATIONS OF CUPBOARD IN WALL D2

FIG.17 Front and side elevations of the wall cupboard in wall D2 (V&B 1989a:70).

A small rectangular recess, acting as a wall-cupboard, was later created in wall D2, during the period when such furniture became more fashionable (FIG.17).

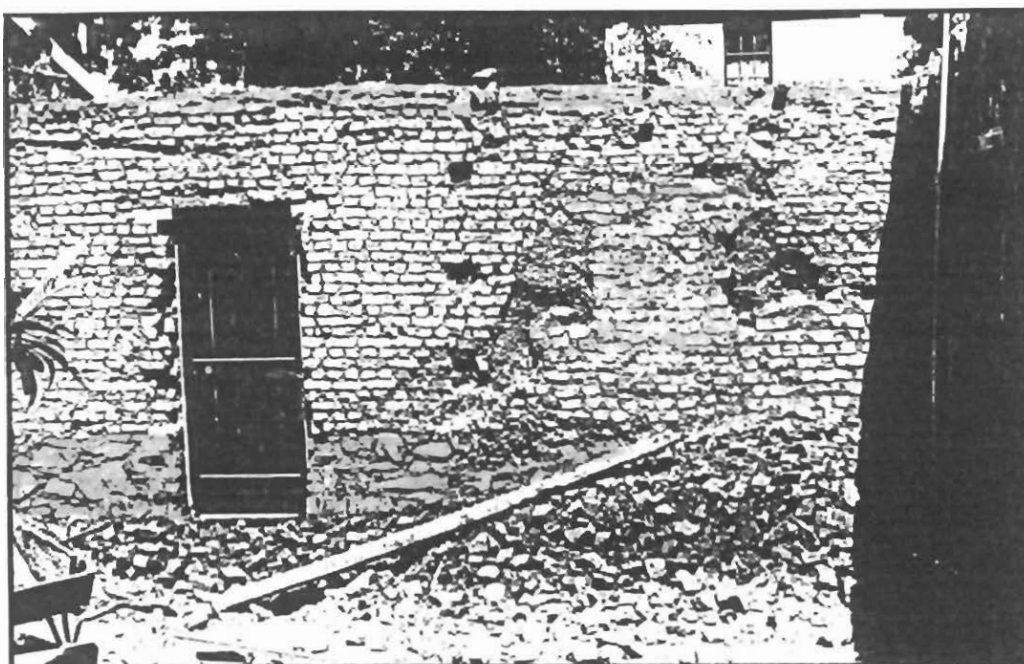
19. View of the exterior wall CC/C, looking W. By means of colour the following is identified (Le Roux 1975).

- Red: granite foundation (>1740).
- White: raw brick (c.1740).
- Orange: added brickwork (19<sup>th</sup> century).
- Yellow: fill with outline of earlier chimney.
- Pink: blocked-up window.
- Blue: brickwork (19<sup>th</sup> century).

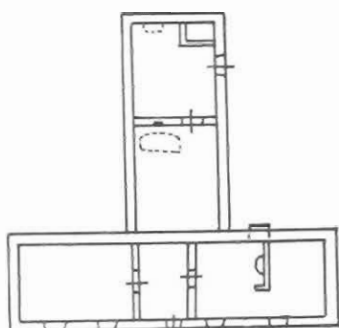
FIG.18 Possible alterations to Schreuderhuis from c.1735.

In Room CC the floor hearth A was replaced by another floor-level hearth with a hood and chimney. Evidence of a chimney was visible on the exterior of wall C2 during the 1975 restoration (FIG.18).

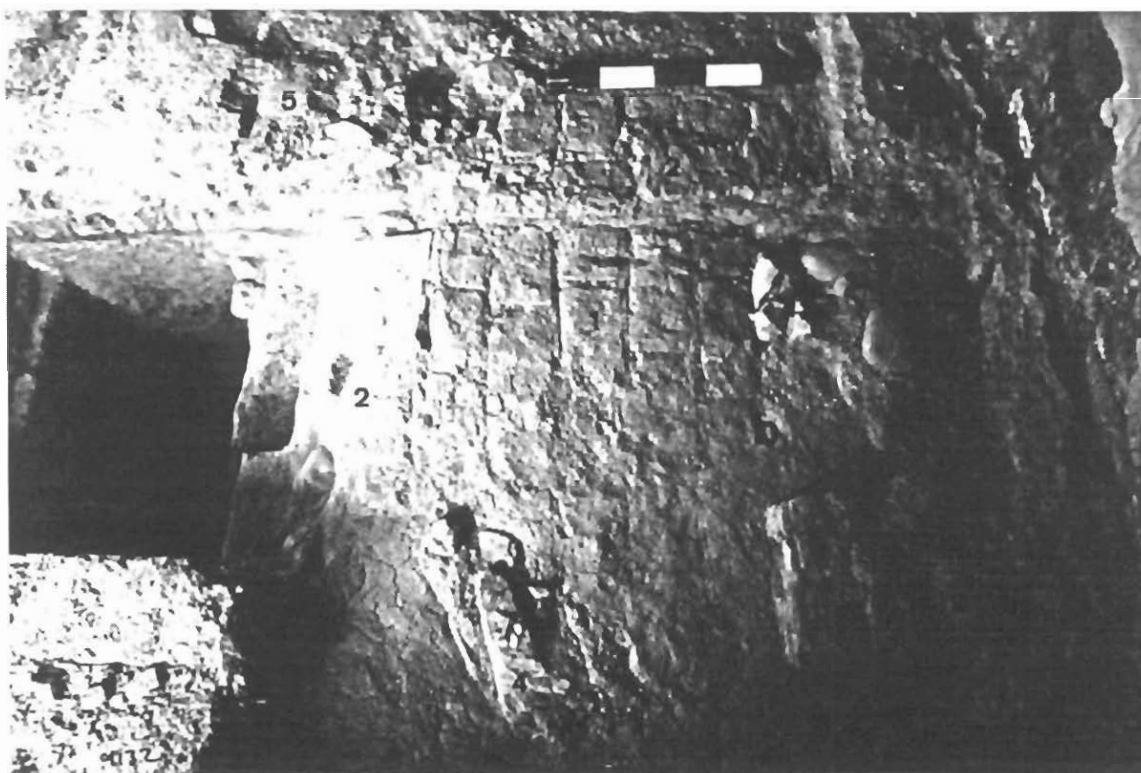
20. The corner pantry in Room D, unit C, sections a & b, is best visible in natural light (looking N). Note the raw brick floor (1), the raw brick walls (demolished)(2), stone foundation (3), fill (4) and a remnant (rest was removed) of c.1830 brickfloor (5).

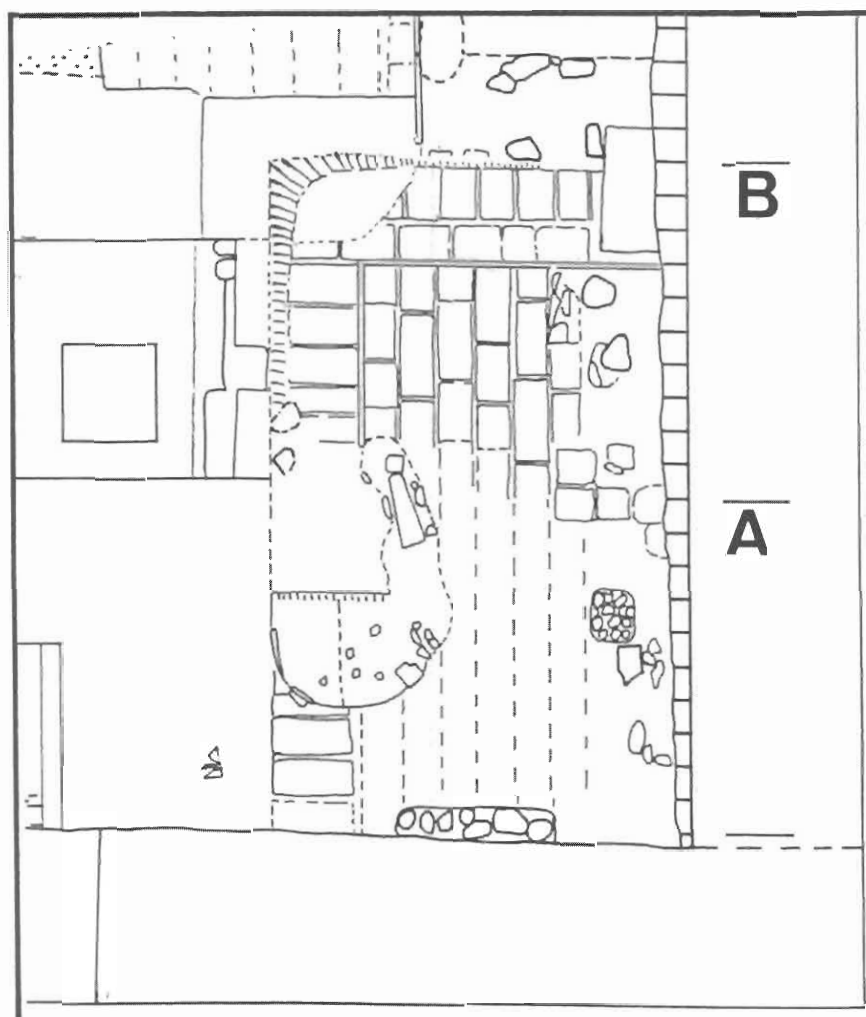
FIG.18.1 The pantry of c.1740 was built with raw brick walls and floor

In Room E the floor-level hearth against the end-wall E2 continued to be used. A small room in the SE corner, which dates from this time or earlier (c.1740), had a foundation in stone, and walls and a floor of raw brick (FIG18.1). It probably served as a pantry. From 1720s onwards numerous post-holes of various sizes were sunk into the clay floors, particularly in Room DD/D. They don't appear to be scaffolding posts, for they are spaced randomly and are with various dimensions (see V&B 1989a). This is one of those puzzling aspects of the *Experimentation period* left unexplained by the historical record.

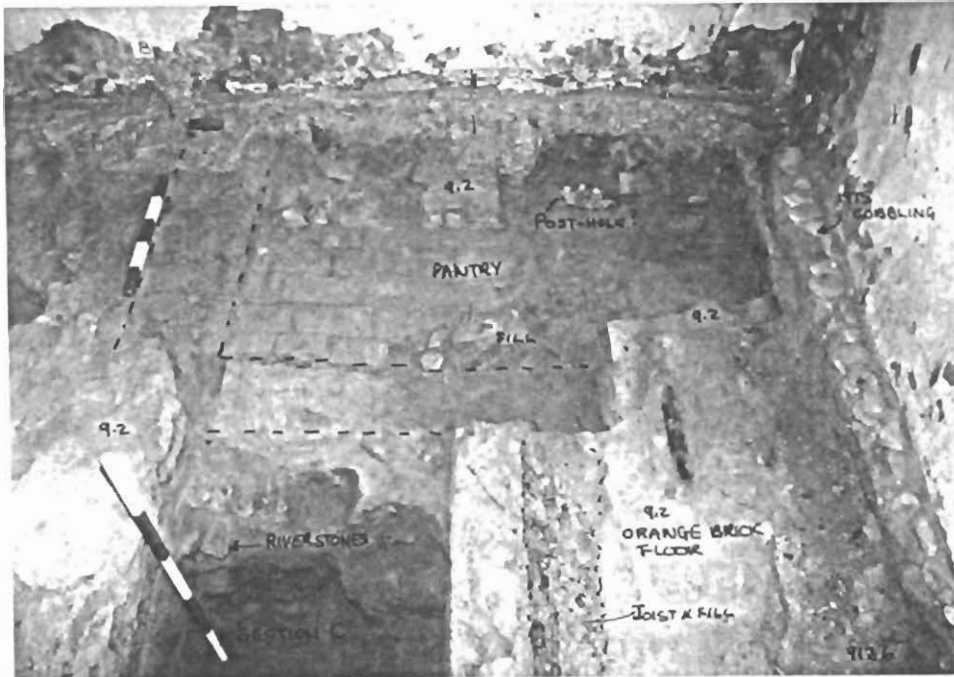
21. View of the corner pantry in Room D, with explanatory text (looking E).

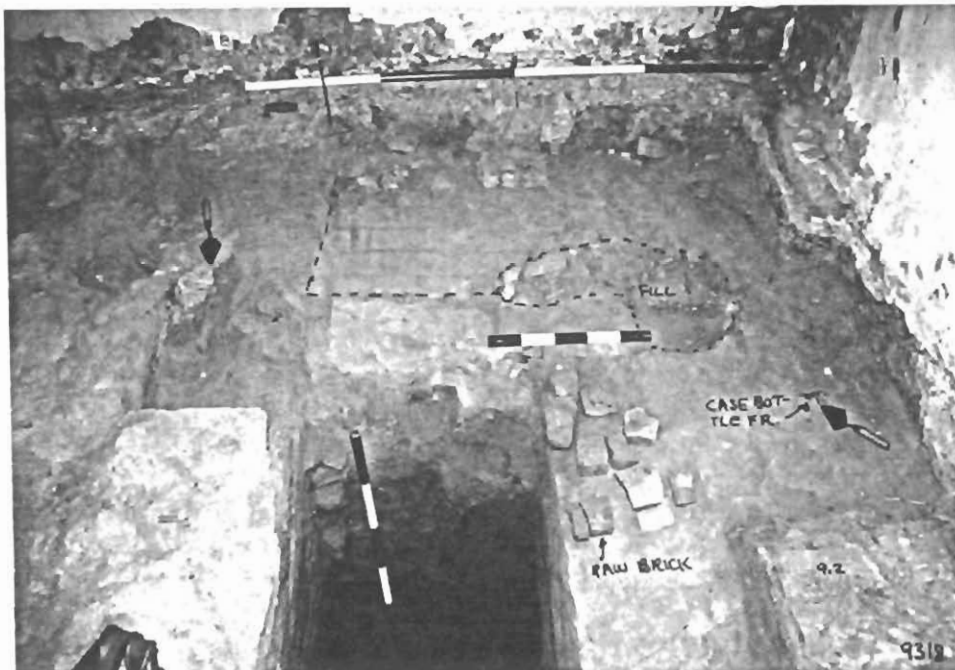
22. Same view, but the 18<sup>th</sup> century clay floor on the right has been more fully exposed. The raw brick were used as fill for the orange brick floor (scales 50cm, 1m, 2m).

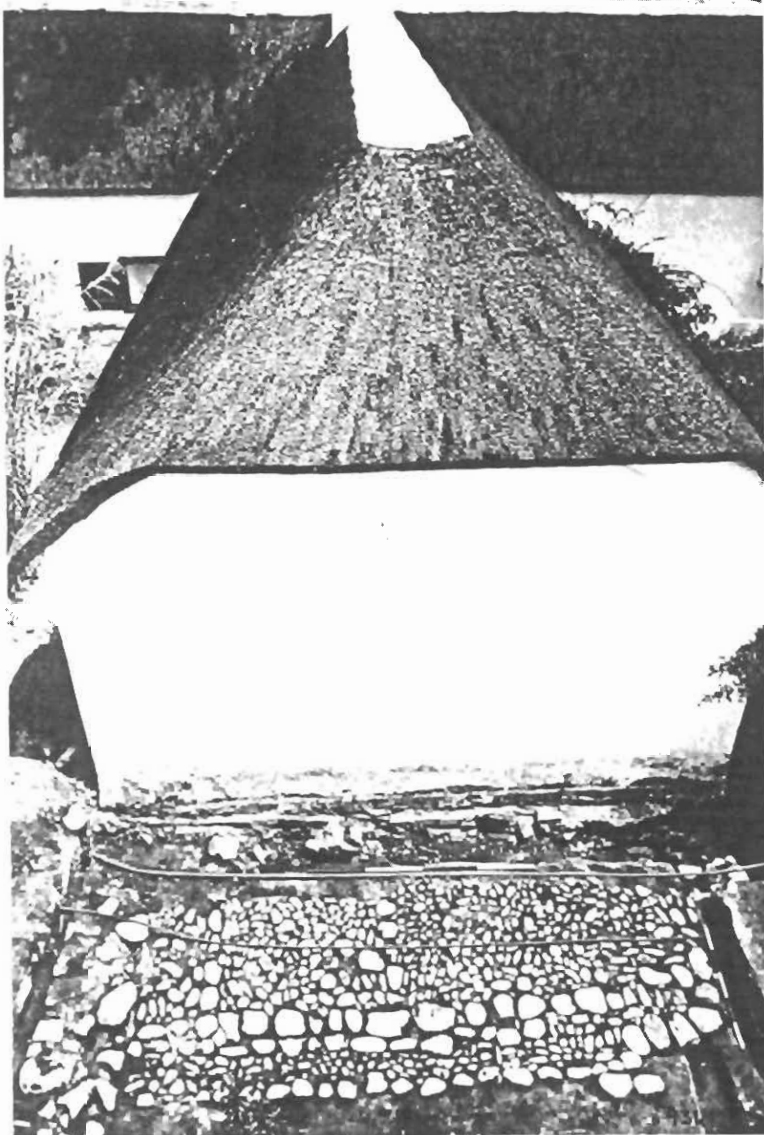
23. View of the tail of Schreuderhuis with the exposed cobbled stoeep and furrow (larger stones), dated to at least to 1750-1760. Room F was later (>1800) constructed over it and on the left a part of the foundation is visible (looking W)(scale 2m)(1988).

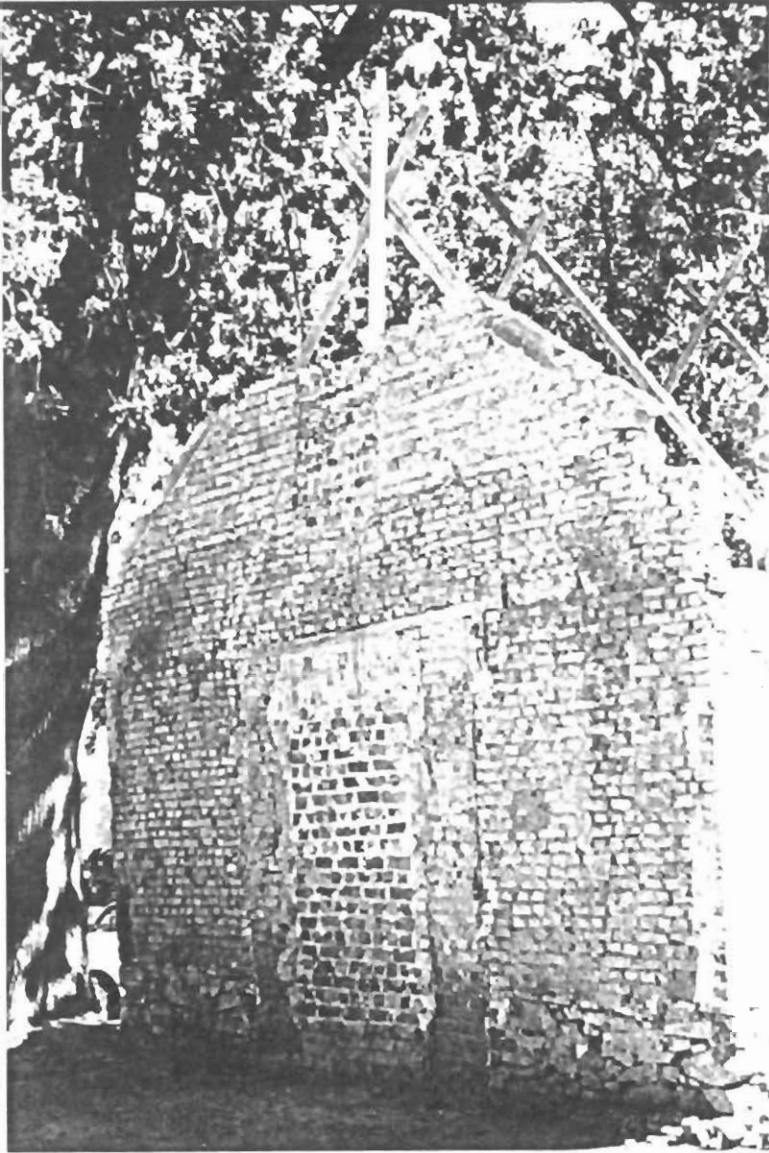
24. The endwall C3 (c.1740) in raw brick, later received a coach-door, then a smaller door and lastly the Edwardian sash-window, bricked-up in 1975. The upper portion of the end gable was drawn-up in 19<sup>th</sup> century brickwork and the loft door bricked-up in 1975. Note the neat granite wall built-up for about 60cm above ground level (see photo 25)(Le Roux 1975).

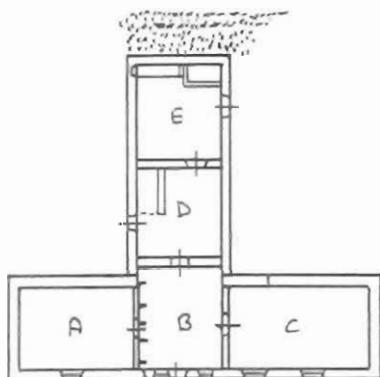
FIG.21 Towards the late 18<sup>th</sup> century (c.1770), there was a large hearth, oven and chimney extant in Room E2, while the hearth in Room CC was replaced by one in Room D2. The cobbled surface behind Room E was also in use. Room CC/C has been rebuilt and lengthened after 1740. The gabled *voorhuis* was supplied with yellowwood beams.

Thus, by the late 18th century (>1770), the *voorhuis* had become a prominent reception room with much furnishings. From here guests were taken to the *pronkkamers* (either left or right). As was the custom of the period, half casements were added, with the central gable as the most prominent status symbol. These alterations may be contemporaneous with the rebuilding of the far wall (BB/B2) slightly further back, to create a more spacious reception room (FIG.21, FIG.21.1).

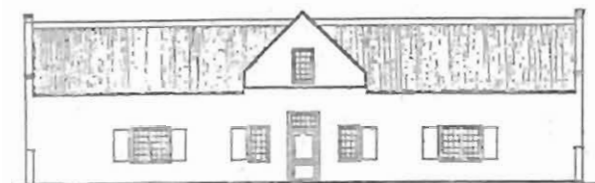
FIG.21.1 The dwelling may have acquired a simple central gable (a) (Fagan & Fagan 1974), or a more elaborate one (b) (Vos).

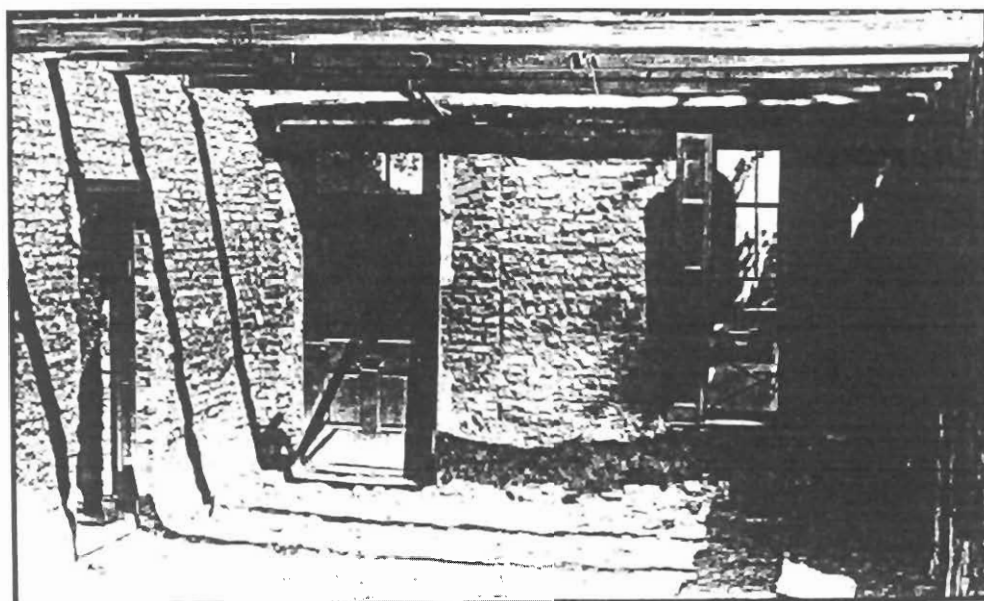
26. View towards the interior of the *voorhuis* BB/B4, looking W (1). Note the blocked-up front door (2) and the yellowwood beams (3) (Le Roux 1975).

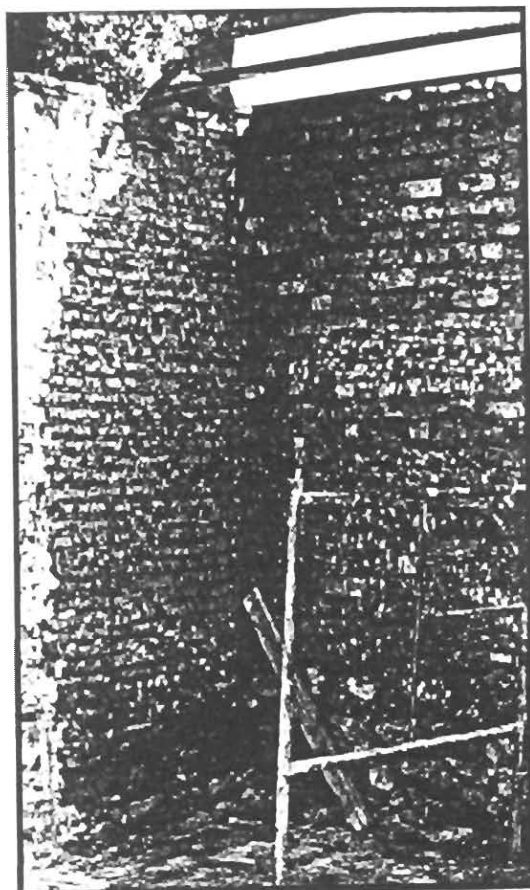
27. View towards the corner AA4/2, to show the contrast.  
Left (AA4): flat raw brick above a low (20-30cm) stone foundation.  
Right (AA1): A 50cm undressed stone foundation with hard-fired orange brickwork of the late 18<sup>th</sup> century (Le Roux 1974).

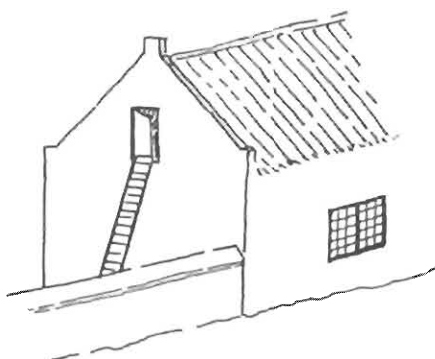
FIG.22 Access was gained to the loft via the end gable AA1 by means of a ladder.

Beams (aligned N-S) and a ceiling of yellowwood were installed in the *voorhuis*, further emphasizing its status. A loft (without a clay *brandsolder*) would thus have been created for storage purposes with access presumably via a door in the northern end gable (Room AA1), using a ladder. Note that this end gable wall was also rebuilt late 1700 (FIG.22).

28. In the loft the end gable AA1 shows a door opening, presumably old, which could have been reached by a ladder (FIG.22). Beyond it is the end gable of Room H1, of early 1900 (Le Roux 1975).

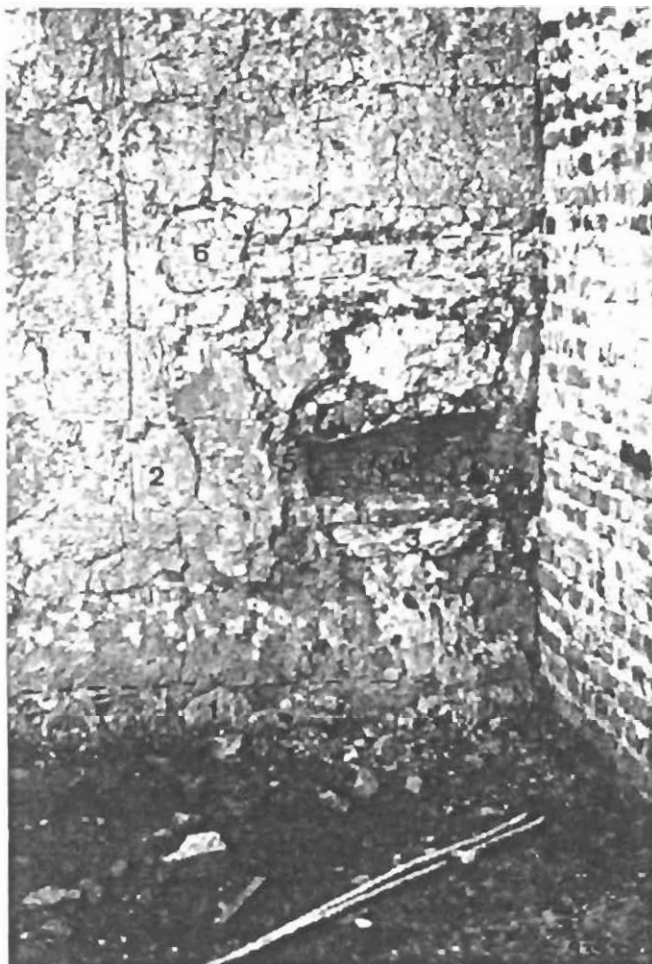
29. A fine photograph of E1 (Le Roux 1975) detailing:

- 1 The foundation slate stones (40cm above the 18<sup>th</sup> century floor).
- 2 Stacked clay layers.
- 3 Large slate stone to oven entrance.
- 4 Filled-in clay when the oven became redundant.
- 5 Iron band to support upper fill of brick (6) (19<sup>th</sup> c.).
- 6 Filled-in brick (19<sup>th</sup> century) of hearth beam.
- 7 Chimney hood contact line (filled-in with 19<sup>th</sup> c. brick).

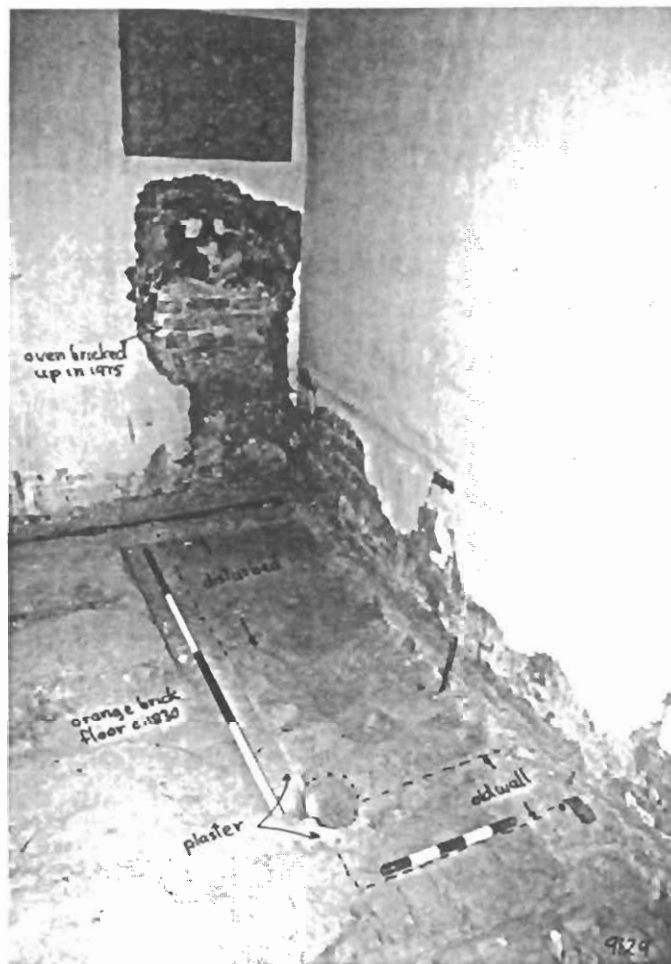
30. In 2000 the old oven opening was partially exposed to determine its exact position in relation to the raised hearth.

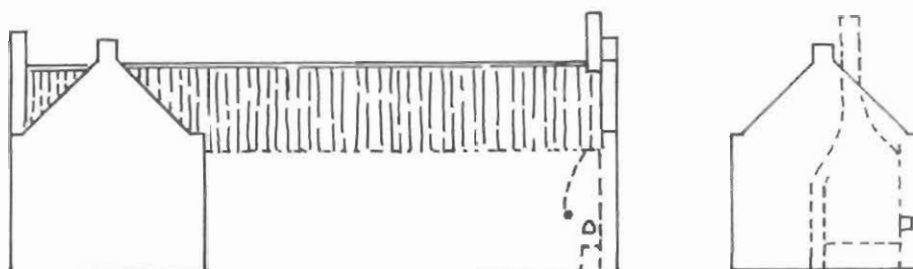
FIG.23 Elevation of SH indicates the installation of the newly raised hearth >1770, either against a hipped end gable or a built end gable.

In the corner of Room E1/2, just above the hearth, traces of an old oven opening cut into the stacked clays, were discovered in 1974 (FIG.23). This old *bakoond* is lined with orange brickwork set in grey mortars (1750s), with an iron band strengthening the supporting arch. It has all the trappings of a *bakoond*, but with an interior hearth about 2.6 m wide. Here we have for the first time evidence of the transition of a floor-hearth to the well-known raised hearth with a small oven, which only continued about 40 c within the old 50 cm clayed up wall. There are no signs that the oven penetrated the exterior wall to form a *buitebakoond* (see photo 13 and FIG.12).

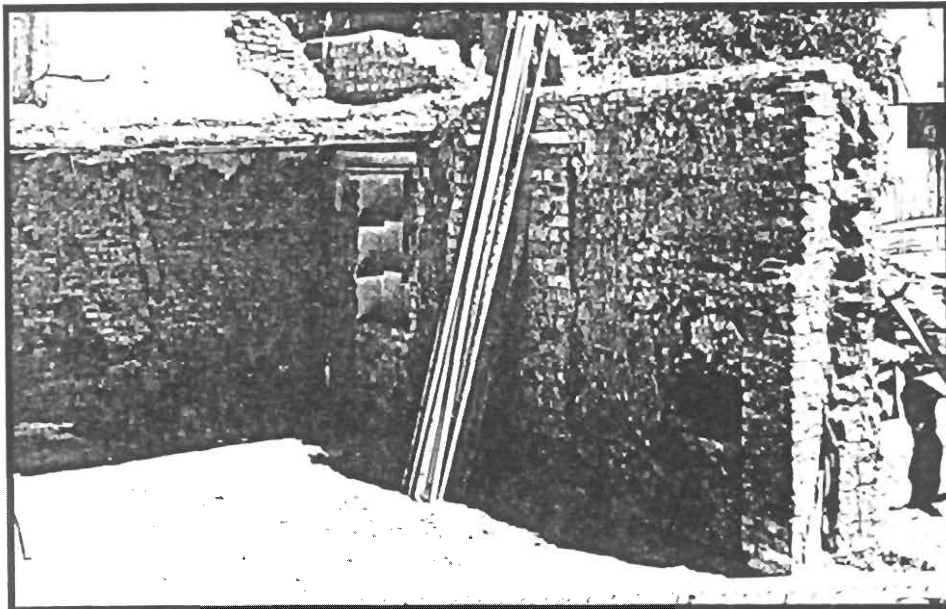
30.1 After much of the additions were demolished, the position of the old hearth relative to the rest of the northern clayed-up wall was clearly determined (Le Roux 1974).

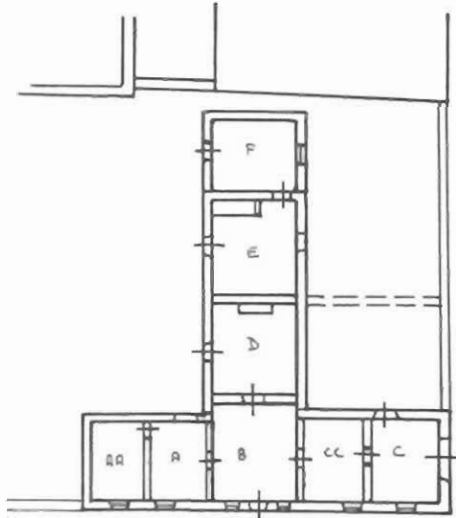
FIG.24 Site plan of Schreuderhuis as it probably appeared in about 1800.

Around 1800 **Room F** was added at the end of the tail. It had foundations of river stones and walls of the same for waterproofing, topped by bricks laid in clay mortar. Note that about 40 cm of above-ground walling was still underground in 1974. There was possibly an opening (door/window), which was blocked up, with a low, slit "airvent" of unknown purpose, possibly associated with a pantry inside Room F3/4. The built-up hearth (phase I) against wall E2 was still in position, but the old "pantry cupboard" (E2/3) was demolished to make way for a new door between the two rooms. The two Rooms E and F possibly formed a unit by themselves from this time onward. Outside, a dividing yard wall was possibly built. These rooms were probably let as a "*huurhuis*", a practice that continued till early in the 20th century (FIG.24).

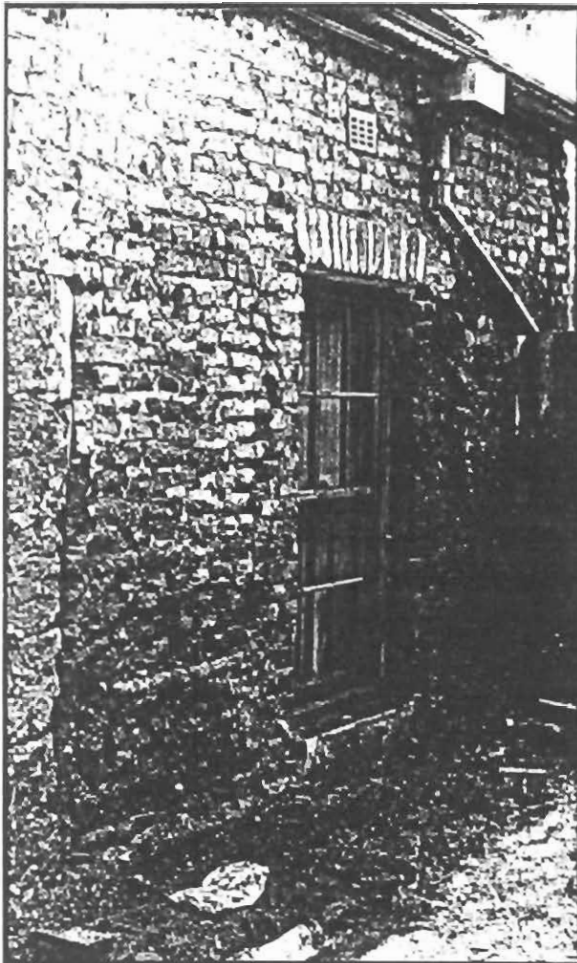
31. Exterior of Wall F3, looking NE. The sash-window apparently dates to the RCC period when they installed it in 1910 (see FIG.36)(Le Roux 1975).

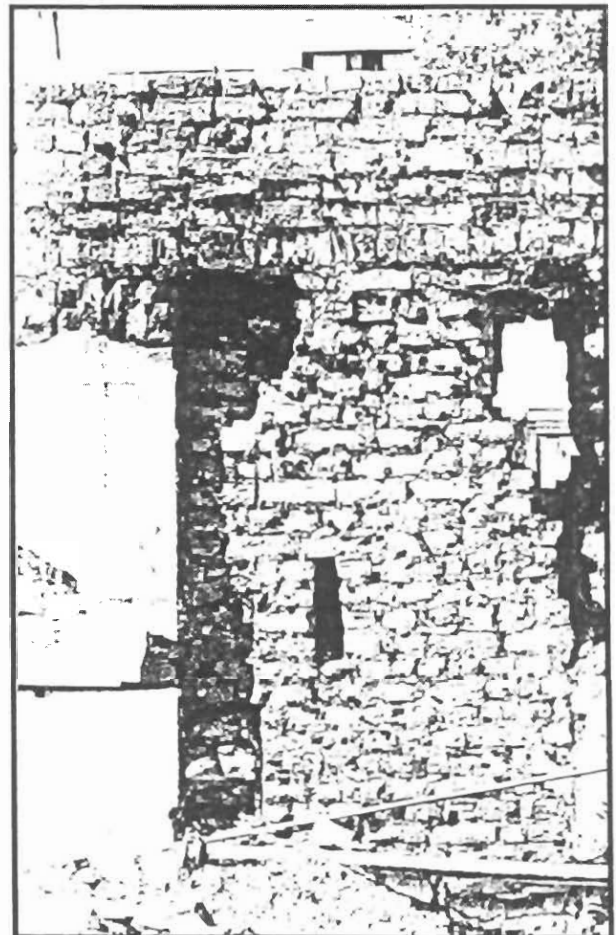
32. Interior of Wall F3 with the old door bricked-up during the 19<sup>th</sup> century, but built with a low air-vent or niche (Le Roux 1975).

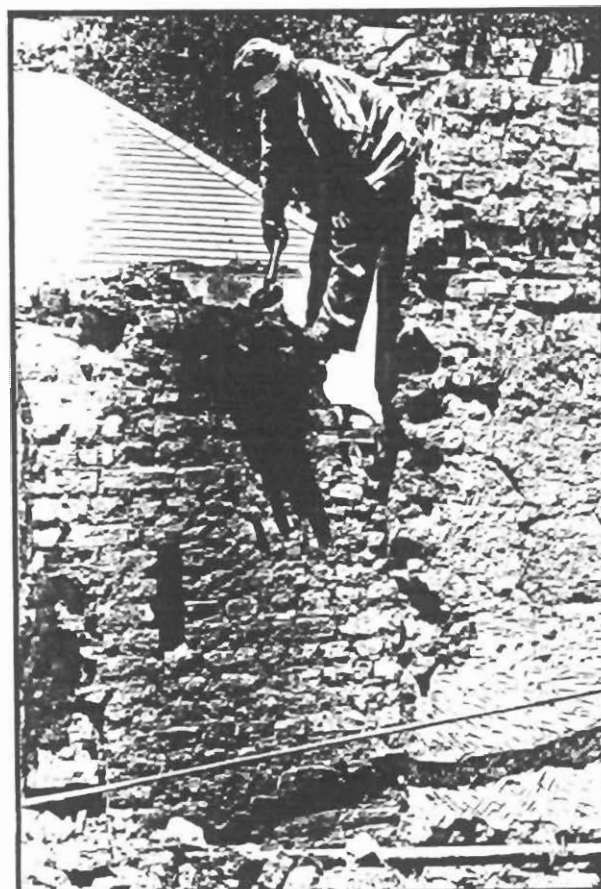
33. Interior of Room F3 (looking S), and its demolition in 1975, next to the c.1735 clayed-up walls (Le Roux 1975).

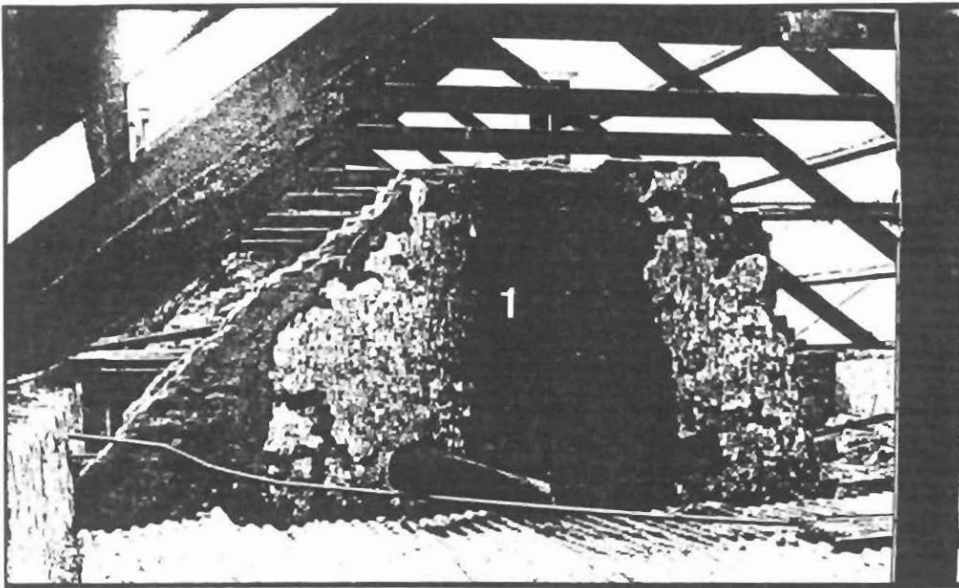
34. Views of the interior wall D2 (Le Roux 1975):

.1 The black soot indicating the old chimneystack on the upper gable.

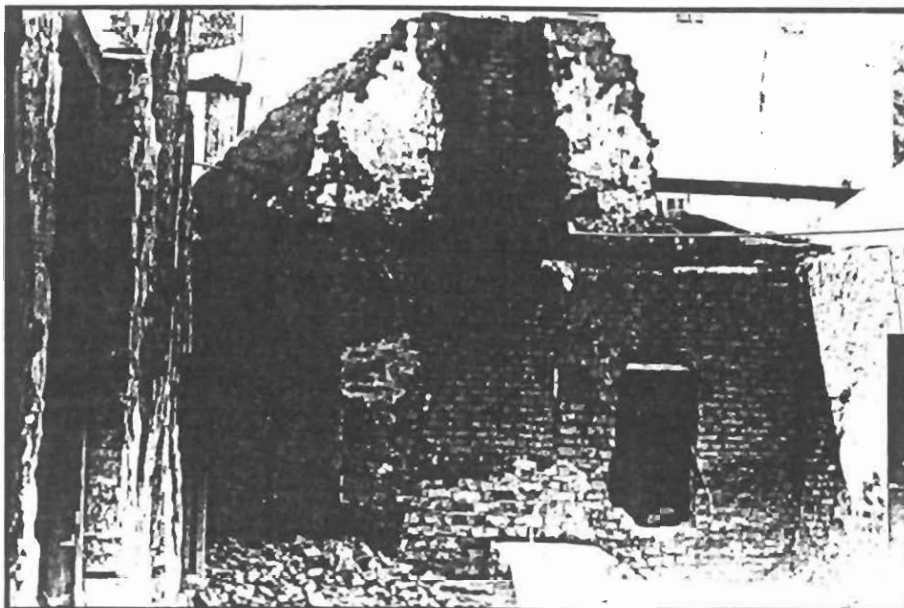
.2 The context of the old gable, with the wall cupboard left, and door on right partially unblocked.

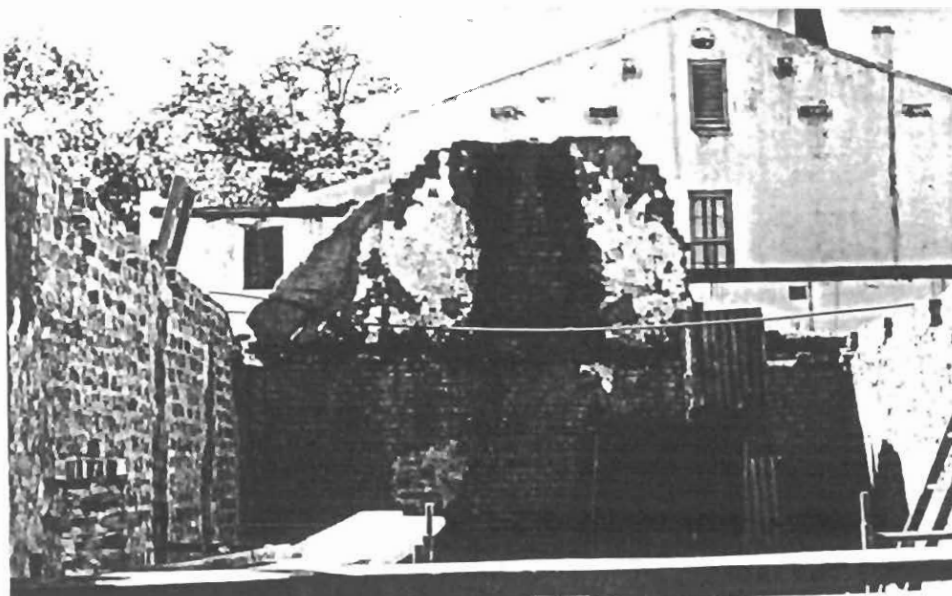
.3 The context of the wall and gable to Berghuis in the background.

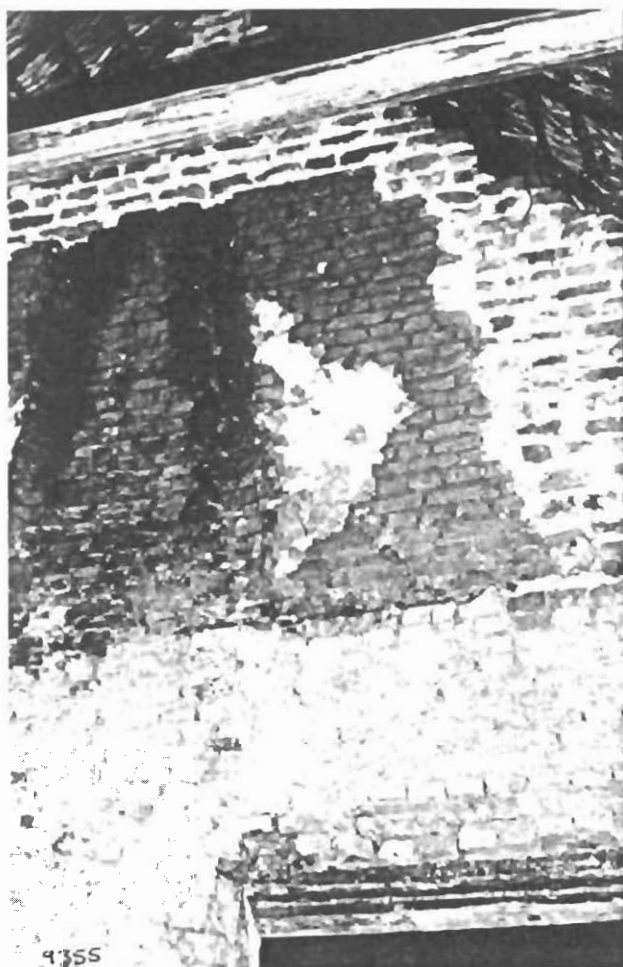
35. Wall D2 showing the difference in clays and raw brick colour of the lower and upper portions, indicating different periods of construction. The old lintels are still in position (Le Roux 1975).

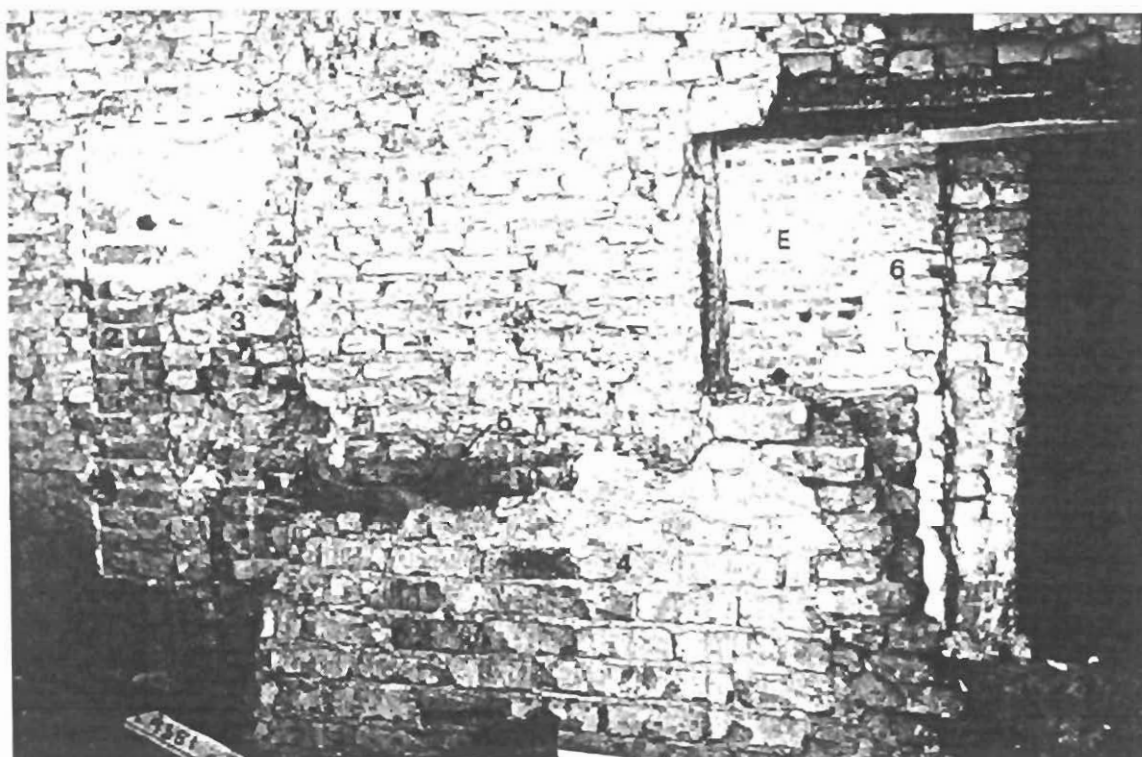
36. The lower portion of D2 shows the yellow, flat raw bricks and mortar of c.1735 (1). Note the cupboard with two periods old brick: raw bricks on the left (2), and later brickwork (3), where the old chimney wall was bonded in (in line with the old stone foundations). The c.1890-1900 brickwork in front (4) represents an attempt to strengthen the old wall where it burnt away (see black soot-5). Beyond the door, we glimpse Room E, the two walls, unit B3 (6) and pantry A1 (7)(see also photo 36.1 and FIG.51).

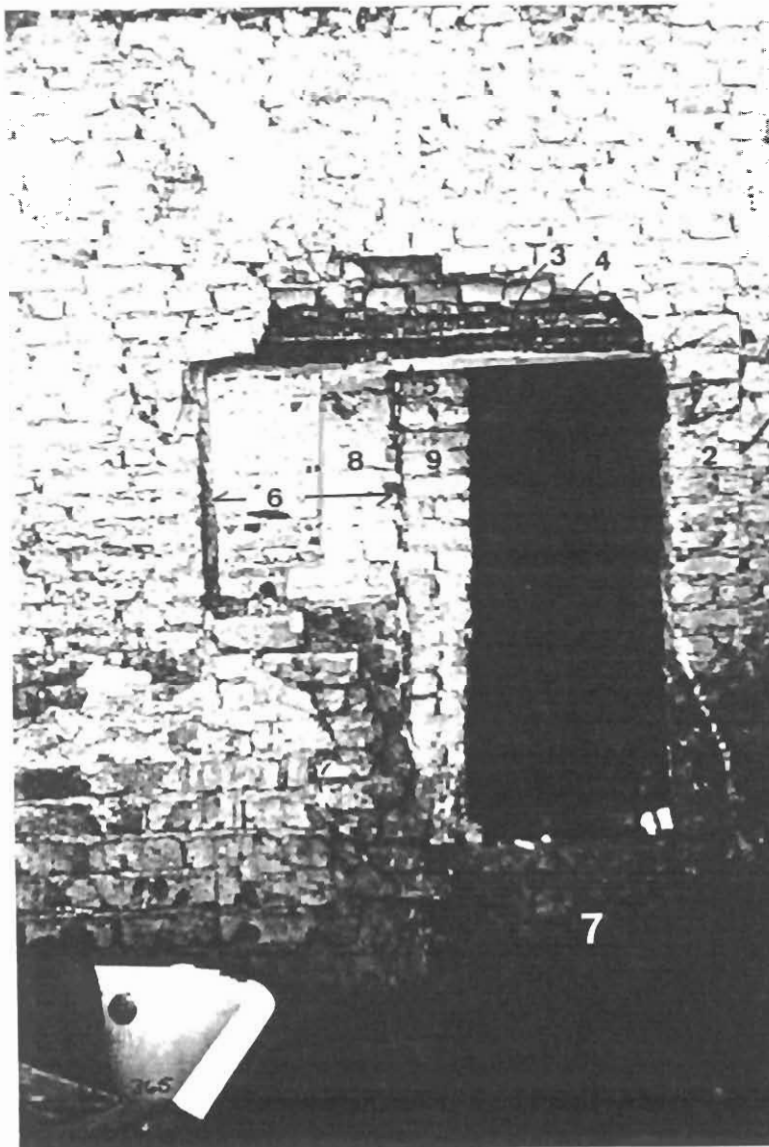
36.1 A similar view of Room D2 as photo 36. Note that the raw brick on either side (1 & 2), line perfectly up at the reveals (c.1735). There are two lintels (3 & 4). The door was diminished (lintel painted white)(5), with a window (6) adjacent to it during the 19<sup>th</sup> century. They were both blocked-up by the late 19<sup>th</sup> century. In Room E, a remnant of the old hearth base in brick and wall above (8), later received an arched doorway (>1900). Wall A1 represents the pantry wall of c.1860 (9). (looking E)(Le Roux 1974).

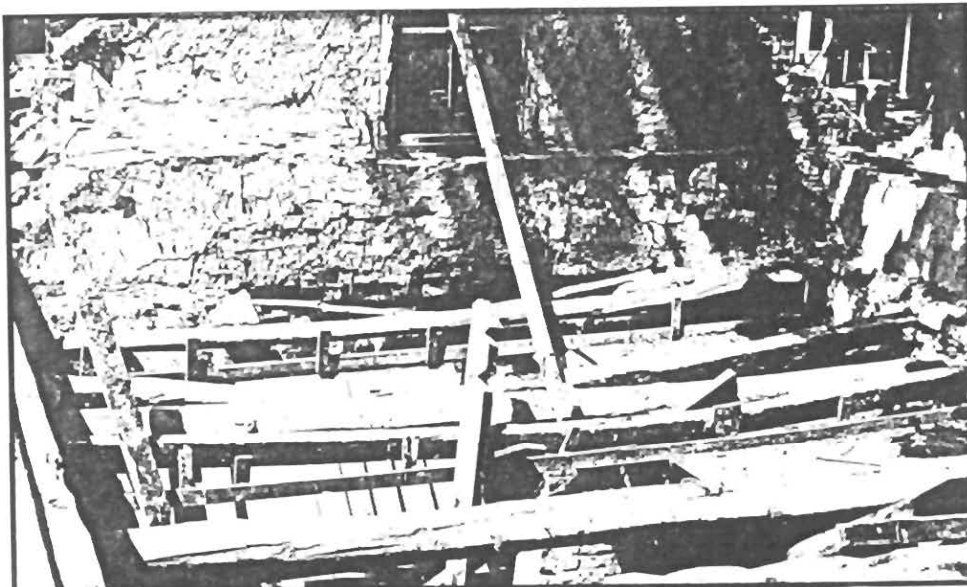
37. A view of the upper loft of Room C, showing the two sets of beams (round poplar & square ones). Both sagged significantly.

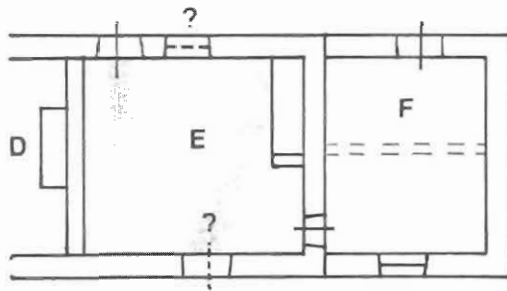
AREAS WORN THINLY

FIG.25 Site plan of Room E, showing the extent of the orange brick floor of about 1830.

Room E and F continued as a unit, but the floor had to be renewed. The old 18th century clay floor was uneven, much worn and patched. To remedy this, a layer of brown soil and brick rubble was applied to produce a level base layer. Some areas near door E3 were so worn that 5 cm raw brick halves were specifically laid to fill in the depression. In this fill artefacts of the early 19th century occurred, in particular English Staffordshire fine earthenwares, which dated this floor. Over the fill a thin layer of yellowish clays was smeared upon which a layer of soft-fired brick was laid. Originally these bricks may have been thinly lime-washed (FIG.25).

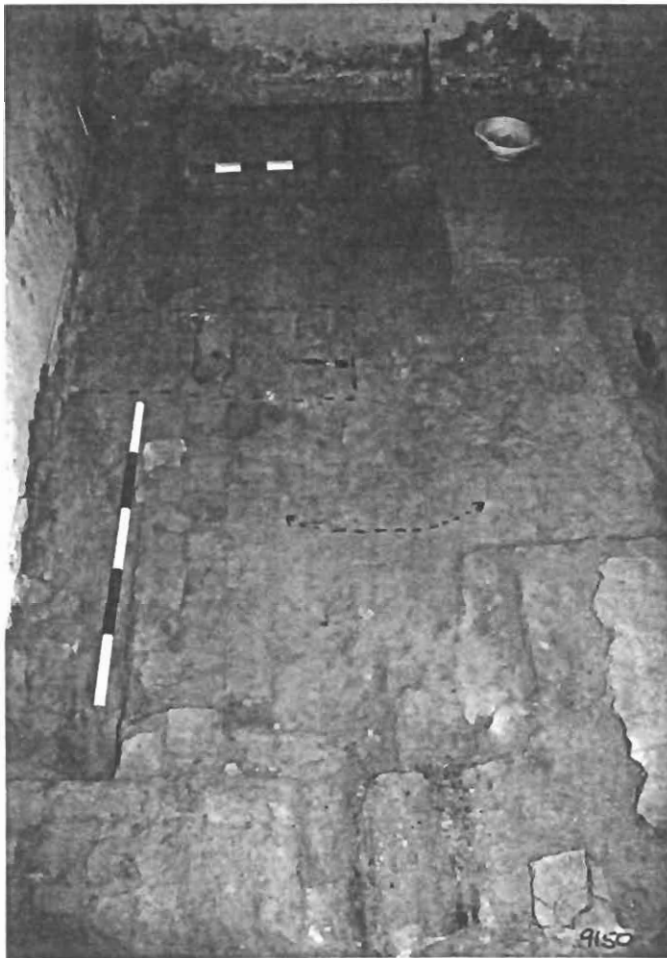
38. View of Room E, unit B, looking N (scales 50cm & 1m). Note how the orange brick floor (c.1830) stretches against wall B4. The 1m scale lies in a shallow furrow dug for the joist of c.1870. See also the worn depression immediately in front of the hearth.

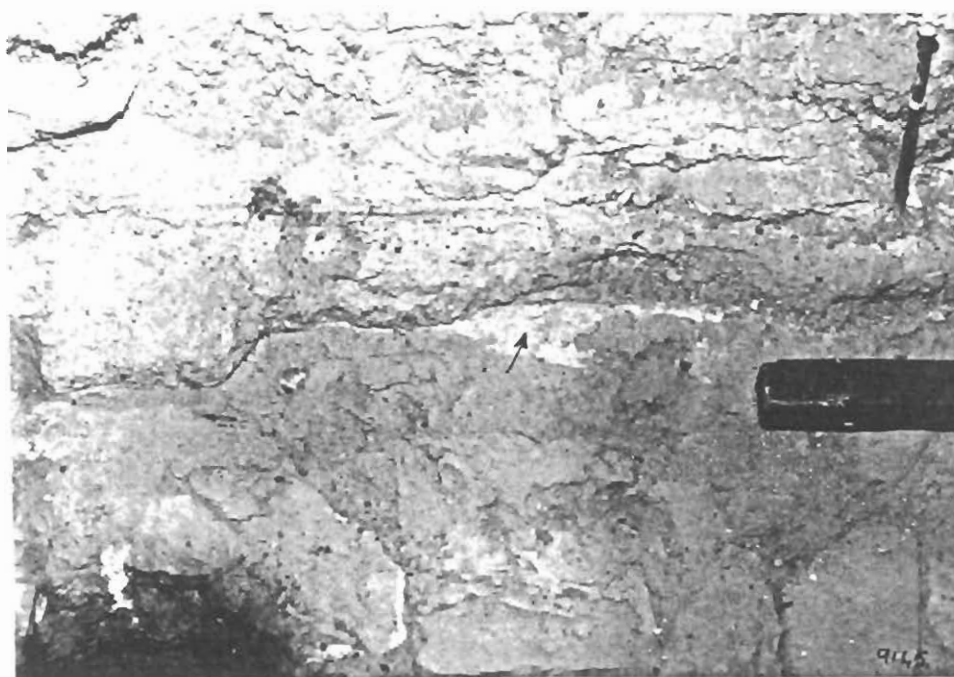
39. In Room E, against wall B4 (unit B), underneath the yellow clay, remnants of limewash may indicate that the orange brick floor was once limewashed. The one post-hole is partially visible on the left.
