# SCHREUDERHUIS, STELLENBOSCH

AN OVERVIEW OF ITS EVOLUTION,  
HISTORY AND ARCHAEOLOGY  
WITH PARTICULAR EMPHASIS ON  
A KITCHEN, ROOM E  
NOVEMBER 2001

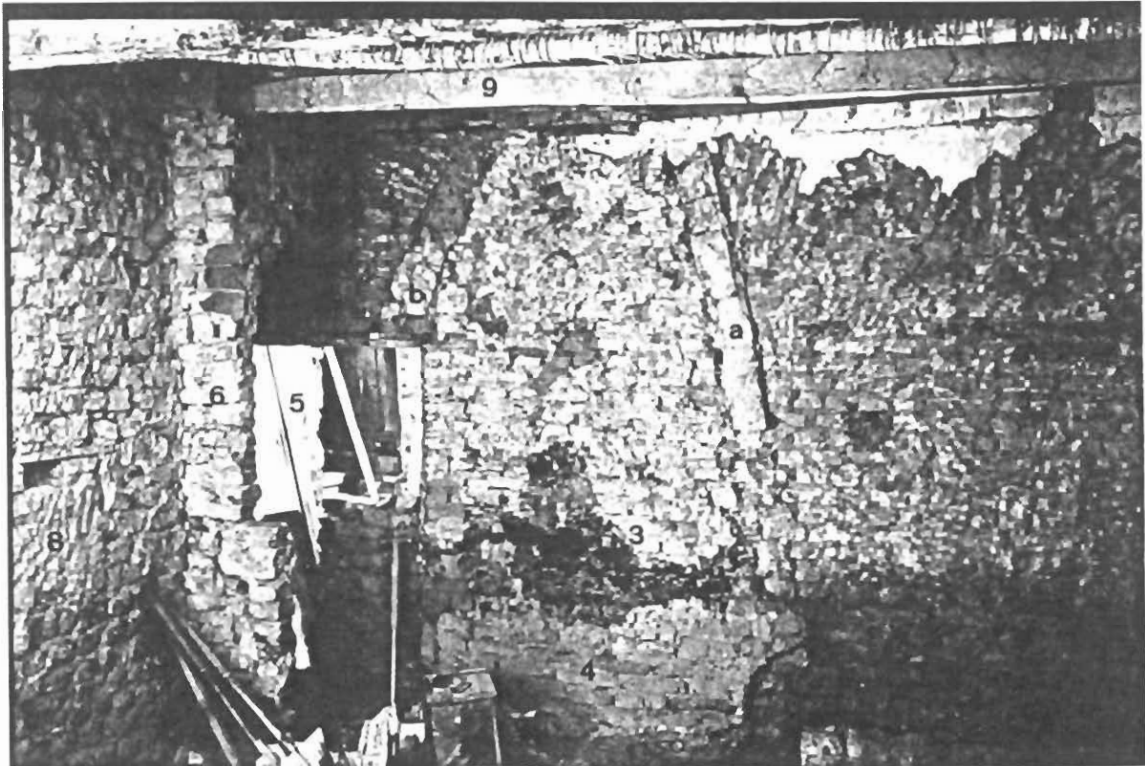
40. View of the hearth IIA period, detailing later alterations (Le Roux 1975).
- .1 Wall B4 of flat raw bricks c.1740.
  - .2 Hood lines a and b of the hearth IIA (c.1835), blocked-up with rawbricks when the hearth was demolished.
  - .3 Black soot indicating the height of the raised hearth, with late 19<sup>th</sup> century brickwork (4) below it.
  - .5 Blocked-up doorway (c.1735) partially reopened in 1975.
  - .6 Old hearth sidewall b (c.1835)(altered?), with a doorway cut into it (>1900?) to access the c.1870 pantry, unit A.
  - .7 Wall B3 was part of the c.1870 walls and had a niche (8) built (or cut) into it, blocked-up with 19<sup>th</sup> century reused brick.
  - .9 The old ceiling is partially visible (see later).

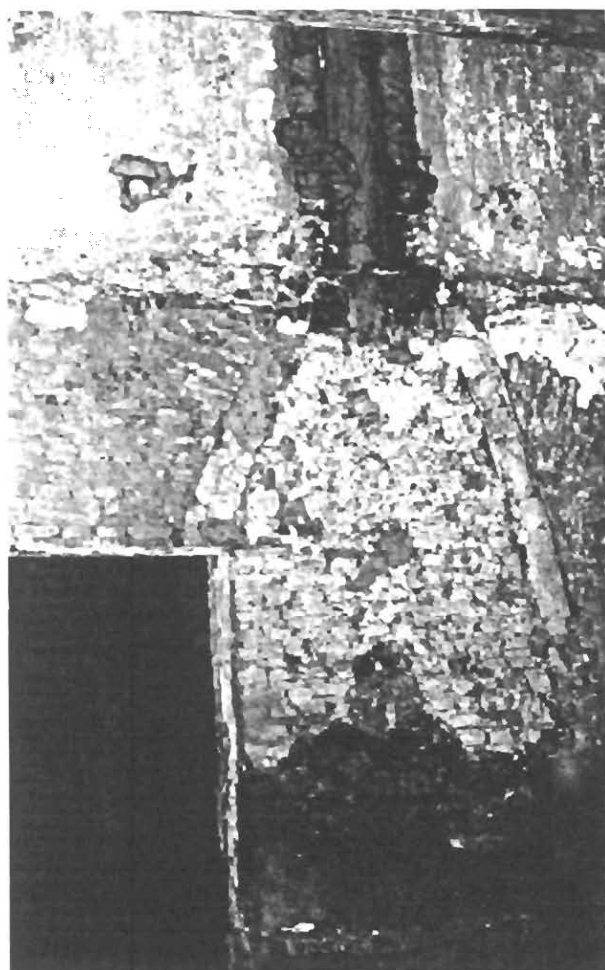
41. This view of E4 is after the removal of the 19<sup>th</sup> century walls, added brickwork and chimney (1835)(Le Roux 1975). The brickwork around the doorway (c.1735) appears to be original.

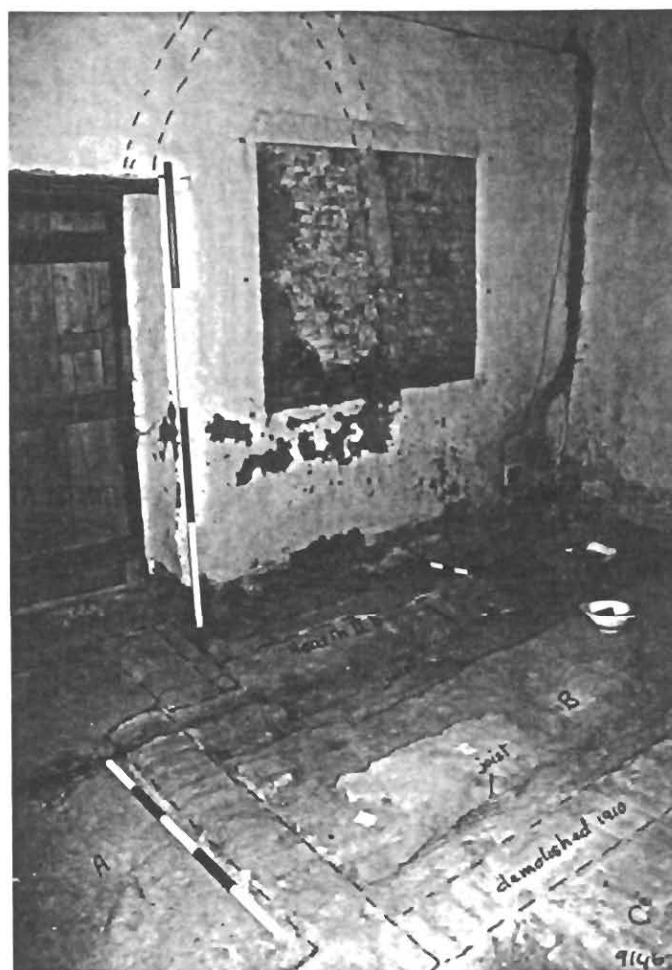
42. View of the excavations (scales 50cm, 1m, 2m), reconstructing the c.1835 hearth wall B3 with its plinth platform, and the 1870 pantry walls (A1, A2) as found in 1975.

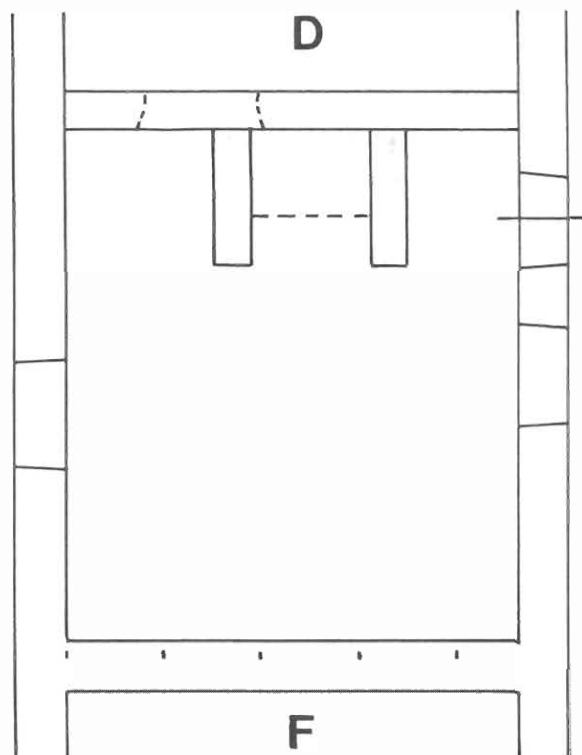
FIG.26 Site plan of Room E, with the newly installed hearth IIA, after about 1830.

In the early 1830s kitchen E was altered. For some reason the old hearth I (E2) was moved to the position of **hearth II** against the opposite wall E4 (FIG.26). Was the old hearth too dilapidated or impractical?

The new kitchen hearth underwent a few transformations (IIA, IIB with two phases). Initially **hearth IIA** was of substantial proportions (**FIG.26**). In the middle of wall E4 two parallel foundations of river stone were constructed at a depth of respectively 20 and 30 cm below the earlier brick floor. The sidewalls (a & b) ended in a chimney stack that was still present in 1974. The hearth surface may have been low, for ash and charcoal were concentrated against the footing of the hearth wall b.

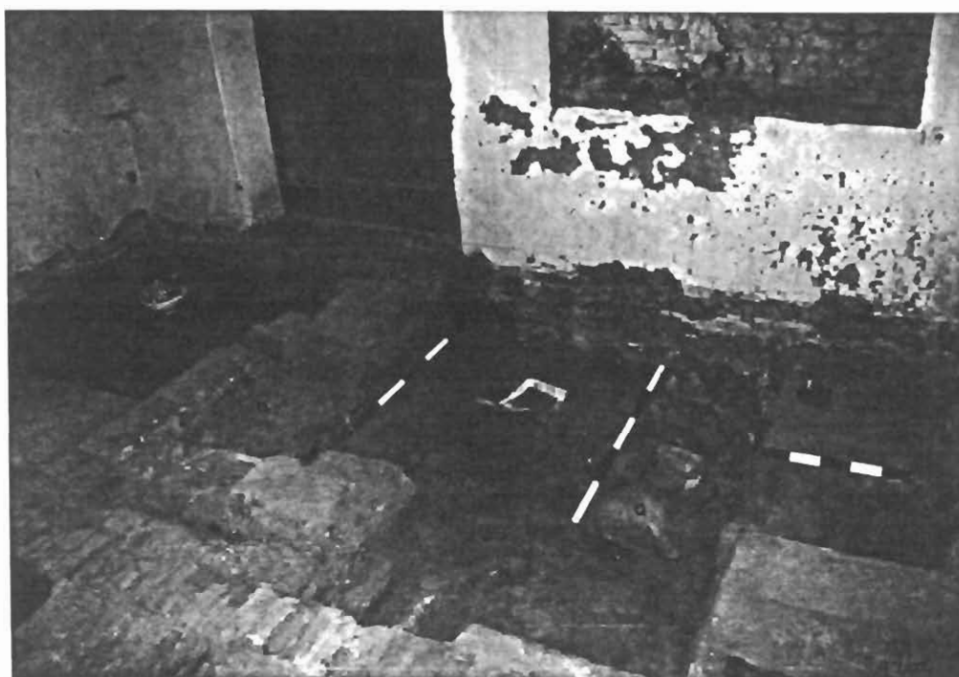
43. Lower layers in units A & B and exposing the twin stone foundations of hearth IIA. The grey clay floor in-between dates from the 18<sup>th</sup> century (>1735) (scales 1m, 50 cm) (looking E).

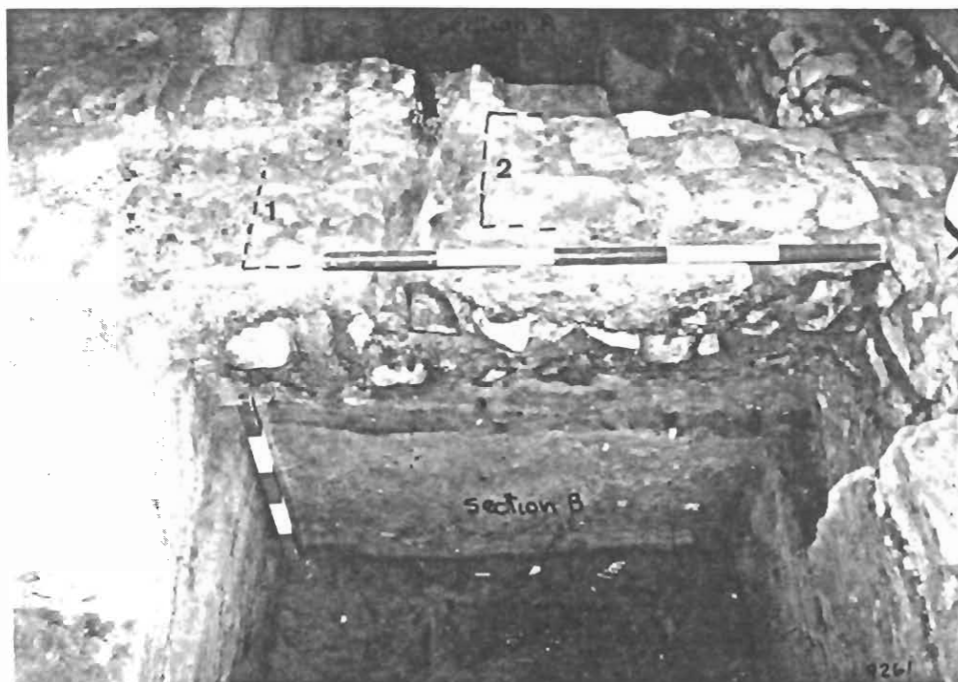
44. This view is of B3, unit B (looking S)(scales 50cm, 1m). It shows the hearth IIAb foundation stones (loosely packed) with some original brick still intact up for its original length (1). In 1975 the brick wall (of 1975) only continued to 2.

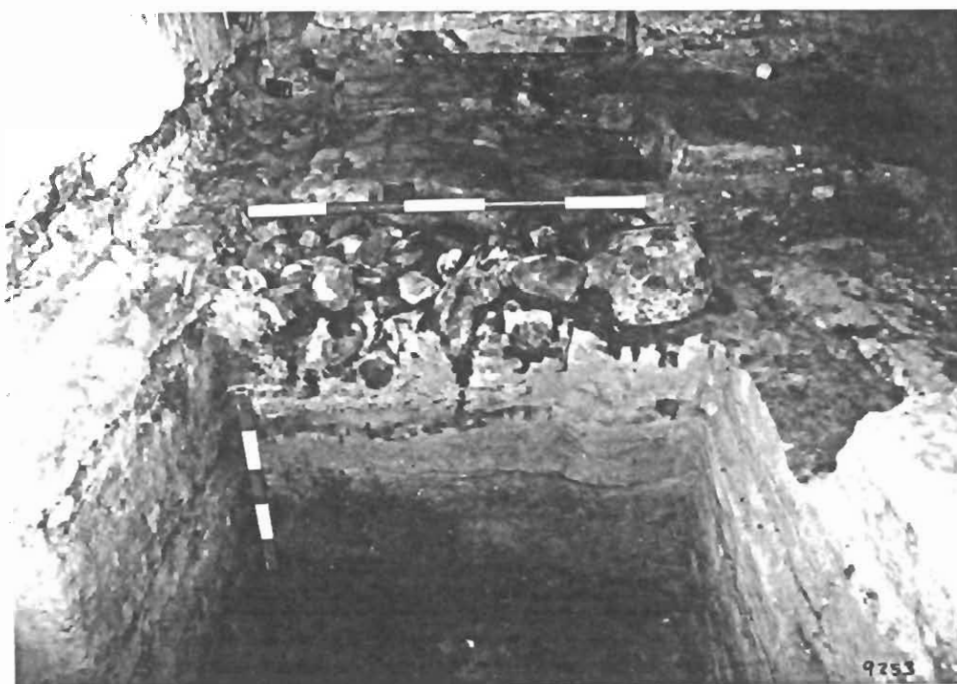
45. Still in unit B, section B, looking N. The riverstones and some odd granite was rather loosely dug into the old 18<sup>th</sup> century layers as a foundation for hearth IIAa wall.

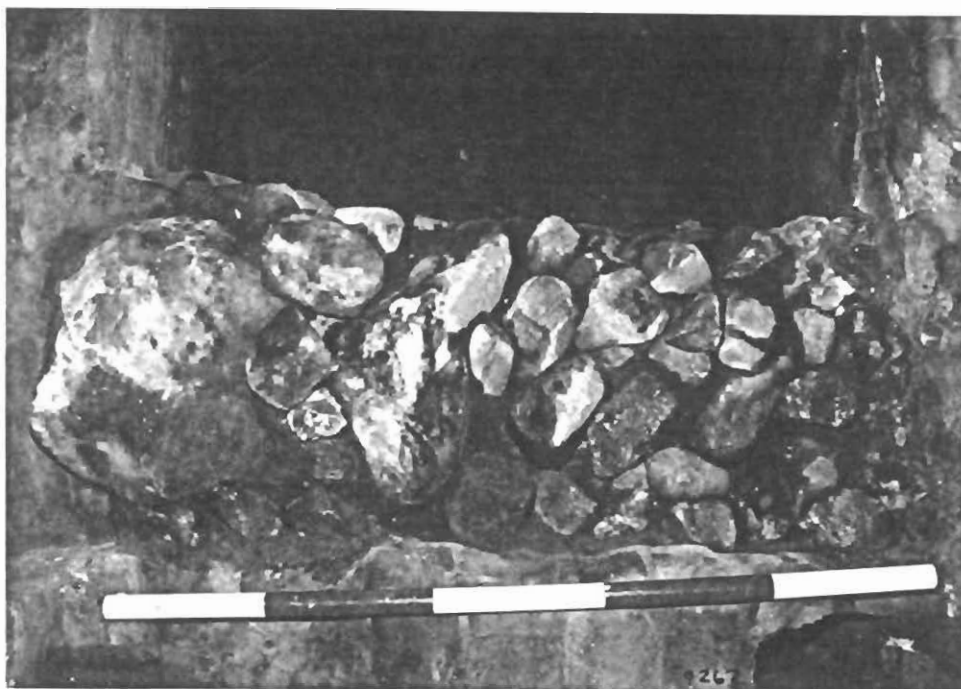
46. A close-up of the hearth IIAa stone foundation (scale 1m).

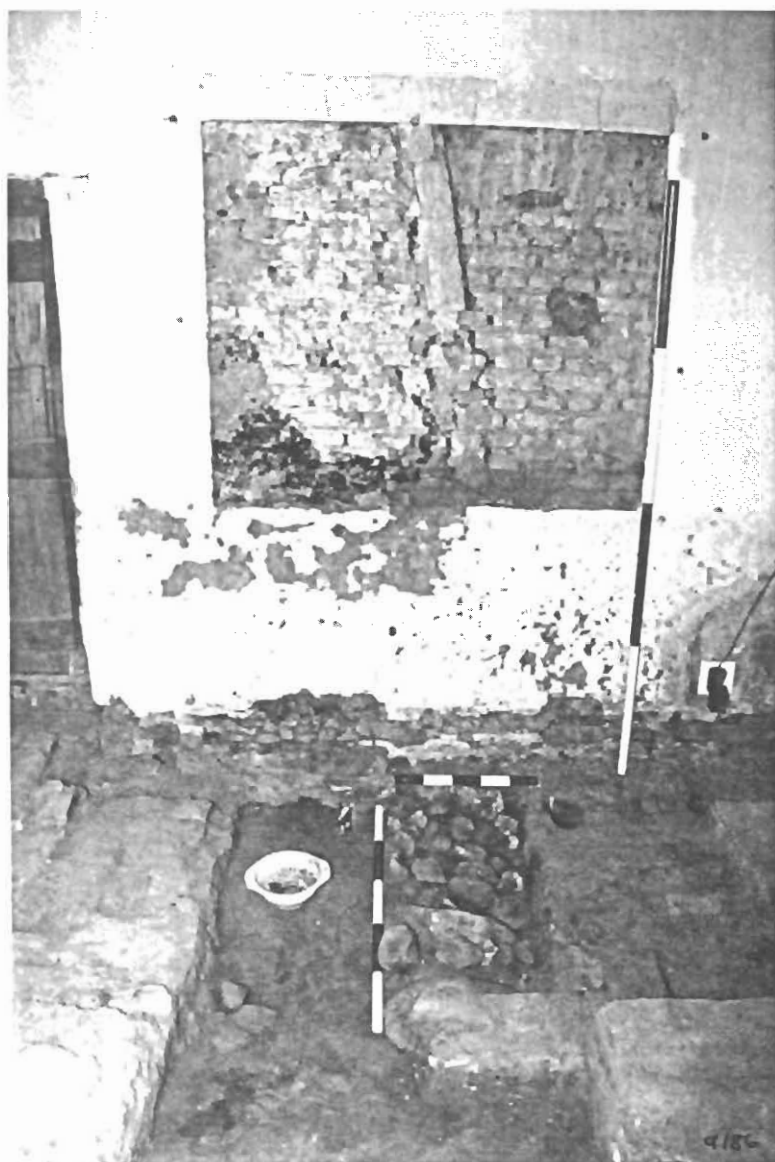
47. Note how the hearth IIAa foundation is situated directly in line below the chimney hood line (scales 50cm, 1m, 2m).

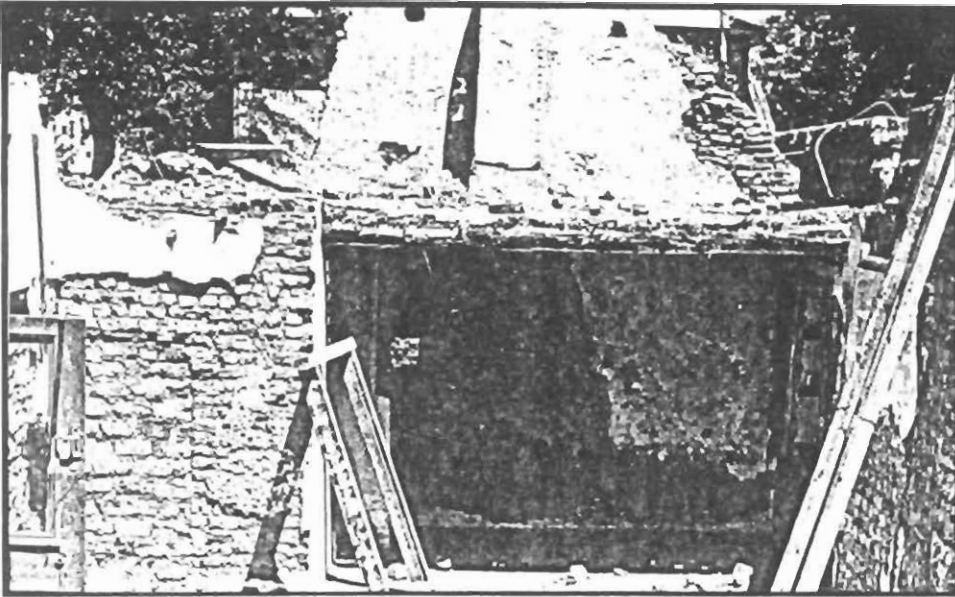
48. View in Room E, units A and B, looking west (Le Roux 1975). In unit A, the old 1870 door has been blocked-up (c.1910)(1), the ceiling beams are partially intact (2), including the upper chimney in the loft (3)(Le Roux 1975).

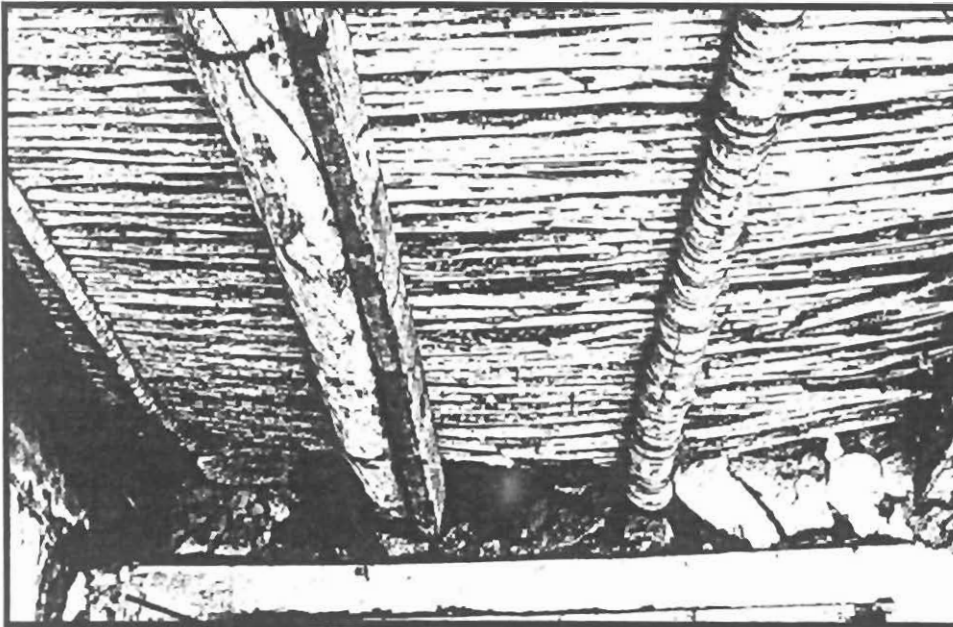
49. Close-up of the ceiling with its reed loft, bamboo and poplar beams. Rectangular beams (20<sup>th</sup> century) were inserted to support the sagging ceiling (looking N, to wall B1)(Le Roux 1975).

An old, quite low ceiling was possibly fitted then (if not earlier). It consisted of a variety of crude beams (poplar and a square beam), with thin poplar or thick bamboo in between, and other *loopriete*. A ceiling of reeds (white-washed) was lashed on top, with a layer of clay as a *brandsolder*, which probably covered the whole ceiling of the kitchen E at a certain stage.

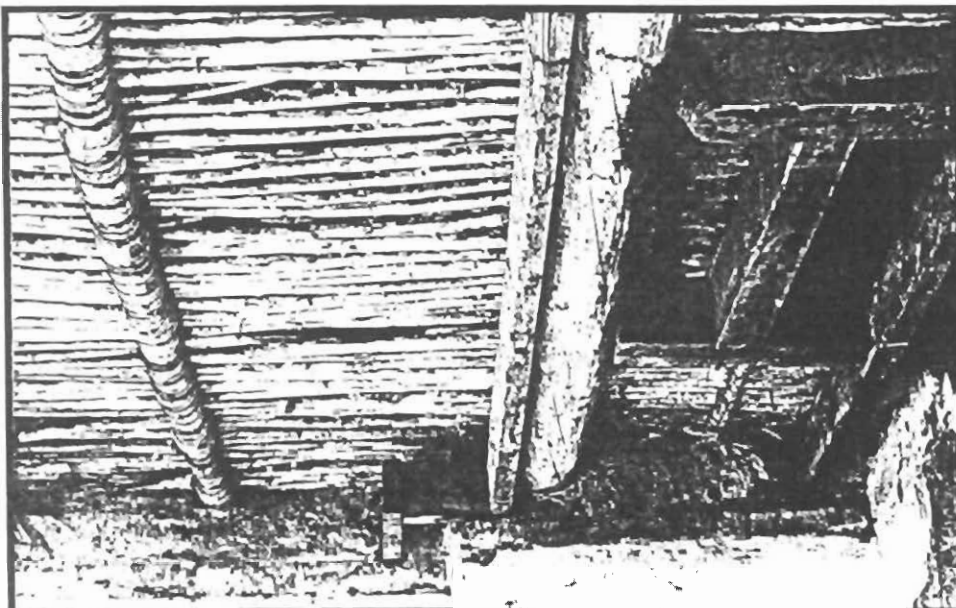
50. Same ceiling, looking S, to wall B3. The wooden section on the right was where the old chimney (c.1835) would have been (Le Roux 1975).

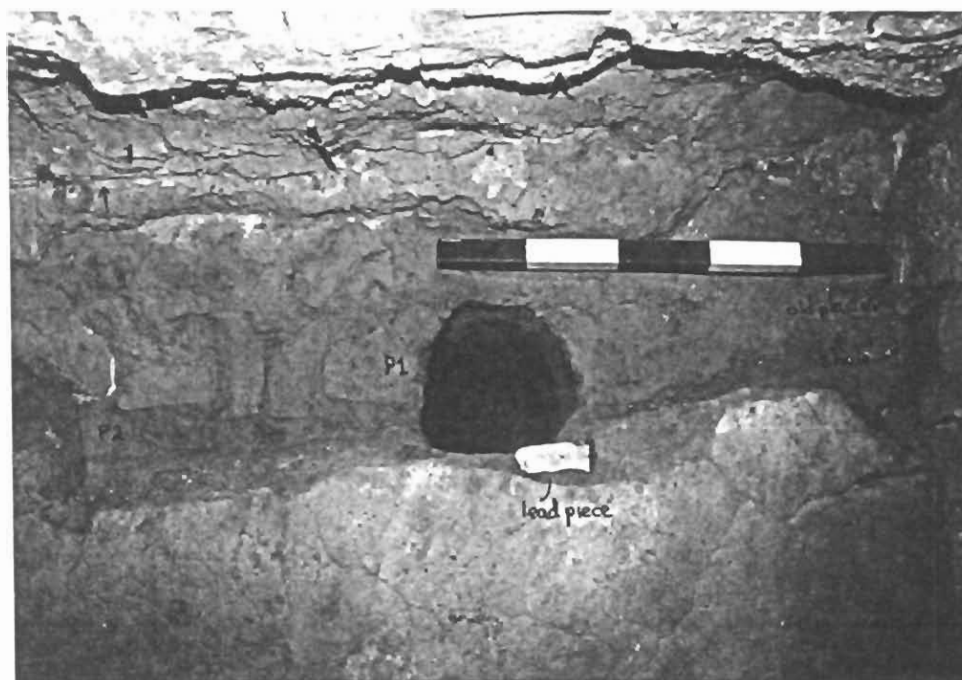
51. View from above of section B4/1, where the postholes (P1 & P2, unexcavated) were discovered within the orange brickwork (layer 9.2) of c.1830. The posthole P2 is still unexcavated. Note the flat, sharp lines in the plaster (1), above the yellow clays, which could indicate the side impressions of a tiled floor.

Just north of hearth IIA were two similar oval holes (section B4, corner), dating to sometime after the brick floor. The two holes are possibly post-holes for scaffolding, and both may have been dug at the same time. They were filled with grey brown soil, bits and pieces of orange brick and plaster, but no artefacts were present.

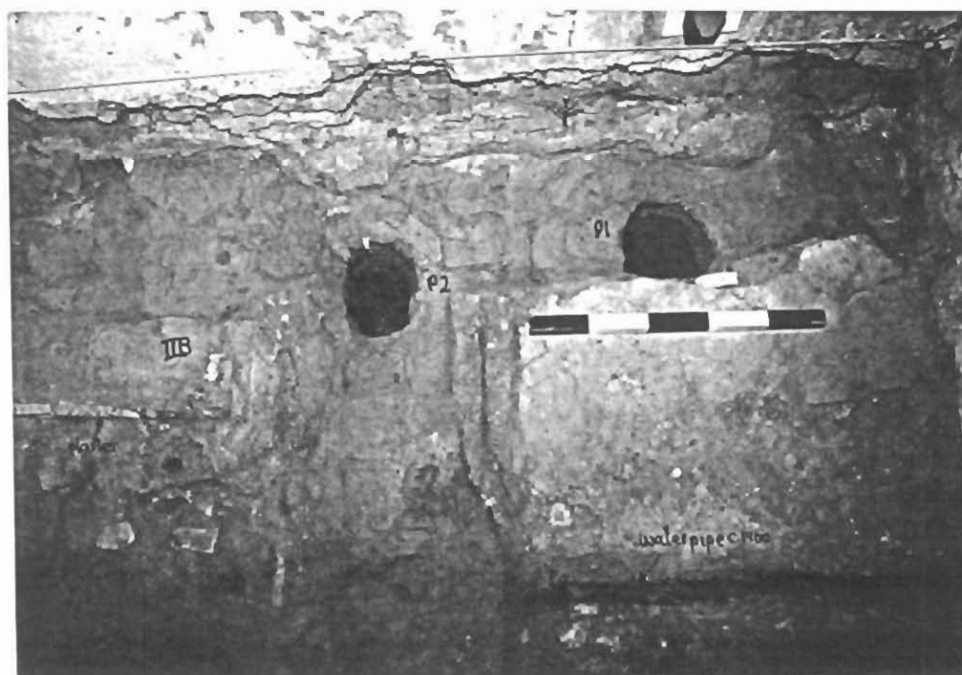
52. Same view of the post-holes (probably dug for scaffolding posts), both post-dating 1840. A piece lead lie above P1 in an upper layer. Hearth IIB is visible on the left.

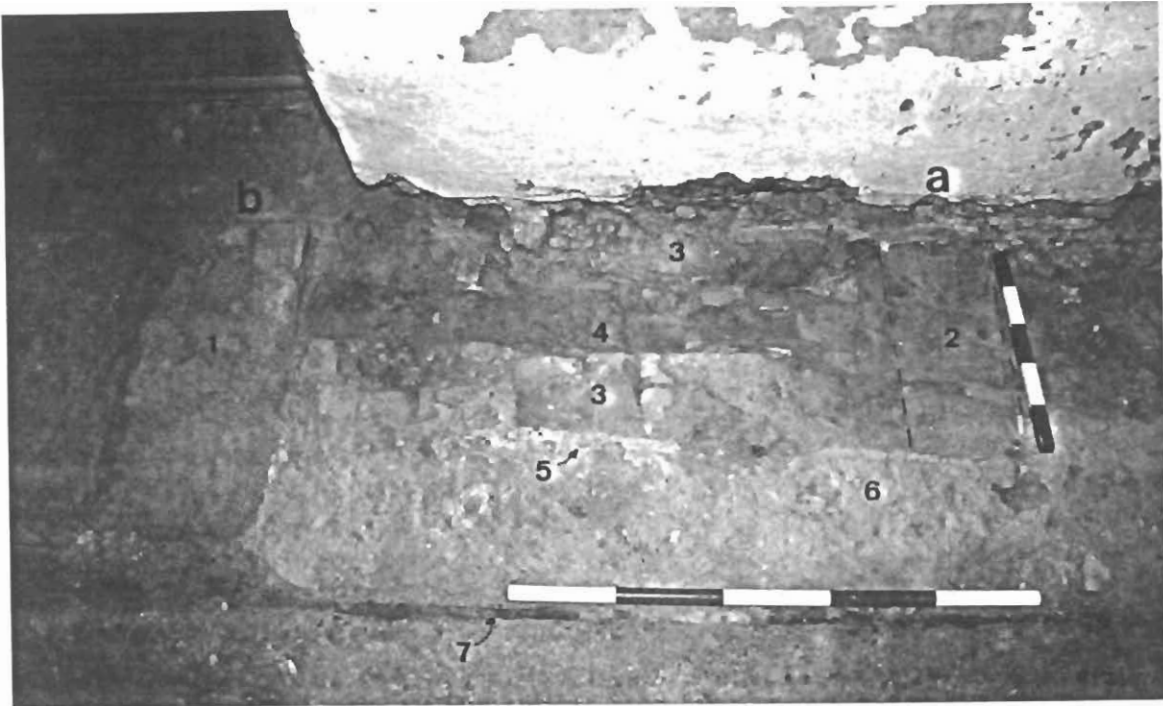
53. View towards unit B4 (looking E), where the later hearth IIB (>1845) was installed on a slightly higher level. It reused the sidewall IIAb (left)(1) and apparently rebuilt sidewall IIAa (right)(2) in yellow brick (samples still *in situ*). The space between these two sidewalls was resurfaced in raw brick halves (c.1740)(3). The lower orange brickfloor (4) is exposed because of the joist furrow (1870), which cut through the raw brick. On the front of the raw brick two old plaster lines are visible (5), with signs of a low incline, once provided with tiles (6). The iron (water?) pipe (7) ran the length of the room and dates to about 1900.

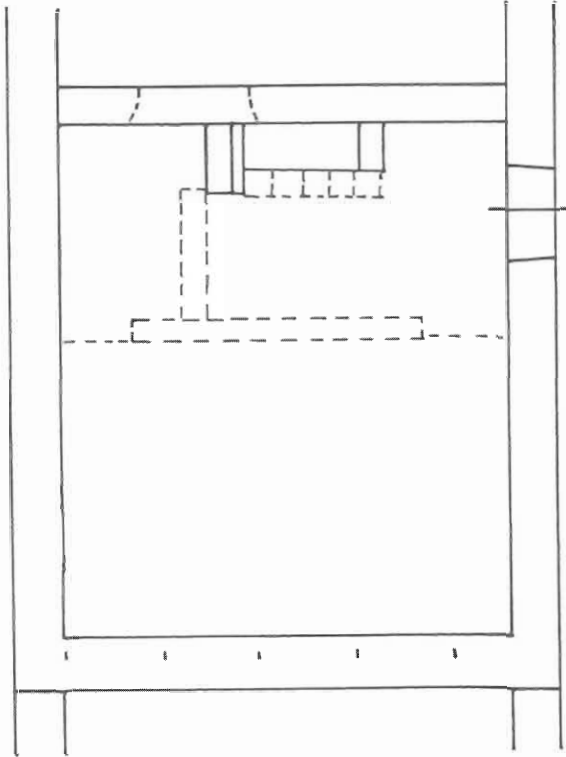
FIG.27.3 A reconstruction of what hearth IIB phase 2 could have looked like >1860.

There are definite signs that tiles were laid at an oblique angle in front of the hearth IIB phase 2 (FIG.27.3). A few of these broken tile pieces were still present. As the brickwork wore away, floor depressions were filled in with fine orange brickwork and clays. The interior of the hearths was apparently rather low, if not close to floor level. Rodent activity was still a scourge, for in the raised section towards the front of the hearth, a small rathole was filled with long slivers of window glass to discourage their burrowing.

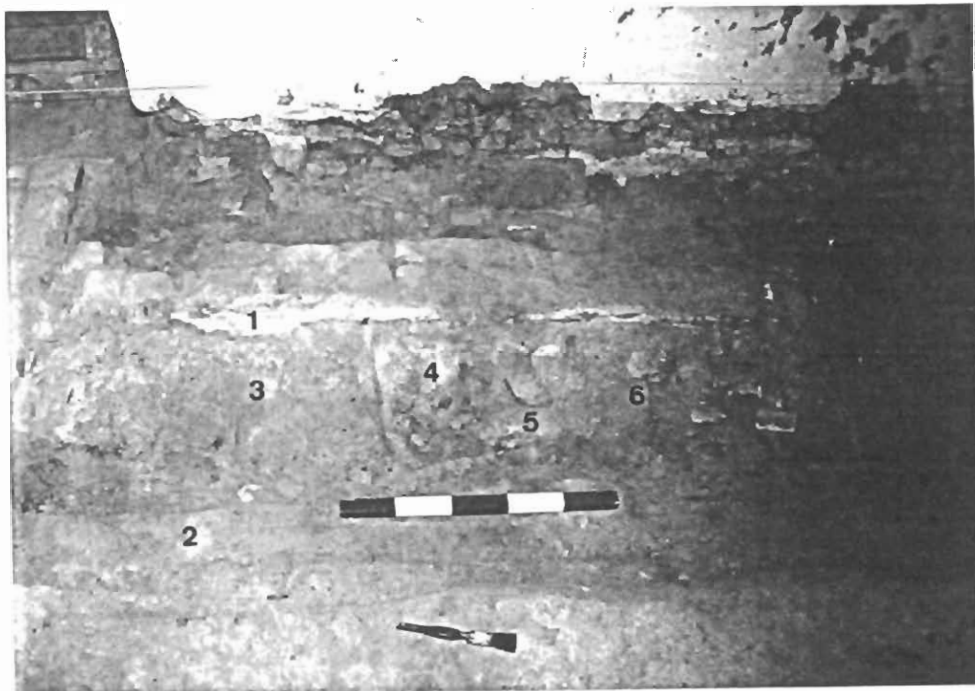
54. Exposure of hearth IIB (>1845) on a more detailed scale. The old plaster lines (1) adhere directly to the raw brick. The floor (orange brickwork and higher)(2) slopes up (3) towards the plaster and the fill (4), which contained samples of broken tiles (5)(some pieces *in situ*?), plaster (6) and yellow clay and rubble (looking W)(scale 50cm).

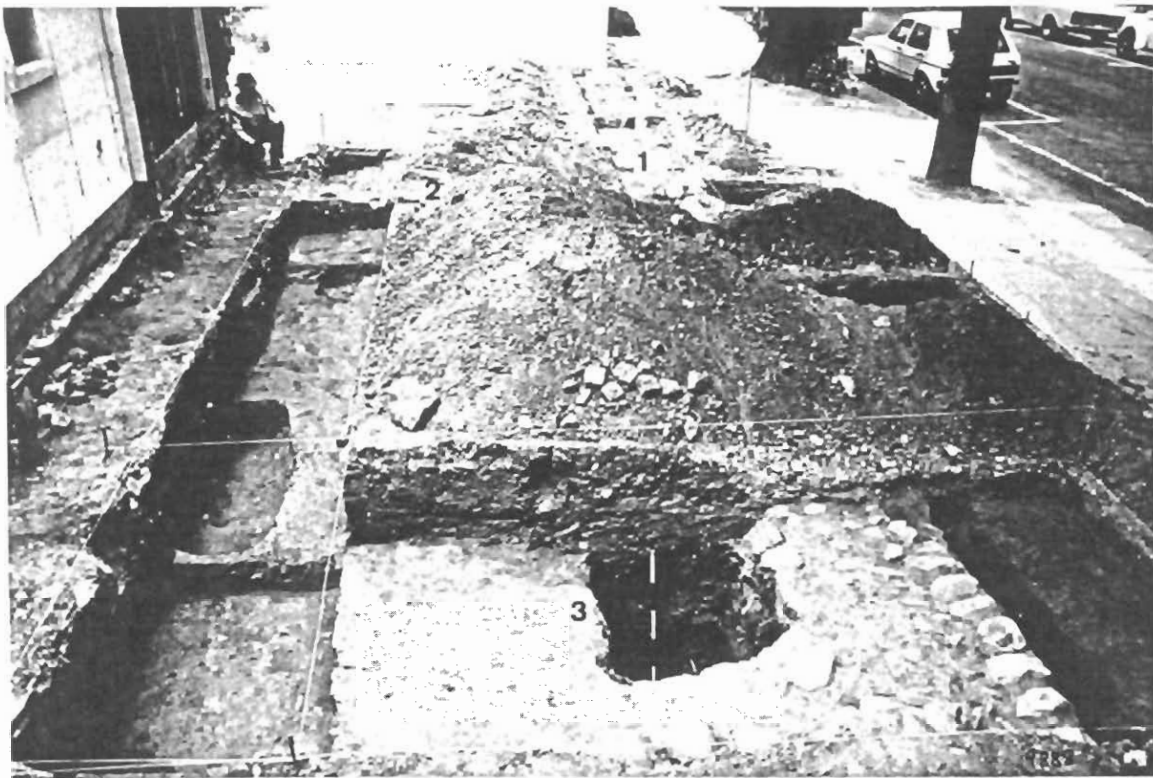
55. Excavations conducted in 1983, in front of Enrico's Restaurant, revealed the foundations of an old boundary wall (1), another perpendicular wall (2), fill and dumps. In the foreground the c.1820-1830 rubbish pit (3) is partially dug, with its remainder still below the mound of soil! (looking S).

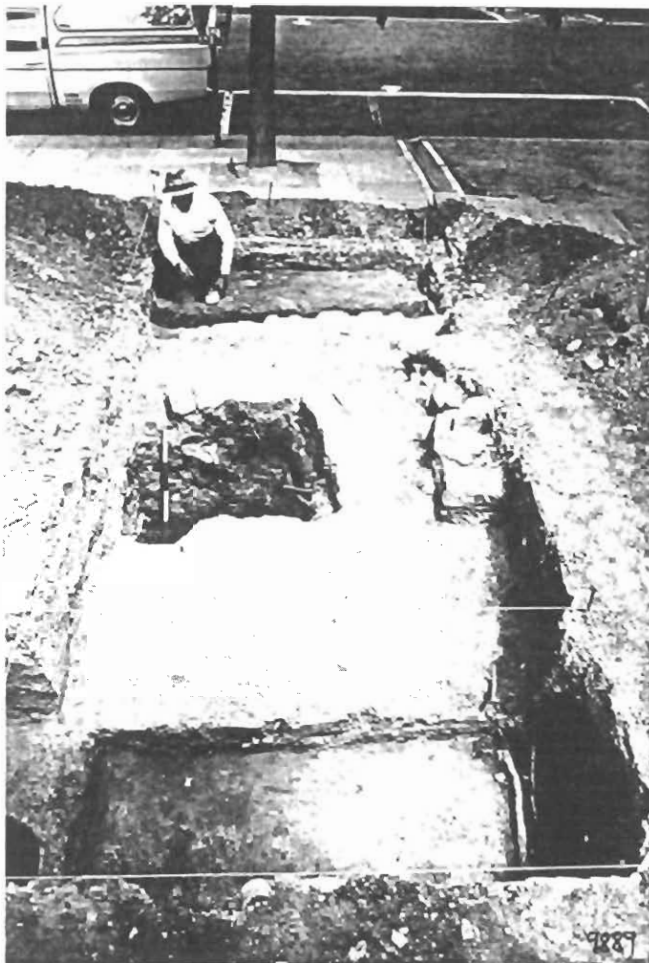
56. Another view of the excavation, showing its location to the proximity of the street. The rubbish pit was about 1.3m deep (looking W).

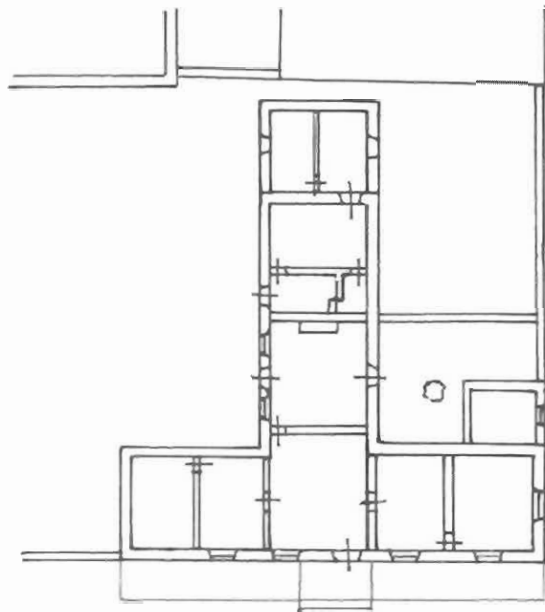
FIG.29 Plan of the tail, showing the extent of the yellow clay floors in Room E (possibly with tiles), Room F (divided in two) and the stone-lined privy in the courtyard. The façade fenestration is based on the SH photographs of the 1890s.

Between about 1860 and 1870, Room E was again altered, this time more drastically. The room was subdivided by means of two walls, incorporating a portion of the wall of the old hearth IIB. All of the units, viz. A, B and C, were then provided with hard yellowish clay floors (FIG.29). There does not appear to be any signs of tiling, although fragments of tiles were found in the filled-in gullies dug for the later joists. A portion of the low ceiling of rough beams (poplar, reused yellowwood and bamboo) and reed, with its clay fireproof ceiling, was incorporated within unit B and possibly in unit A (uncertain). Was a hearth still in operation? In the backyard a cesspit/privy was built in a circular fashion with river stones. Rubbish was later deposited in it, including iron, brass and glass (discovered 1975/6). It still awaits a full excavation.

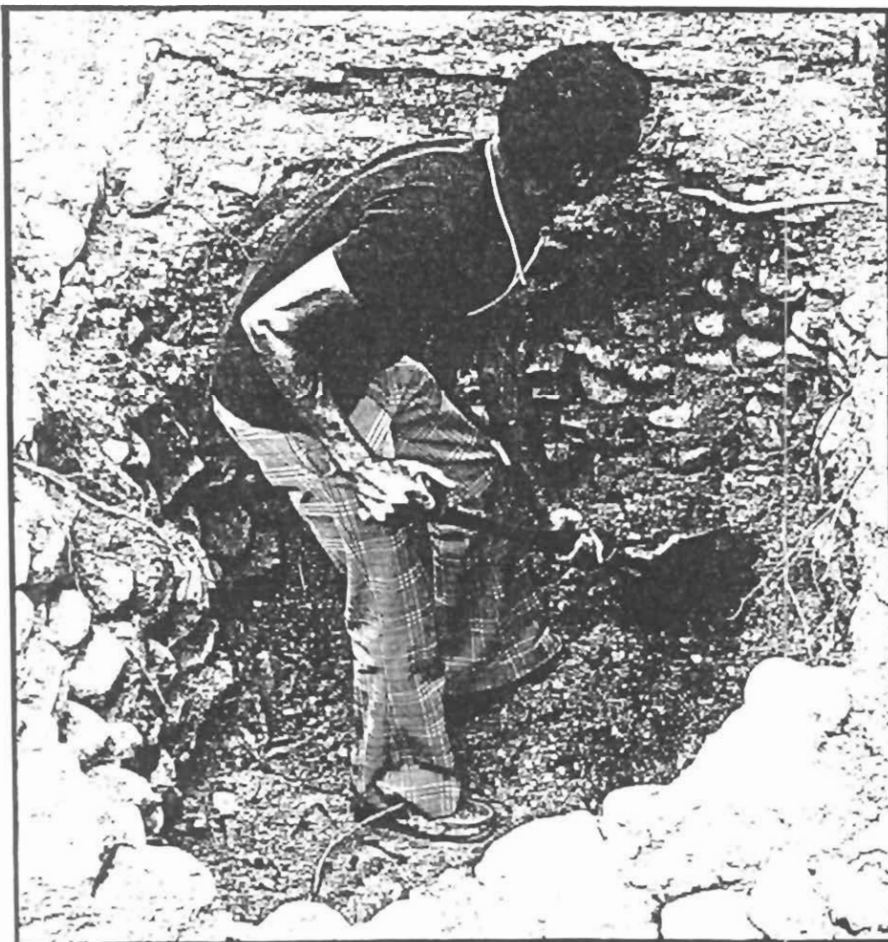
57. During April 1975 a rescue excavation was undertaken (with no equipment), of a stone-lined privy of the late 19<sup>th</sup> /early 20<sup>th</sup> century, with Freddie Groenewald excavating the fill. The cesspit was accidentally discovered in 1975, when a water tap was re-located and a rescue excavation of the upper portion followed. It was refilled with clean sand and awaits a proper excavation (photo by Studio 7).

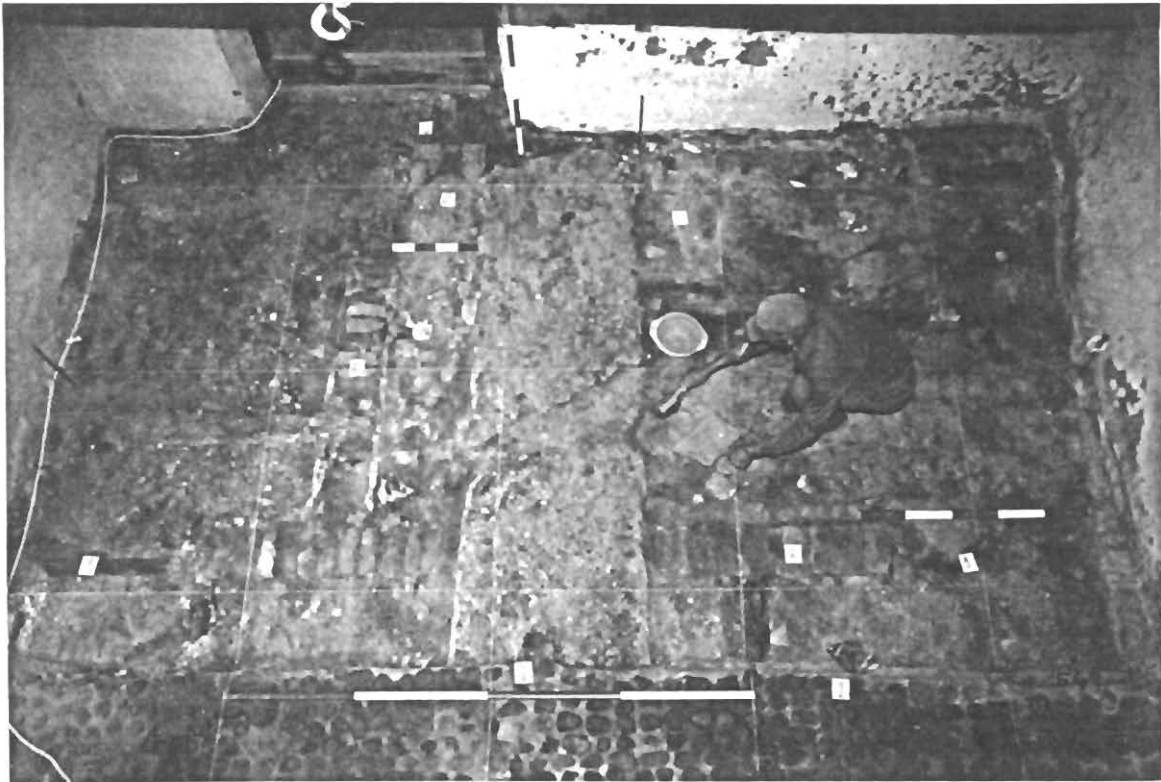
58.1 During August 1988, the upper surfaces of Room E were partially excavated. The central vertical clay layer once covered all of the room. The cobbles (1) were laid in 1975, the brick walls (2) and thresholds (3) date from about 1860. Some of the joists (1870)(4) are also visible (looking W; scales 2m, 50cm).

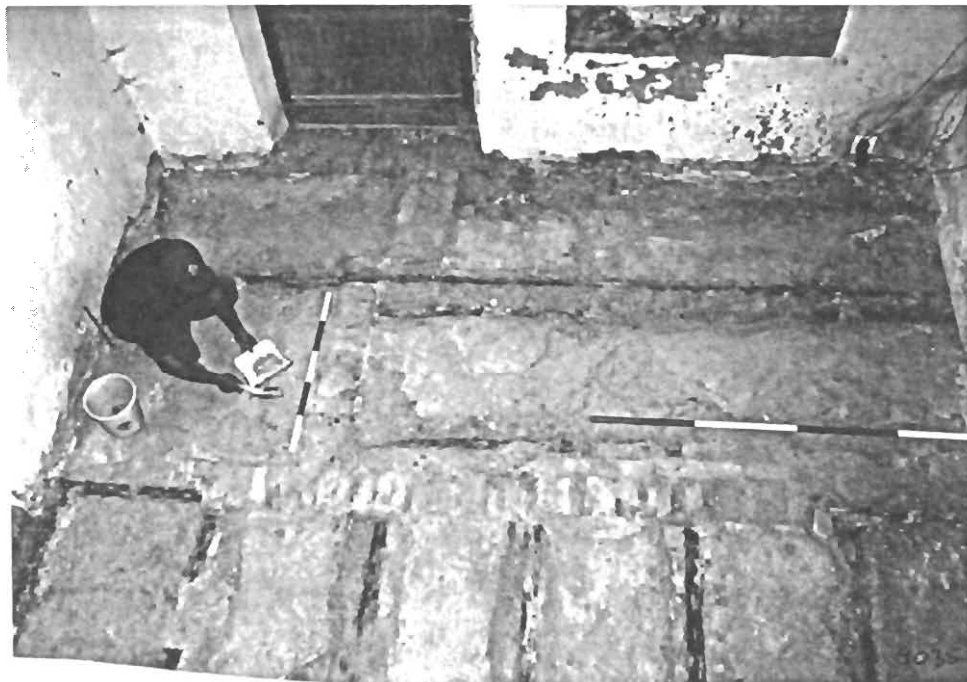
58.2 Same view but more exposed in 2000. The rusty iron water pipe was probably connected to the southern toilet (>1923) (looking W).

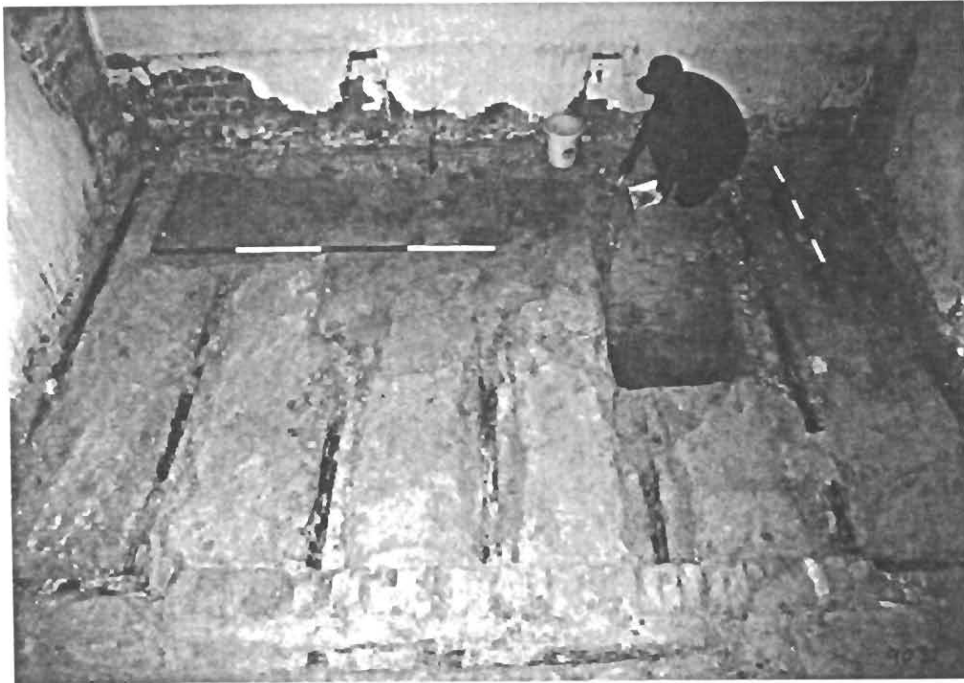
58.3 View of unit C with its joists. Note the extra joist behind the excavator, parallel to the 1m scale. It serves as proof that there was once a doorway here. The 2m scale is in line with the old >1760 hearth wall. The test pit (section C) was dug in 1981 (looking E).

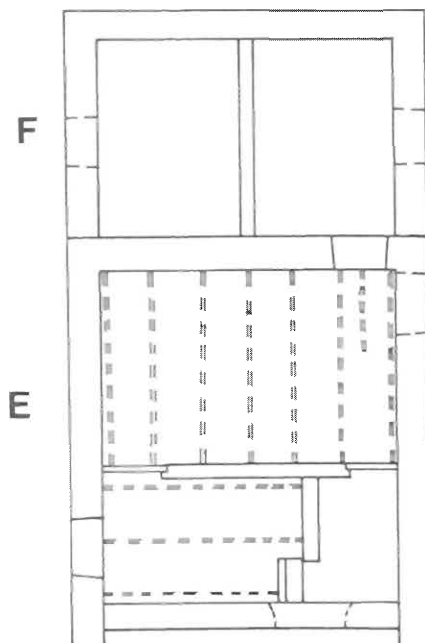
FIG.31 Plan of Room E, detailing the floorboard joists of Room E, for the period after 1870. Room F was already divided by a brick wall, built above the 18<sup>th</sup> century cobbling on a clay floor.

Around 1870 the gravel floors (or tiles) were replaced by floorboards on joists in unit B (3 joists) and unit C (7 joists), which cut widely and deeply into the clay surface. The wooden floor would have come to rest only about a centimetre or two above the yellow clays (FIG.31). All these smaller units indicate greater specialization and probably a larger family. Presumably unit B functioned as a kitchen, probably with a stove. Room F was likely then also divided into two rooms, as the base of a dividing wall was found in 1981.

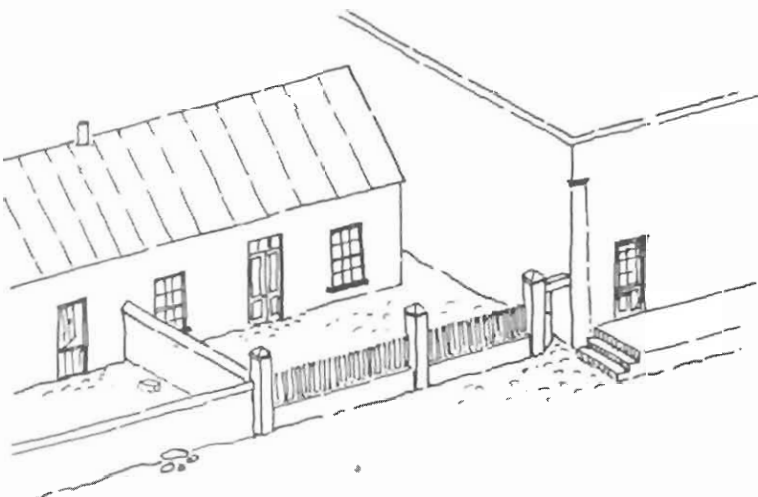
FIG.35 Alterations were made to the tail to transform it into a church hall for the Catholics. It probably looked like this from Church Street. The left window fell into the "vestry" (Vos 2001).

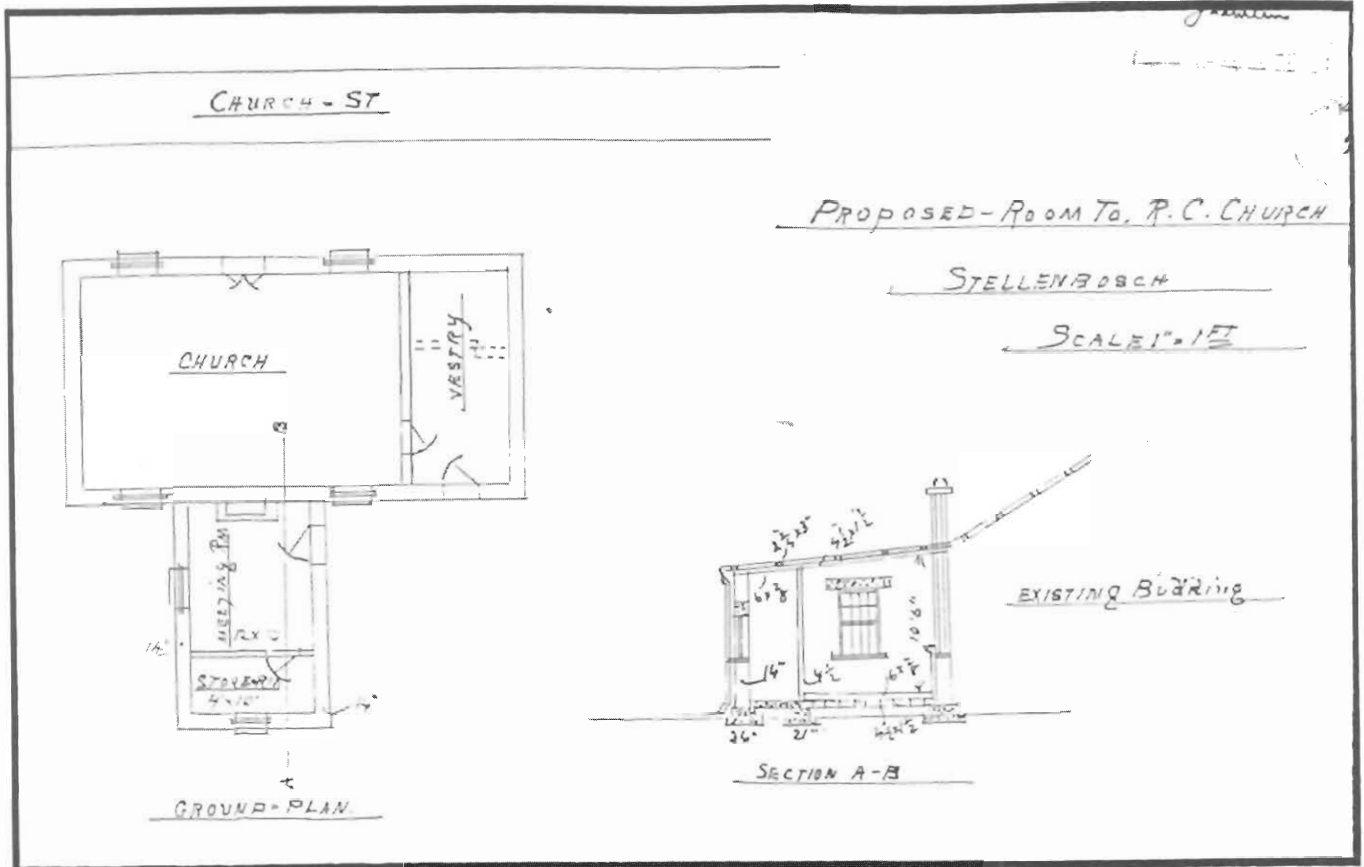
FIG.36 In 1923 a *meeting room* and *store room* as added towards the north. The layout of the church is given, though another 19<sup>th</sup> century wall (my addition), certainly existed in the vestry (SB Municipality). Note the grate and chimney in the meeting room (SB Municipality, plot 1275, no 308, 25.11.1923).

Judging by a rough plan of 1923 (**FIG.36**), major changes had occurred in 1910, including the demolition of the main dividing wall E2/F4, and the blocking up of the door in unit A2 (early 1900 machine-made bricks). In wall A1 (the old hearth IIA wall), an arched doorway was cut through. There may have been a door once (absent in 1972). The priest entered through unit B1 (from outside) into the vestry and the "pulpit" must have been at the western end. The church extended the full length of unit C (Room E) and Room F, and contained four large sash-windows for extra light. A double door served as entrance from Church Street. Further, a *meeting room* with a grate and a small store on the northern side were added (Room H)(**ADD.F**). On the boundary line of an old wall along Church Street, a new entrance was built flush with Berghhuis, together with a low wall topped by a cast-iron railing (**FIG.37, FIG.38**).

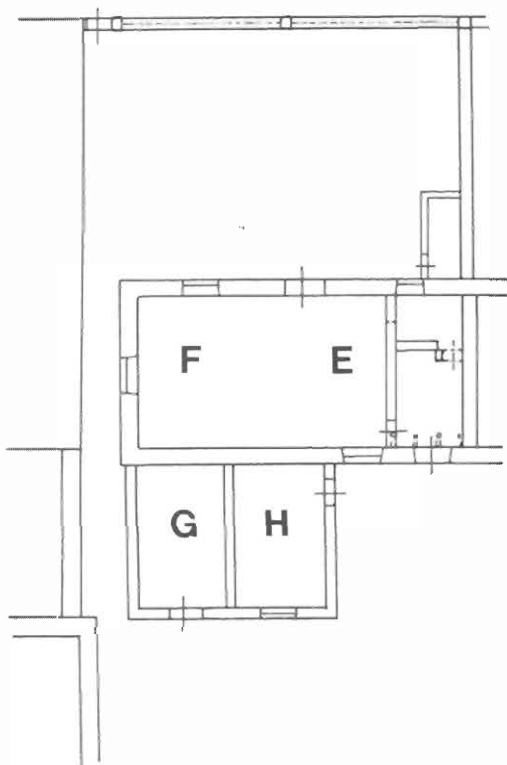
FIG.39 An interpretation of the Schreuderhuis tail and church of about 1925-30, with the addition of Room G; the latter and Room H now turned into living quarters.

In c.1927 the small flat-roofed, northern structure H was incorporated into the enlarged lean-to G H (**FIG.39**). The toilet (I) may then have been erected, as this was the time when a new drainage system was installed in Stellenbosch. Note that on a plan of 1927, the church was called St Josephs (**FIG.40**). The congregation must have outgrown the premises and in 1932 the RCC acquired the Kromme Rivier farm complex, where a church was established in the building dated 1771 (Smuts 1979:271; Vos & Boshoff 1989c).

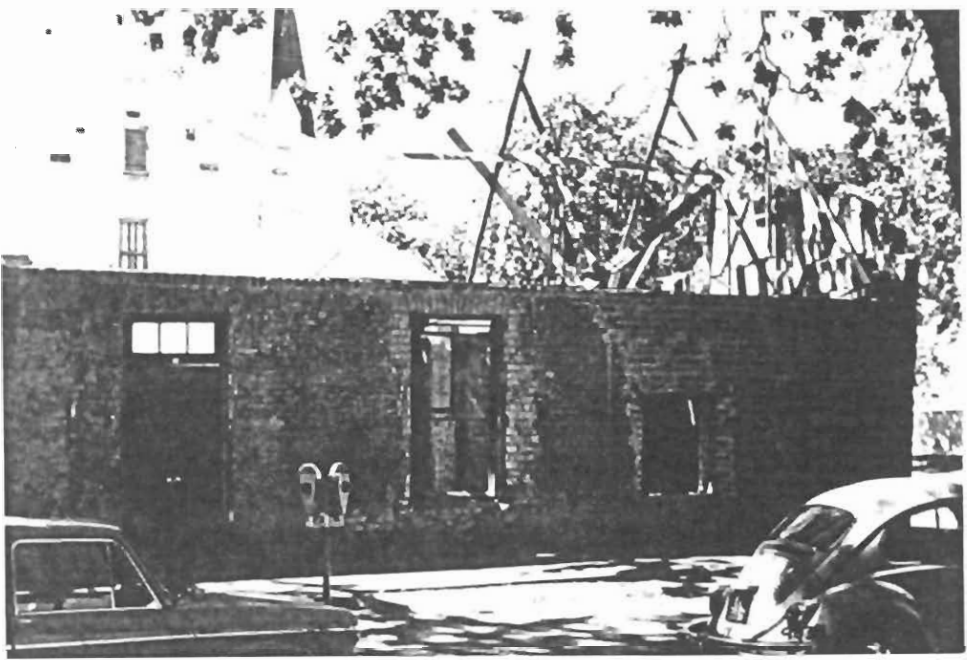
59. The restoration of Schreuderhuis lasted from about 1972-1975. Here the Victorianised façade is reconstructed (looking E)(Le Roux 1975).

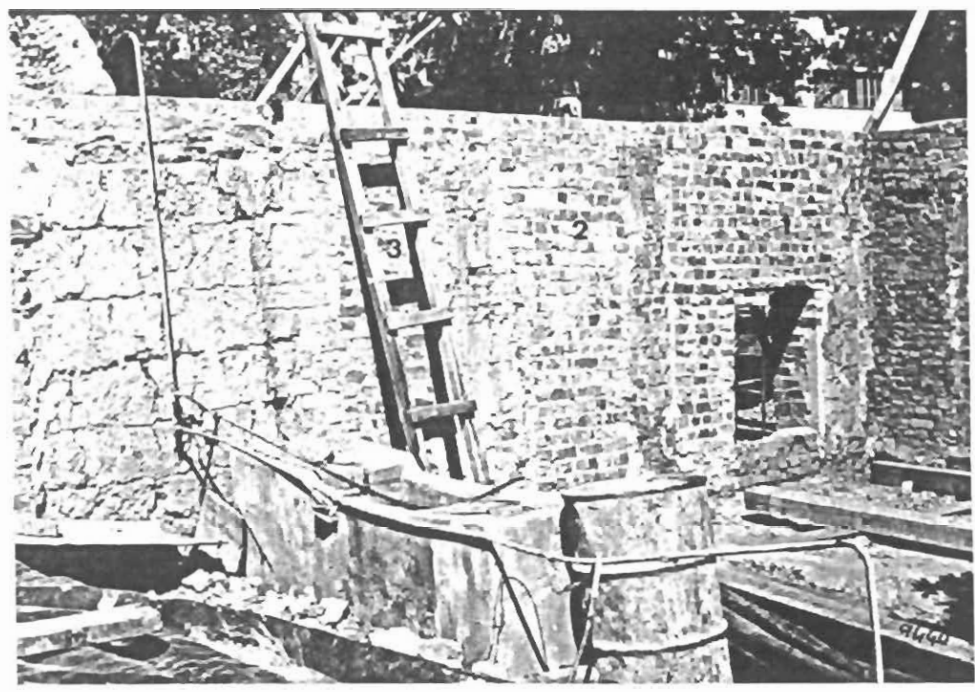
- reused brick 1975
- reddish low-fired brick
- yellowish raw brick
- reddish low-fired brick

60. The tail contained old openings that were blocked-up in 1975. Room D opening 1 contained a sash-window (now a c.1700 casement); opening 2 a door, which was reopened after 1988, and it proved to be an 18<sup>th</sup> century doorway; opening 3 a previous window; Room E opening 4, which was a door by at least 1830, and still used as such during the RCC period 1910-1932. It was then closed-up and used as a cupboard with shelves.
