# SCHREUDERHUIS, STELLENBOSCH

AN OVERVIEW OF ITS EVOLUTION,  
HISTORY AND ARCHAEOLOGY  
WITH PARTICULAR EMPHASIS ON  
A KITCHEN, ROOM E  
NOVEMBER 2001

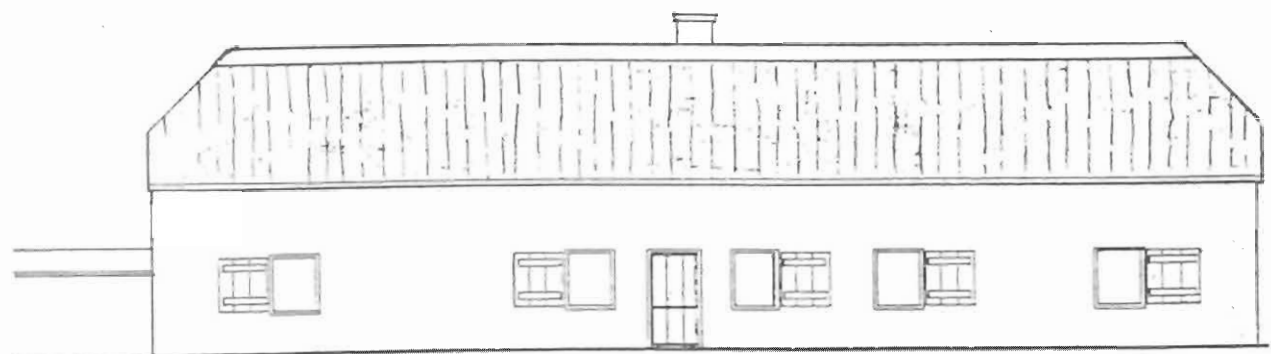
FIG.45.4 View of the façade of SH as it was restored to in 1975. The windows represented wax-immersed linen cloth (historically with whale oil), as gleaned from early 1800 sources (Based on a plan by Fagan 1975).

It should be borne in mind that Schreuderhuis was restored about eight years before the above was written, at a time when the points mentioned above were perhaps not all taken into account sufficiently (FIG.45.4). Numerous other papers on restoration or conservation were delivered at the same Symposium, i.a. one on *The role of archaeology in historic site restoration* (Vos 1982b), an aspect not initially addressed at Schreuderhuis (FIG.45.5).

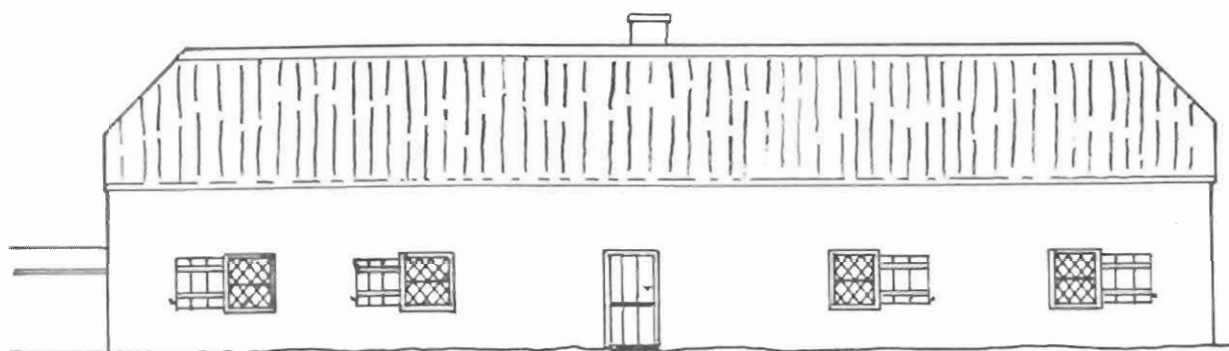
FIG.45.5 View of the façade of SH as it was altered to in 1990. This decision was only taken after thorough historical, structural and archaeological research. The existing window casements were then supplied with glazed panes in leaded comes, a common practice from 1670-1740 (see Vos 1989).

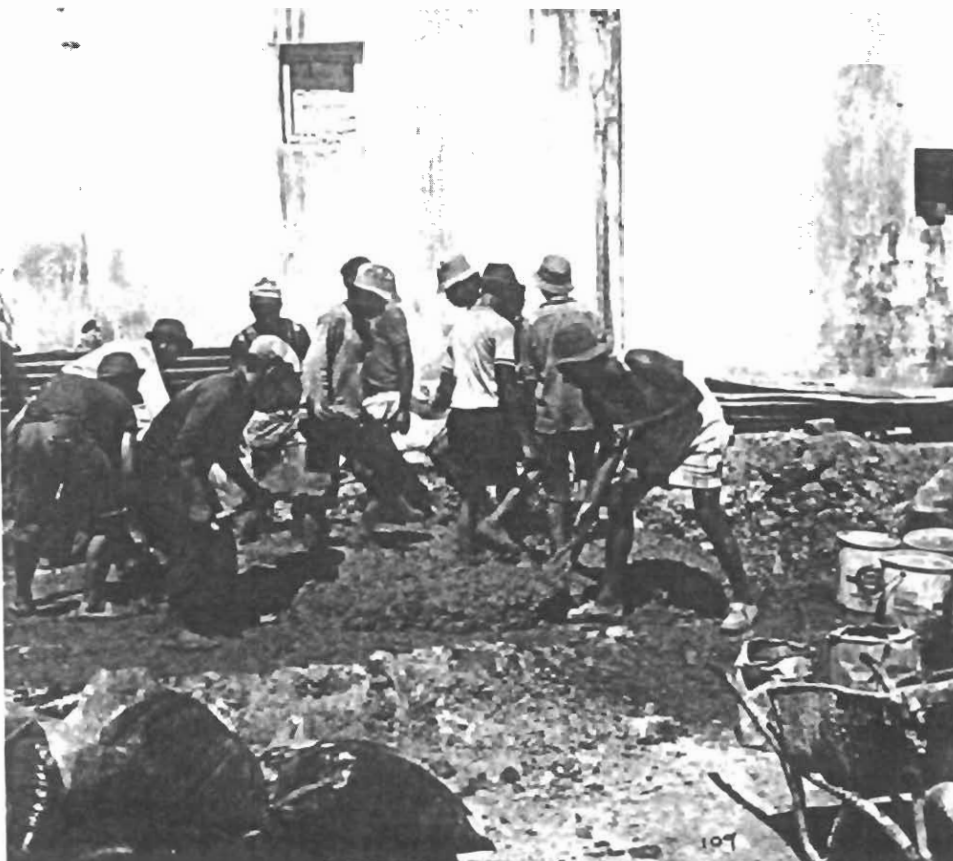
62. Men trampling the clay before it was cast as the clay floor for Schreuderhuis in 1975. Site was just behind SH with Berghhuis at the back (Vos 1975).

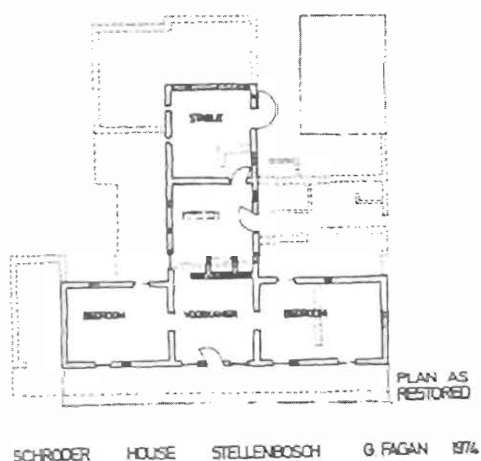
FIG.48 Schreuderhuis as it was approximately restored to in 1975 (Fagan & Fagan 1975).

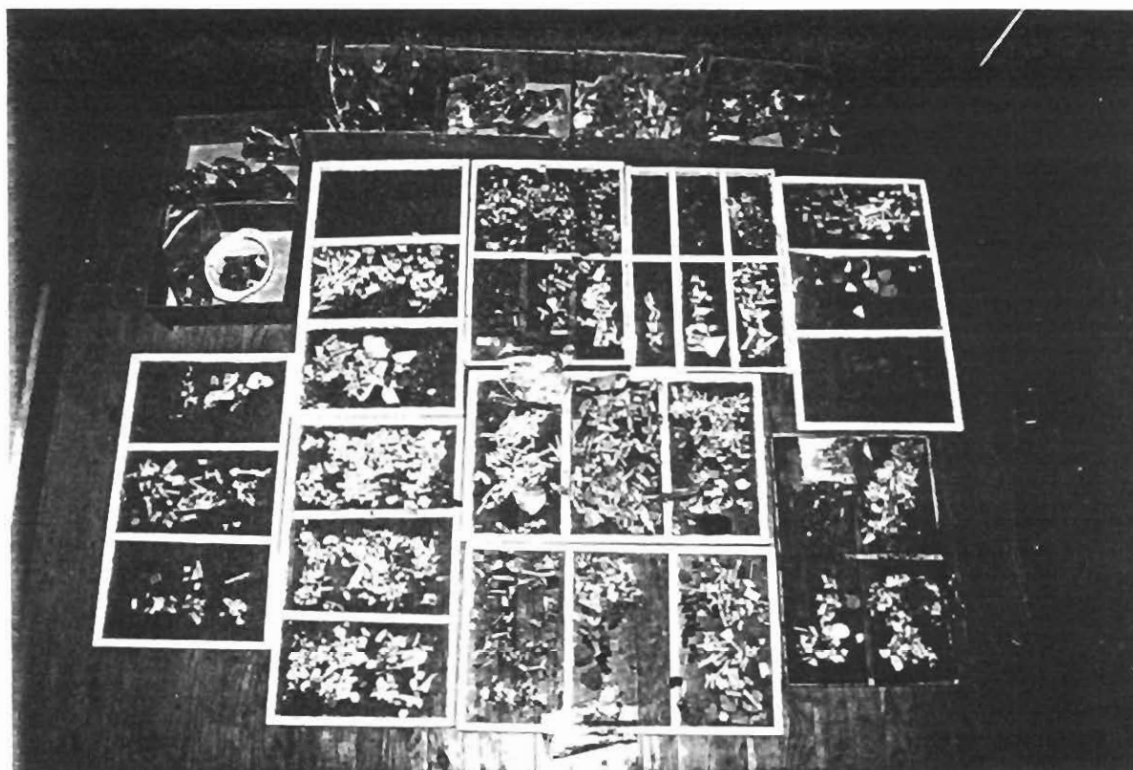
63. View of some of the excavated artefacts from Room E (units A and B). They are dried on mesh racks, and afterwards sorted and bagged.

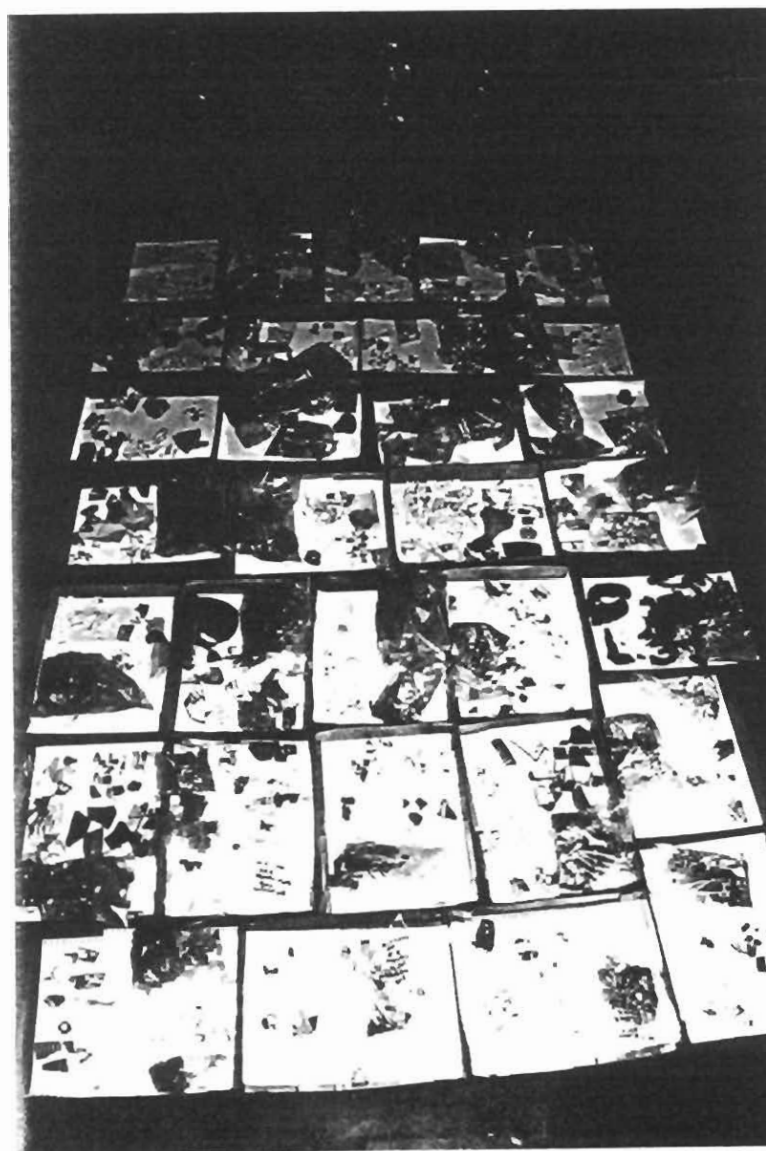
64. Most of the artefacts are laid out in trays to facilitate analysis, sorting and for photographing.
