PHASE 2 ARCHAEOLOGICAL INVESTIGATION: ALBION SPRINGS, RONDEBOSCH

LTA Developments (Pty) Ltd

Archaeology Contracts Office

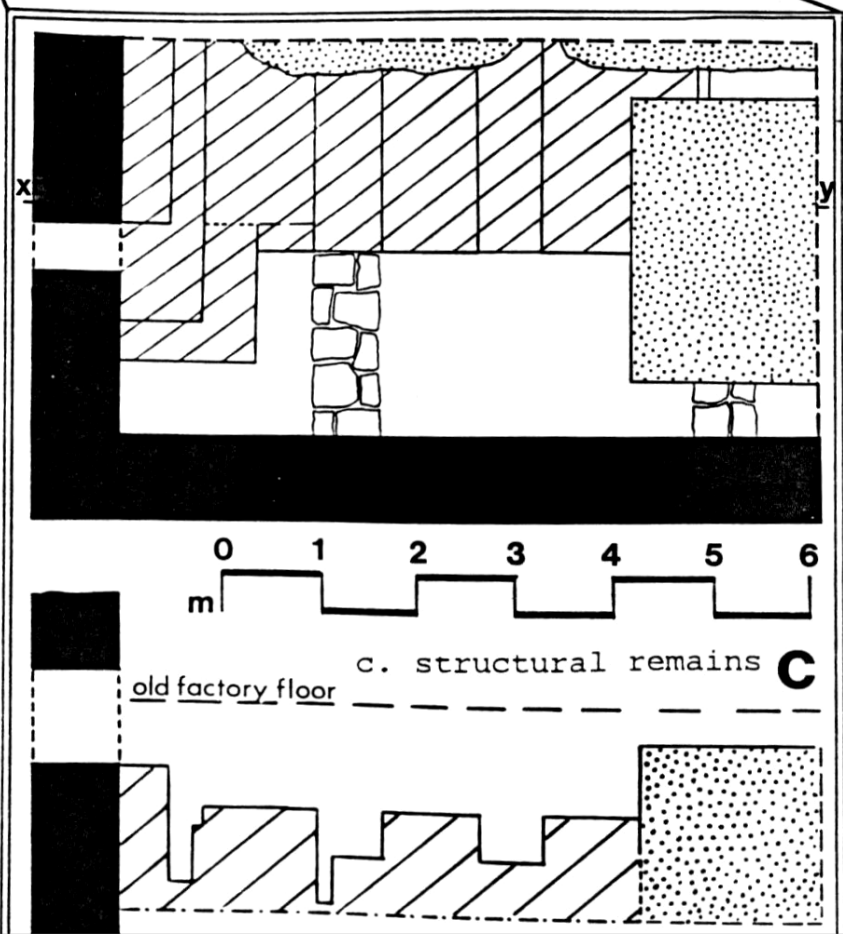
forced concrete

brickwork

rein

The position of the Phase 2 excavations and a plan of the structural remains are presented in Figure 2.1. Also shown are the mill remains located during the Phase 1 investigation superimposed on a plan of the Schweppes factory, and an extract from the 1862 plan of the Mariendahl estate. This extract shows the mill and other buildings located adjacent to the spring. We noted in the Phase 1 report that the orientation of the buildings on the plan did not correspond to the foundations that we uncovered and believe that the drafter of the plan might have mistakenly reversed the outline of the buildings.

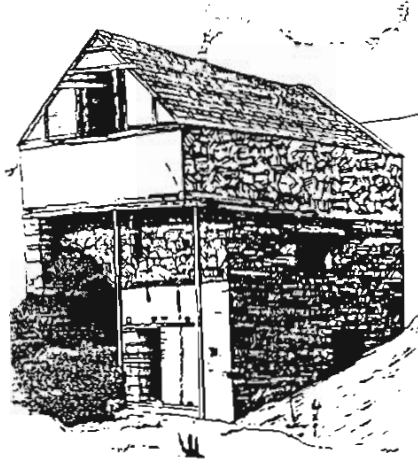
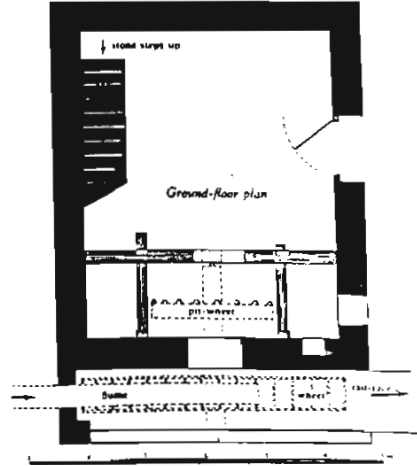
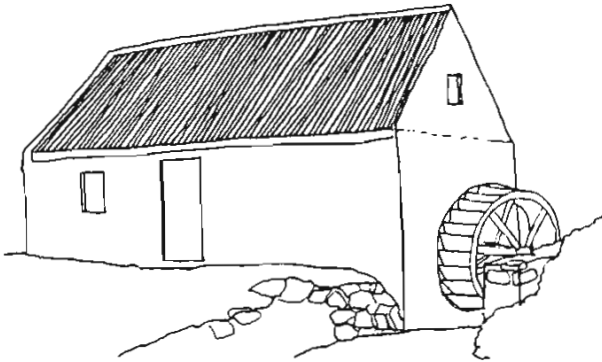
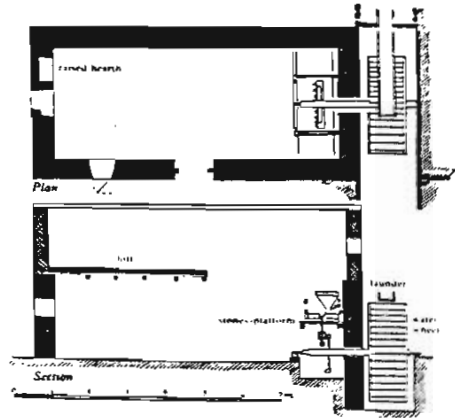
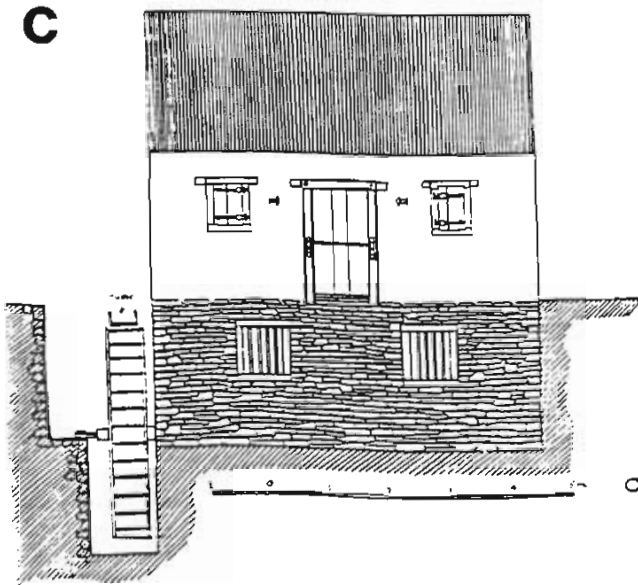
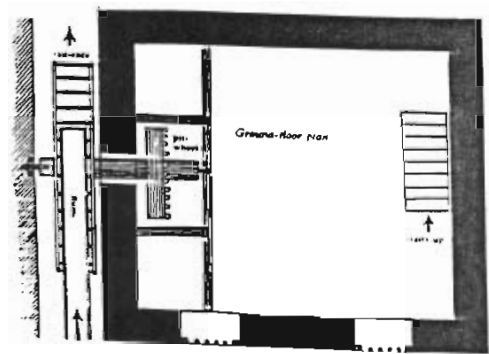
a. Bradshaws Mill - Bathurst

b. Verloren Vlei - Ceres

c. Cuyler Manor Mill - Uitenhage

After Walton 1974

The remains of a second wall lie 1.8 meters from the north wall. It is difficult to say that this is definitely a mill related feature as it is partially incorporated into the ice factory structures. The widths of both the stone walls are identical at 630 mm but smaller than many of the outer wall foundations which were located during the Phase 1 which measured between 850 and 950 mm thick. The location of the inner wall is in terms of its distance from the north wall suggestive of the width of a conventional gear pit in many mills. Some examples of mill plans are shown in Figure 2.2 in which this feature can clearly be seen.

Photographs 3 and 4, showing portions of the Mamre and Elim mills respectively seem to contain striking similarities to aspects of the Albion Mill that have been identified during the investigation. Both have off-center wheels and in addition both are fed from raised wooden mill streams which can also be seen in the photographs. Although no ground plans of these mills are presented they appear larger than those in Figure 2.2 and we imagine that the Albion Mill would originally have resembled these.

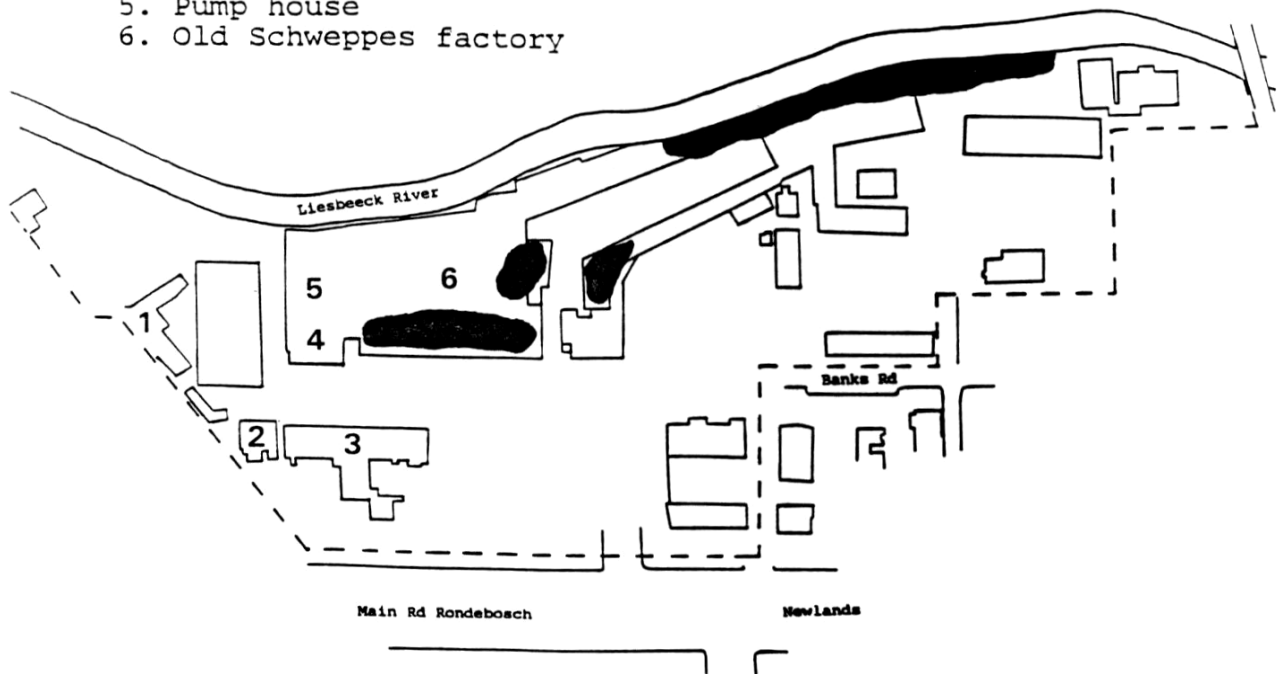
3.1

1. Manager's house
2. Foreman's house
3. Administration building
4. Albion spring
5. Pump house
6. Old Schweppes factory

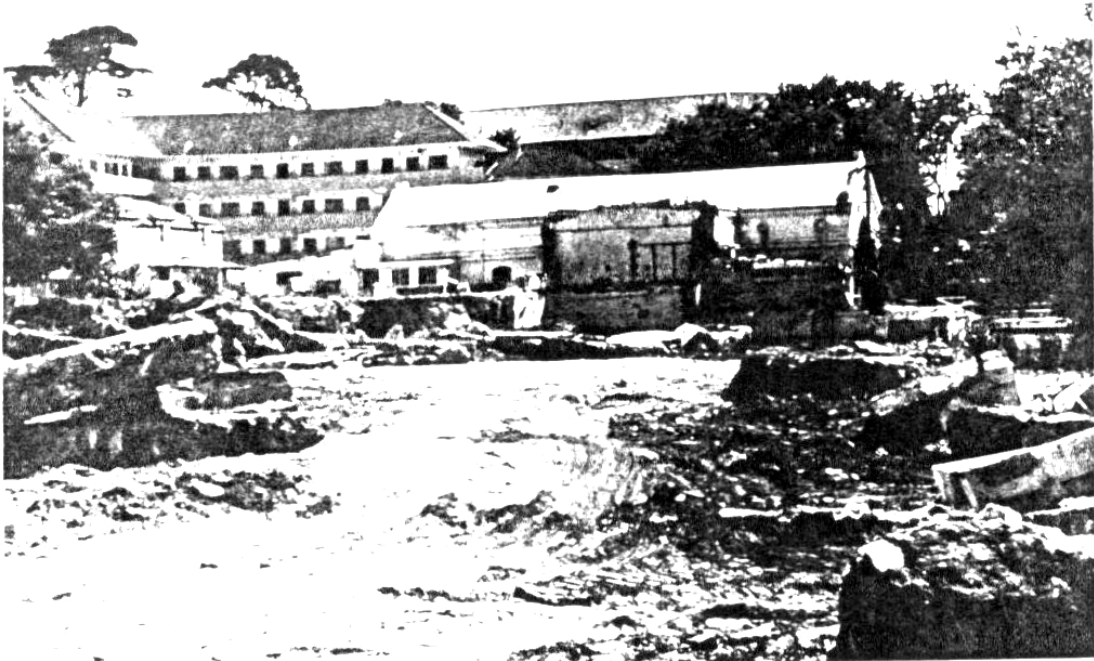
Photograph 1: Outline of the old mill core adjacent to the pumphouse

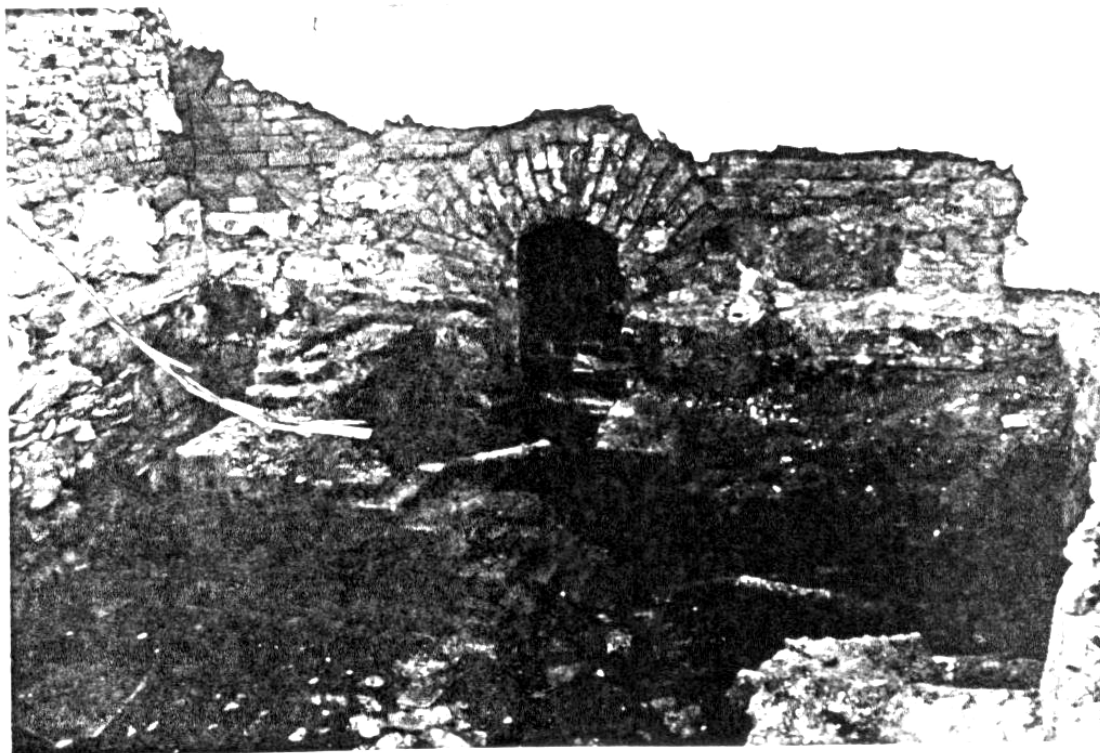
Photograph 2: Axle aperture of Albion Mill and brick features related to the ice factory

Our first interpretation was that water from the spring was entering the channels via a hole in the base of the north wall where some stonework has obviously been removed (see photograph 2). Water seems to be able to flow freely through this gap at present and in fact presented problems during the course of the excavations until the City Council agreed to lower the level of the water in the spring reservoir. Even after pumping water was still present in the substrate albeit at a lower level than previously.
