AFRICAN HERITAGE CONSULTANTS CC

CULTURAL HERITAGE RESOURCES IMPACT ASSESSMENT FOR PROPOSED UPGRADING OF THE LOW-LEVEL BRIDGE AT CROCODILE BRIDGE, KRUGER NATIONAL PARK

February 2008

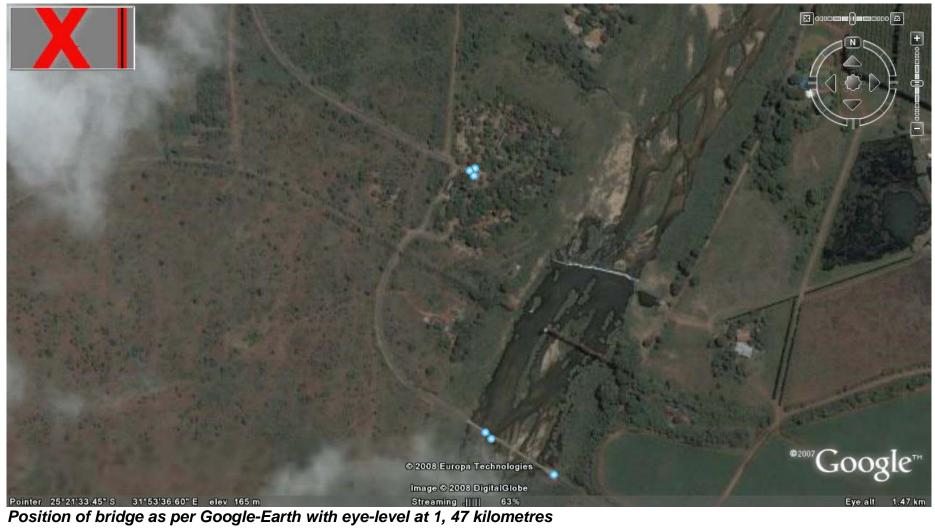
GPS Position of the property under investigation.

1 25° 21' 33.45" South 31° 53' 36.60" East
