HERITAGE IMPACT ASSESSMENT: HISTORIC ELEMENTS AT ESKOM PARK, WITBANK

FINAL REPORT

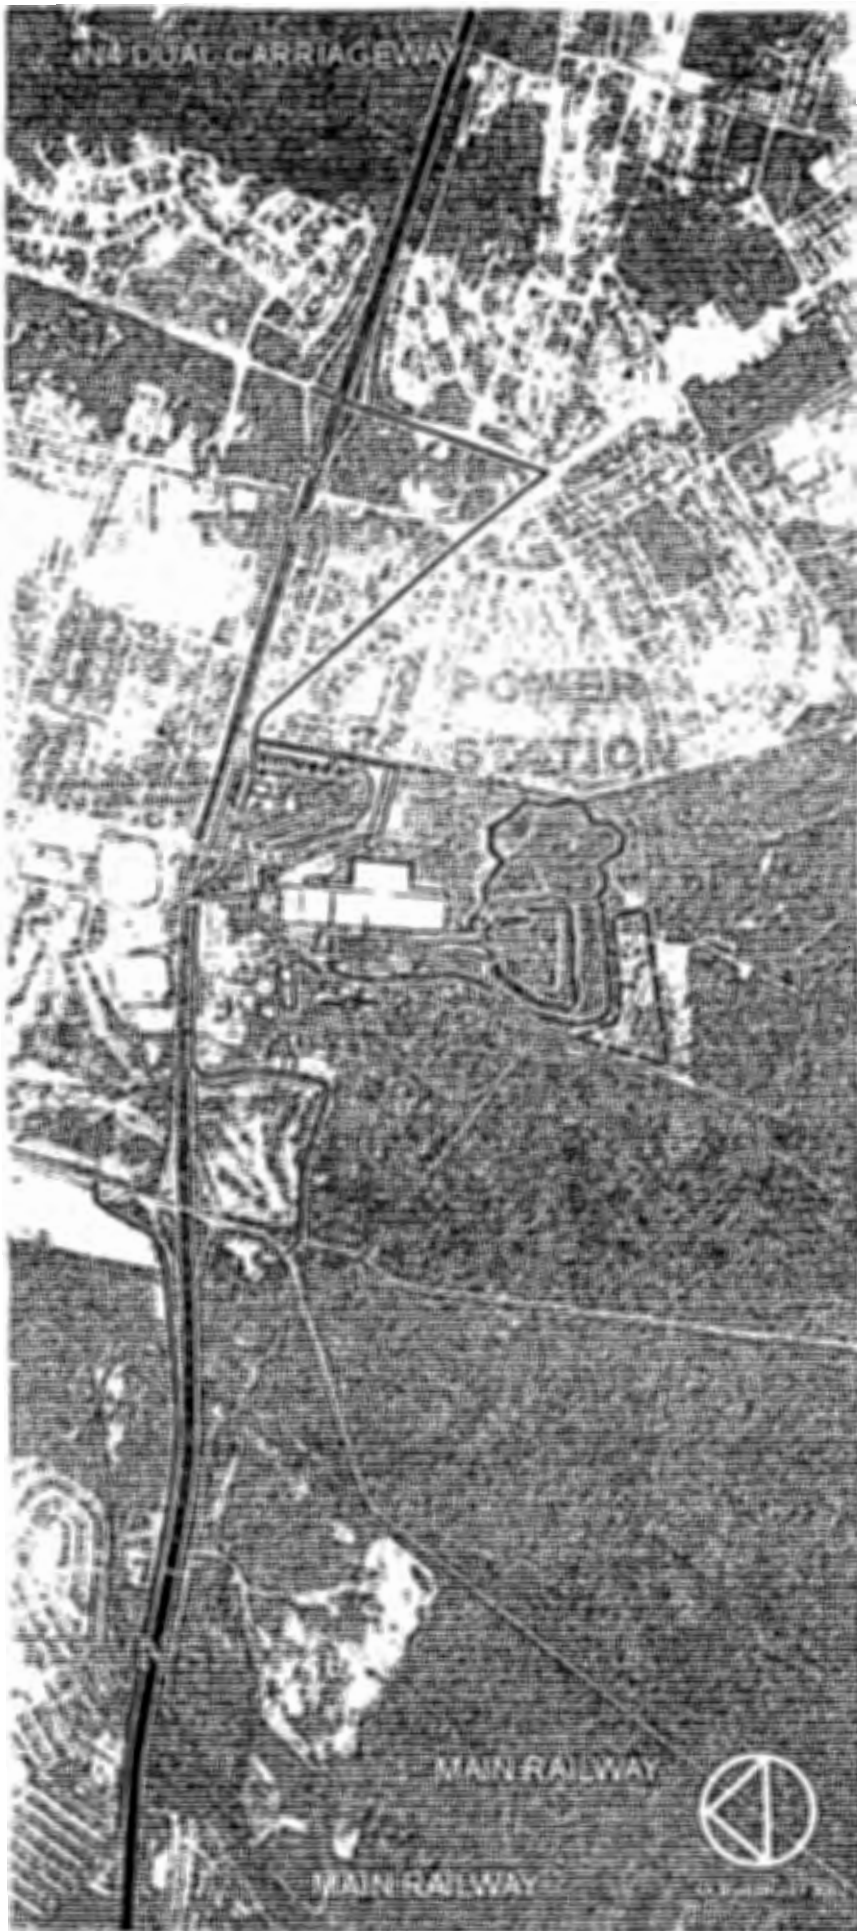
Figure 8 Relationship between Power Station and resources in 1976.

Figure 8: Relationship between power station and resources in 1976

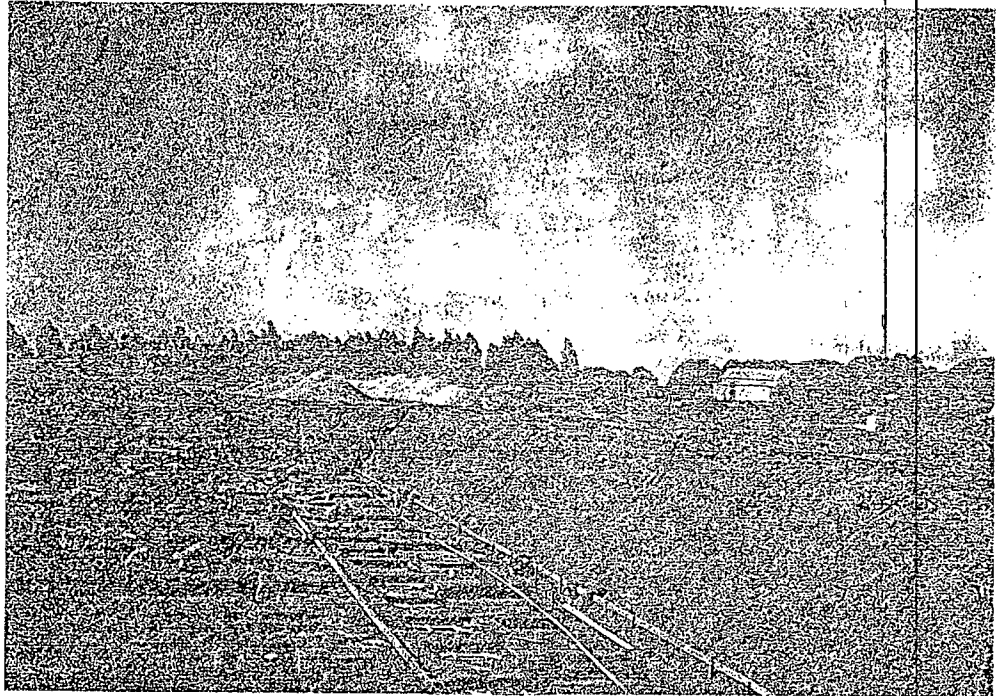
A) View of excavations from substructure foundations in Boiler House (East side), 18/1/25 (VFTP W113).

B) Erection of the 1st building column in the south east corner of the Boiler House, 15/1/25 (VFTP W150).

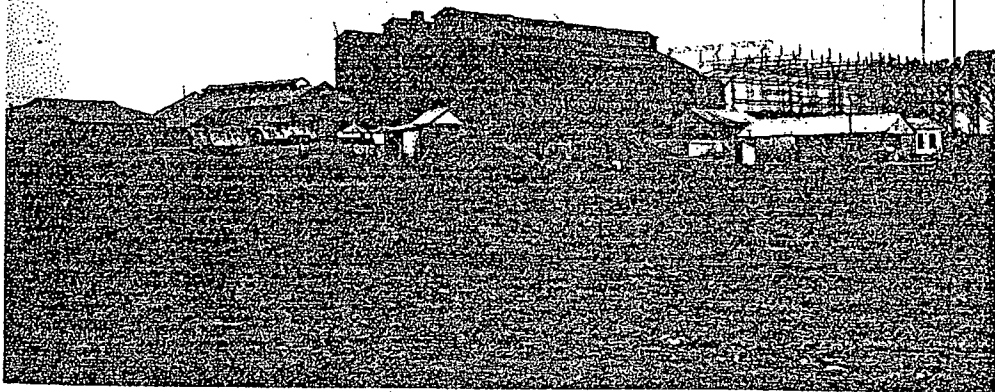
- A) 132KW structure, gear and lines to Brakpan (ESCOM, 5067, photo by Gibbons).
- B) Distant view of station looking south east, 29/9/26 (VFTP W339).

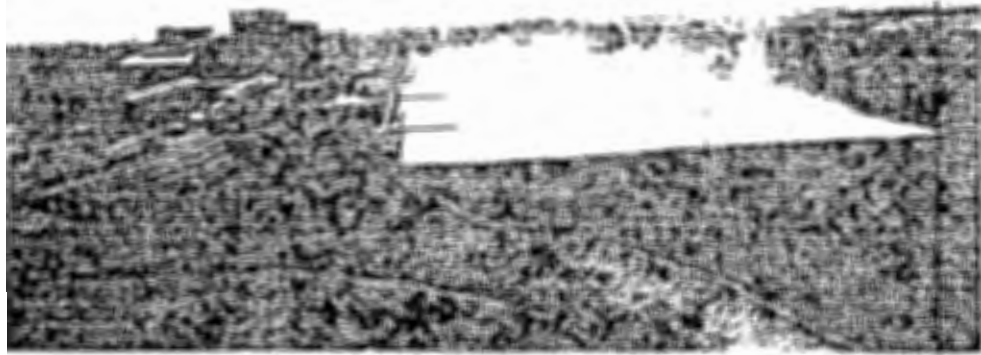
- A) View of power station and cooling ponds from south (ESCOM, 8635, photo by Gibbons).
- B) View of cooling ponds from south-south west (ESCOM, File 9, *sine anno*, no number).

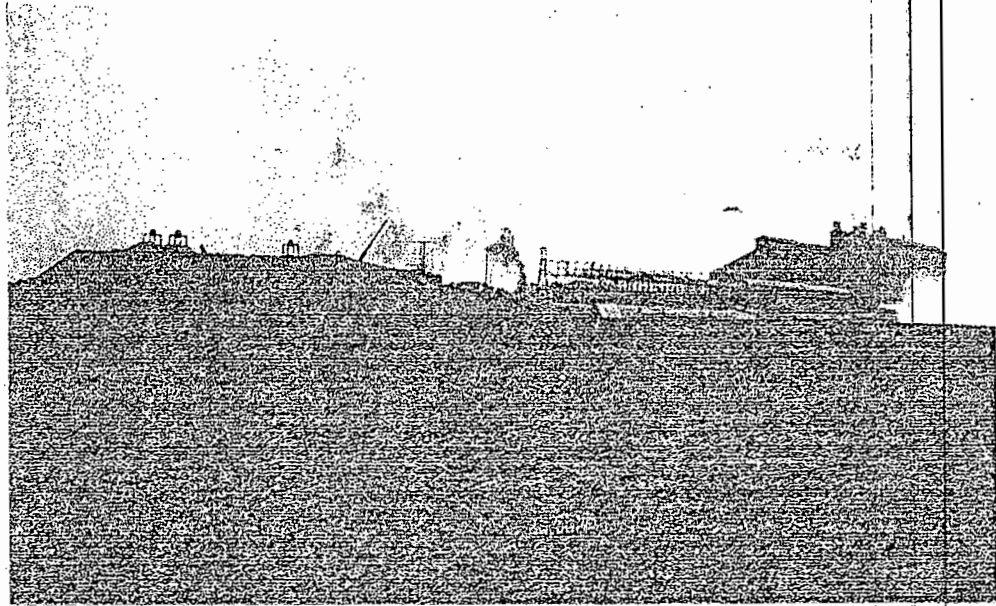
- A) Distant view of station looking north [showing ash dump], 29/9/26 (VFTP W344)
- B) View north from ash dump, 5/3/1929 (VFTP W413).

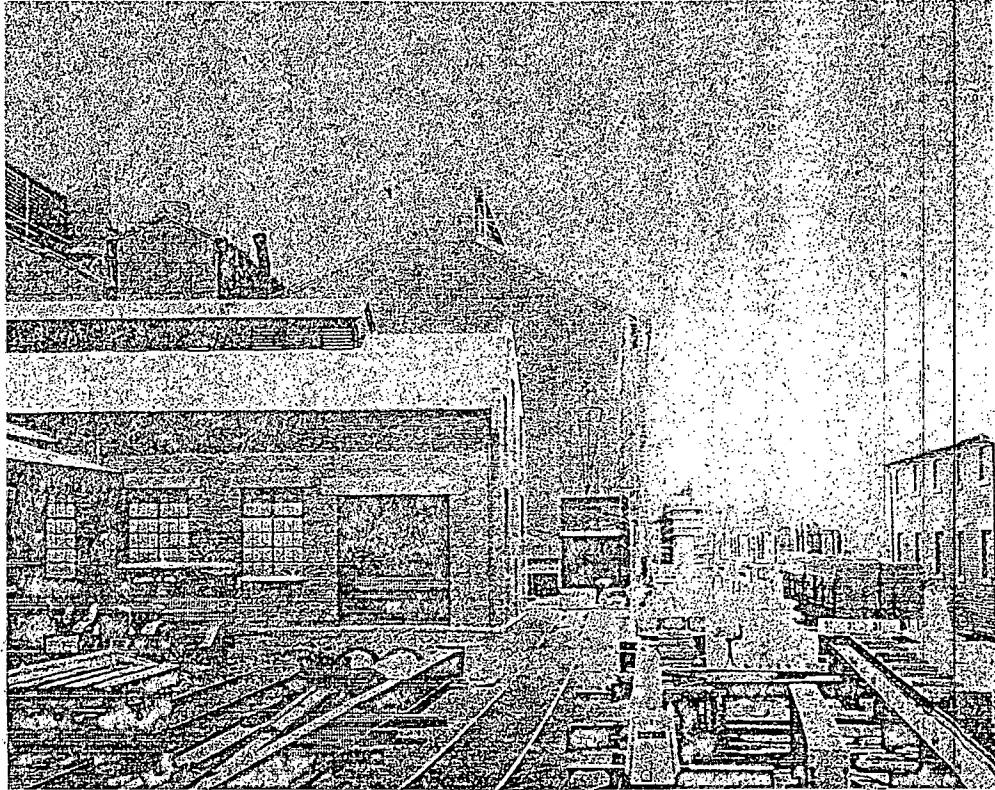
A) View showing assembling and riveting steelwork for Turbine House extension [workshop and other maintenance buildings north of Turbine House, 29/10/1929 (VFTP W439).
